Class One Arboriculture
2832 Manhattan Ave
Glendale, CA 91214
(818) 495-5344

December 24, 2015

On December 21, you sent me an assignment to inspect ***Redacted***. You asked me to inspect and identify the tree in the front yard of the property and to determine if it was responsible for the damage to the driveway of the adjacent property at ***Redacted***. My observations indicate that the tree caused the displacement of the western portion of the driveway.

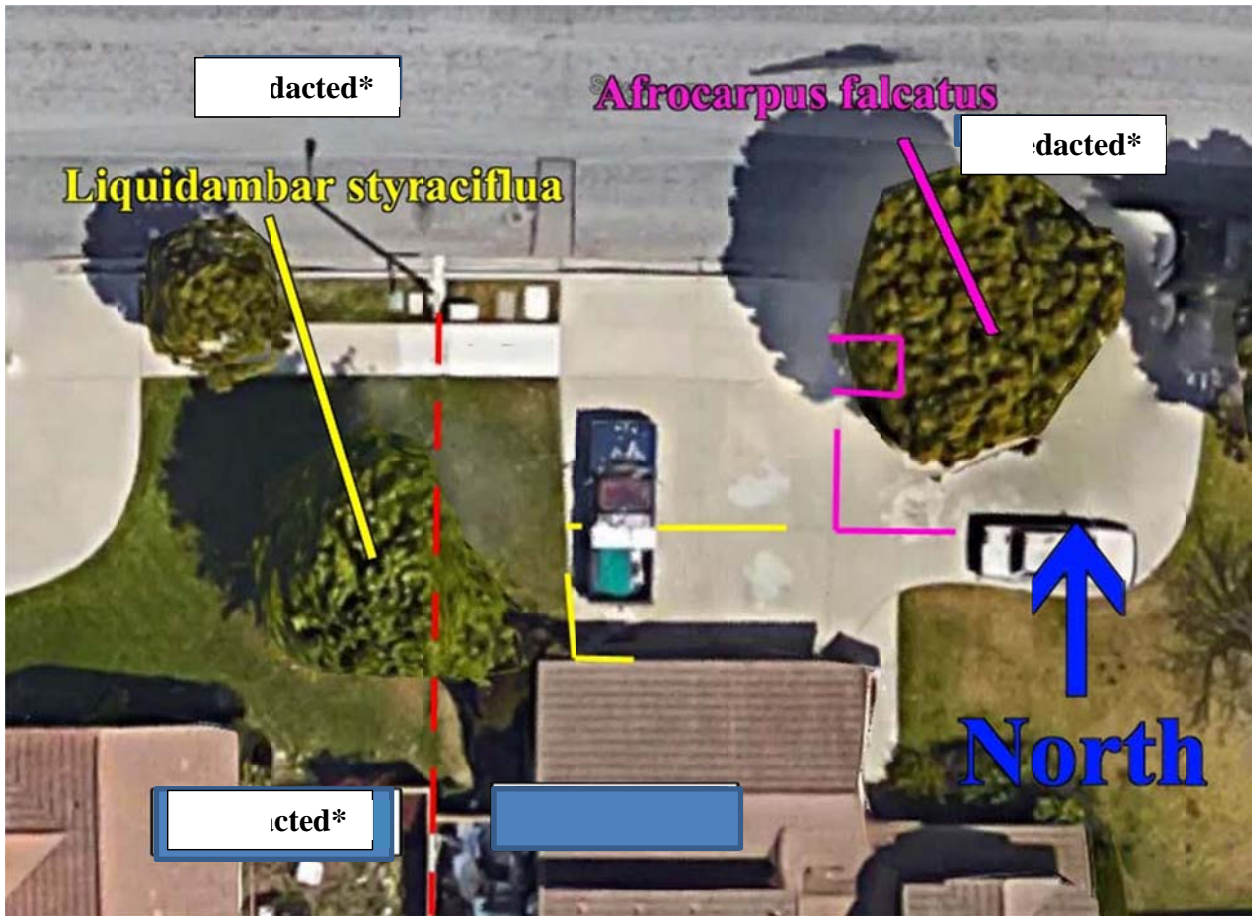
Figure 1: Site map showing the subject *Liquidambar* tree (yellow), the neighboring *Afrocarpus* tree (magenta), and the driveway displacement observed by each tree respectively. The property line is shown as a red dashed line.

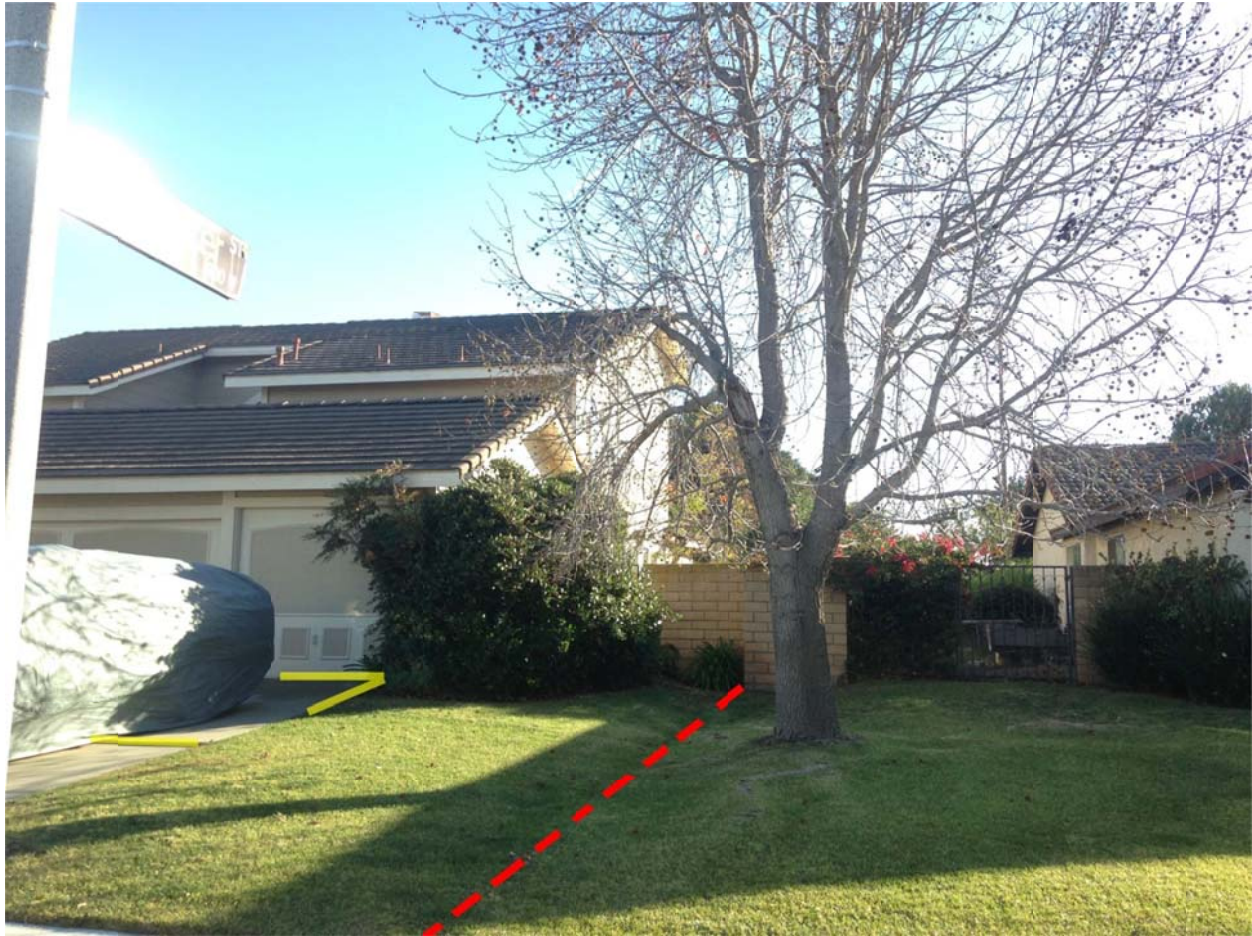
Immediately adjacent to the driveway, there is a shrub of *Rhaphiolepis indica* mixed with a small sprout of *Nandina domestica*. Neither of these are root-aggressive plants, and it is unlikely they caused the driveway displacement. The displacement is greater on the section of the driveway nearer to the *Liquidambar* tree and further from the shrub, suggesting the shrub is not the cause of the problem.

Figure 2: Looking south at the subject *Liquidambar* tree. The driveway displacement is highlighted in yellow. The *Raphiolepis* shrub is next to the garage. It is not likely that this shrub caused the driveway displacement. The displacement in the middle of the driveway (far left) was approximately 1.5 inches, and the displacement nearest to the garage was approximately 1 inch.

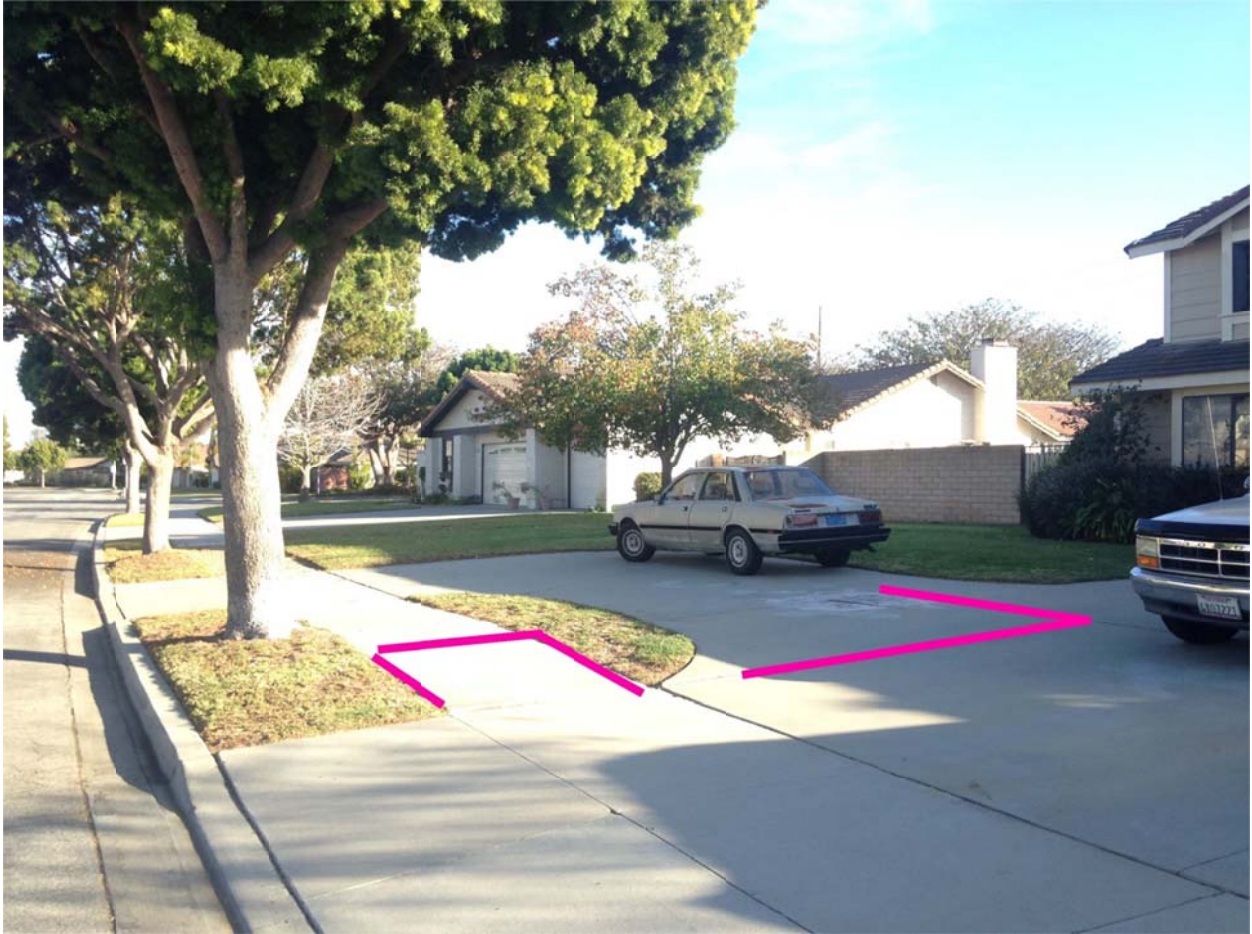
There is only one other tree adjacent to the damaged driveway. This *Afrocarpus falcatus* is growing in the street median strip to the north of the driveway and is showing evidence of lifting portions of the pavement as well. The pattern of concrete displacement indicates that both the *Afrocarpus* tree and the *Liquidambar* tree are causing the driveway to lift in different places. The *Afrocarpus* appears to be displacing the north and eastern portions of the driveway, and the *Liquidambar* tree appears to be displacing the southwestern portion of the driveway. The displacement is greater closer to each respective tree, ranging from 1.5 inches displacement near the trees down to 0.5 inches displacement about 10 to 20 feet further away.

Figure 3: Looking southeast. The next closest tree to the neighbor's driveway is the *Afrocarpus* tree (left) growing in the street median. It appears to be causing the concrete displacement highlighted in magenta.

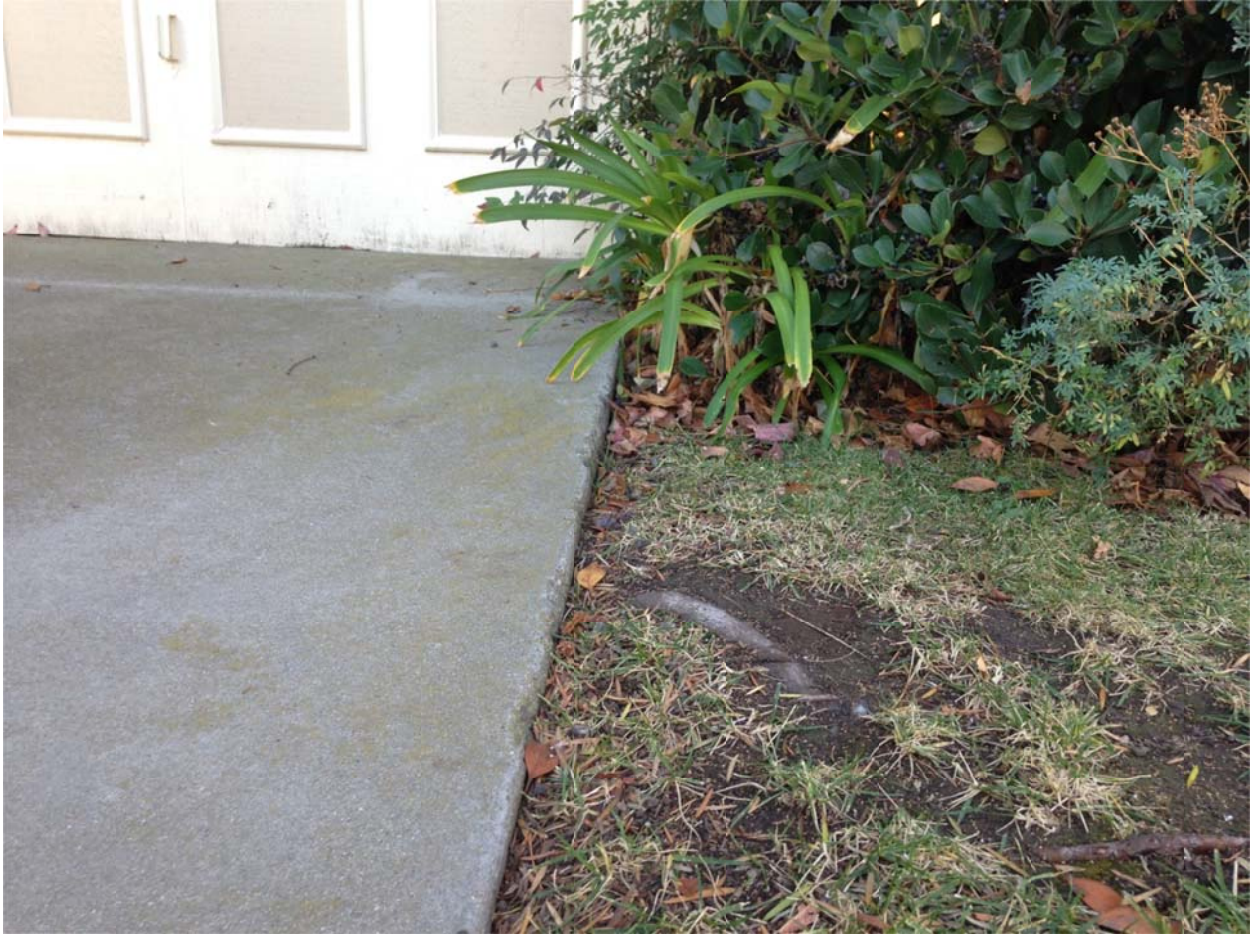
The subject driveway shows evidence of strong displacement. A portion of the driveway has lifted by as much as 1.5 inches, and another section near the garage door has lifted far enough to prevent the garage door from being opened.

Figure 4: Close up of the displacement in front of the garage door. The displacement of the concrete is approximately 1 inch, making it impossible to open the garage door. The surface root seen at the center of the photo is not likely from the *Rhaphiolepis* shrub. Rather, this is likely a surface root from the subject *Liquidambar* tree.

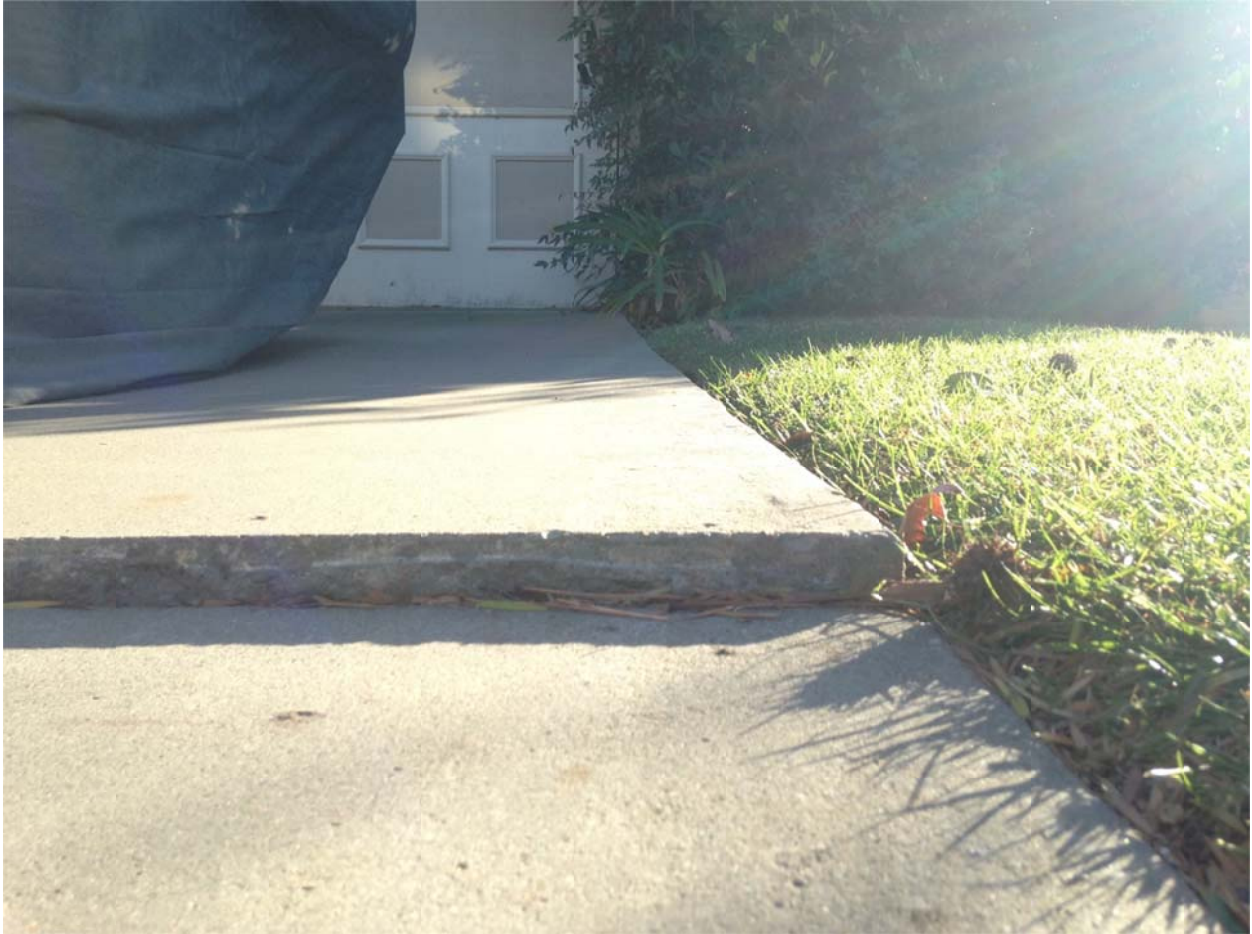
Figure 5: Close up on the displacement towards the middle of the western portion of the driveway. The displacement is approximately 1.5 inches.

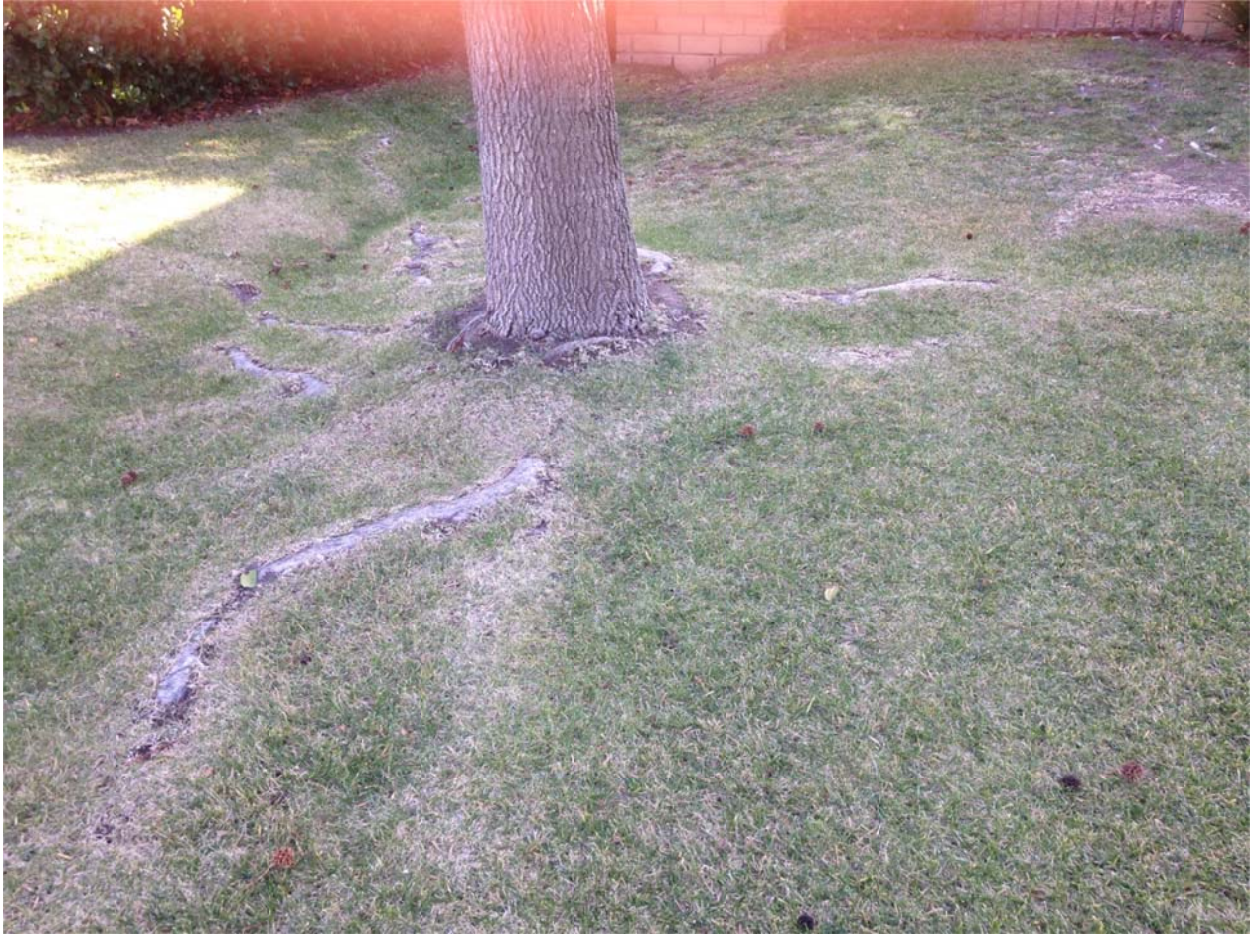
Redacted told me that she had maintained her lawn herself up until about 4 years ago when she and ***Redacted*** hired a gardener. She told me that there had not been significant surface rooting while she was caring for the lawn. After she hired the gardener, she did not pay attention to the tree roots, and she only noticed the surface roots once they were pointed out to her by the neighbor.

Figure 6: Surface roots of the subject *Liquidambar* tree. These roots became apparent above the soil level in the last 4 years according to the client.
