California Water Service Earpod Tree Appraisal Report

Prepared for California Water Service
2632 West 237th St
Torrance, CA 90505

Prepared by James Komen
BCMA WE-9909B
RCA #555

April 5, 2018

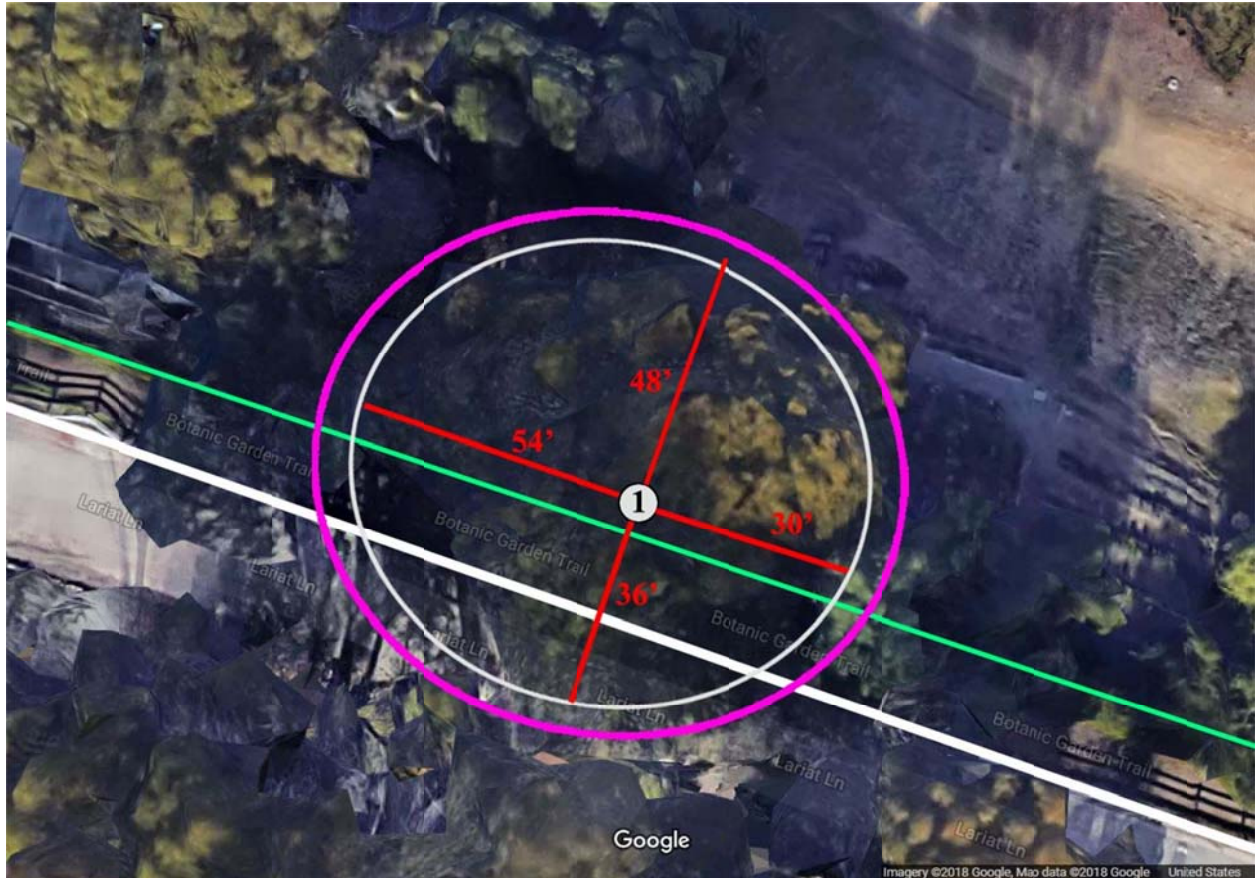
Figure 2: Site map of the subject Earpod tree showing the approximate trunk location and dripline in grey. The Tree Protection Zone is delineated by the purple ellipse, 5 feet beyond the dripline of the tree. The chain link fence along the southern property line is shown in green, and the white rail fence is shown in white. Canopy measurements are shown in red.

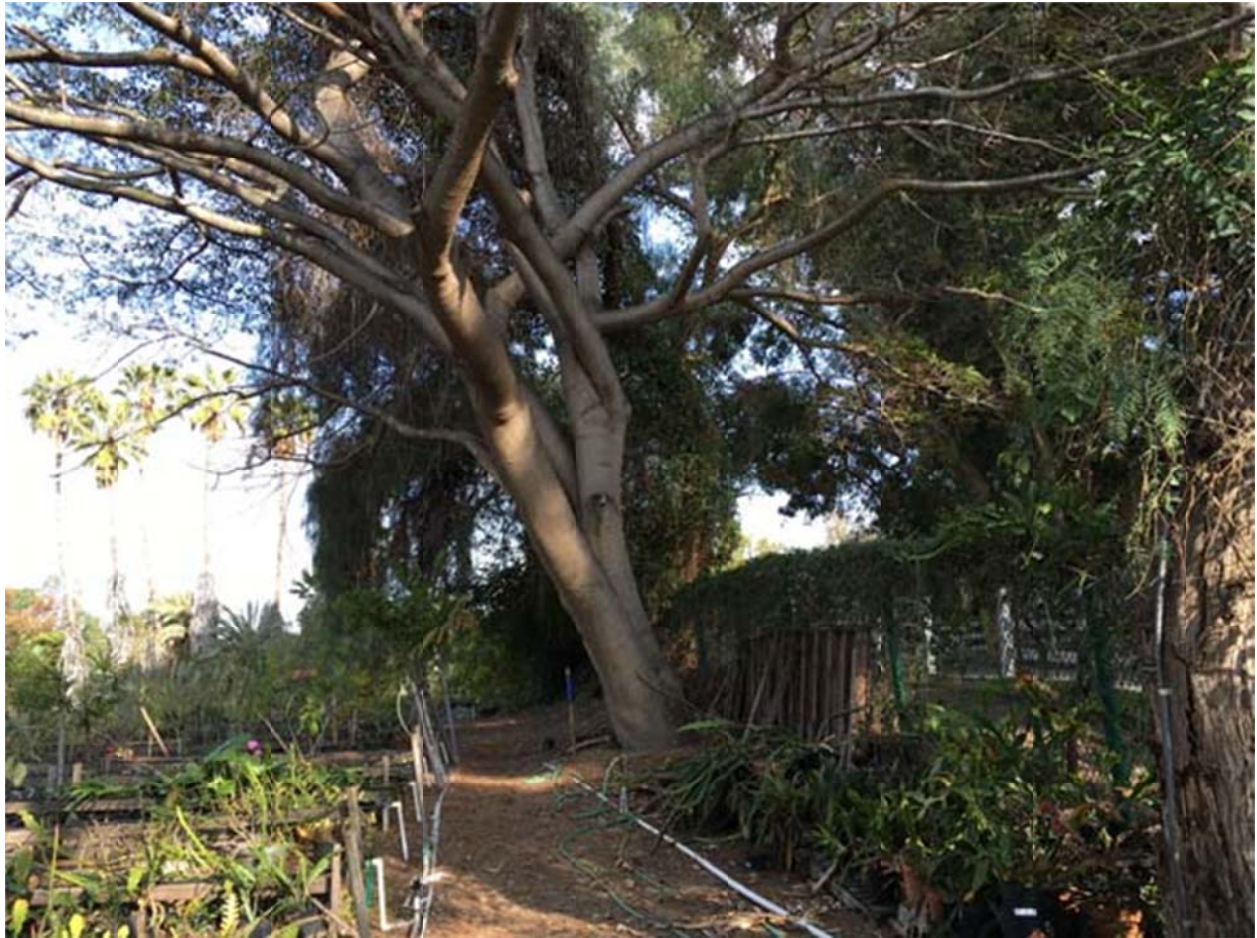
Figure 3: Looking southeast at the Earpod Tree. It has a large canopy that extends to the north over the botanic garden nursery (lower left) and a horse trail (right, behind chain link fence).

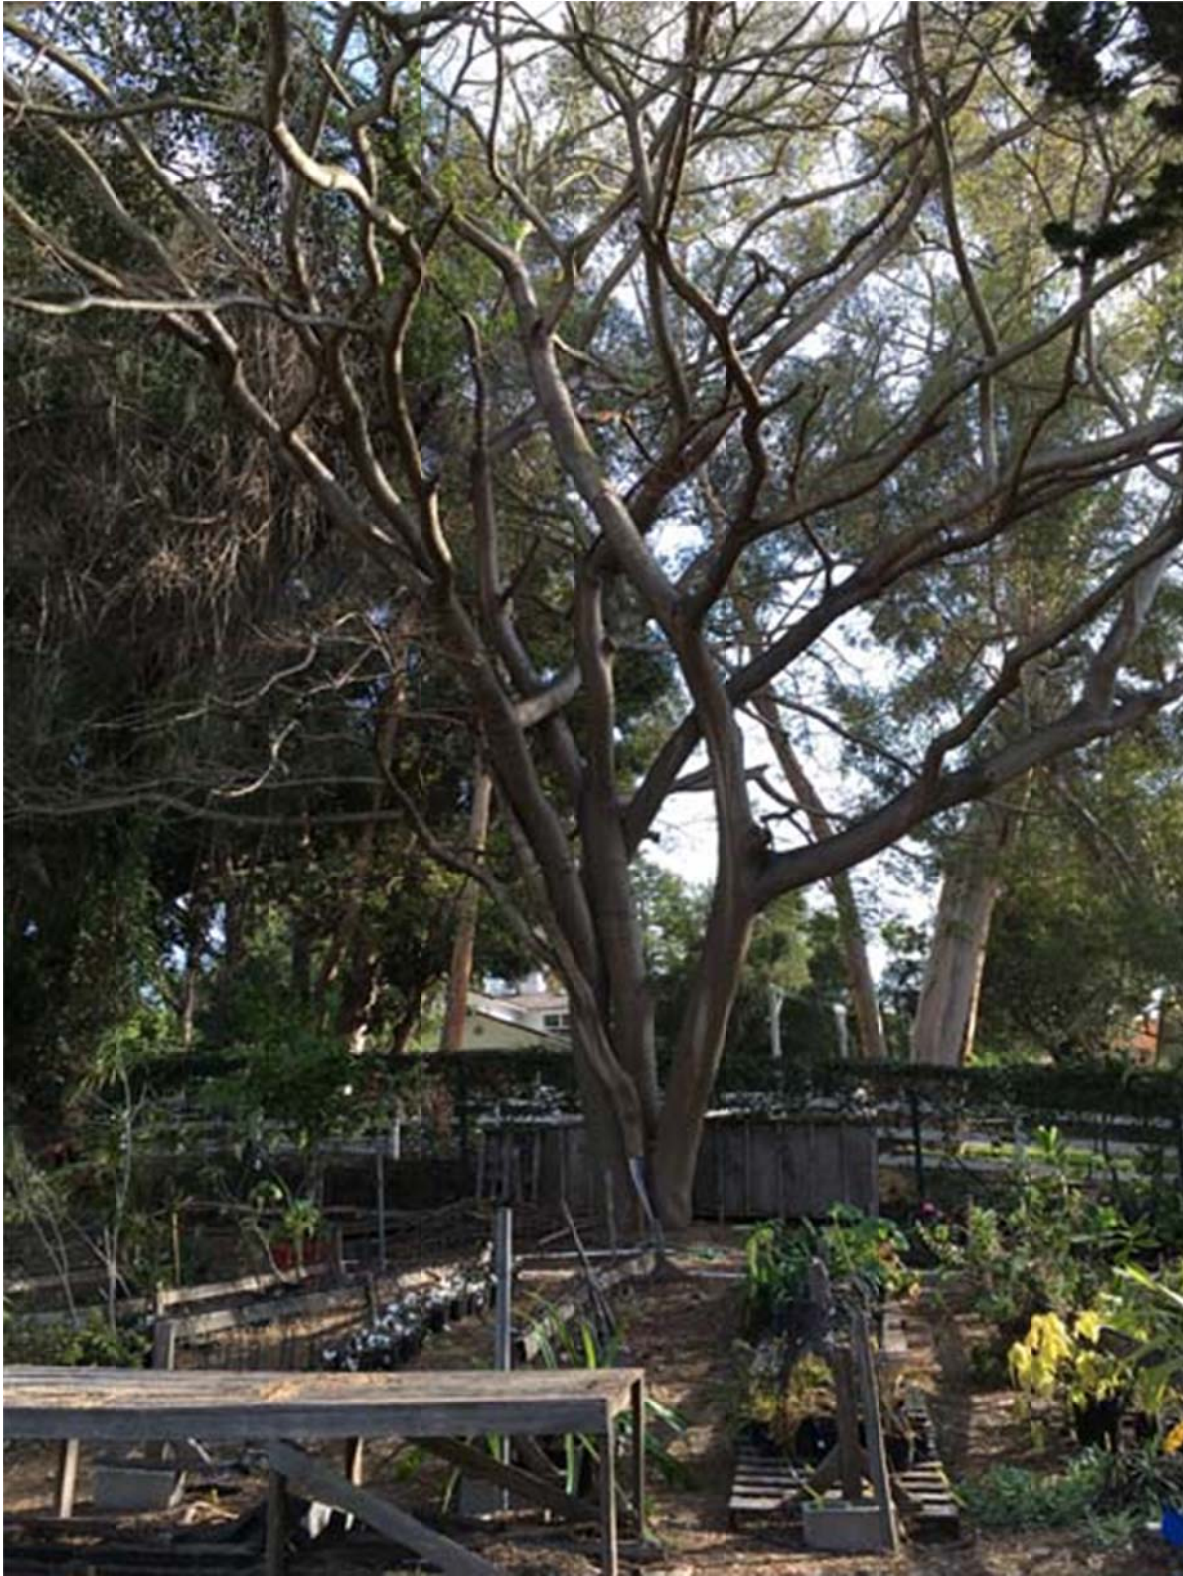
I rated the Scaffold Structure (SS) as 4 for No Apparent Problems. The tree was growing in a normal decurrent form for the species. There was a slight bias of the canopy to the northeast, but the amount of asymmetry was not significant enough to justify a rating of a minor defect.

Figure 4: Looking southwest at the Earpod tree. It has a normal form for the species.

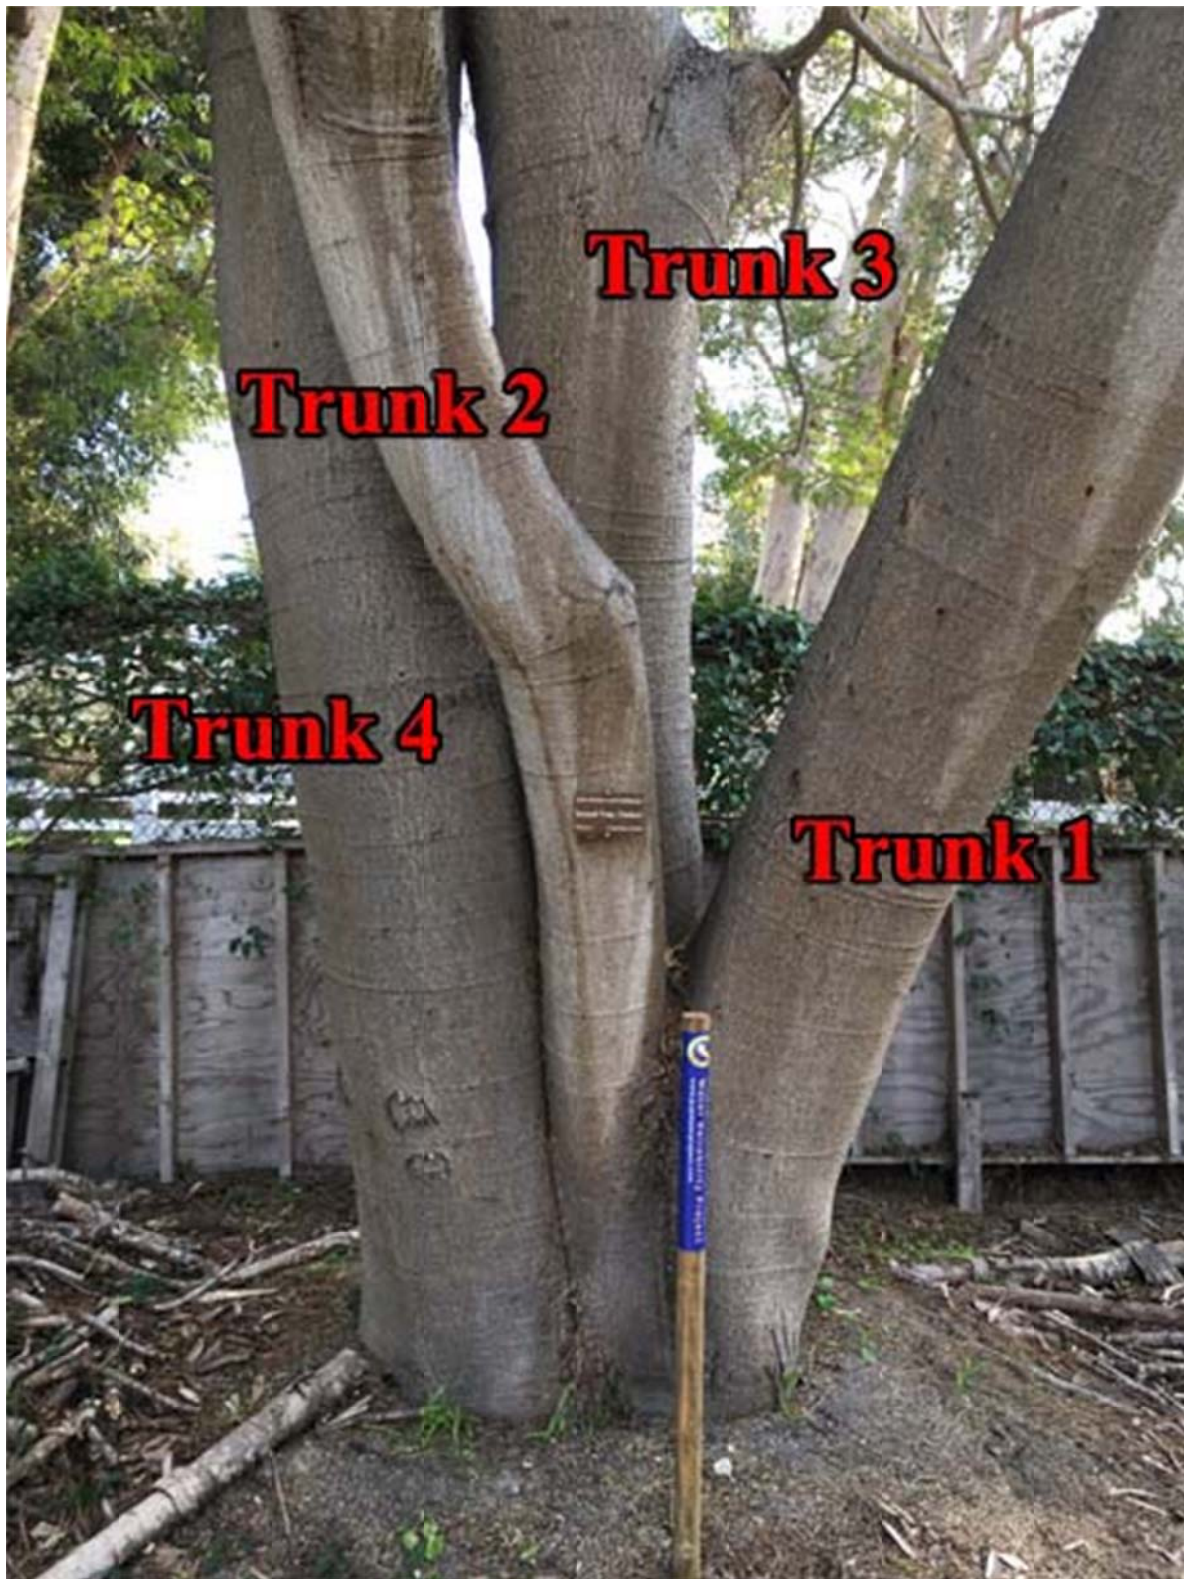
I rated the Trunk Structure (TS) as 2 for Major Problems because there are four co-dominant stems growing tightly together at narrow angles of attachment. The narrow angles of attachment and correspondingly high aspect ratios between adjoining trunks create weak attachment unions that are known for their elevated likelihood of failure when loads are applied. I would have rated the defect as a minor problem if there were a large central stem with significantly smaller co-dominant stems. Here, three of the stems are all approximately the same size. I would have rated the defect as an extreme problem if there were active cracking along their unions. I did not observe active cracking. Therefore, I assigned a rating of Major Problems.

Figure 5: Looking southwest at the labeled trunks of the Earpod tree. There are four trunks with narrow angles of attachment and high aspect ratios.

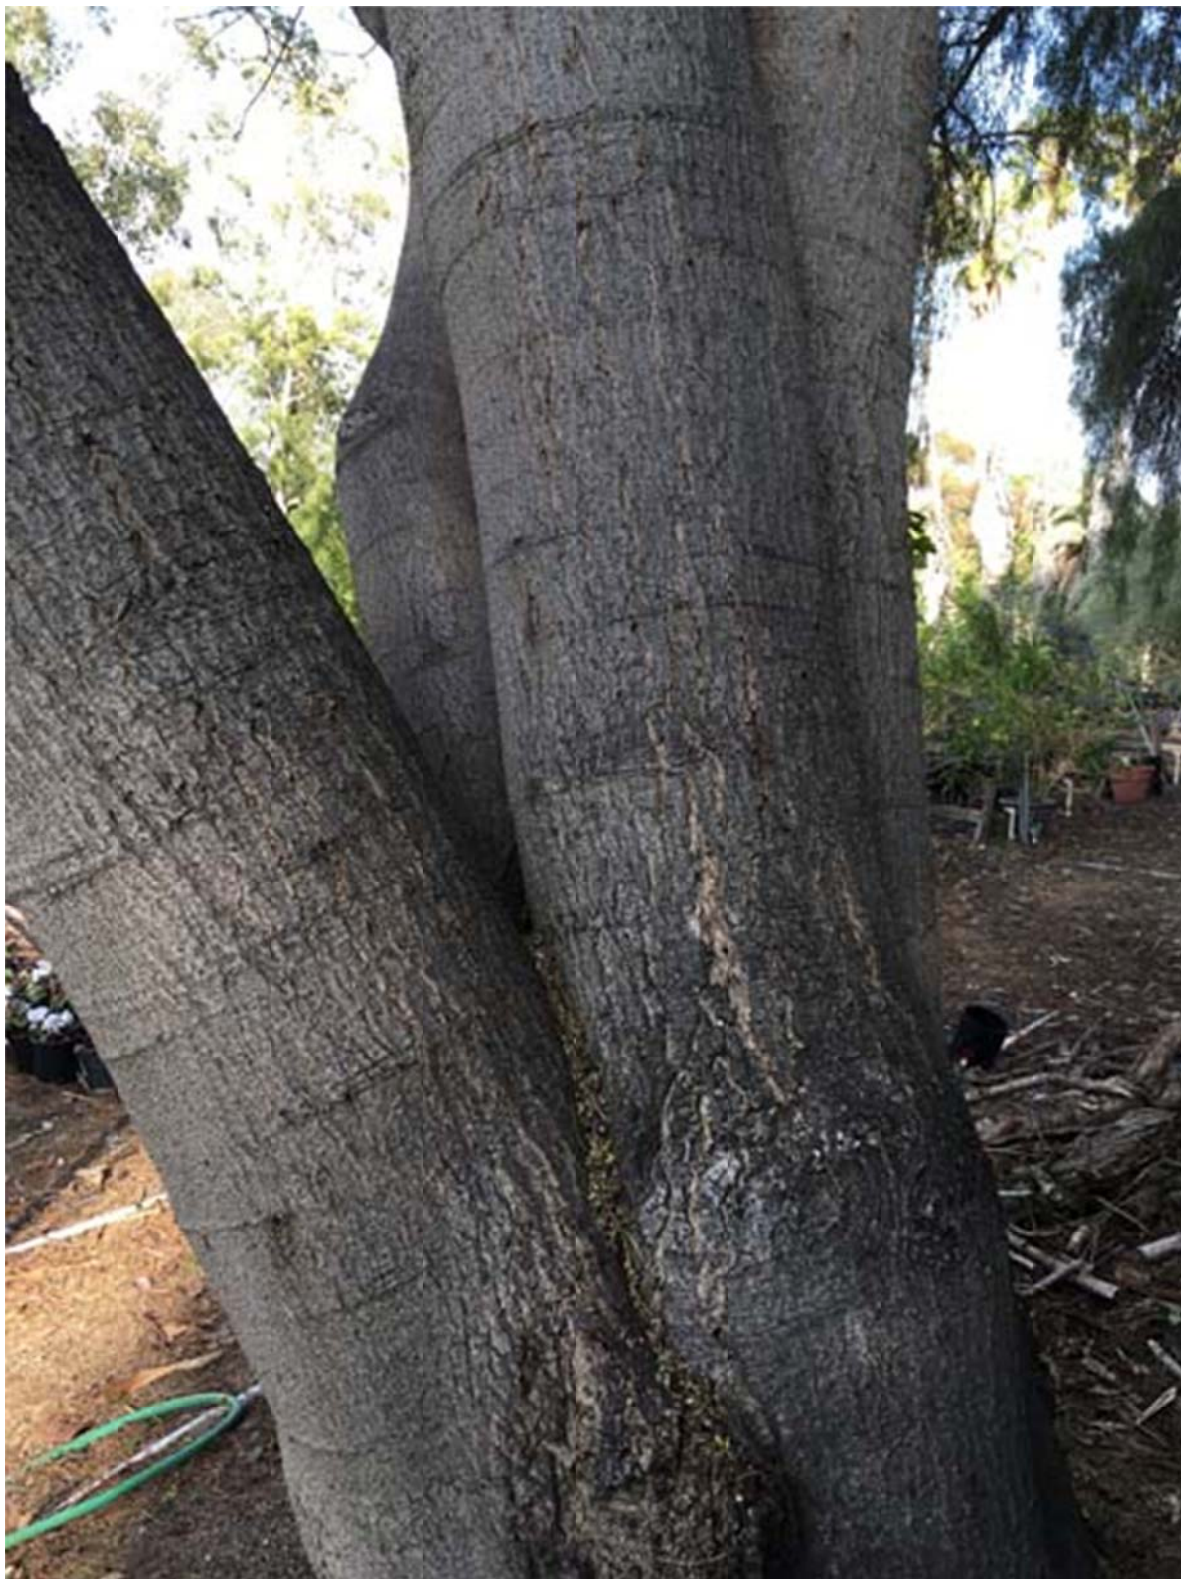
I rated the Trunk Health (TH) as 4 for No Apparent Problems. I observed striations on two of the trunks, but the striations were growth cracks, not stress cracks. They indicate the tree is healthy and growing rapidly.

Figure 6: Looking east at Trunk 1 (left) and Trunk 3 (center). These trunks have growth striations, indicating the tree is healthy and rapidly depositing tissue.

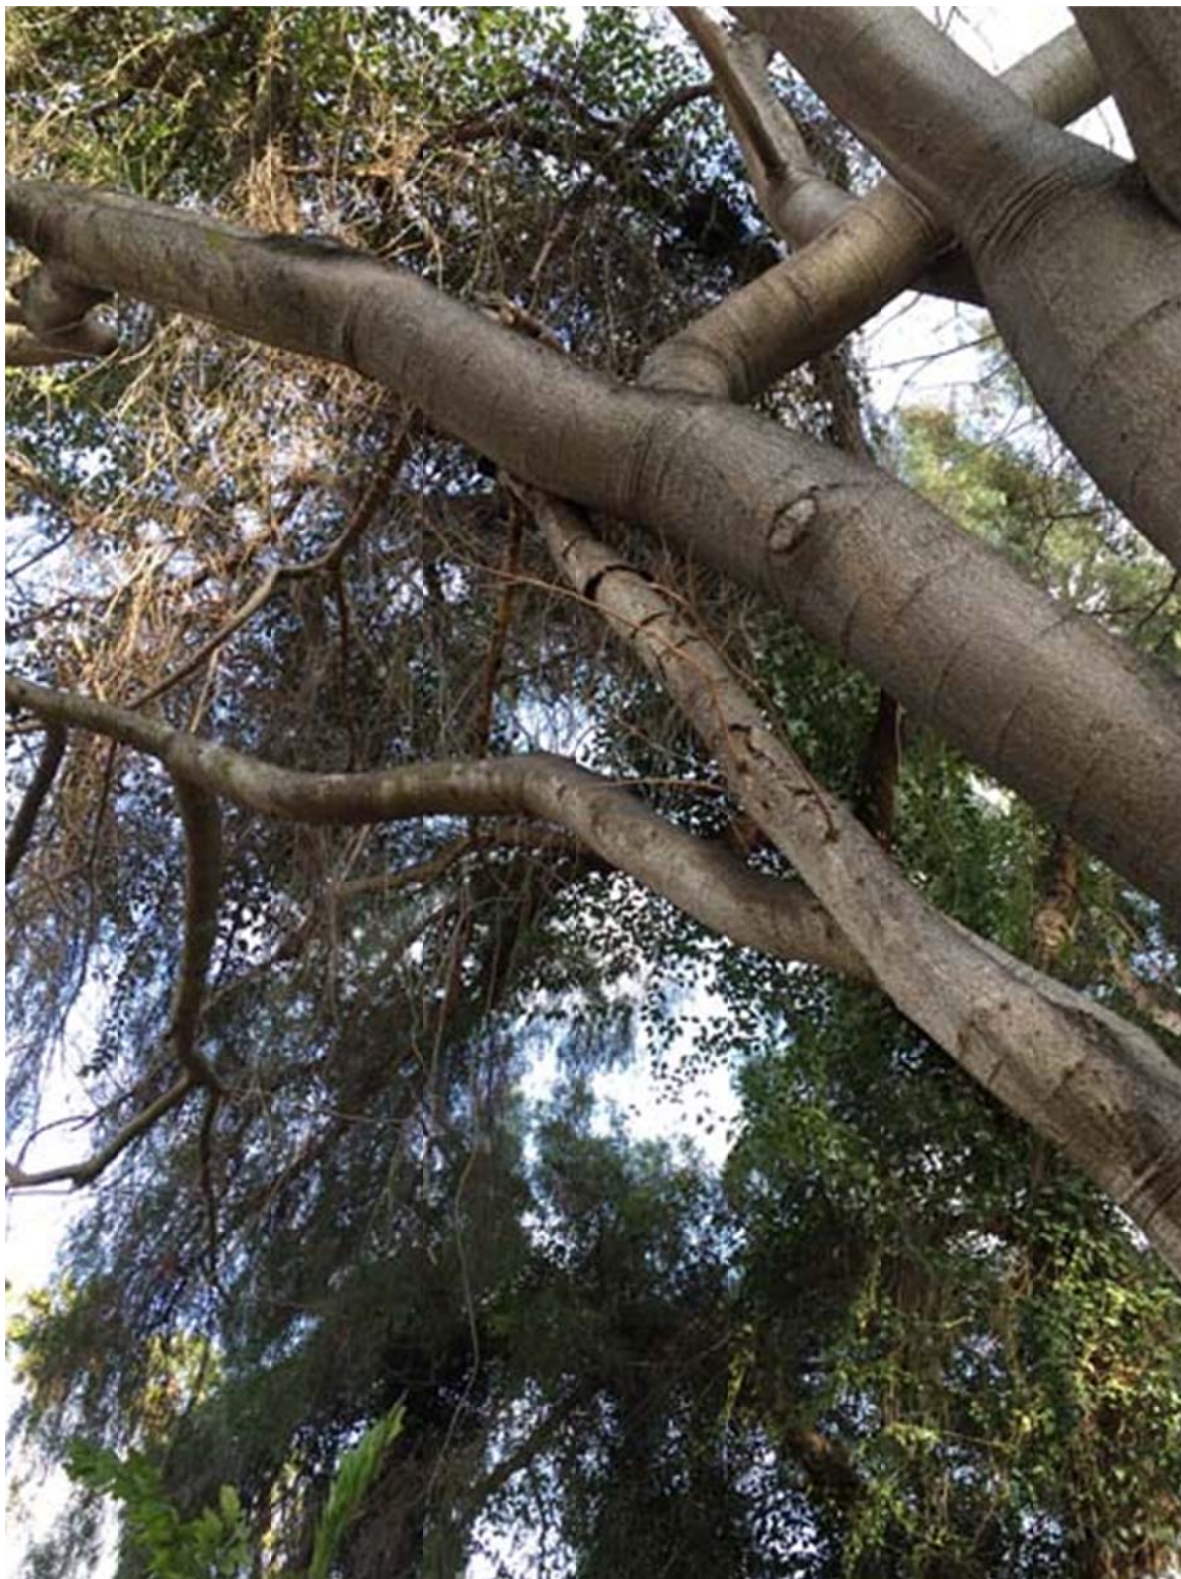
The canopy is generally healthy. There are 6 dead branches to a maximum diameter of 6" in the canopy that could be pruned out or allowed to remain until they self-prune. The smallest of the four trunks divides into two stems at a height of about 9 feet. One of these stems has been dead for at least one year, as indicated by the loss of bark.

I rated the Branch Health (BH) as 3 for Minor Problems. I observed bark loss on several living branches. These branches may die in the near future from reduced conductivity. Overall, most of the branches in the canopy were healthy and functioning normally.

Figure 7: Looking up into the canopy of the tree: there are several dead branches and living branches with bark loss, contributing to the reduced condition rating.

Rather than performing a crown reduction, I recommend prescribed target pruning as needed. If there are dead or defective branches, they can be removed. If there are branches that extend over the roadway or conflict with infrastructure, they can be individually reduced or removed until conflict is mitigated.

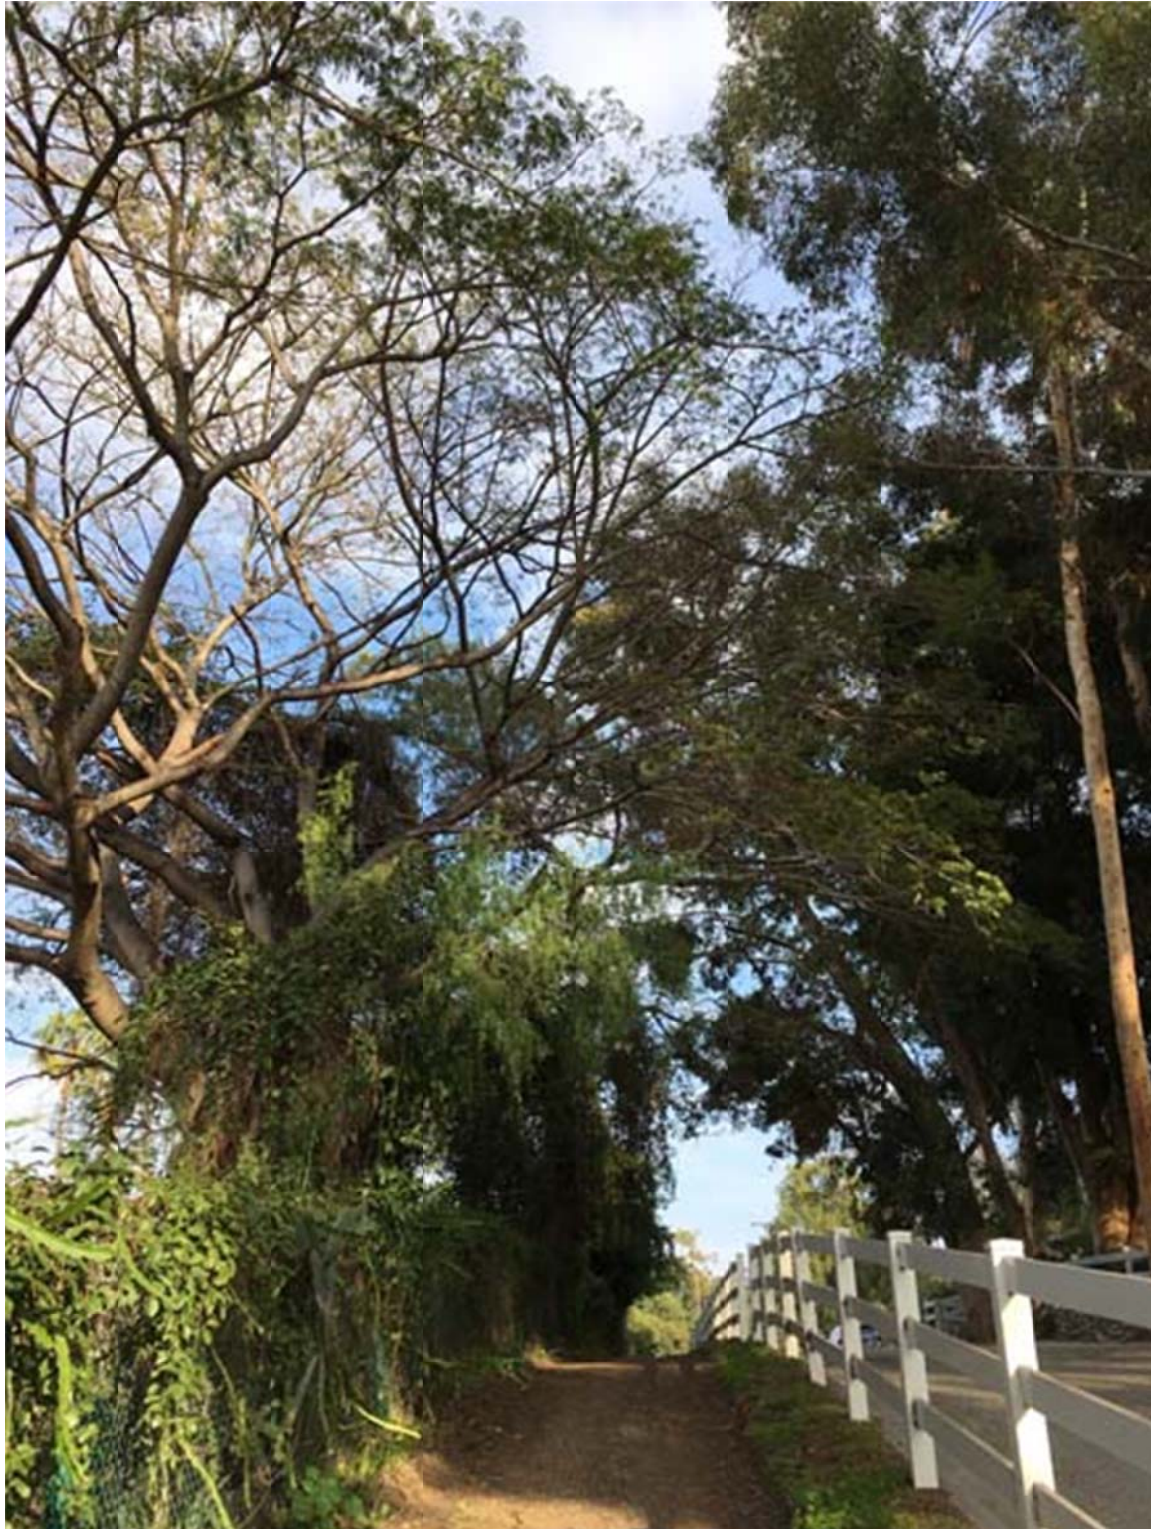
A new 24" water line and 30" suction pipeline are intended to be constructed in proximity to the Earpod tree. The planned location of the new lines would be between the white rail fence and the chain link fence, approximately 10' to the south of the Earpod tree. To install the pipes, a trench must be dug to a depth of approximately 7 feet with a width of 7.5 feet. Working in such proximity to the tree will likely result in some amount of damage to the root system of the subject Earpod tree.

Figure 8: Looking southeast along the horse trail. The subject Earpod tree is seen at left. The proposed trench will be located between the chain link fence (left) and the white rail fence (right).

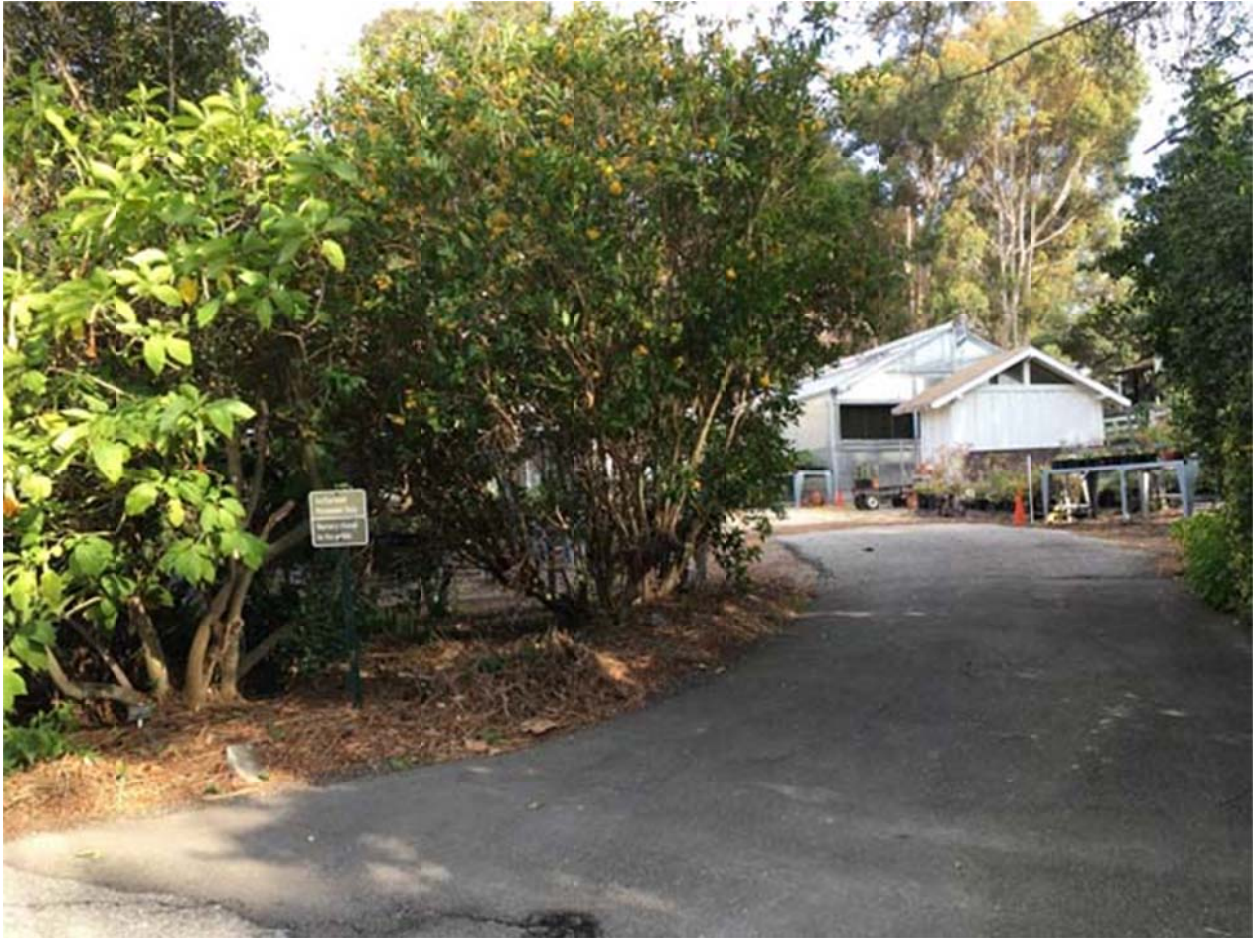
Figure 10: Looking south up the access road to the gardens nursery and the subject Earpod tree. A sign to the left of the driveway restricts access to the general public.

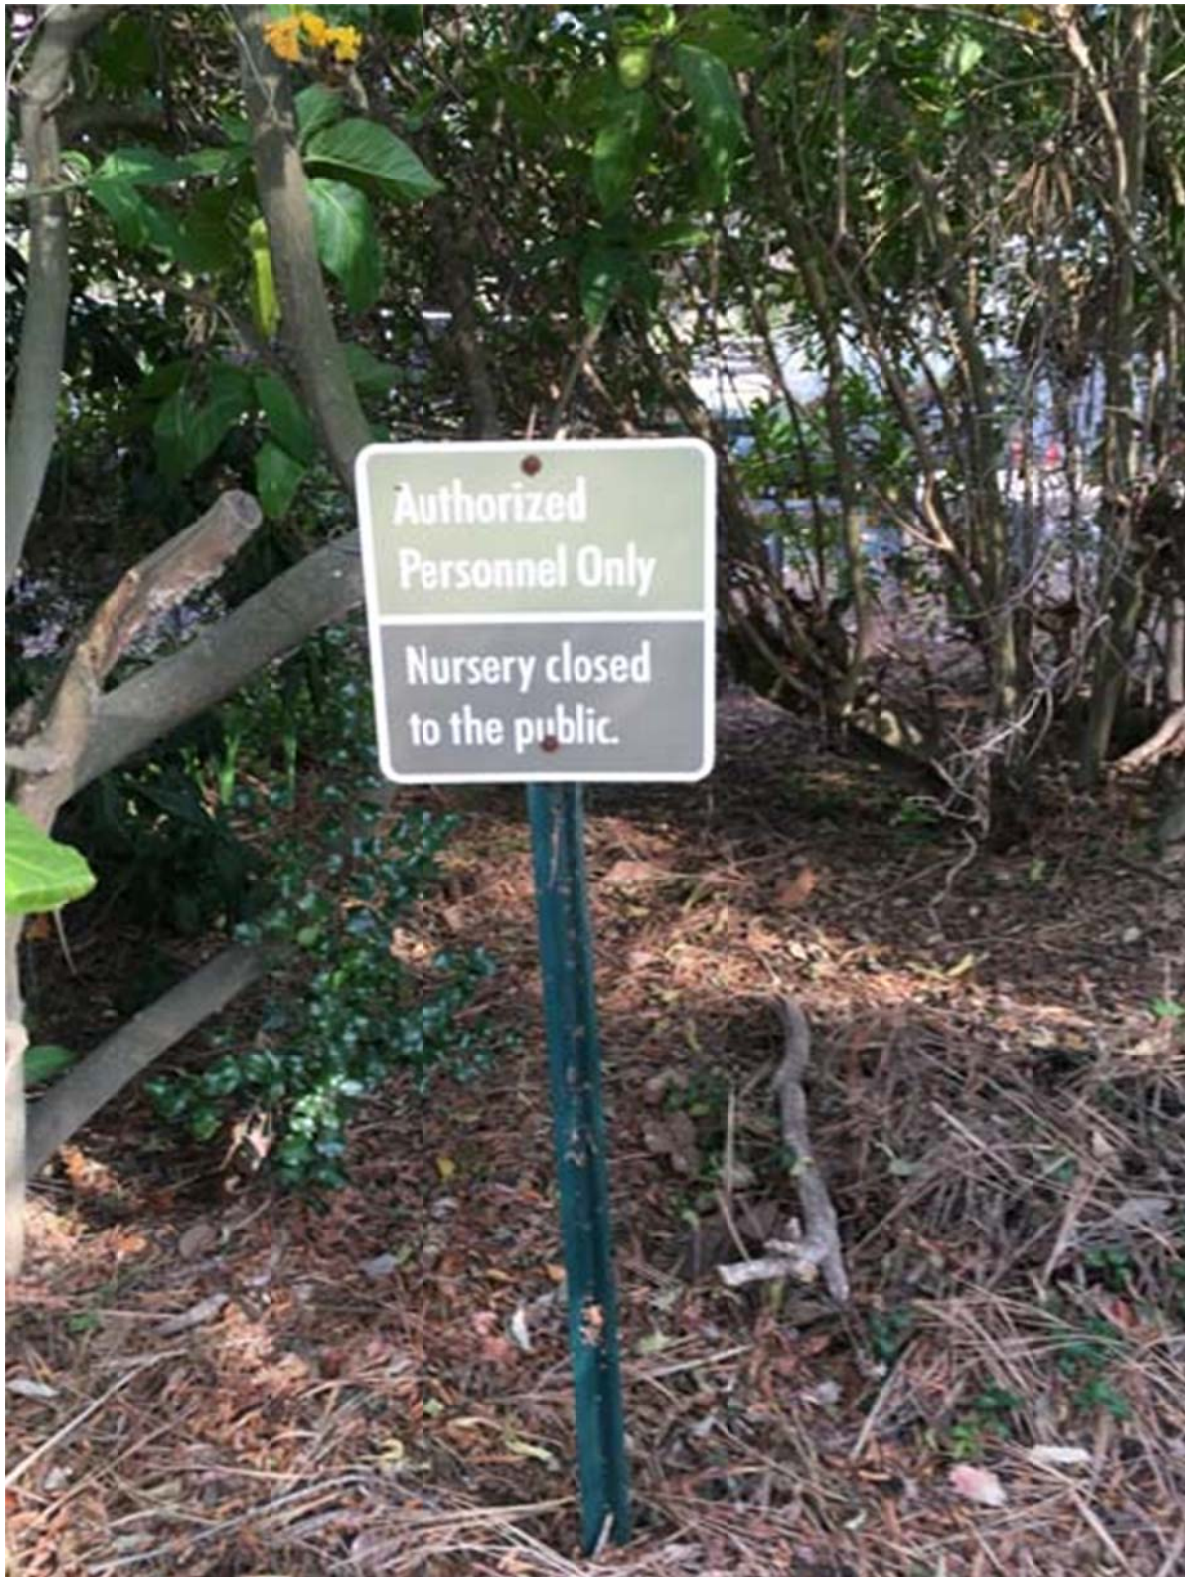
Figure 11: Close up of the sign to the left of the access driveway to the nursery. This sign restricts access to the general public.
