# Tree Appraisal Report

**Prepared by James Komen**  
BCMA WE-9909B  
RCA #555

**Class One Arboriculture**  
3763 Ramsdell Ave  
Glendale, CA 91214  
818-495-5344  
classonearboriculture@gmail.com

August 27, 2018

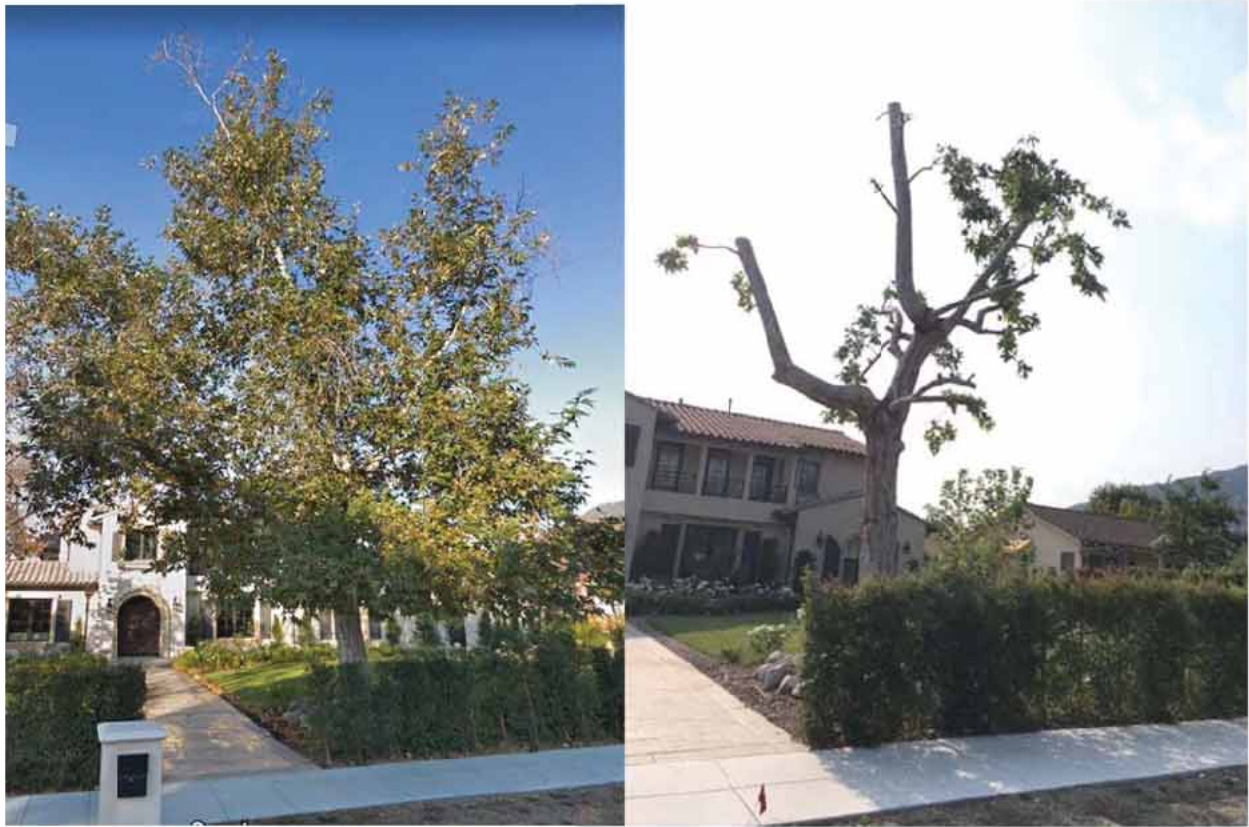
**Figure 1:** Tree 1 Pre-Loss (left) and Post-Loss (right).

The health of the tree is now *Fair*. It has significantly reduced vigor as a result of the removal of 90% of the living foliage. I observed evidence of re-sprouting beginning already, indicating the tree has energy reserves from which to draw, and it still has some vigor.

The structure of the tree is now *Poor*. Multiple significant topping cuts were made on the scaffold branches and trunk. These heading cuts will likely turn into decay sites, significantly limiting the structure of the tree in the long term. Re-growth sprouts will be weakly attached to the scaffold, increasing likelihood of branch failure.

The form of the tree is now *Poor*. It now has an abnormal form due to severe pruning. The pruning detracts to a significant degree from the tree's intended use of an aesthetic specimen tree and screening from street. I did not choose a rating of *Very Poor* because the tree still does provide some function in the landscape, albeit significantly limited.

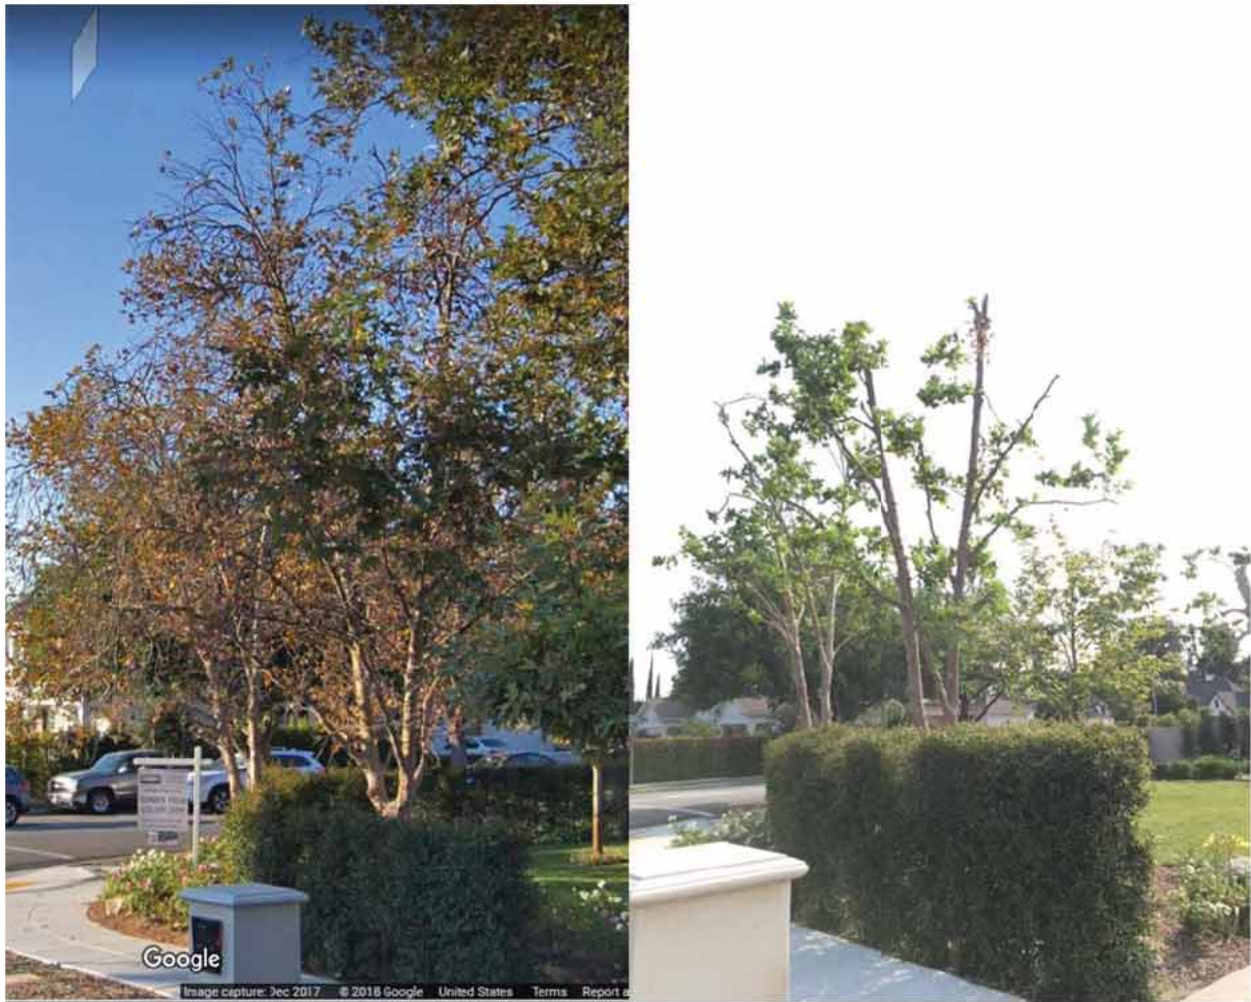
**Figure 1:** Tree 2 Pre-Loss (left) and Post-Loss (right).

The structure was *Fair*. There is a co-dominant stem defect at a height of about four feet. There is a ample response growth joining the two stems, so it was unlikely to fail in normal weather conditions before the pruning.

The structure of the tree is now *Fair*. There are now multiple moderate topping cuts on the scaffold branches. The tree has the potential to recover with several years of restoration pruning management.

The form of the tree is now *Fair*. Its aesthetic function as a specimen tree has been compromised as a result of the topping.

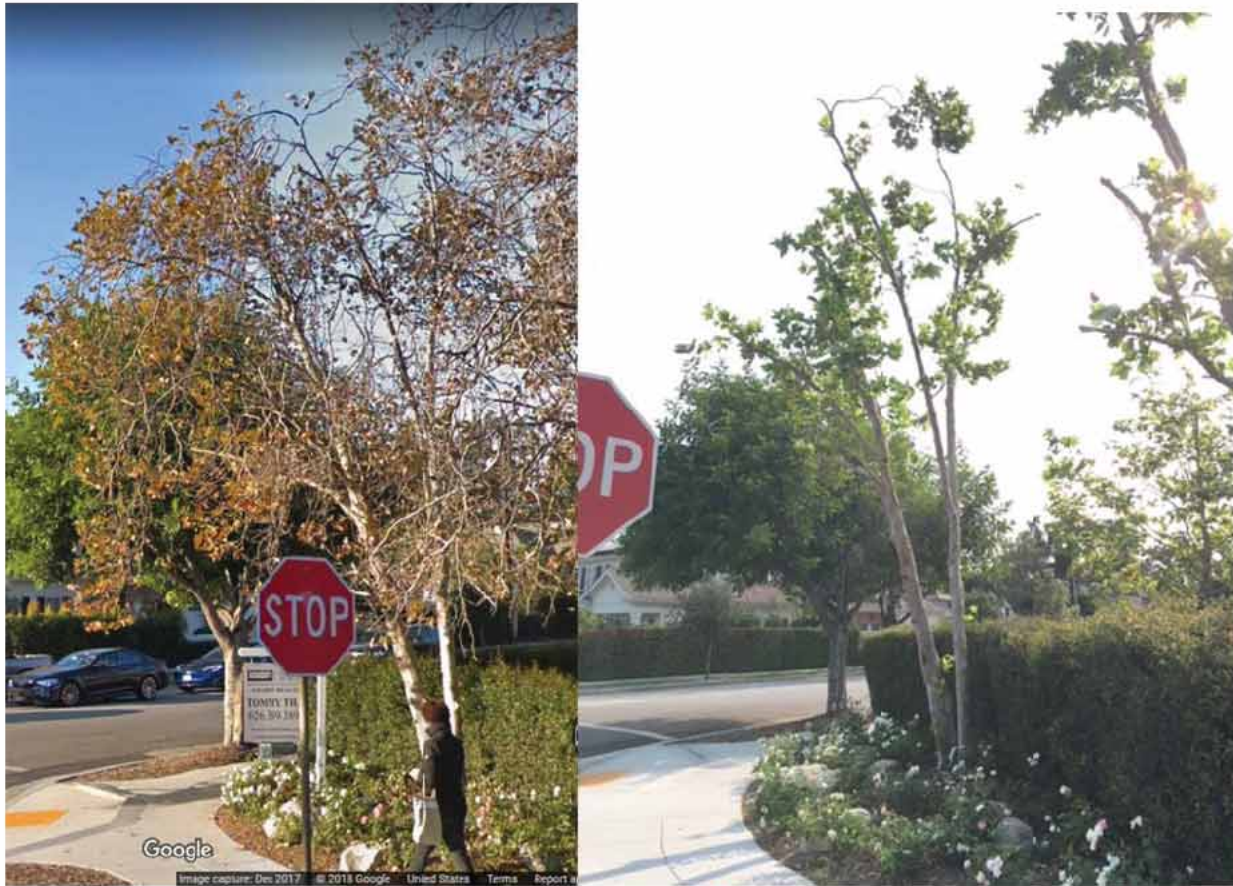
This tree is not protected by ordinance because neither of its two trunks is larger than 10 inches in diameter. It was not appraised as part of this report.

**Figure 1:** Tree 3 Pre-Loss (left) and Post-Loss (right). This tree is not large enough to be protected by ordinance.

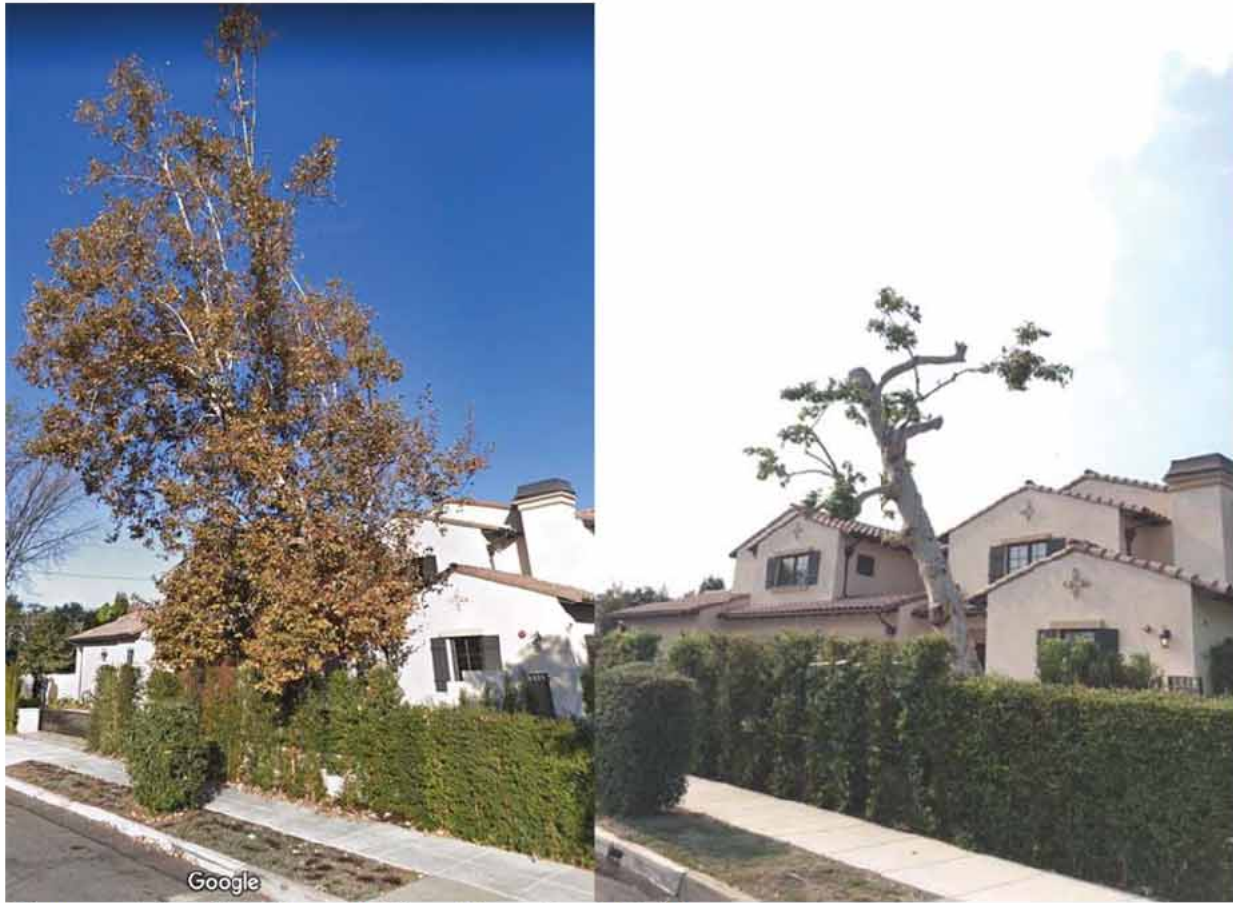
**Figure 1:** Tree 4 Pre-Loss (left) and Post-Loss (right).

The health of the tree is now *Fair*. It has a significantly reduced vigor as a result of the removal of 90% of its living foliage. I observed evidence of re-sprouting beginning already, indicating the tree has energy reserves from which to draw and still has some vigor.

The structure of the tree is now *Poor*. Multiple significant topping cuts were made on scaffold branches and trunk. These heading cuts will likely turn into decay sites, significantly limiting the structure of the tree in the long term. Re-growth sprouts will be weakly attached to the scaffold, increasing likelihood of branch failure.

The form of the tree is now *Poor*. It now has an abnormal form due to severe pruning. The pruning detracts to a significant degree from the tree's intended use of an aesthetic specimen tree and screening from street. I did not choose a rating of *Very Poor* because the tree still does provide some function in the landscape, albeit significantly limited.

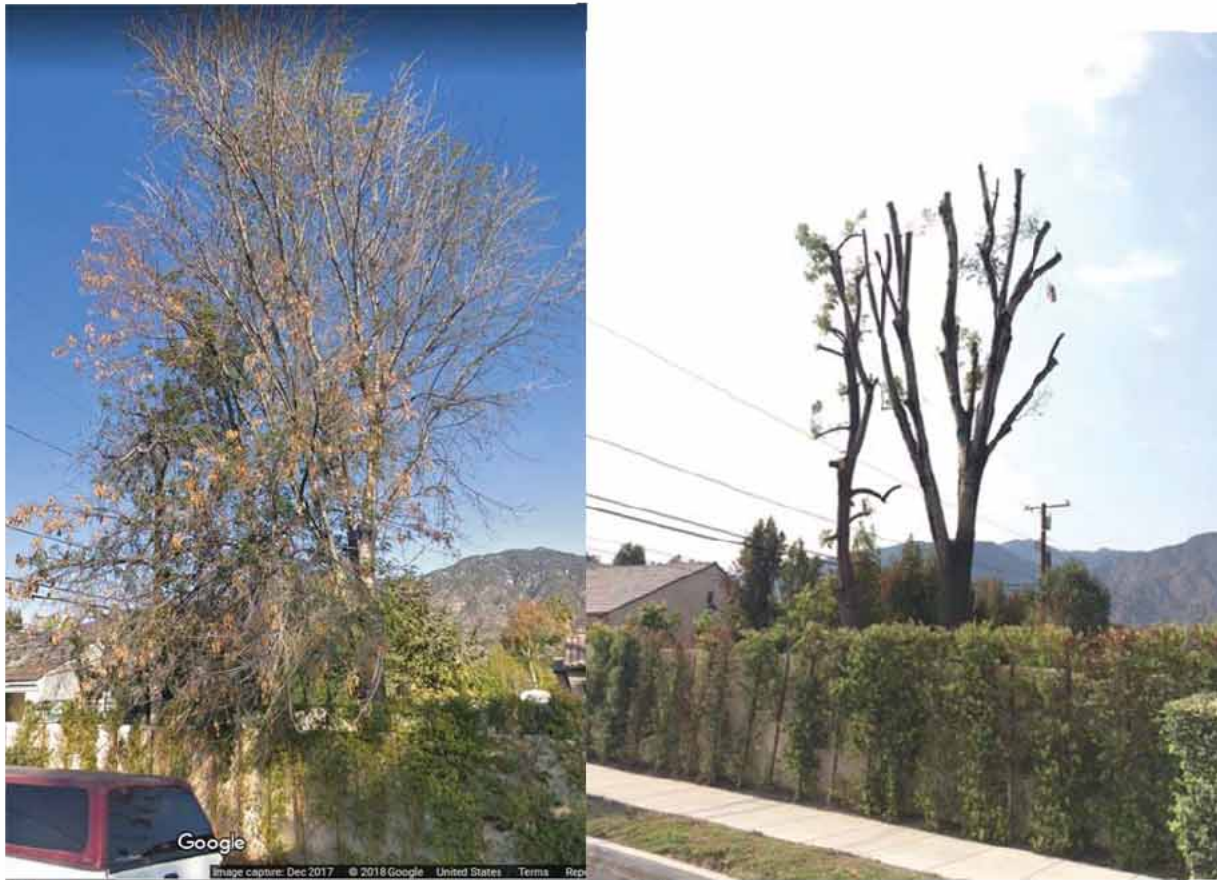
**Figure 1:** Tree 5 Pre-Loss (left) and Post-Loss (right).

The structure of the tree is now *Poor*. The severe topping cannot be corrected, even with restoration pruning over a period of years. Re-sprouting will be weakly attached to the parent stems and will have an increased likelihood of failure.

The form of the tree is now *Very Poor*. The tree no longer provides its intended function of shading the rear yard from southern sun. The severe topping has left the tree visually unappealing.

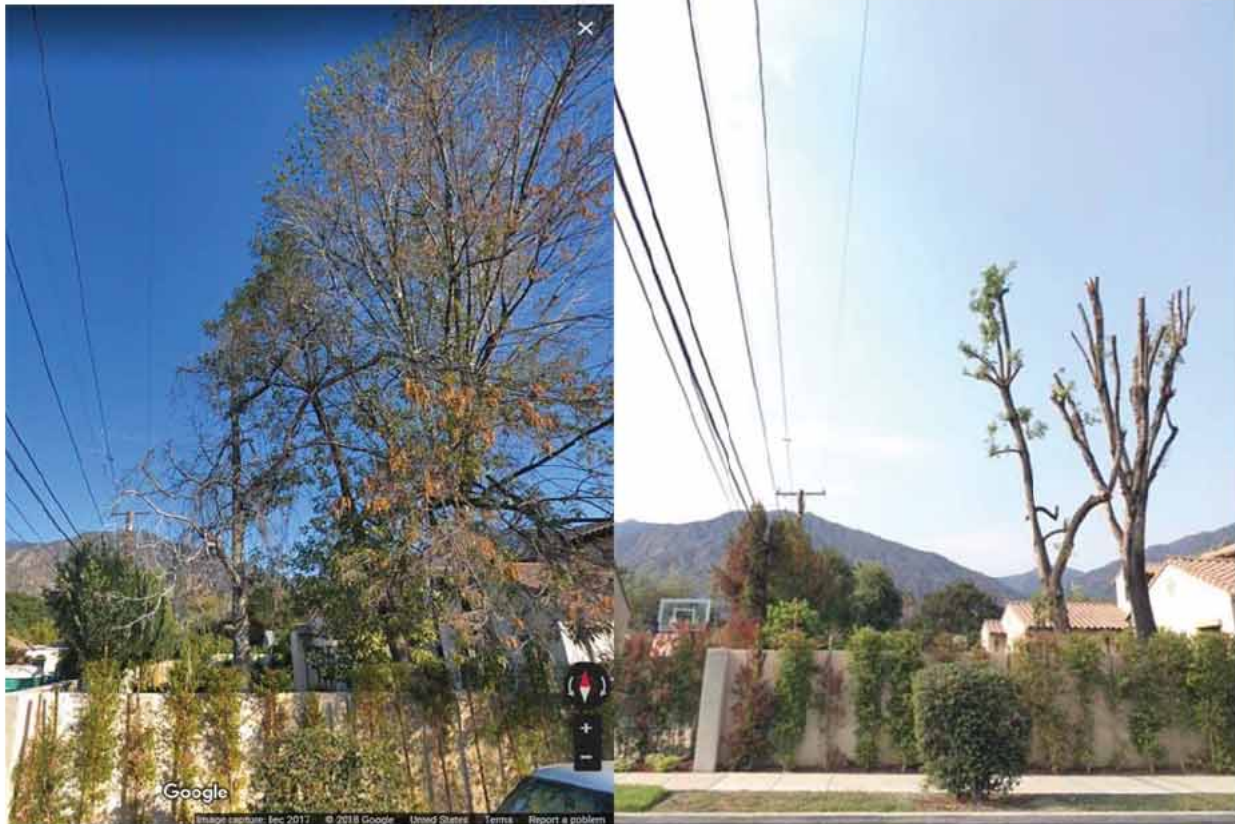
- *Fire Safety from Electrical Lines:* Trees 5 and 6 were the stated catalysts for the pruning event on [REDACTED]. As seen in the pre-loss images of the trees from the street view, these trees were not in contact with the power lines at the time of the pruning.

The structure was *Fair*. Its phototropic response growth towards the west out from under Tree 5 caused the tree to have a prevailing lean. I also observed several weakly attached and hanging branches in the December 2017 Google Maps Street View image.

The structure of the tree is now *Poor*. The severe topping cannot be corrected, even with restoration pruning over a period of years. Re-sprouting will be weakly attached to the parent stems and will have an increased likelihood of failure.

**Figure 10:** Tree 6 Pre-Loss (left) and Post-Loss (right). As seen in the image at left, the branches of Tree 6 and Tree 5 were not touching the power lines prior to the pruning.

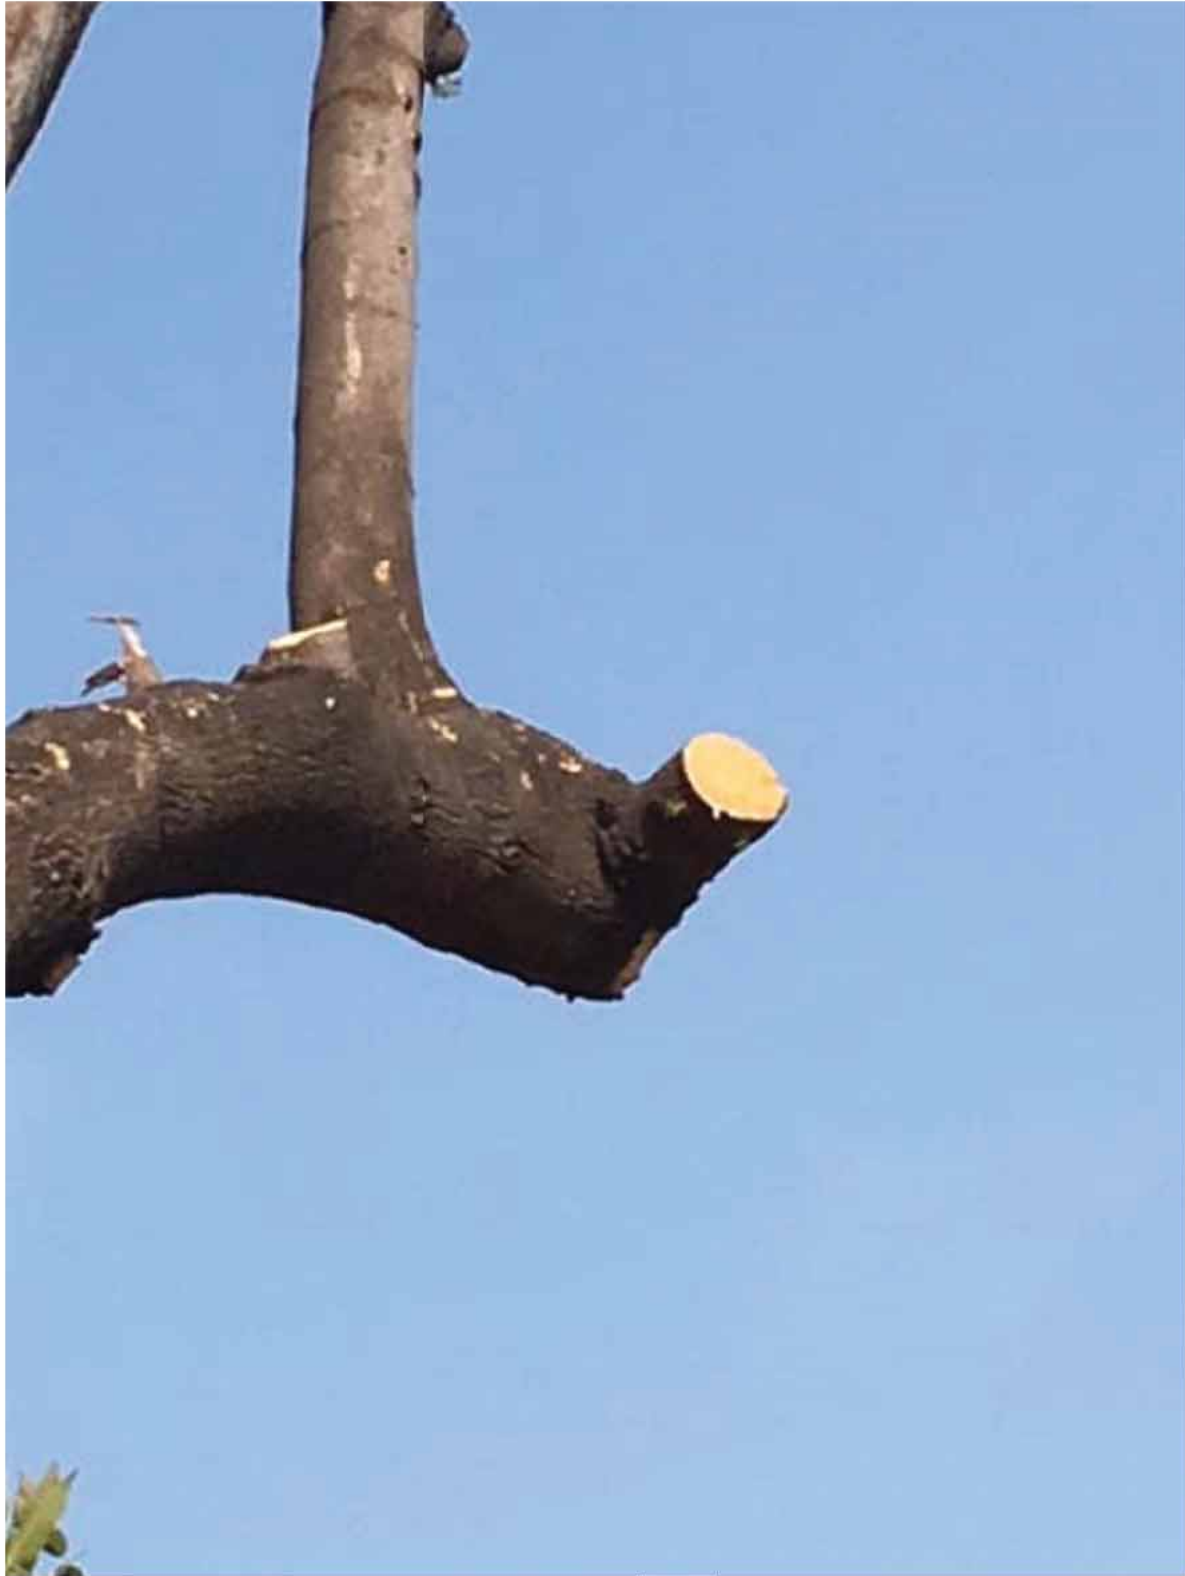
The branch wounds that [REDACTED] pointed out had milky sap exuding from the xylem tissue at the pruning cuts. The presence of sap indicates these branches were not completely compartmentalized off from the tree, so they were still alive at the time of pruning. Furthermore, there were many small watersprouts beginning to emerge from the trunk and remaining scaffold branches of Tree 6. The only way these sprouts could be emerging was if these sections of the tree were still alive. If the objective of pruning Tree 6 was to remove dead branches, then an excessive amount of living tissue was removed to achieve that objective, thereby contradicting the BMP for pruning.

**Figure 11:** Close up of one branch on Tree 6 that [REDACTED] pointed out as being dead prior to the pruning. I observed a milky sap exuding from the pruning cut, indicating it was still alive.

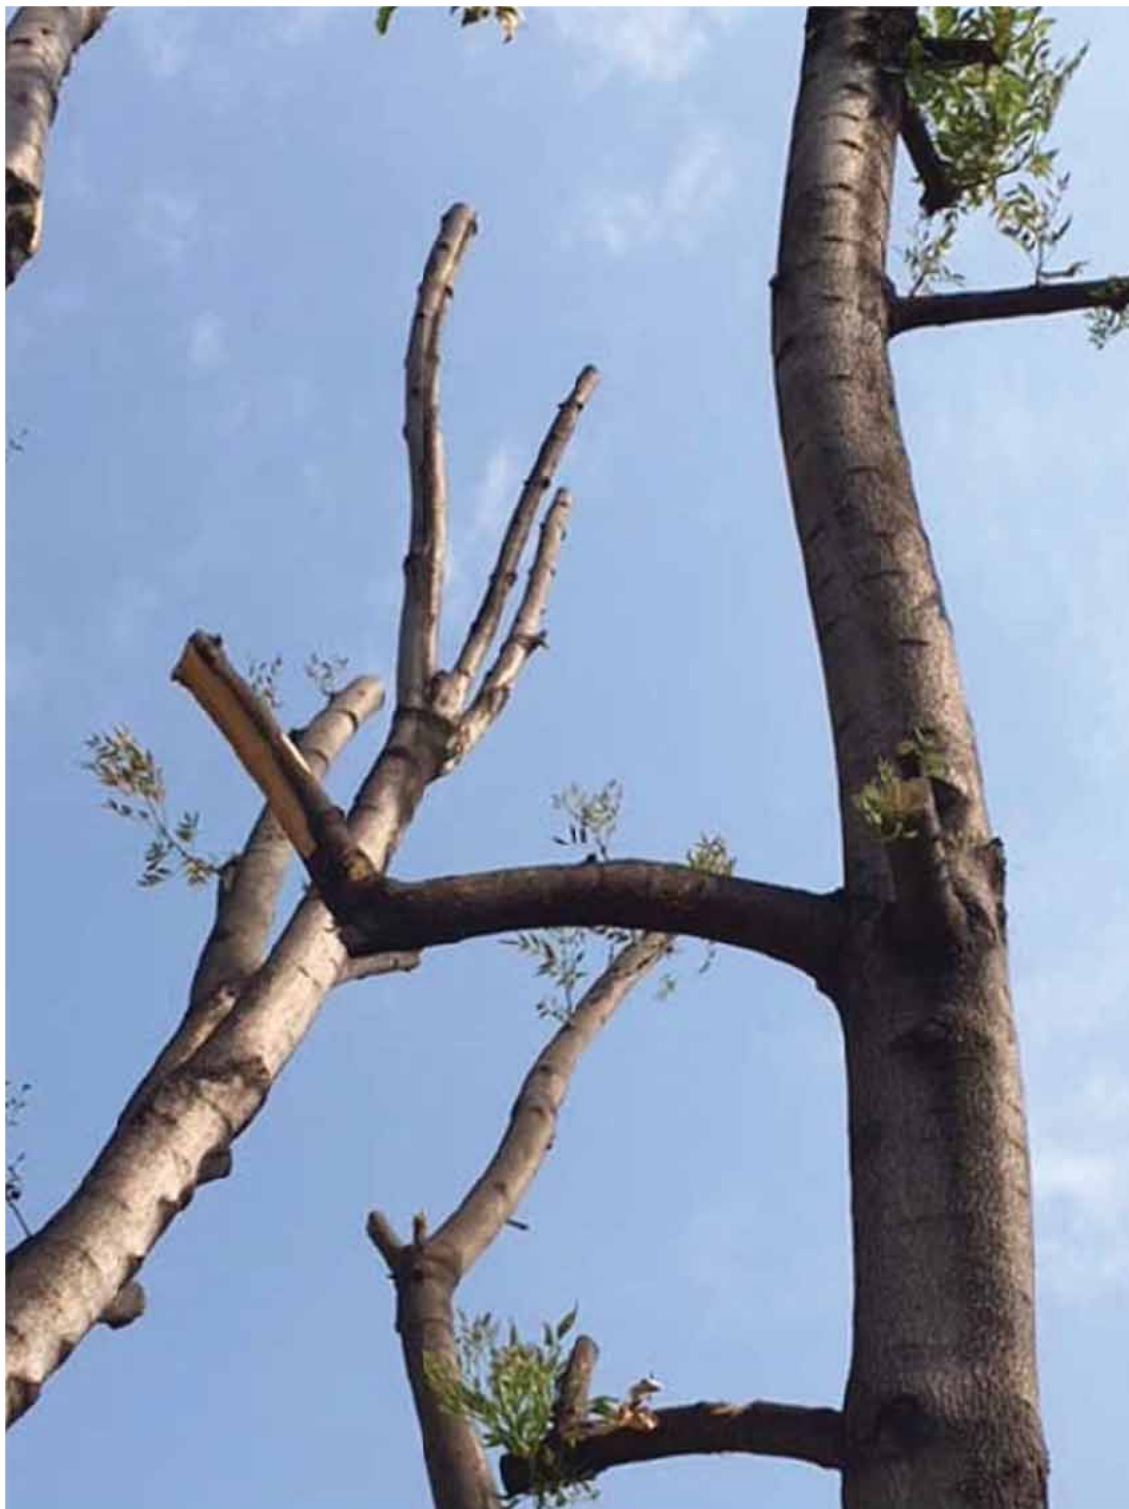
**Figure 12:** Close up of another branch on Tree 6 [REDACTED] pointed out as being dead prior to pruning. I observed many small watersprouts emerging, indicating these branches were still alive. Note the 10-15 inches of torn bark on the pruning cut on the underside of the scaffold branch at left.

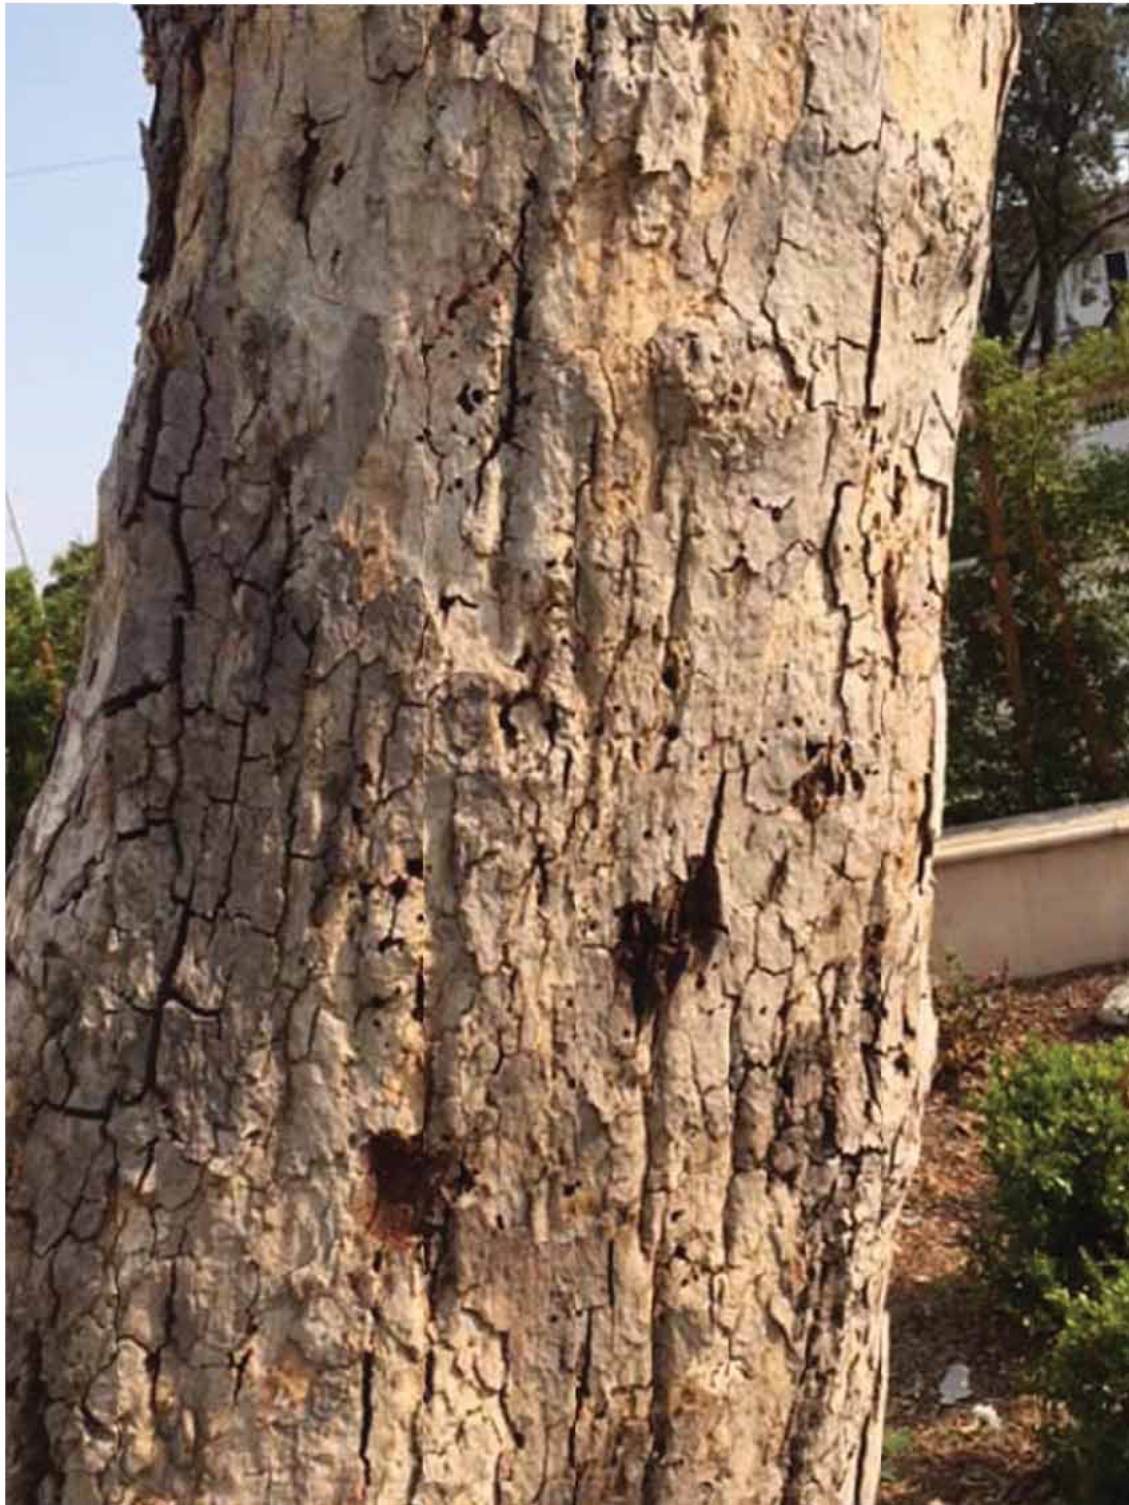
The health of the tree was *Fair*. It had a pre-existing history of the common *Anthraxnose* foliar fungus and minor dieback at tips. I observed minor bark beetle activity in the trunk, but it did not appear to be affecting the conductivity of water along the stem. From the Google Maps Street View image from December 2017, the tree had a dense canopy and normal vigor for species.

**Figure 13:** Close up of the bark of Tree 4. There was some minor bark beetle activity in the trunk prior to the pruning. The activity did not appear to be affecting the overall health or conductivity of water along the stem.
