**Class One Arboriculture**  
3763 Ramsdell Av  
Glendale, CA 91214  
Phone: (818) 495-5344

[REDACTED] – Tree Inspection Report

[REDACTED] # [REDACTED]  
James Komen, Class One Arboriculture Inc.

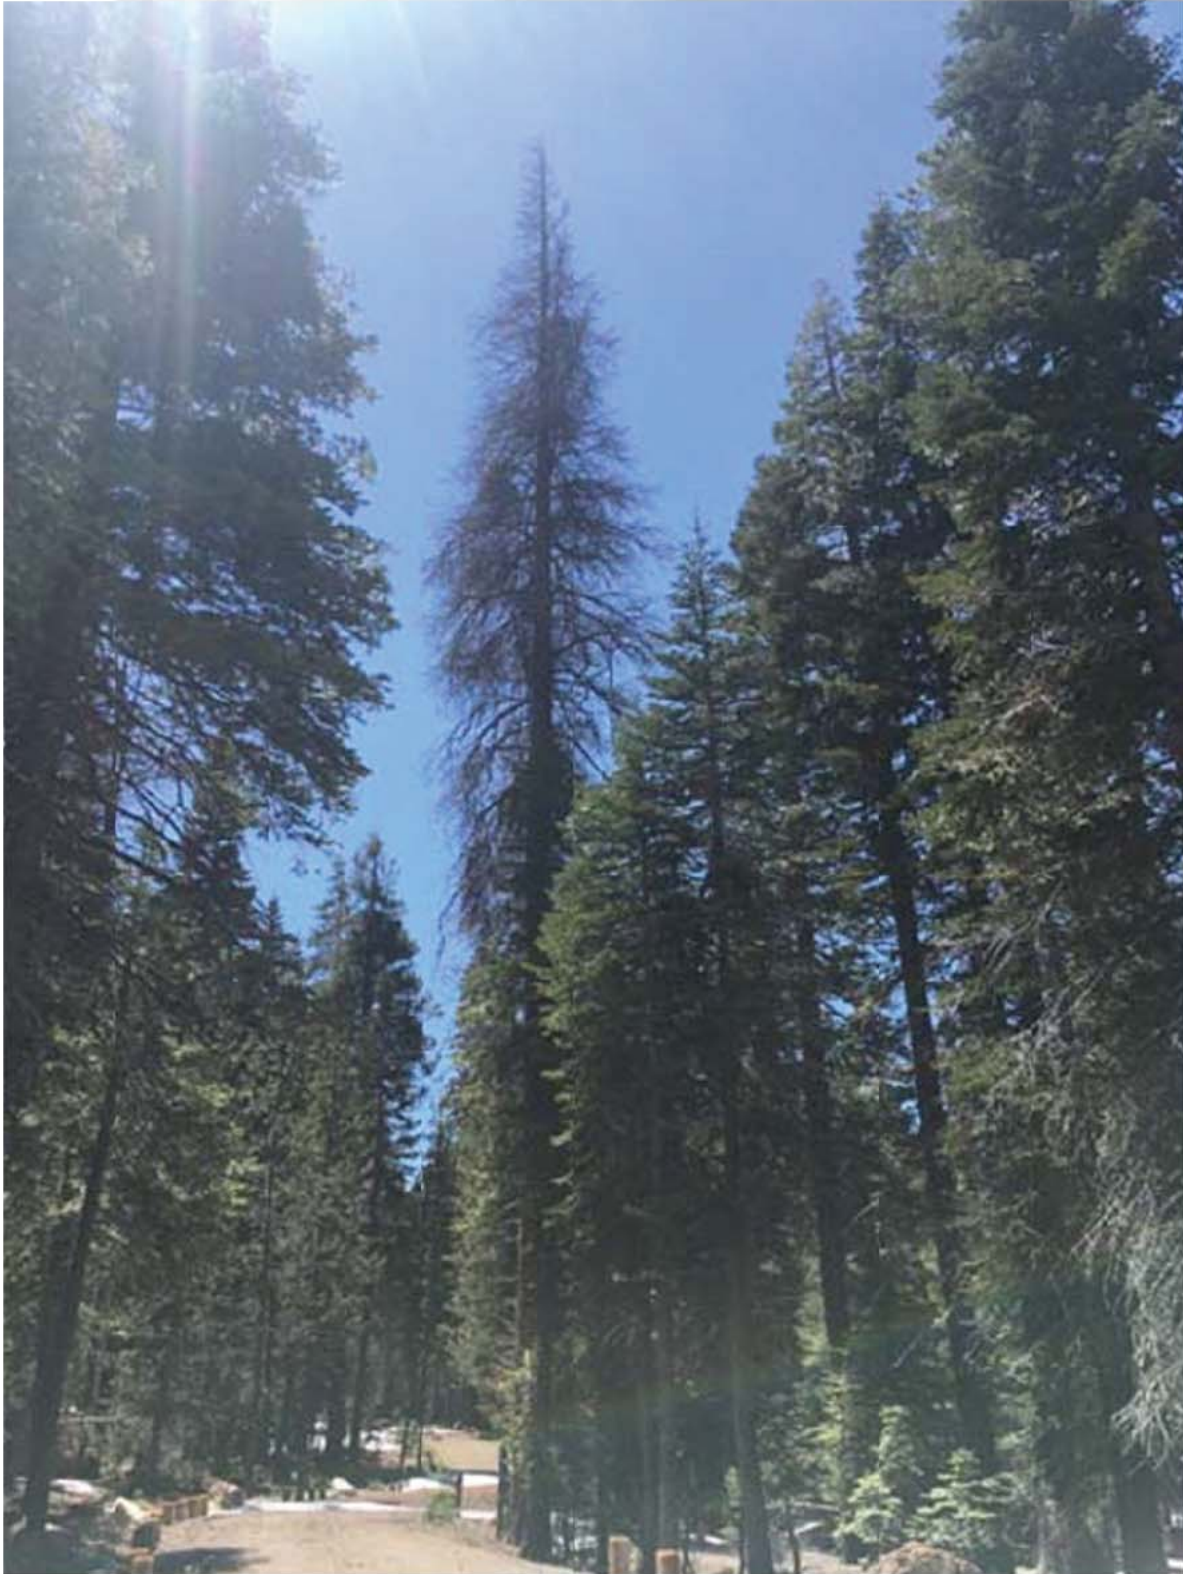
**Figure 1:** Example of typical mortality in the interior area of the campground away from the lake and creek. About 10-15% of the trees had died.

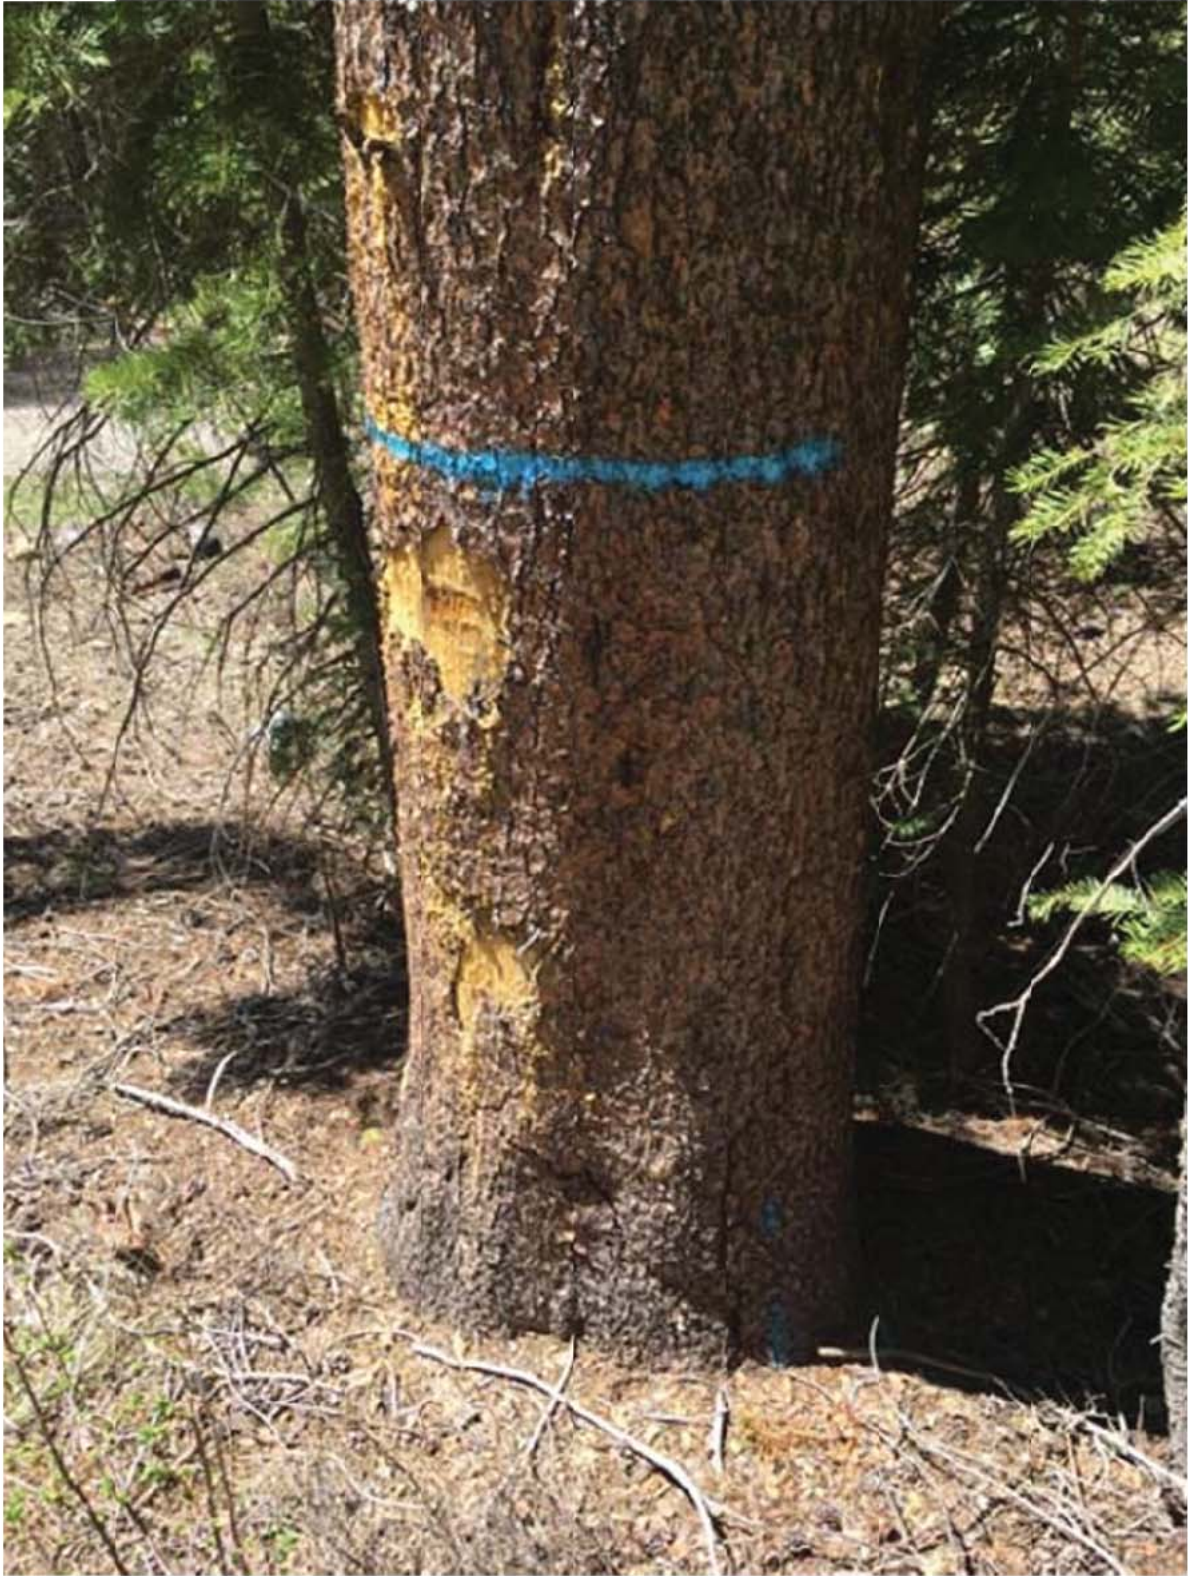
stumps. I observed felled trees that had been lying on the ground 1-2 years and some that had been felled within the past few months. Trees marked for removal that had not yet been felled were marked with blue paint.

**Figure 1:** Trees were marked for removal with blue paint. Sap exudation indicates this tree died recently.

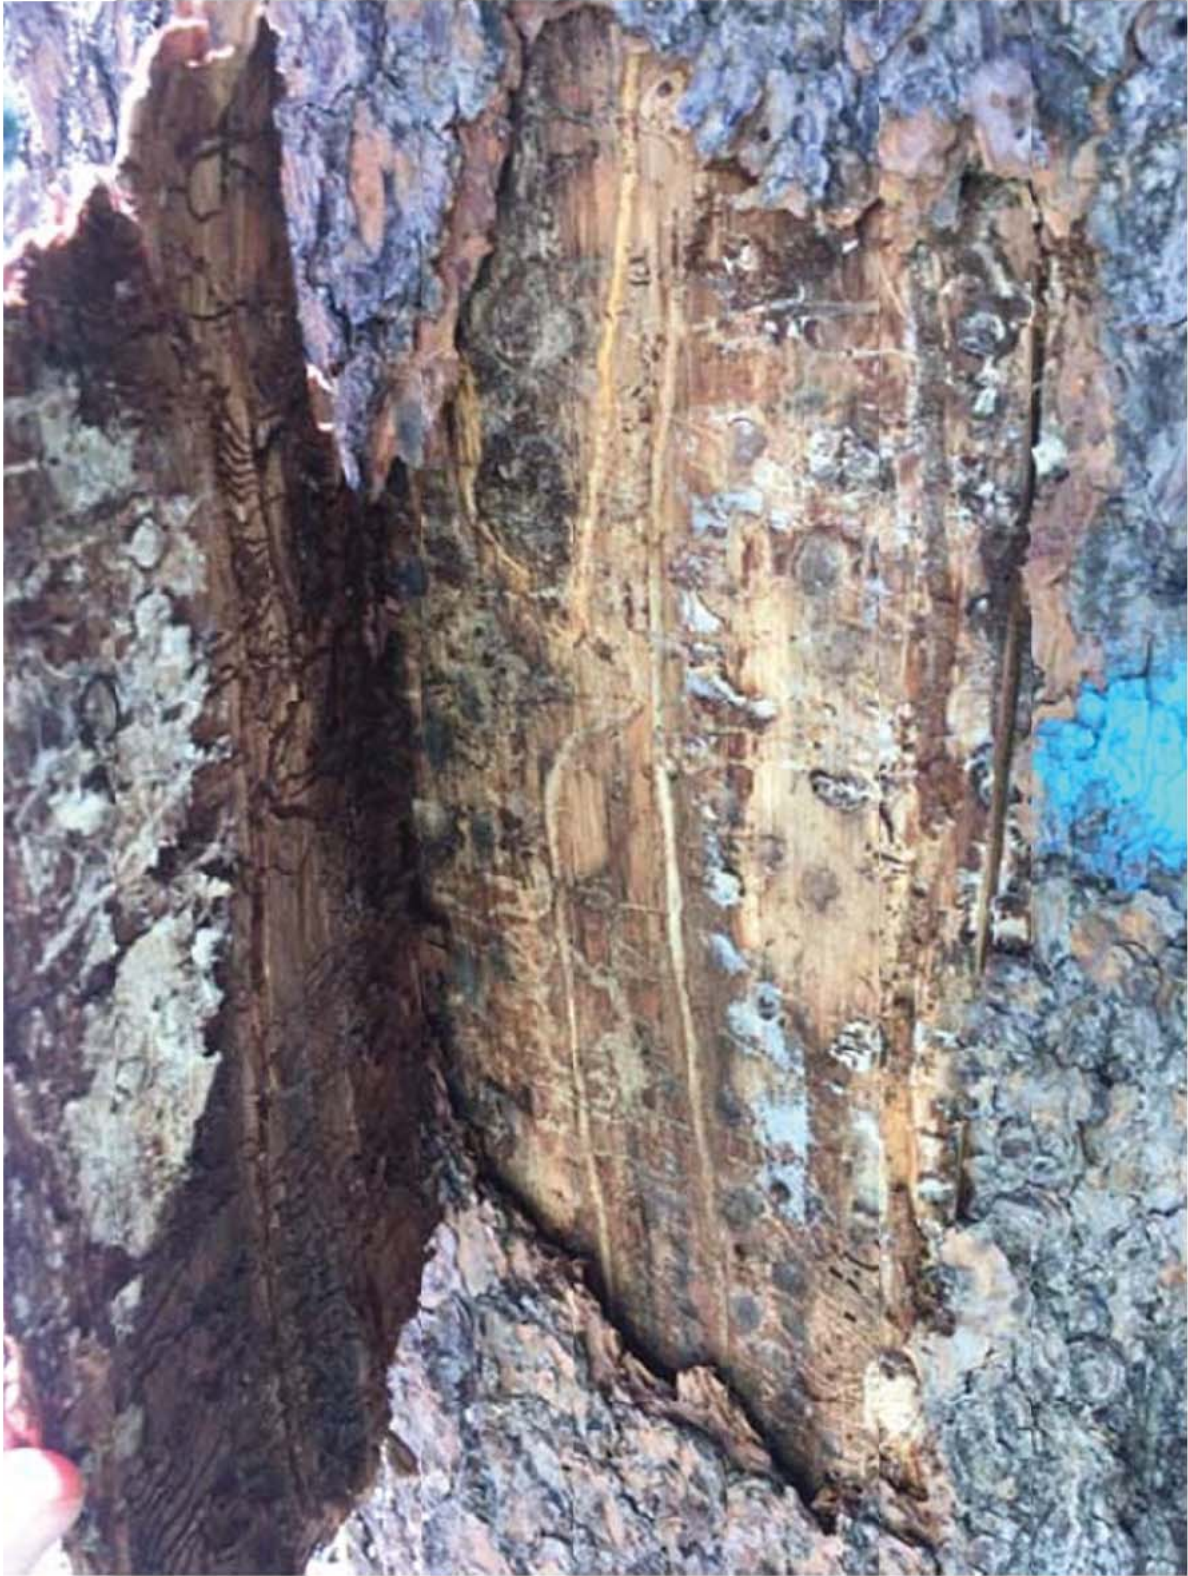
On the trunk of every dead tree I inspected and on most trunks of heavily stressed trees, there was evidence of bark beetle activity. I did not observe the beetles themselves at my site visit, but I did observe their galleries. Based on my inspection of the galleries, the attacking insects may have been Pine Engraver Beetles (*Ips sp.*) or Mountain Pine Beetle (*Dendroctonus ponderosae*) on the pines and Fir Engraver Beetle (*Scolytus ventralis*) on the firs. Additional investigation would be necessary to conclusively determine the species of boring insect present in the trees.

**Figure 1:** Underneath the loosely-attached bark, I observed bark-borer galleries.

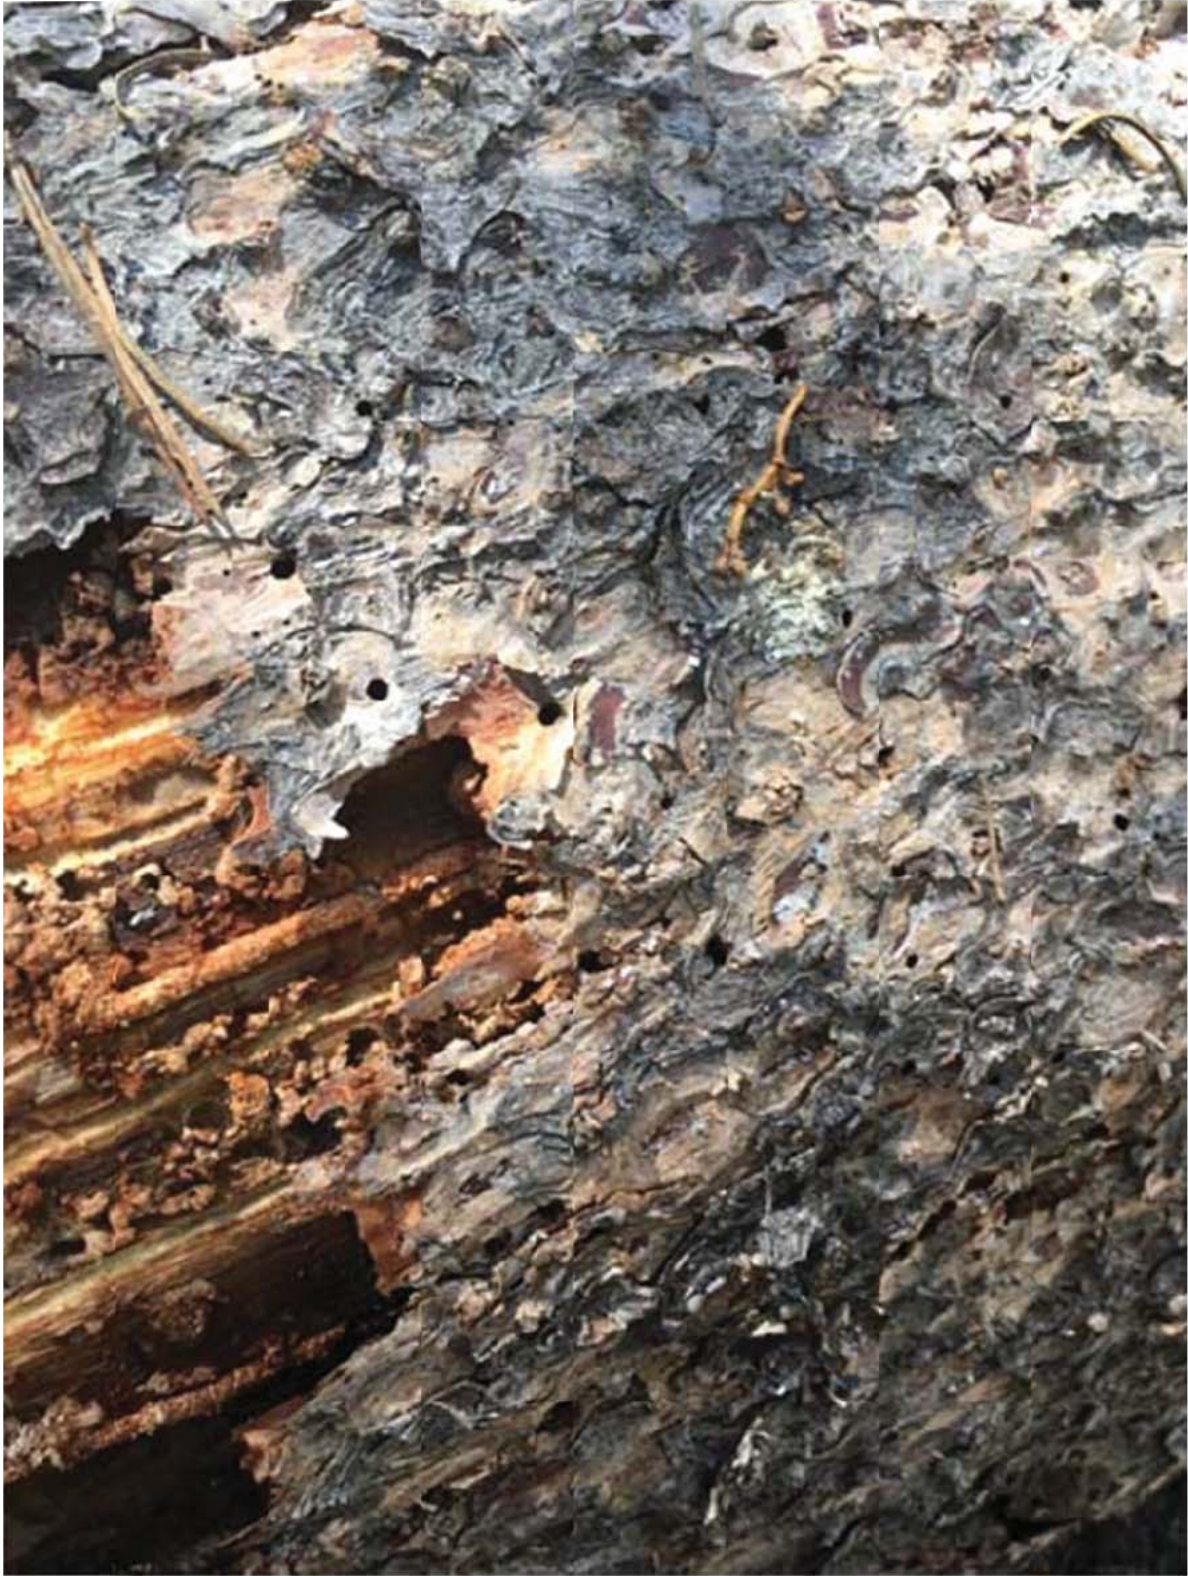
There were many entry/exit holes in the bark of the affected trees. Some of the entry/exit holes were dry, indicating the trees' sap flow had been cut off before the holes were bored. Some trees were exuding sap from the boreholes, indicating sap flow was still active when the boreholes were made. Dead trees and trees with advanced symptoms of decline had bark that was loosely attached to the trunk. I peeled off the bark in sections, revealing galleries between the bark and the heartwood.

**Figure 1:** Another close up of the galleries (left) and entry/exit holes (right) on a dead tree.

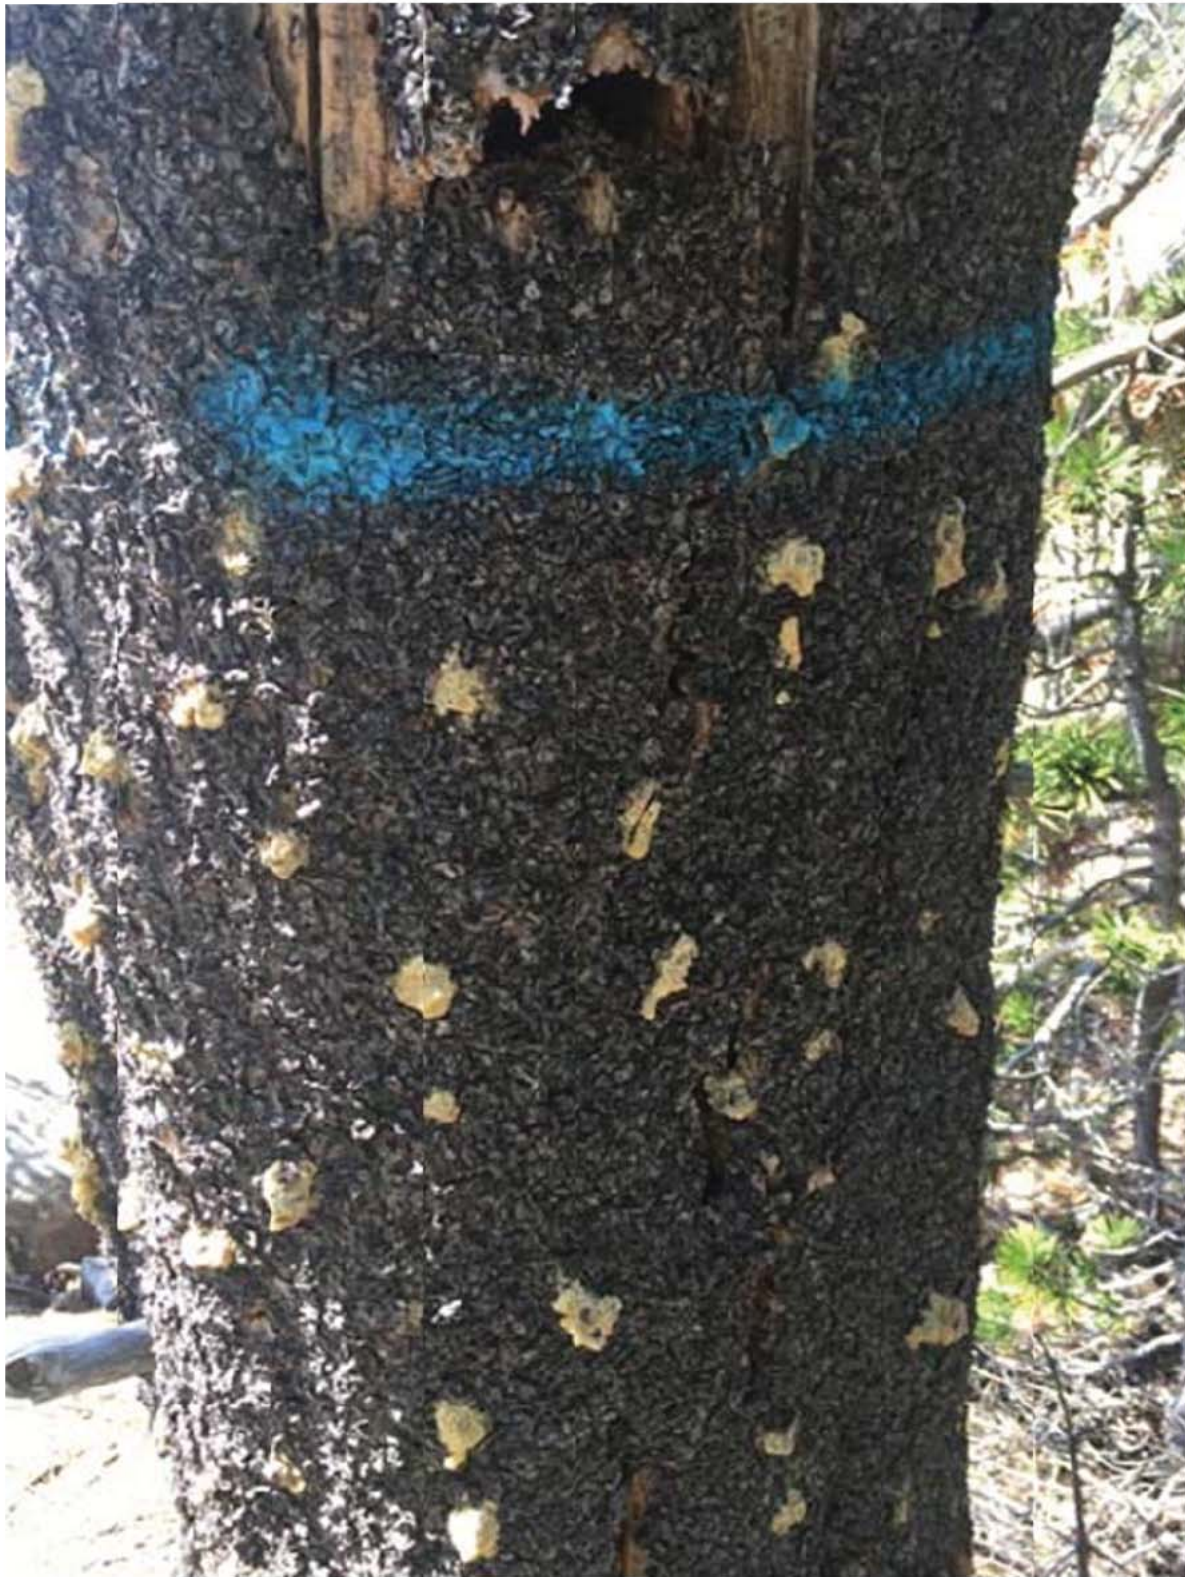
**Figure 11:** Close up showing the entry/exit holes with sap exudates, indicating the tree had died recently.

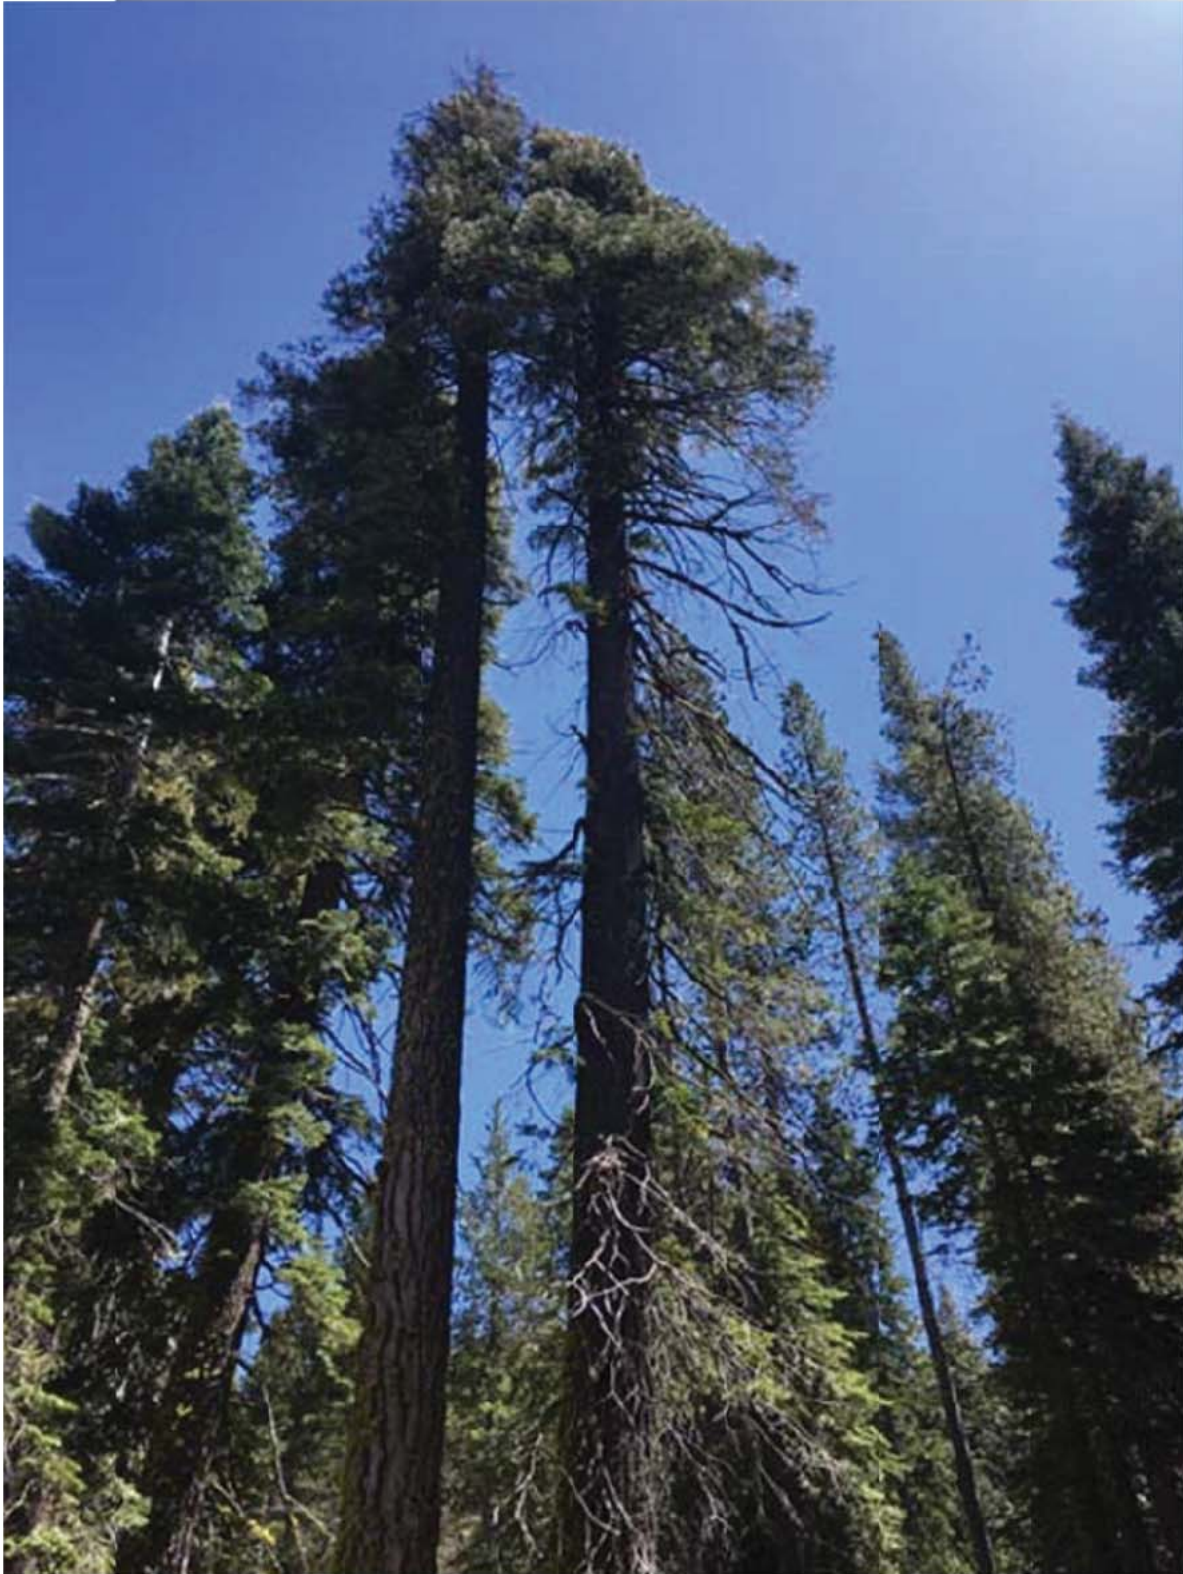
In a dense forest stand, trees compete with each other for light and resources. Before the drought began, the aggregate forest canopy was so dense that it blocked out the light to the trees' lower branches, leading to a concentration of foliage at the tops of the mature overstory trees. When some of the older trees died off from drought and insect infestation, the remaining trees were newly exposed to the sun. The increase in solar exposure led to an increase in the rate of evapotranspiration water loss, putting a greater water demand on the newly exposed trees.

**Figure 12:** Typical interior trees developed foliage concentrated near the top, making them more exposed to sun when neighboring trees died and were removed.

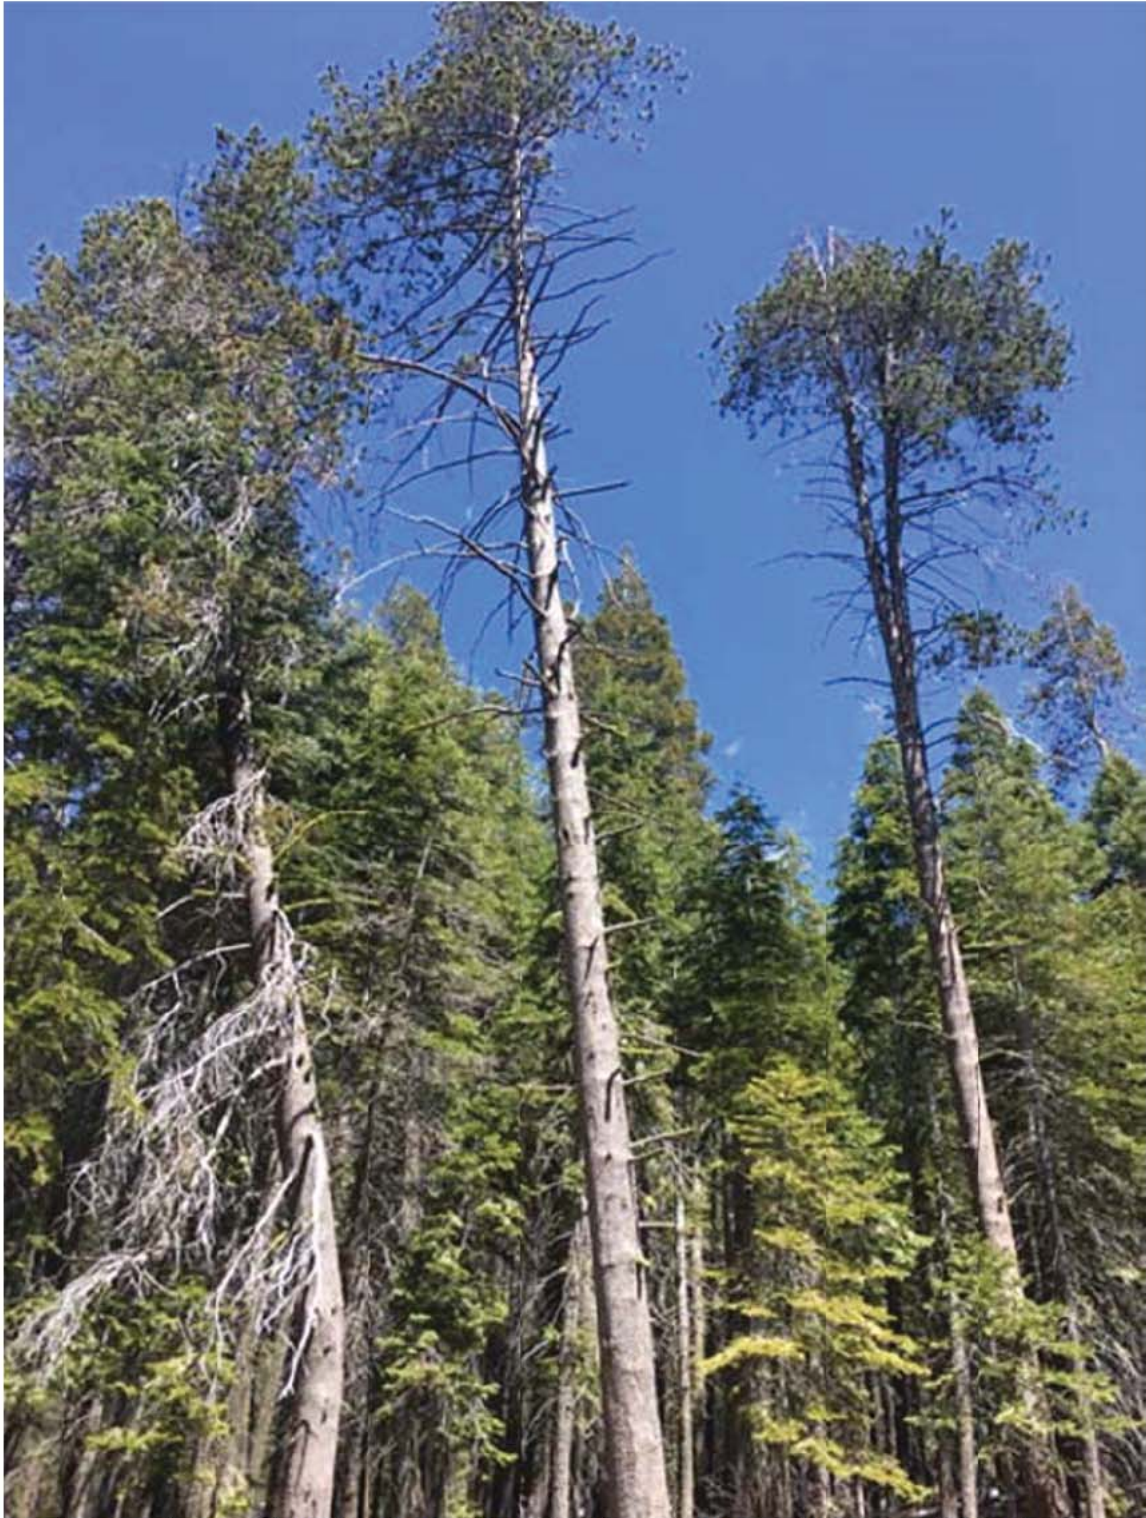
**Figure 13:** Interior trees lost their lower branches due to competition with neighboring trees in the past. When the neighboring trees were removed, the remaining trees were exposed to new sun, further stressing them. These pines in the foreground are not likely to survive for much longer.

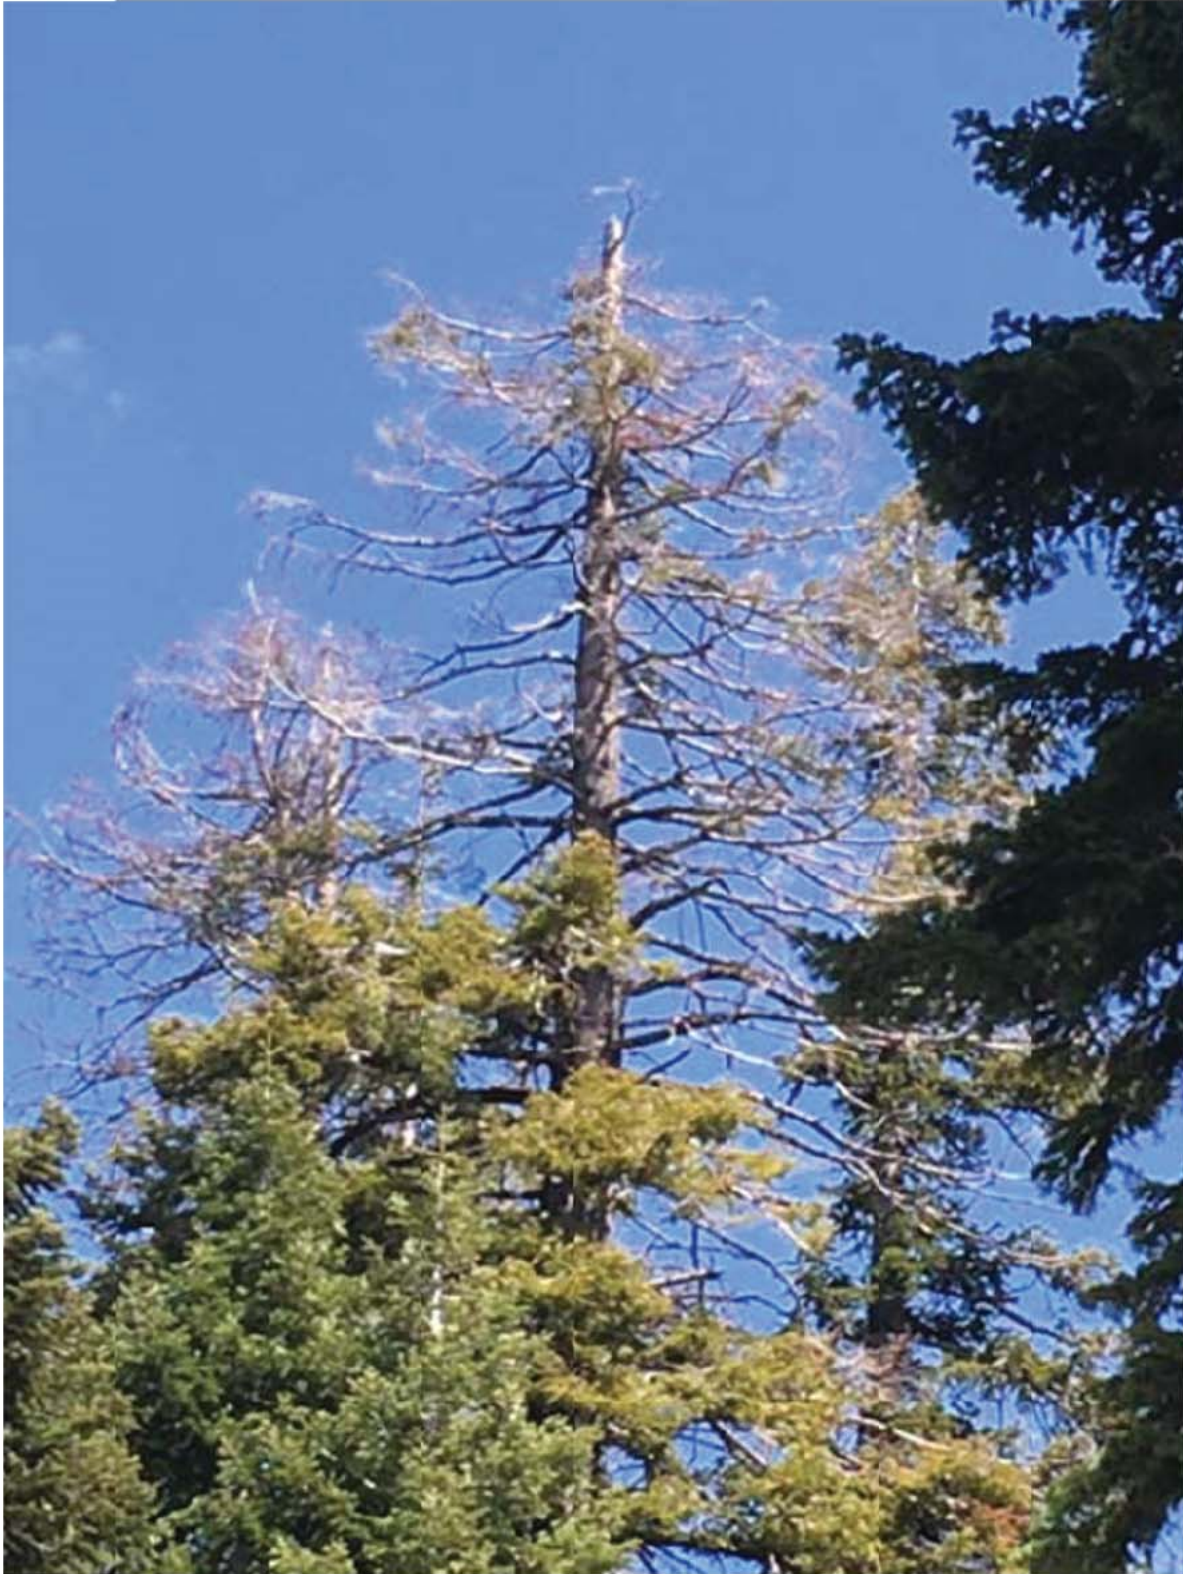
**Figure 14:** Typical tip dieback on a declining tree. Trees like this were alive at the time of my observations, but they may be expected to continue to decline.

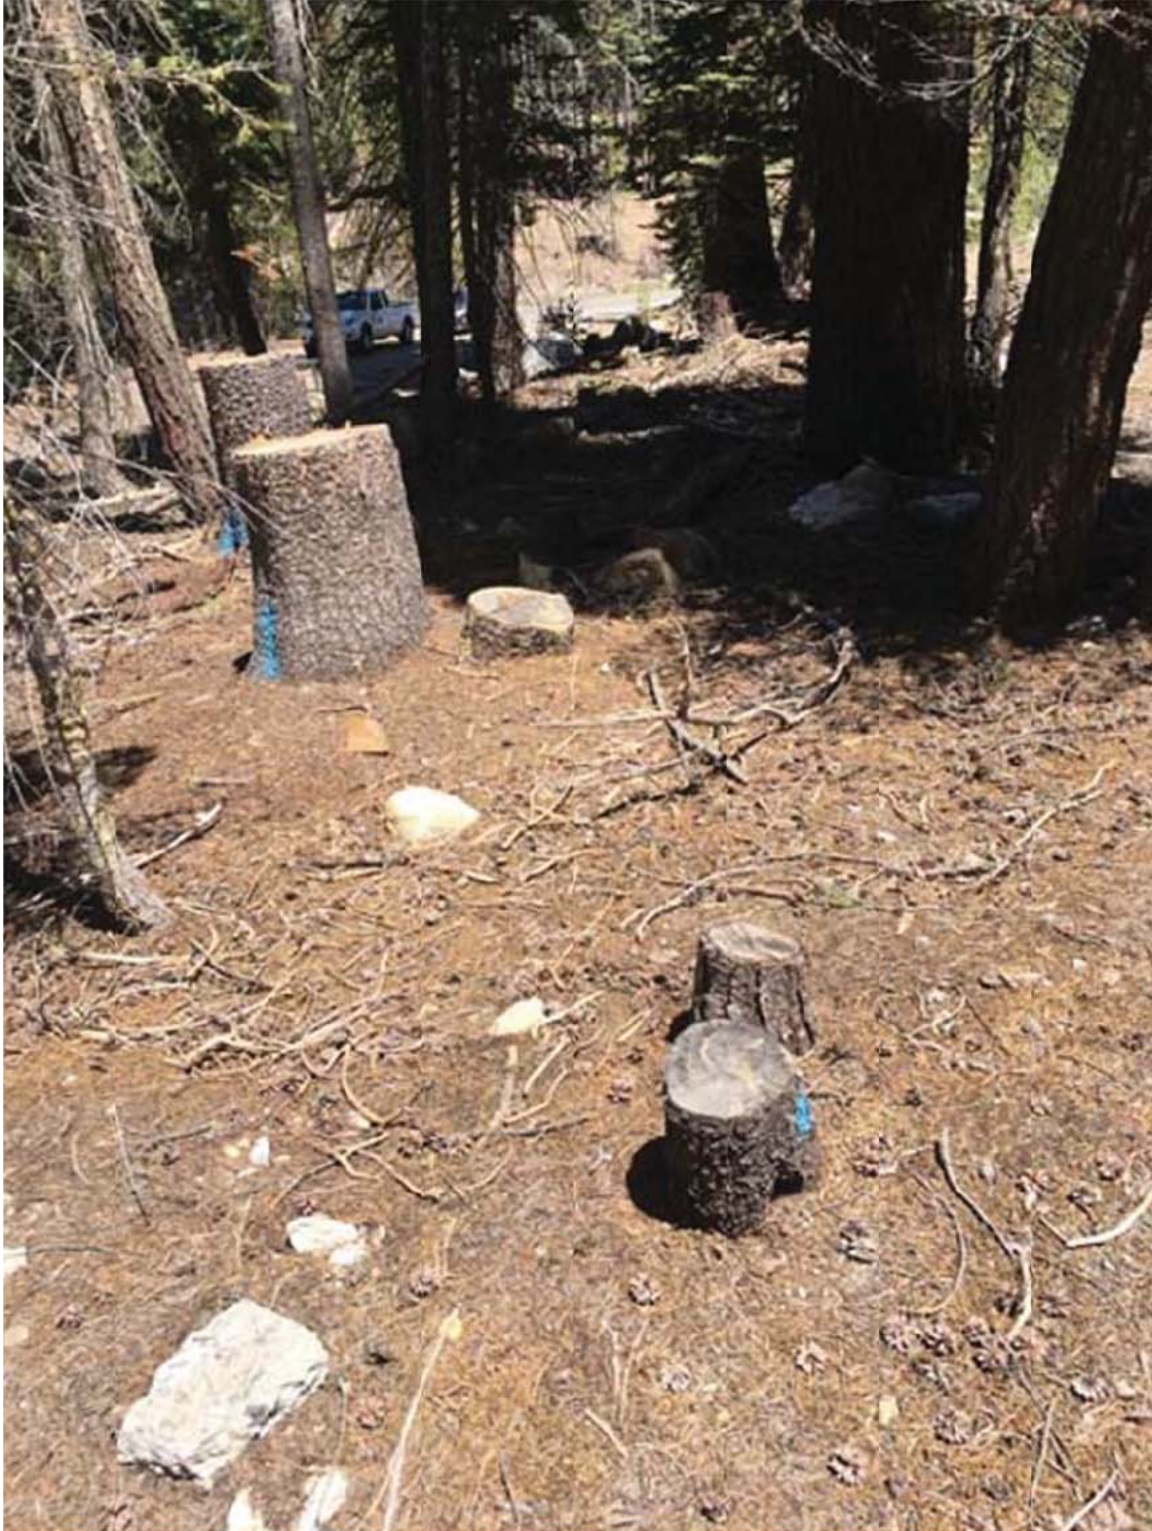
The timing of tree felling paralleled the mortality distribution over the three general areas of the campground. Recent and 1-2 year old felled trees were distributed around the entire campground. Even distribution of timing shows that the tree mortality occurred gradually over time over the entire campground. Even when all of the dead trees had been cleared out of one area of the campground at a particular point in time, the decline and death of neighboring trees continued. To address the advance of tree decline over time, the felling operations were repeated multiple times in each area of the campground over the past 2 years. About 70% of the campsites I observed had at least one adjacent dead or dying tree that had not yet been felled.

**Figure 15:** Tree felling occurred on the campground throughout the past 2 years. Two older stumps from about 2 years ago (foreground) can be seen near some more recent stumps from the past few months (middle ground, left).

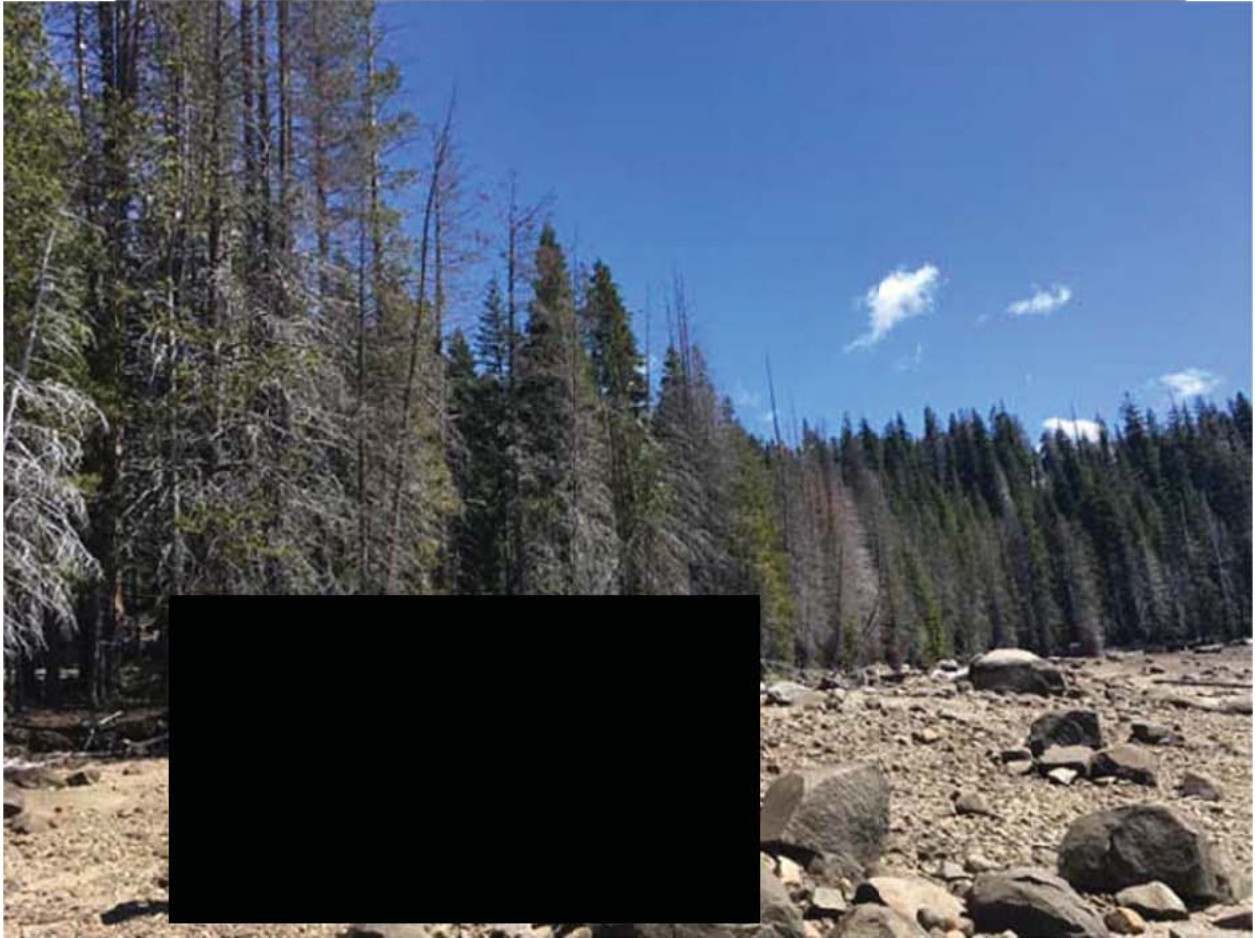
Next, the trees near the lake had developed shallow root systems in response to the saturated soil conditions at the lake's natural water level. However, the lake level declined substantially during the period of drought, making water less available to the lakefront tree roots. In contrast, trees further from the lake had grown deeper roots and were able to access a less-variable source of water.

**Figure 18:** The rocky/sandy area in the foreground would have been covered by the lake's natural water level. The water level in the lake was very low at the time of my site visit.

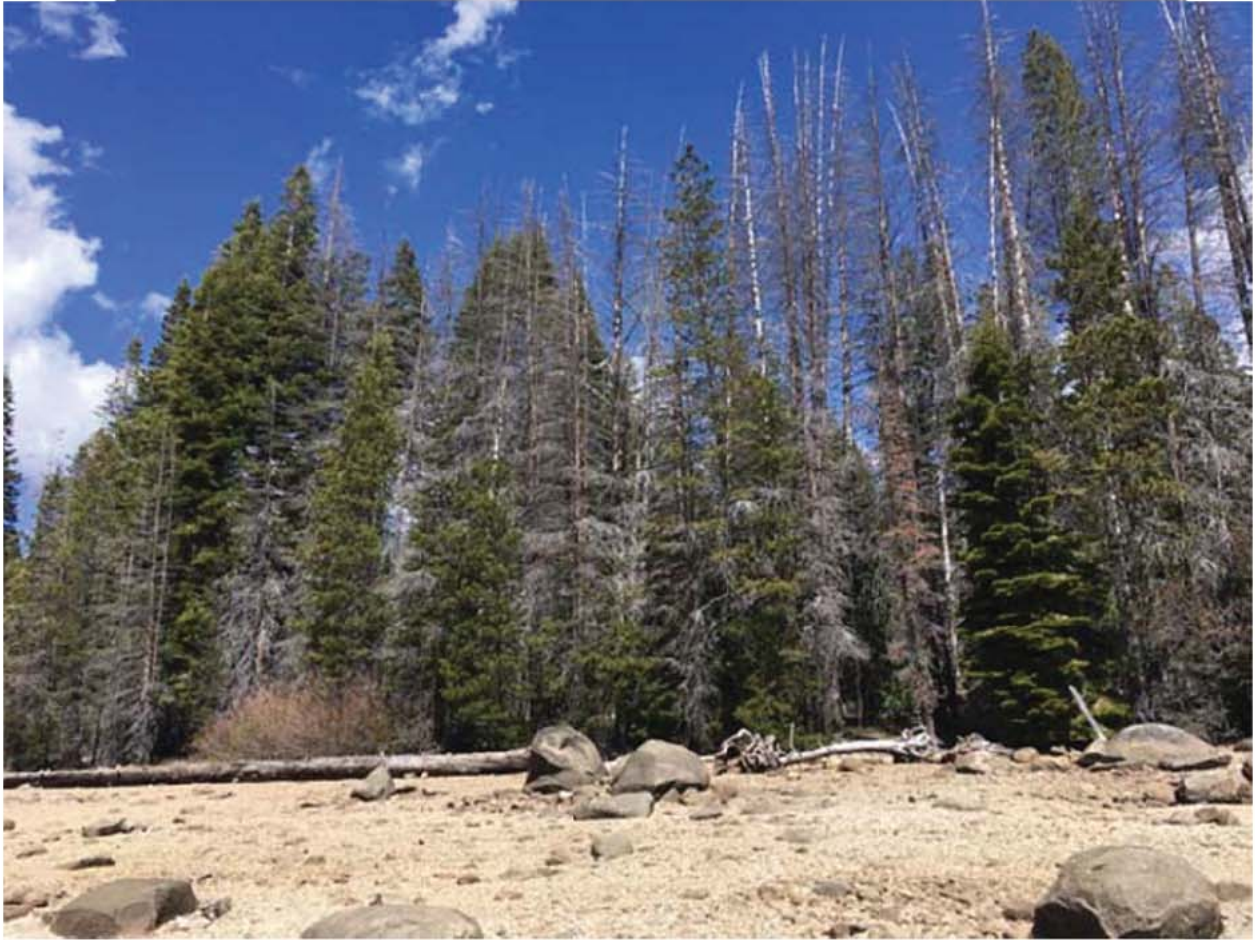
**Figure 19:** Mortality was highest near the lake. Low water level (foreground, sandy area) contributed to drought stress.

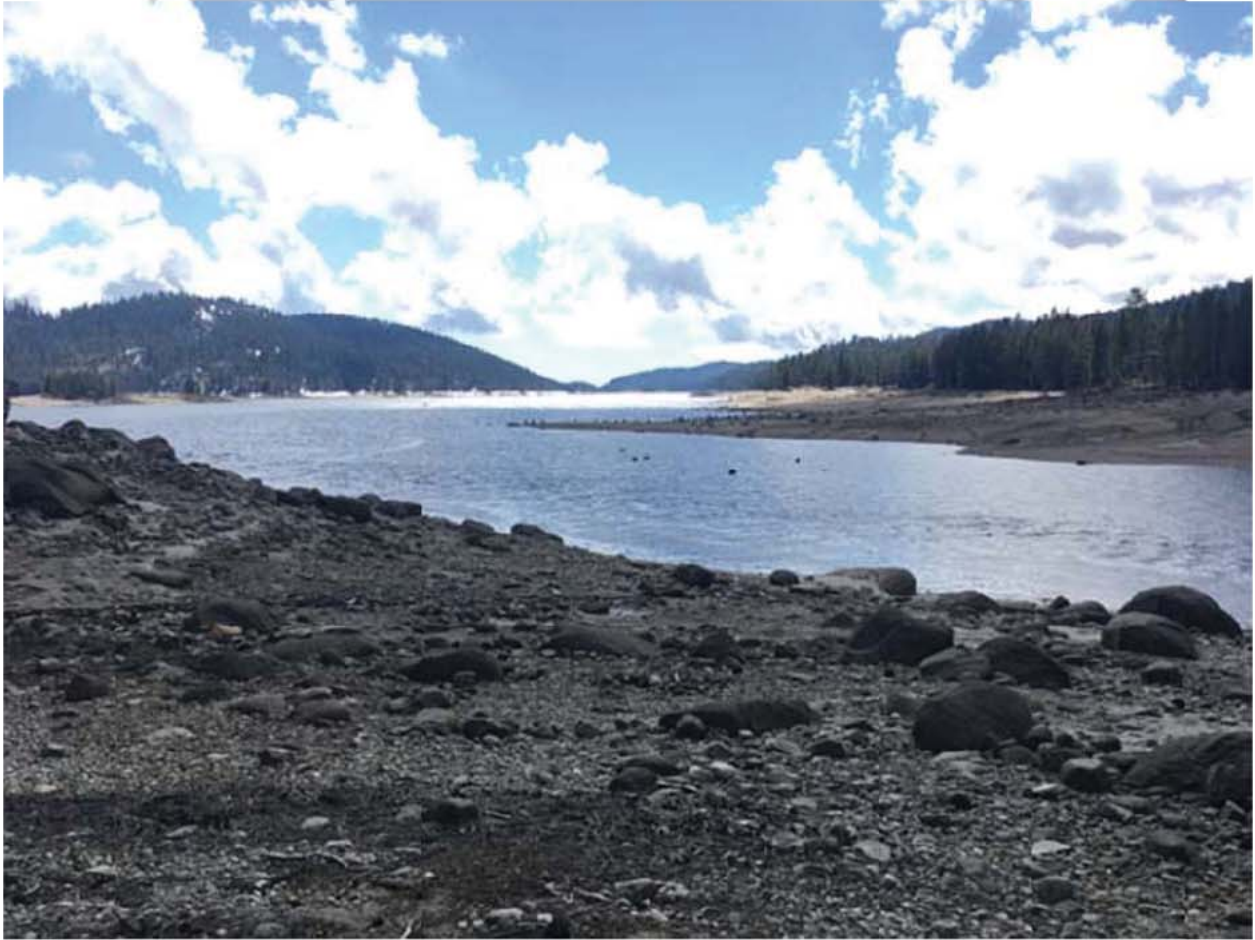
**Figure 10:** Water level in the lake was abnormally low.

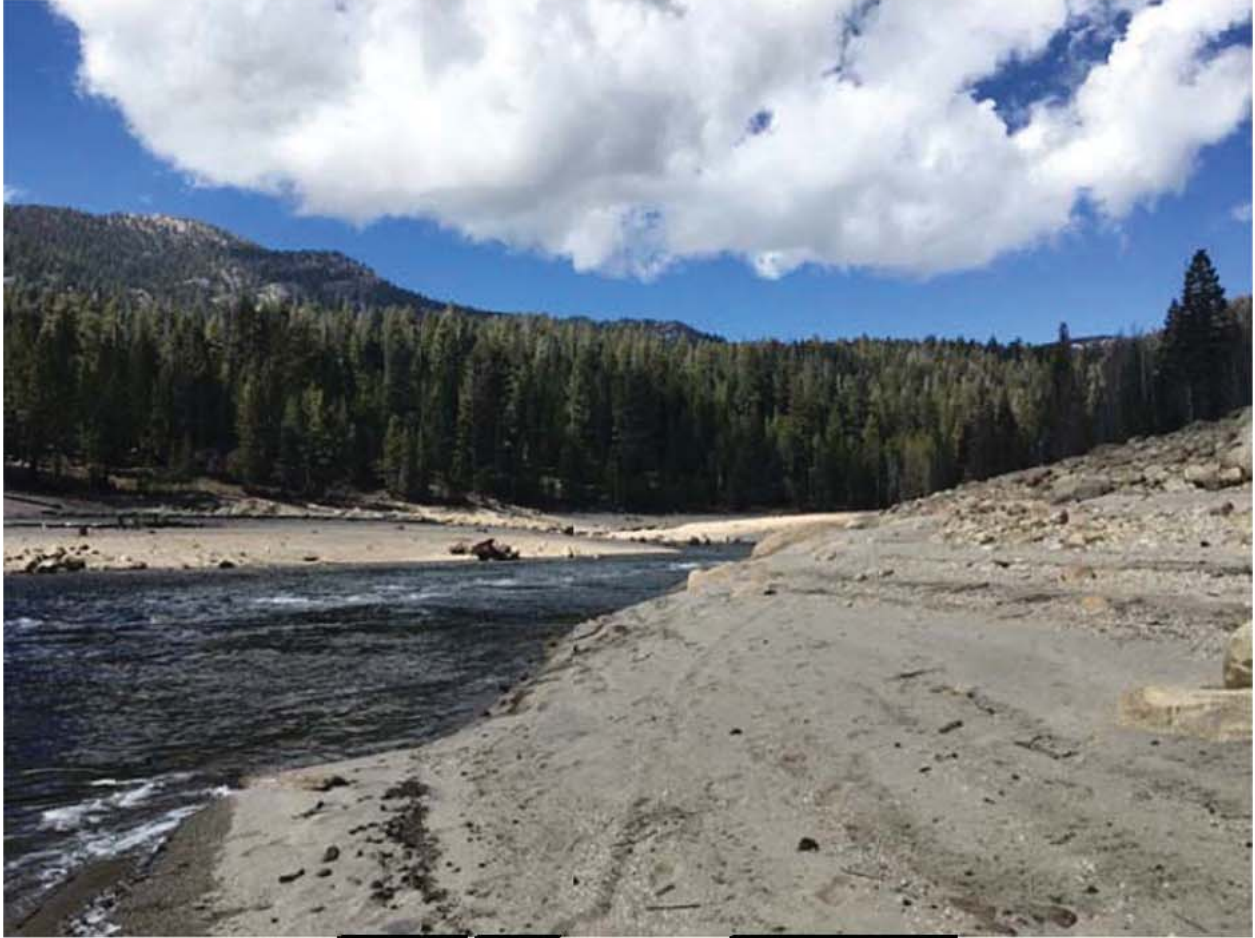
**Figure 1:** Water level in [REDACTED] which feeds [REDACTED] was abnormally low.
