**Class One Arboriculture**  
3763 Ramsdell Av  
Glendale, CA 91214  
Phone: (818) 495-5344

[REDACTED] – Tree Inspection Report

[REDACTED] # [REDACTED]  
James Komen, Class One Arboriculture Inc.

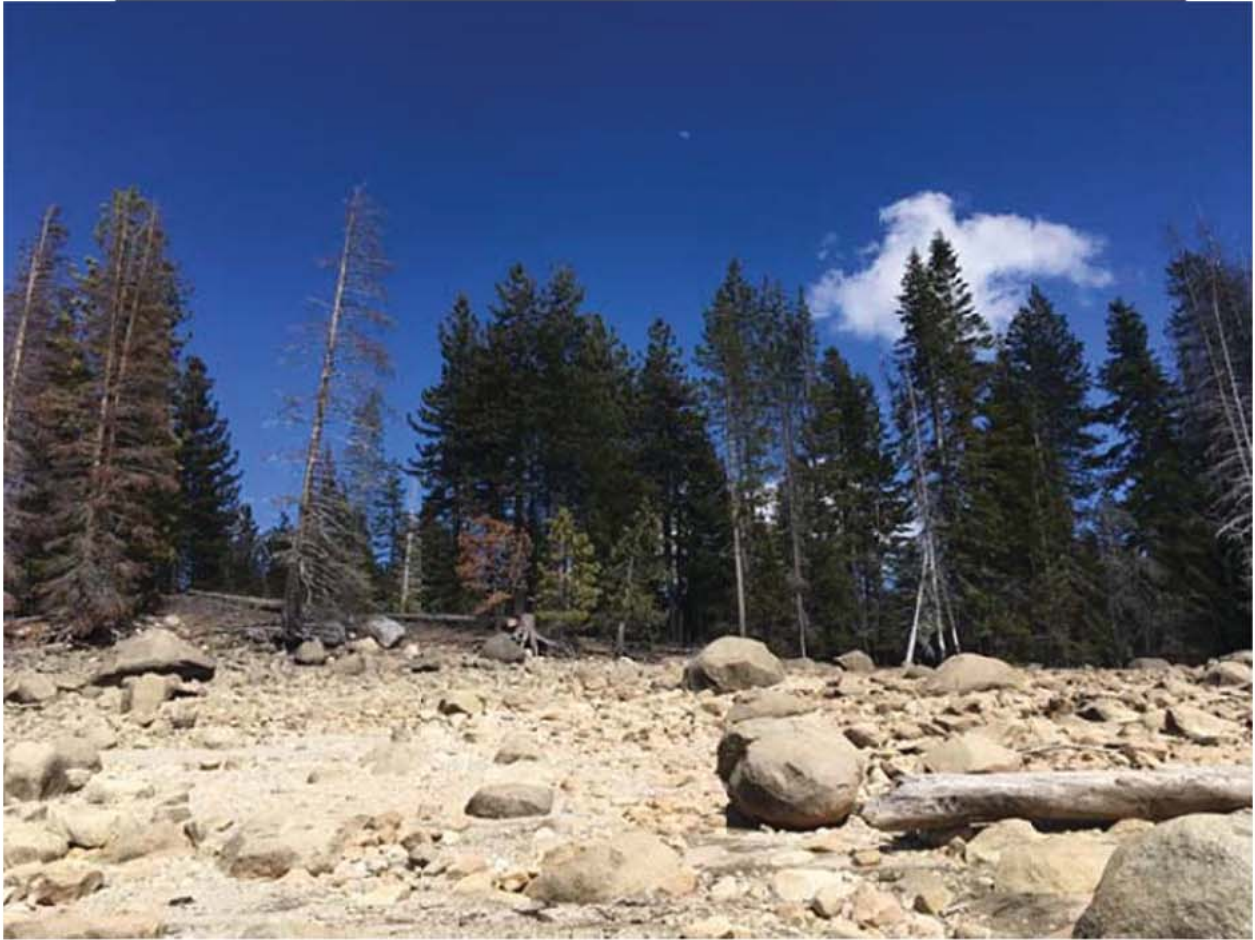
The area at the northern edge of the campground bordering Rancheria Creek had a higher mortality rate than the interior trees away from both the creek and the lake. Like with the lakefront trees, there were more pines than firs closer to the creek. There was also a substantial change in the water level during the drought, likely reducing the availability of water to these trees. But the mortality was lower than by the lakefront because there were more firs and because the exposure was to the north and not the west.

**Figure 2:** Tree mortality was higher along the creek, but not as high as along the lake.
