Example Mt. Washington Arborist Report

Prepared by James Komen

Class One Arboriculture

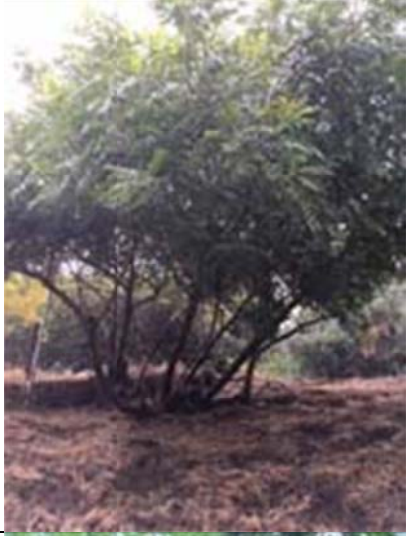
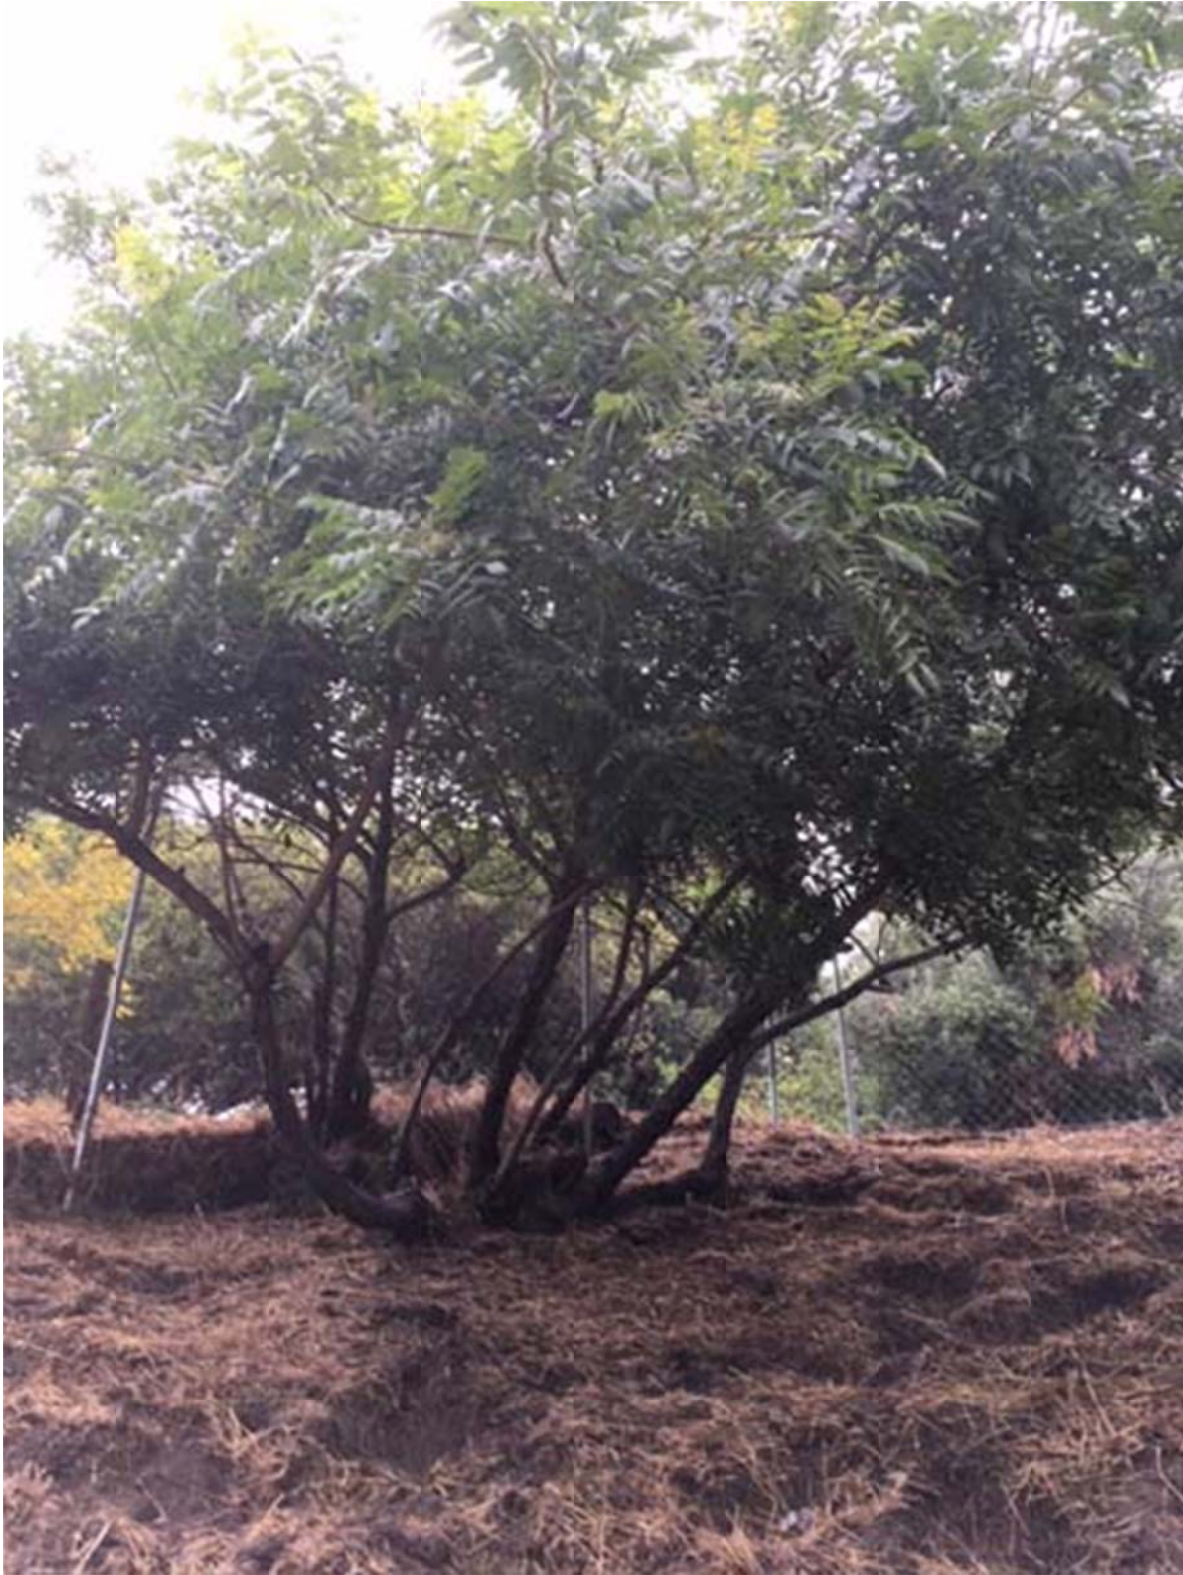
Figure 3: Tree 1

<p>Tree 1 <i>Juglans californica</i> – California Black Walnut</p> <p>This tree is protected by ordinance. It is showing signs of minor stress in the foliage. It has nine trunks of varying sizes emerging from an old stump. This tree is intended for preservation on site. If the tree protection fencing is not crossed, this tree stands a good chance at survival following construction.</p>

- Prune Trees, 1, 4, and 16 for clearance with the work area. Hire a crew directly supervised by a certified arborist on site to ensure the pruning cuts are made to branch unions and do not remove an excessive amount of foliage. As the project progresses, only prune when deemed necessary by the project arborist; as much live foliage as possible should be preserved through the construction process to give the trees the best opportunity to thrive after construction is complete.

- Apply a bimonthly irrigation to Trees 1, 4, 5, and 16. Irrigation should be adjusted so the application rate is slow enough to avoid runoff and the duration is long enough to allow water to infiltrate to a depth of 6-12 inches in the soil. If water hookups are unavailable, consider an irrigation bladder bag for each tree. Fill the bags with water bimonthly and allow them to slowly drain into the soil.

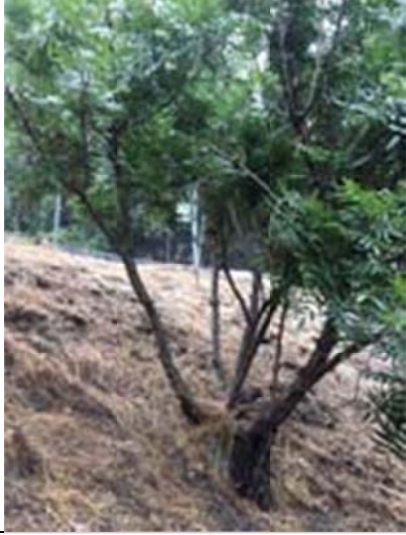
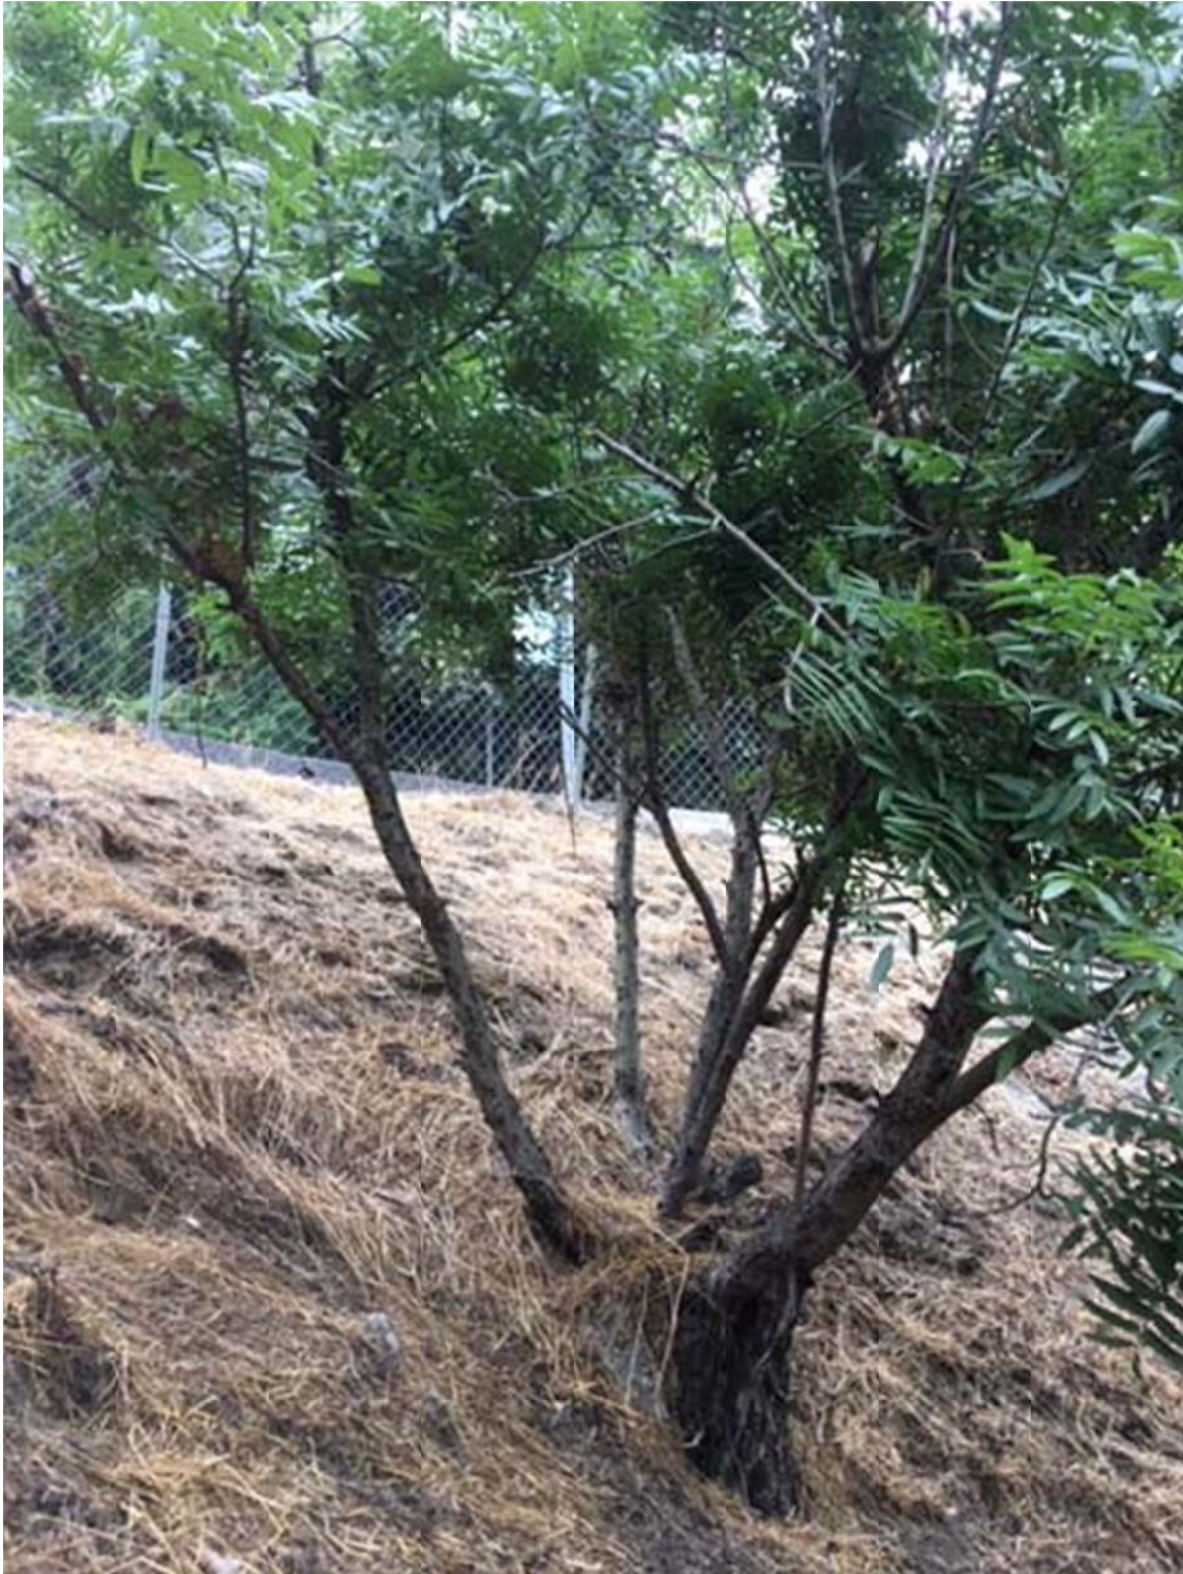
Figure 4: Tree 2

<p>Tree 2 <i>Juglans californica</i> – California Black Walnut</p> <p>This tree is protected by ordinance. It is showing signs of minor stress in the foliage. It is proposed for removal because it is growing too close to the proposed driveway – 30% of its critical root zone will be severed. If it were retained, most of its branches would have to be removed for clearance. In its already stressed condition, it would not likely survive.</p>

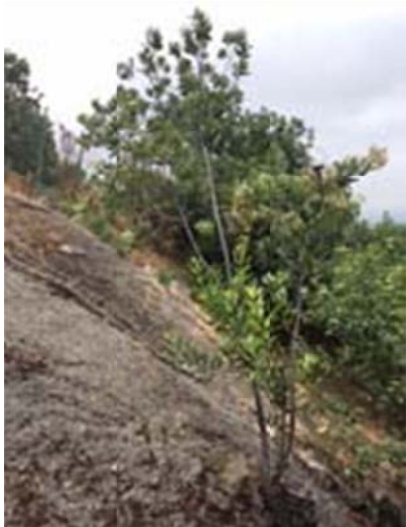
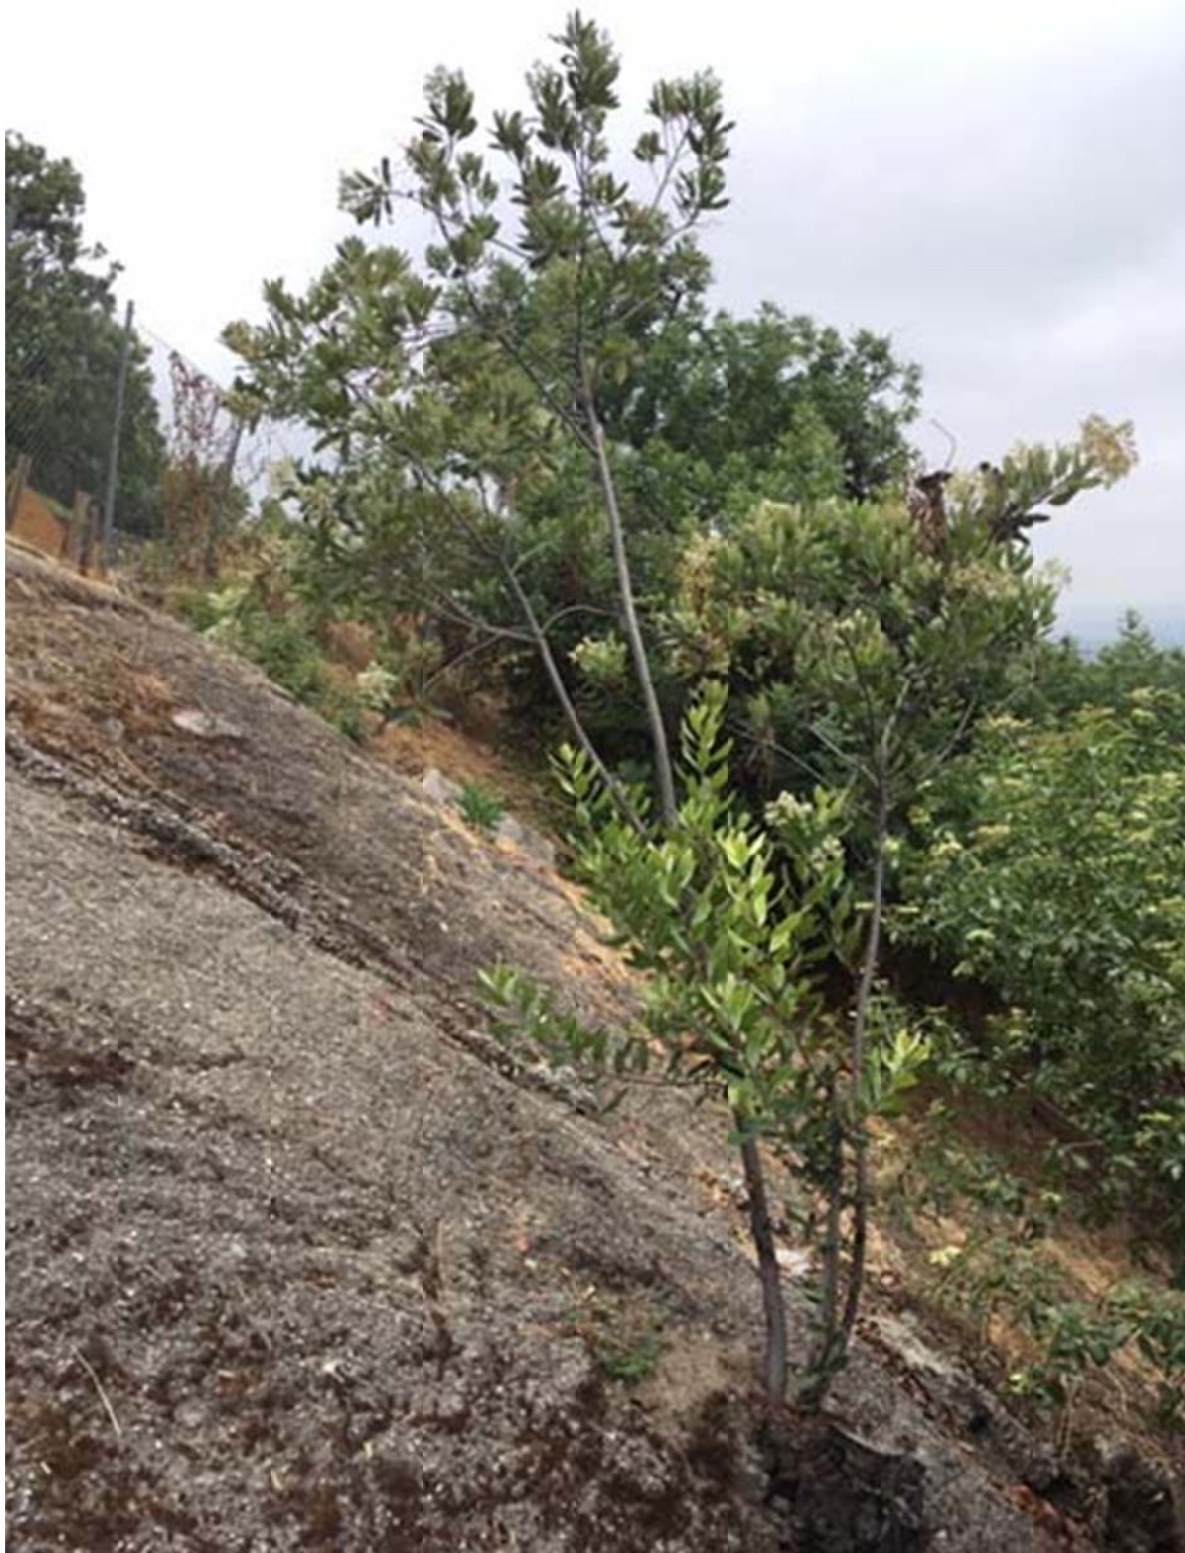
Figure 5: Tree 3

<p>Tree 3 <i>Heteromeles arbutifolia</i> – Toyon</p> <p>This tree is not protected by ordinance. It is proposed for removal.</p>

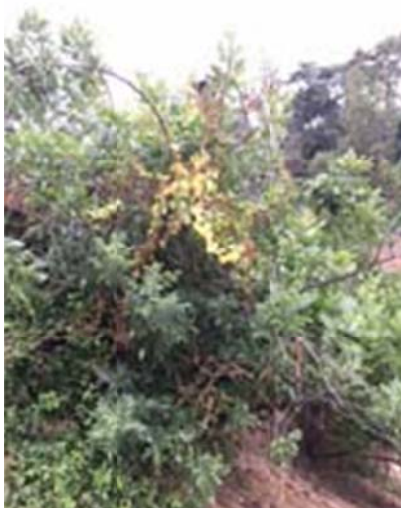
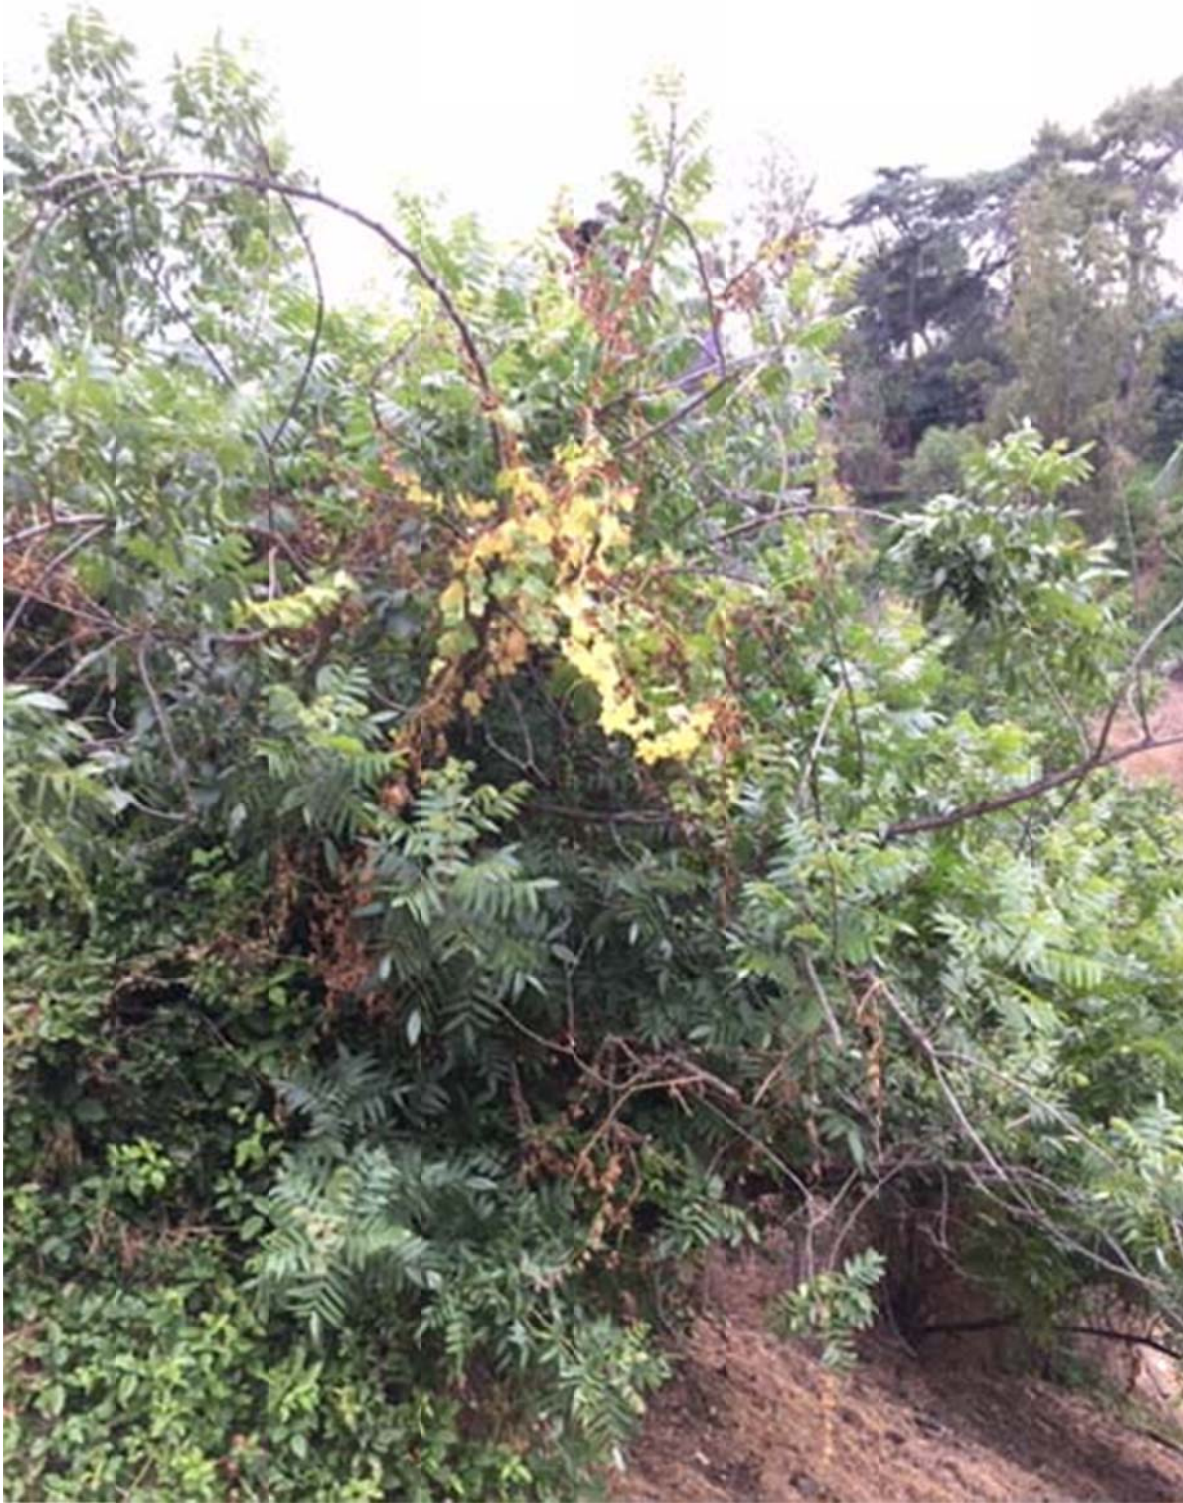
Figure 6: Tree 4

<p>Tree 4 <i>Juglans californica</i> – California Black Walnut</p> <p>This tree is protected by ordinance. At some point in the past, the top section of the trunk failed, leaving an exposed stump. Most of the foliage on this tree is a result of secondary re-sprout growth from near the base of the tree.</p> <p>This tree was wrapped in poison oak, precluding direct trunk measurement. My measurements of this tree's trunk dimensions were visually approximated.</p> <p>This tree is intended to be retained in the landscape.</p>

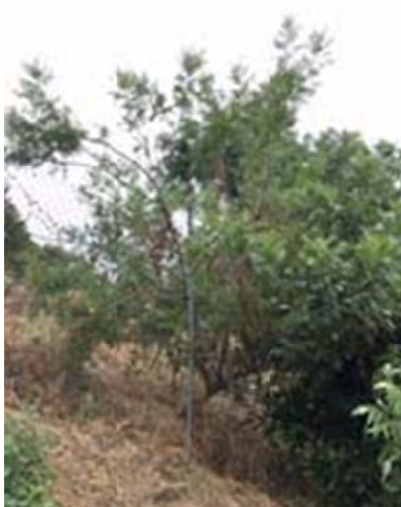
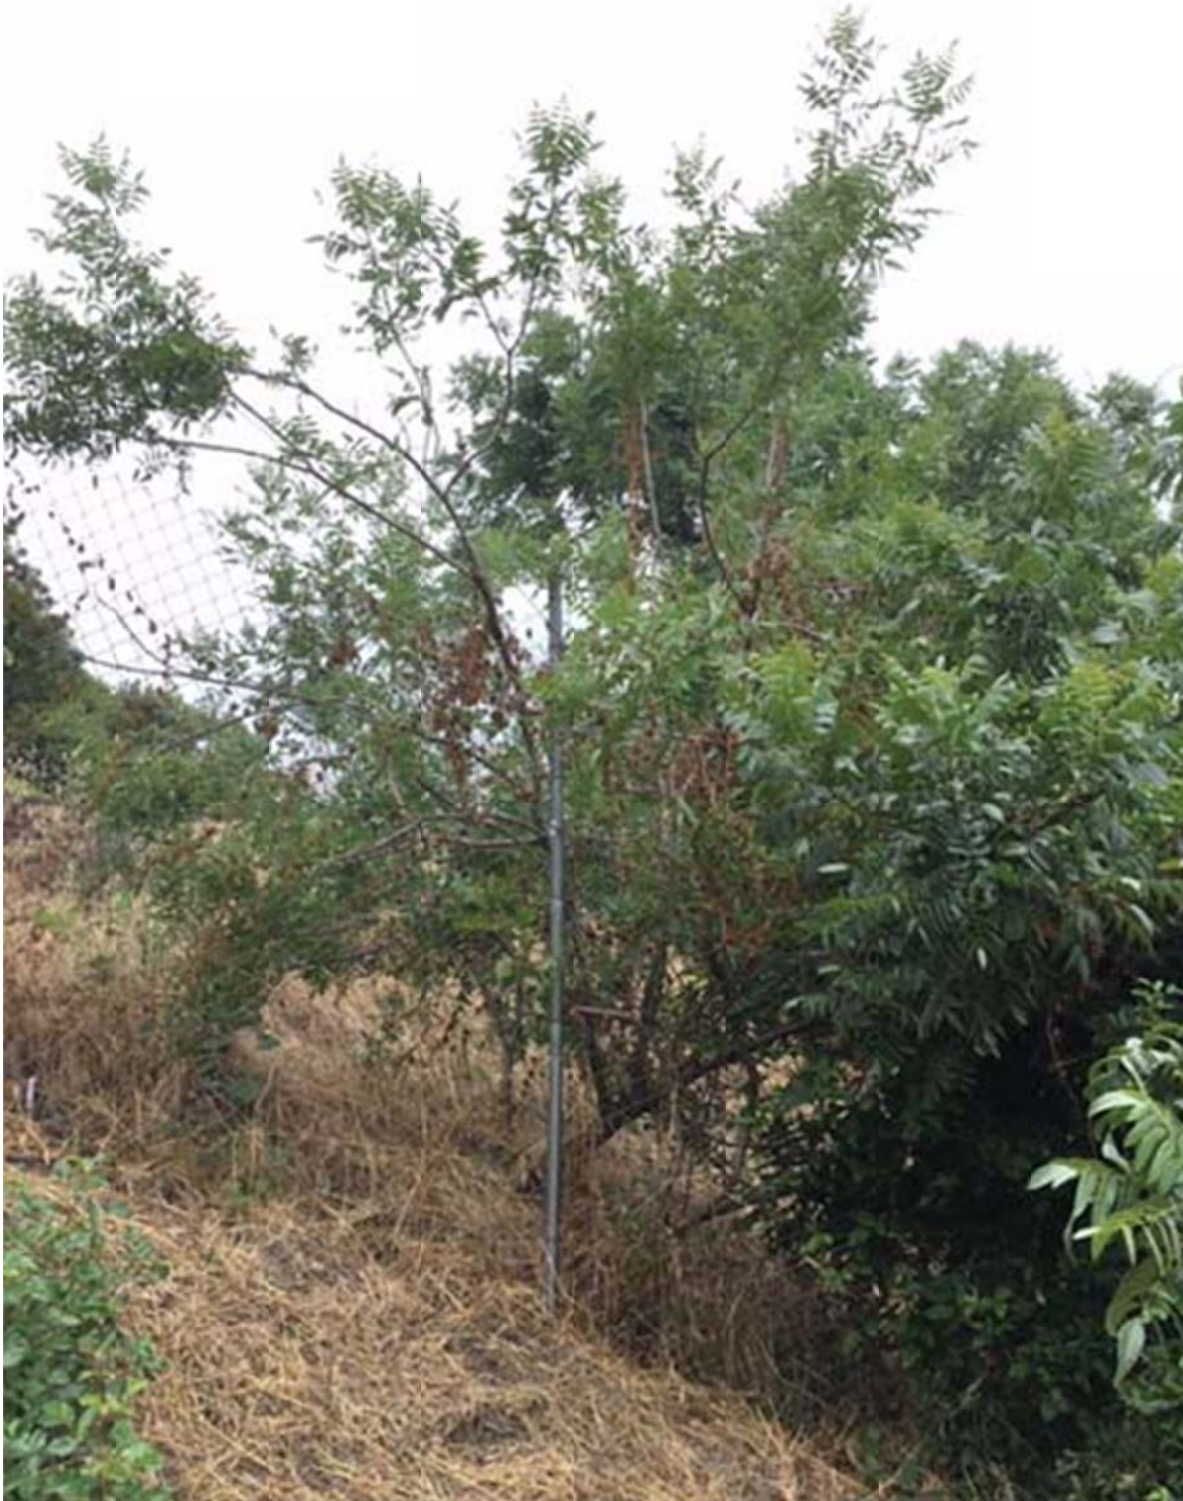
Figure 7: Tree 5

<p>Tree 5 <i>Juglans californica</i> – California Black Walnut</p> <p>This tree is too small to be protected by ordinance. It will not be removed as part of the construction process.</p>

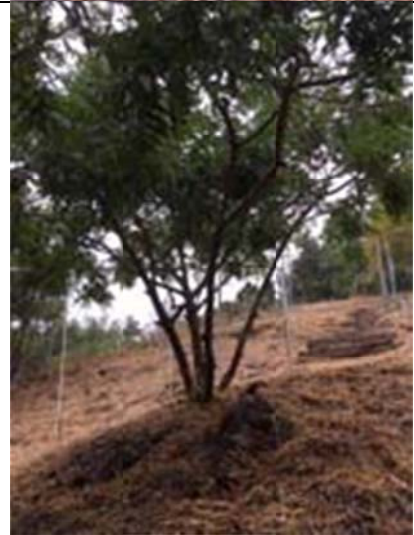
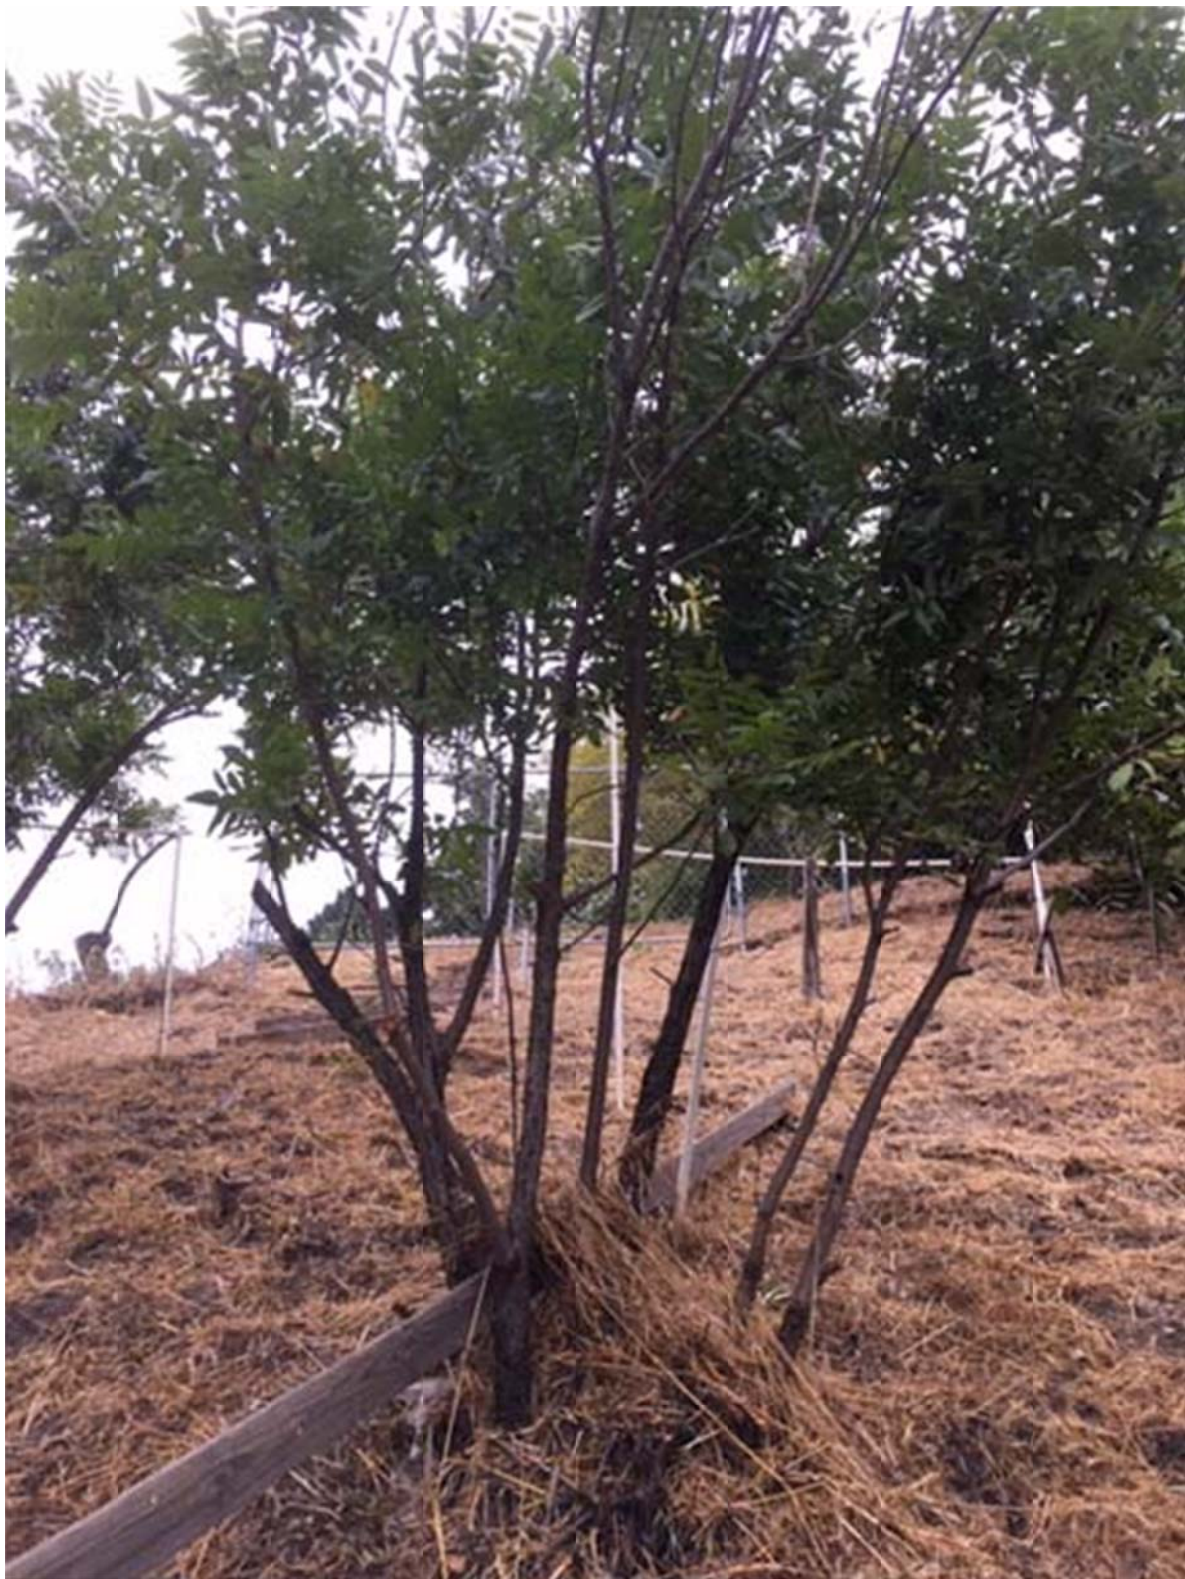
Figure 9: Tree 7

<p>Tree 7 <i>Juglans californica</i> – California Black Walnut</p> <p>This tree is protected by ordinance because the cumulative diameter of the four trunks totals 4” in diameter measurements. This tree must be removed because it is within the footprint of the proposed construction.</p>

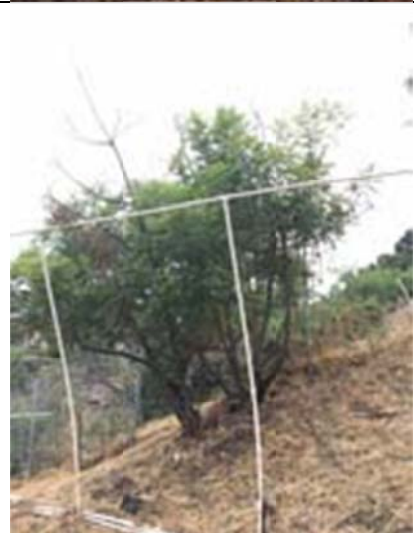
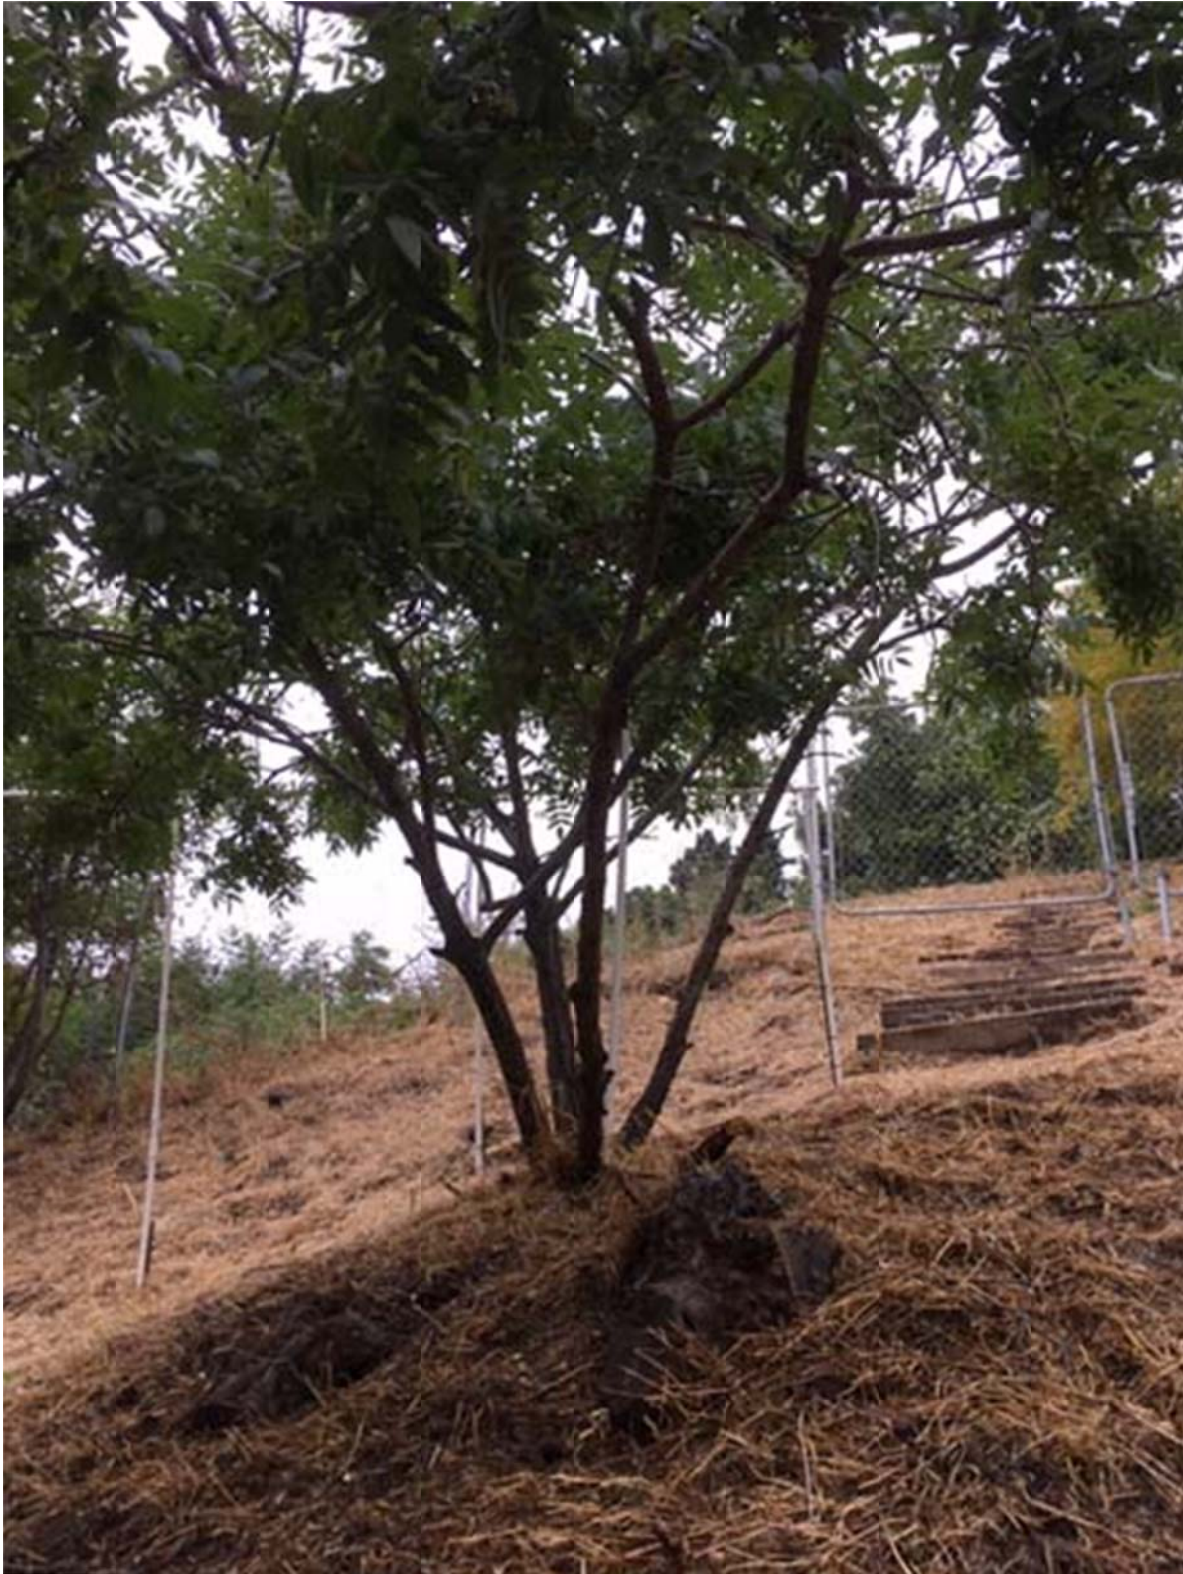
Figure 10: Tree 8

<p>Tree 8 <i>Juglans californica</i> – California Black Walnut</p> <p>This tree is protected by ordinance. This tree must be removed because it is growing within the footprint of the necessary access walkway along the side of the proposed house. Preserving this tree would preclude access to the proposed garage deck.</p>

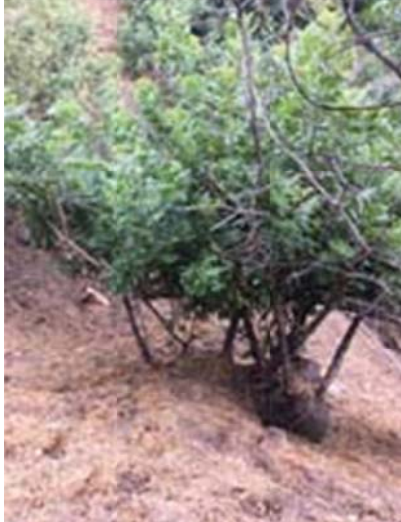
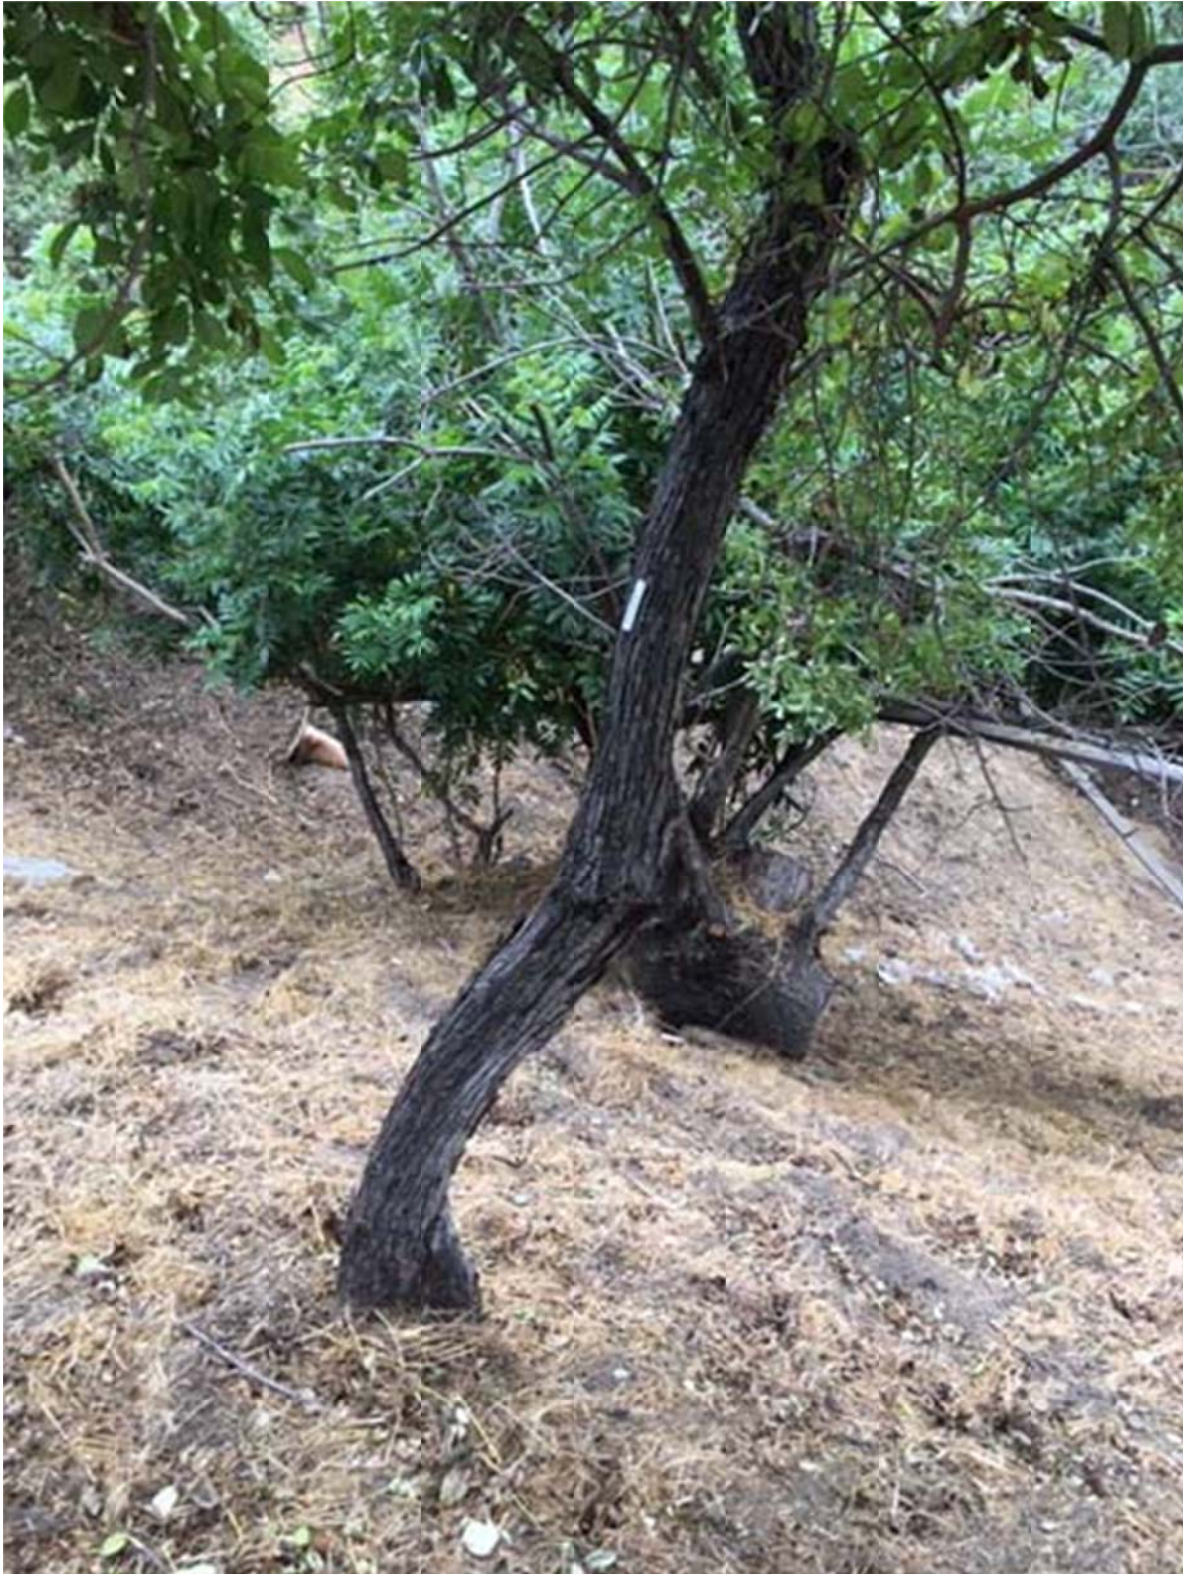
Figure 13: Tree 11

<p>Tree 11 <i>Juglans californica</i> – California Black Walnut</p> <p>This tree is protected by ordinance. It is dead, so it will be removed.</p>

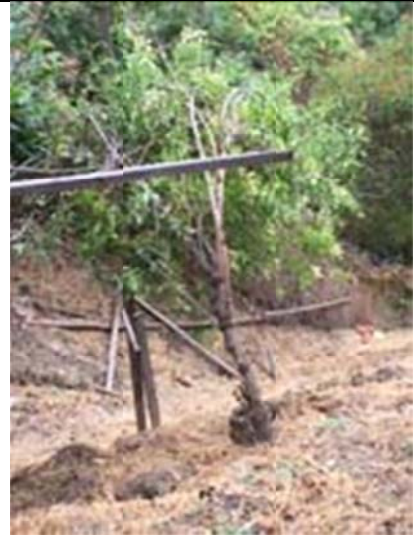
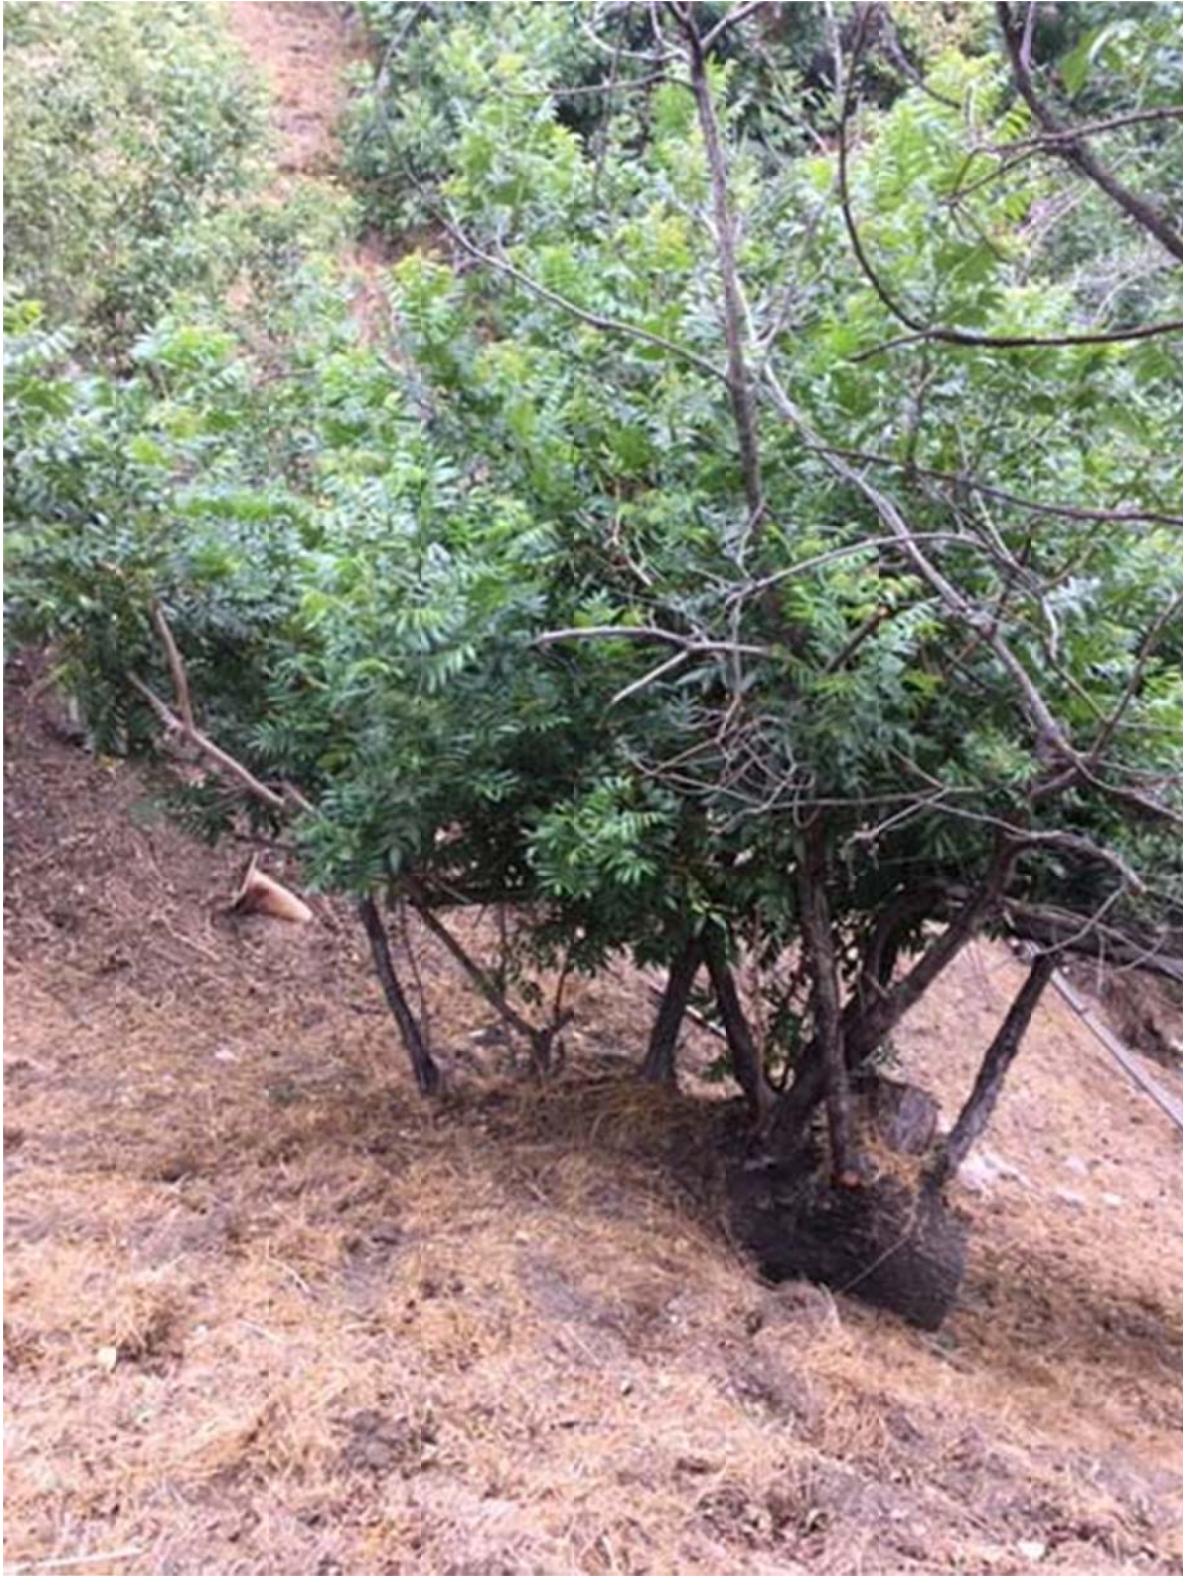
Figure 14: Tree 12

<p>Tree 12 <i>Juglans californica</i> – California Black Walnut</p> <p>This tree is protected by ordinance. There are nine 3” re-sprout stems emerging from an old failed stump. This tree must be removed because it is within the footprint of the proposed construction.</p>

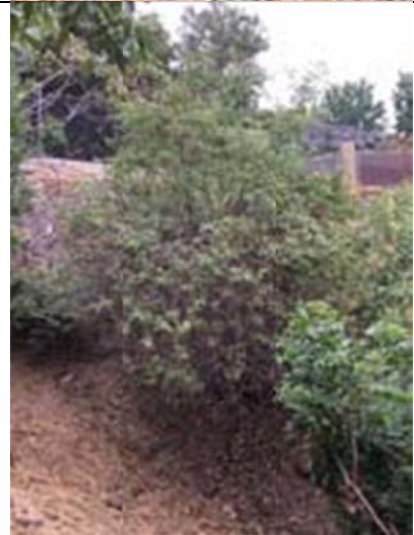
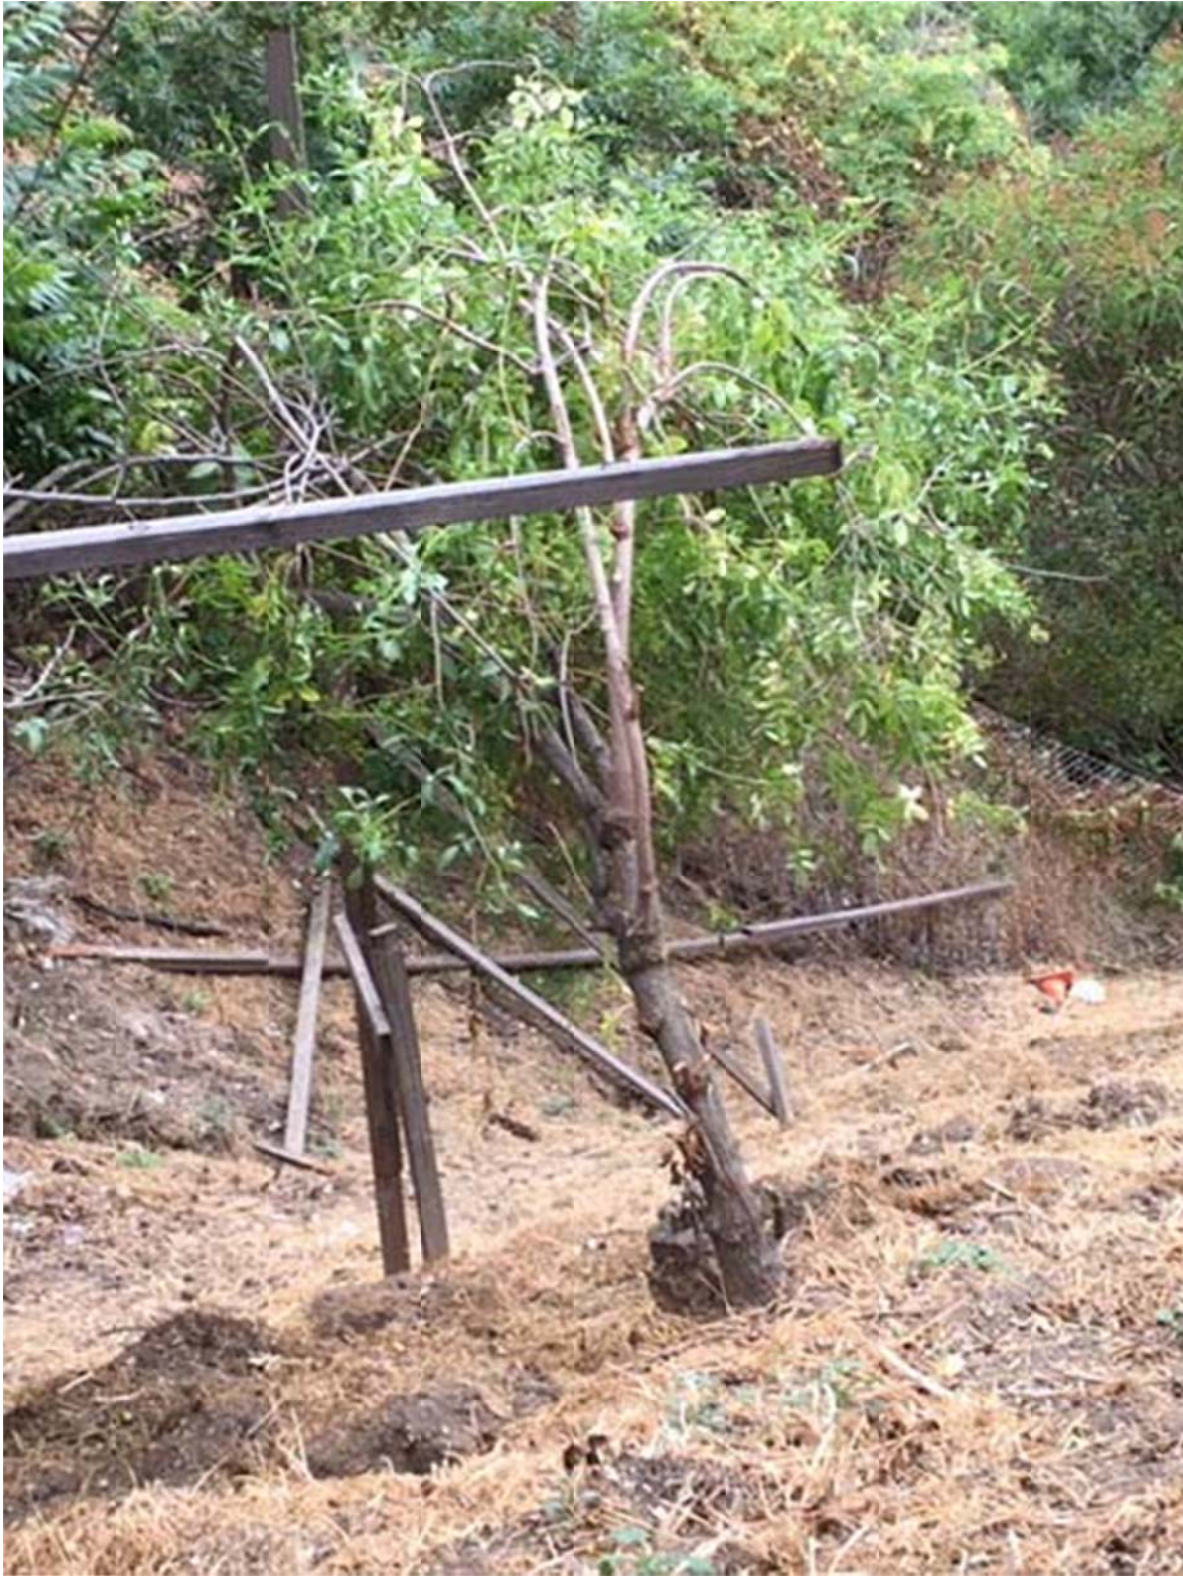
Figure 15: Tree 13

<p>Tree 13 <i>Sambucus mexicana</i> – Mexican Elderberry</p> <p>This tree is not protected by ordinance. This tree must be removed because it is within the footprint of the proposed construction.</p>
