Example Mt. Washington Arborist Report

Prepared by James Komen

Class One Arboriculture

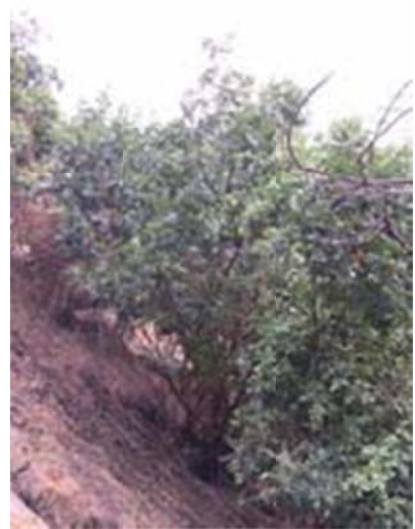
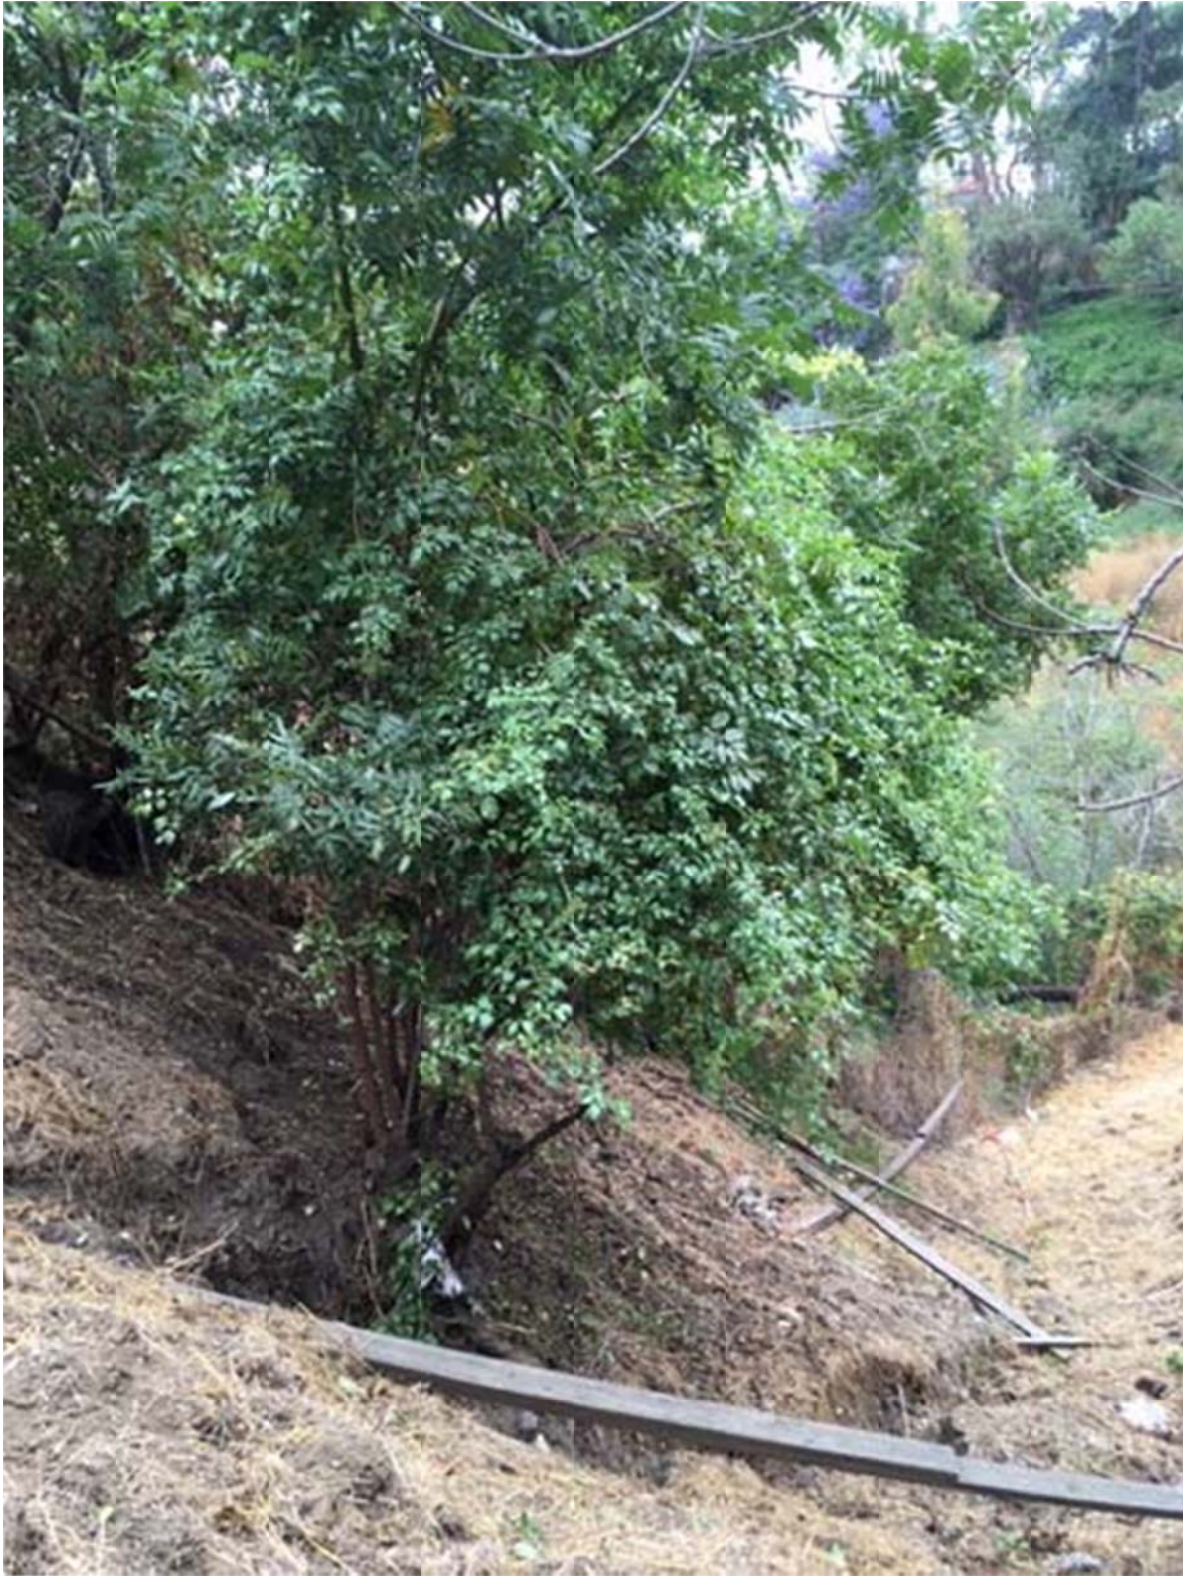
Figure 17: Tree 15

<p>Tree 15 <i>Sambucus mexicana</i> – Mexican Elderberry</p> <p>This tree is not protected by ordinance. This tree must be removed because it is within the footprint of the proposed construction.</p>

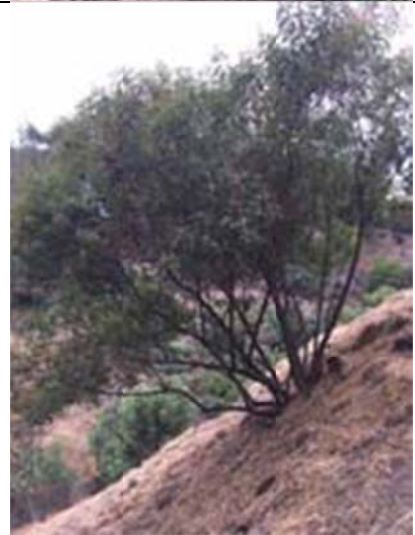
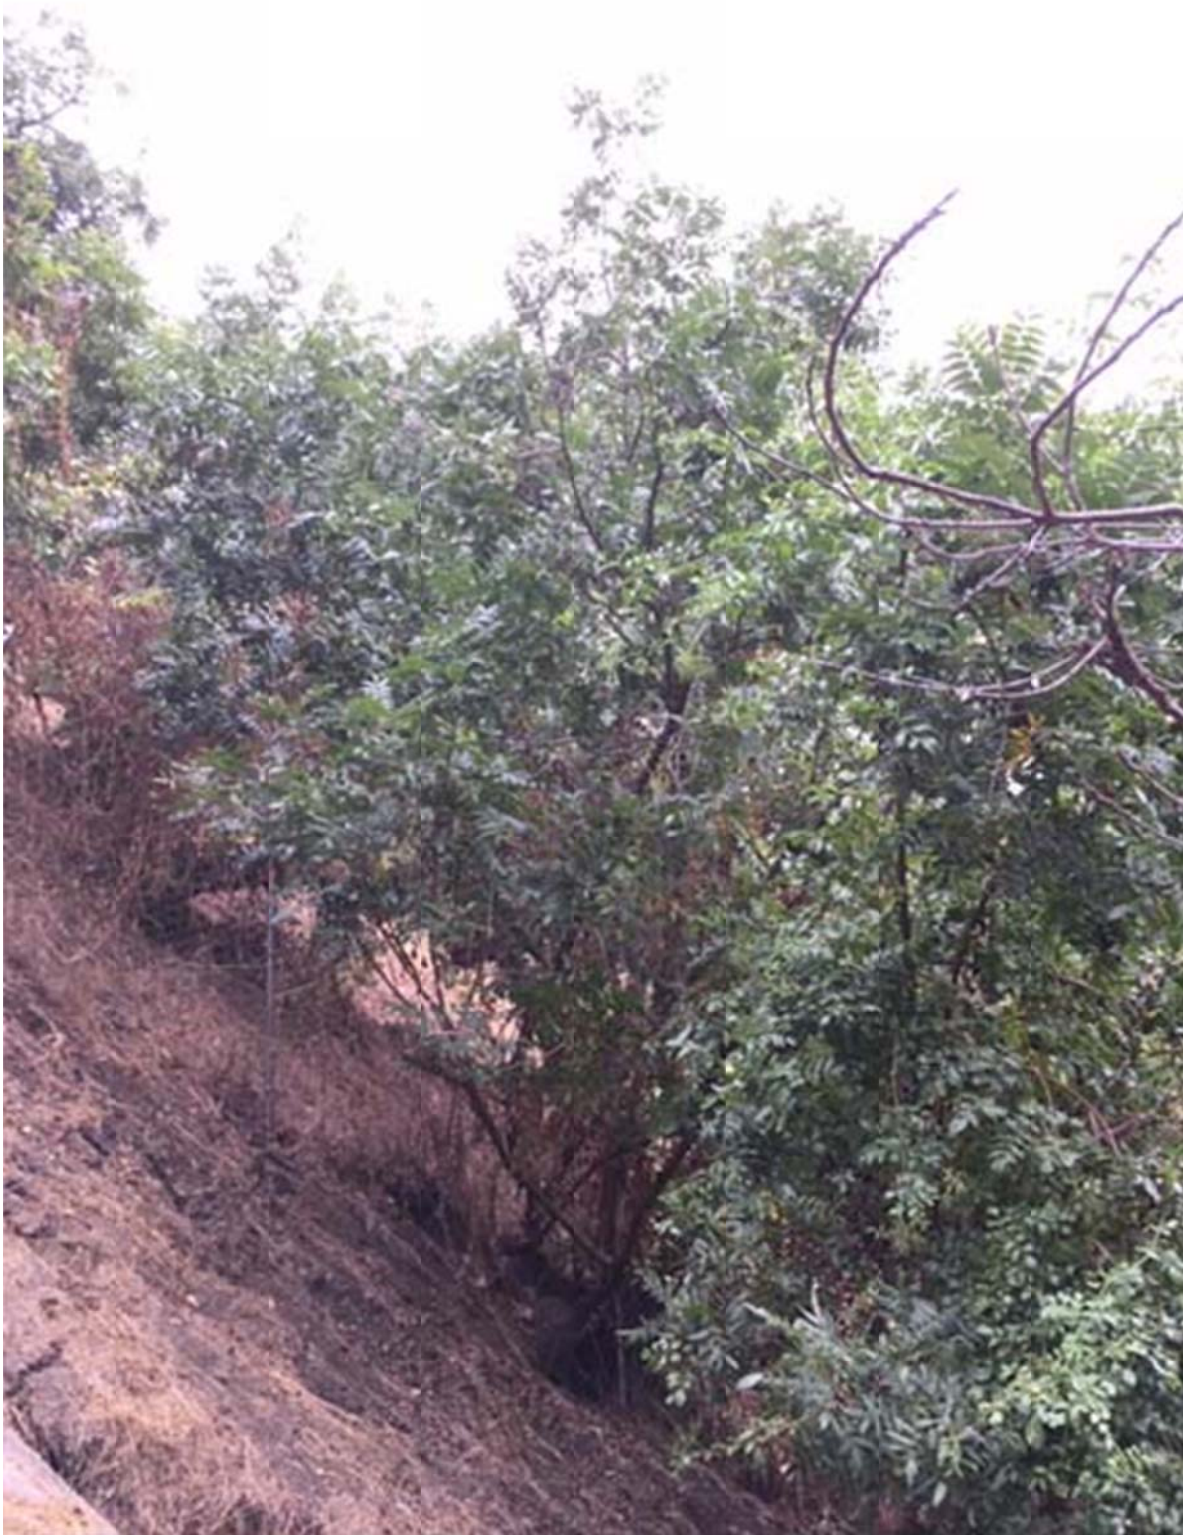
Figure 18: Tree 16

<p>Tree 16 <i>Juglans californica</i> – California Black Walnut</p> <p>This tree is protected by ordinance. It has a significant cavity of decay at the base of the tree. All eleven of its small stems are emerging as secondary growth from an old, decayed stump of a former tree. This tree will be retained through construction. Some of its eastern branches will have to be pruned back a few feet to allow for the erection of a tree protection fence. This pruning will not have a significant effect on the overall health of the tree.</p>

- Prune Trees, 1, 4, and 16 for clearance with the work area. Hire a crew directly supervised by a certified arborist on site to ensure the pruning cuts are made to branch unions and do not remove an excessive amount of foliage. As the project progresses, only prune when deemed necessary by the project arborist; as much live foliage as possible should be preserved through the construction process to give the trees the best opportunity to thrive after construction is complete.

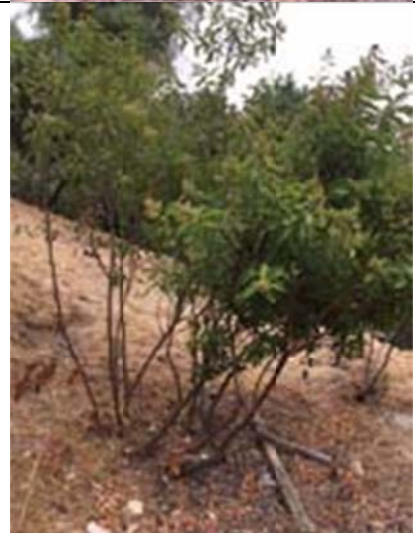
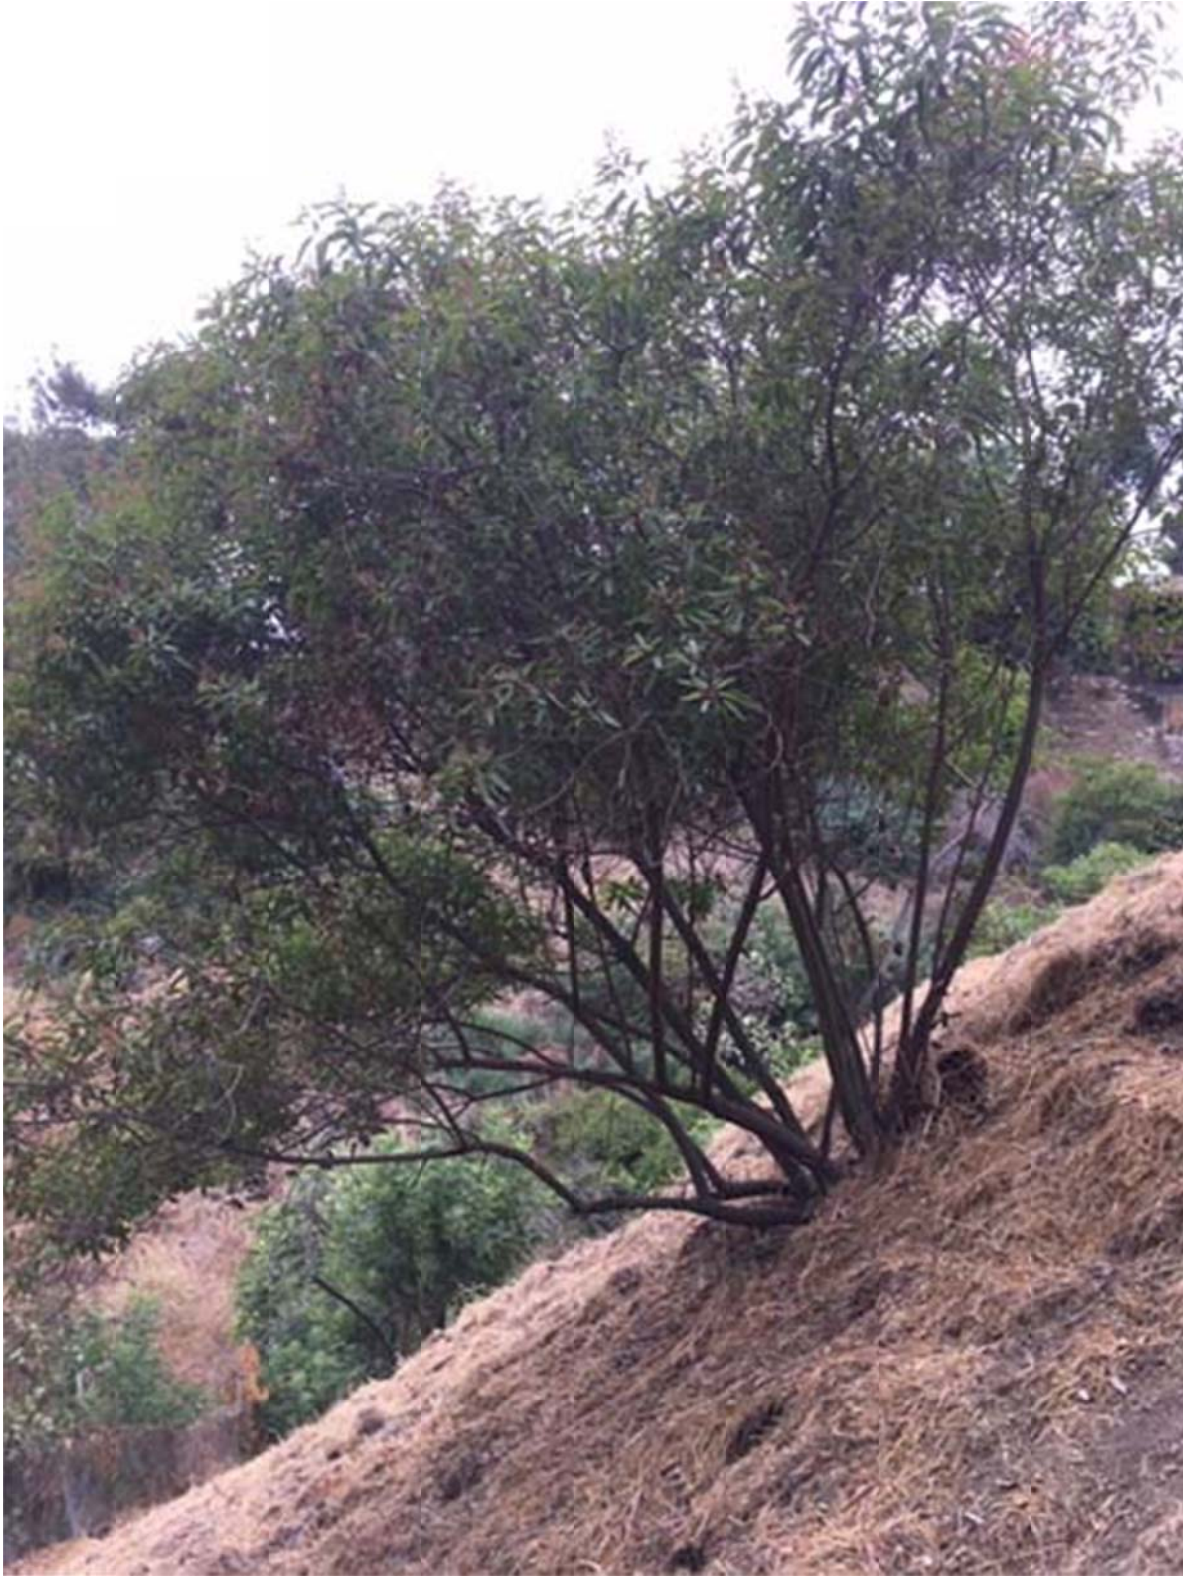
Figure 19: Tree 17

<p>Tree 17 <i>Malosma laurina</i> – Laurel Sumac</p> <p>This tree is not protected by ordinance. This tree must be removed because it is within the footprint of the proposed construction.</p>

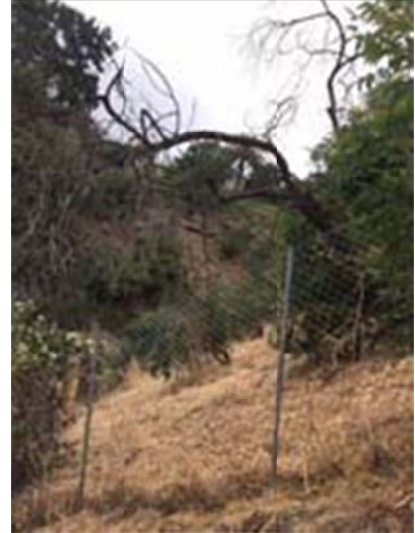
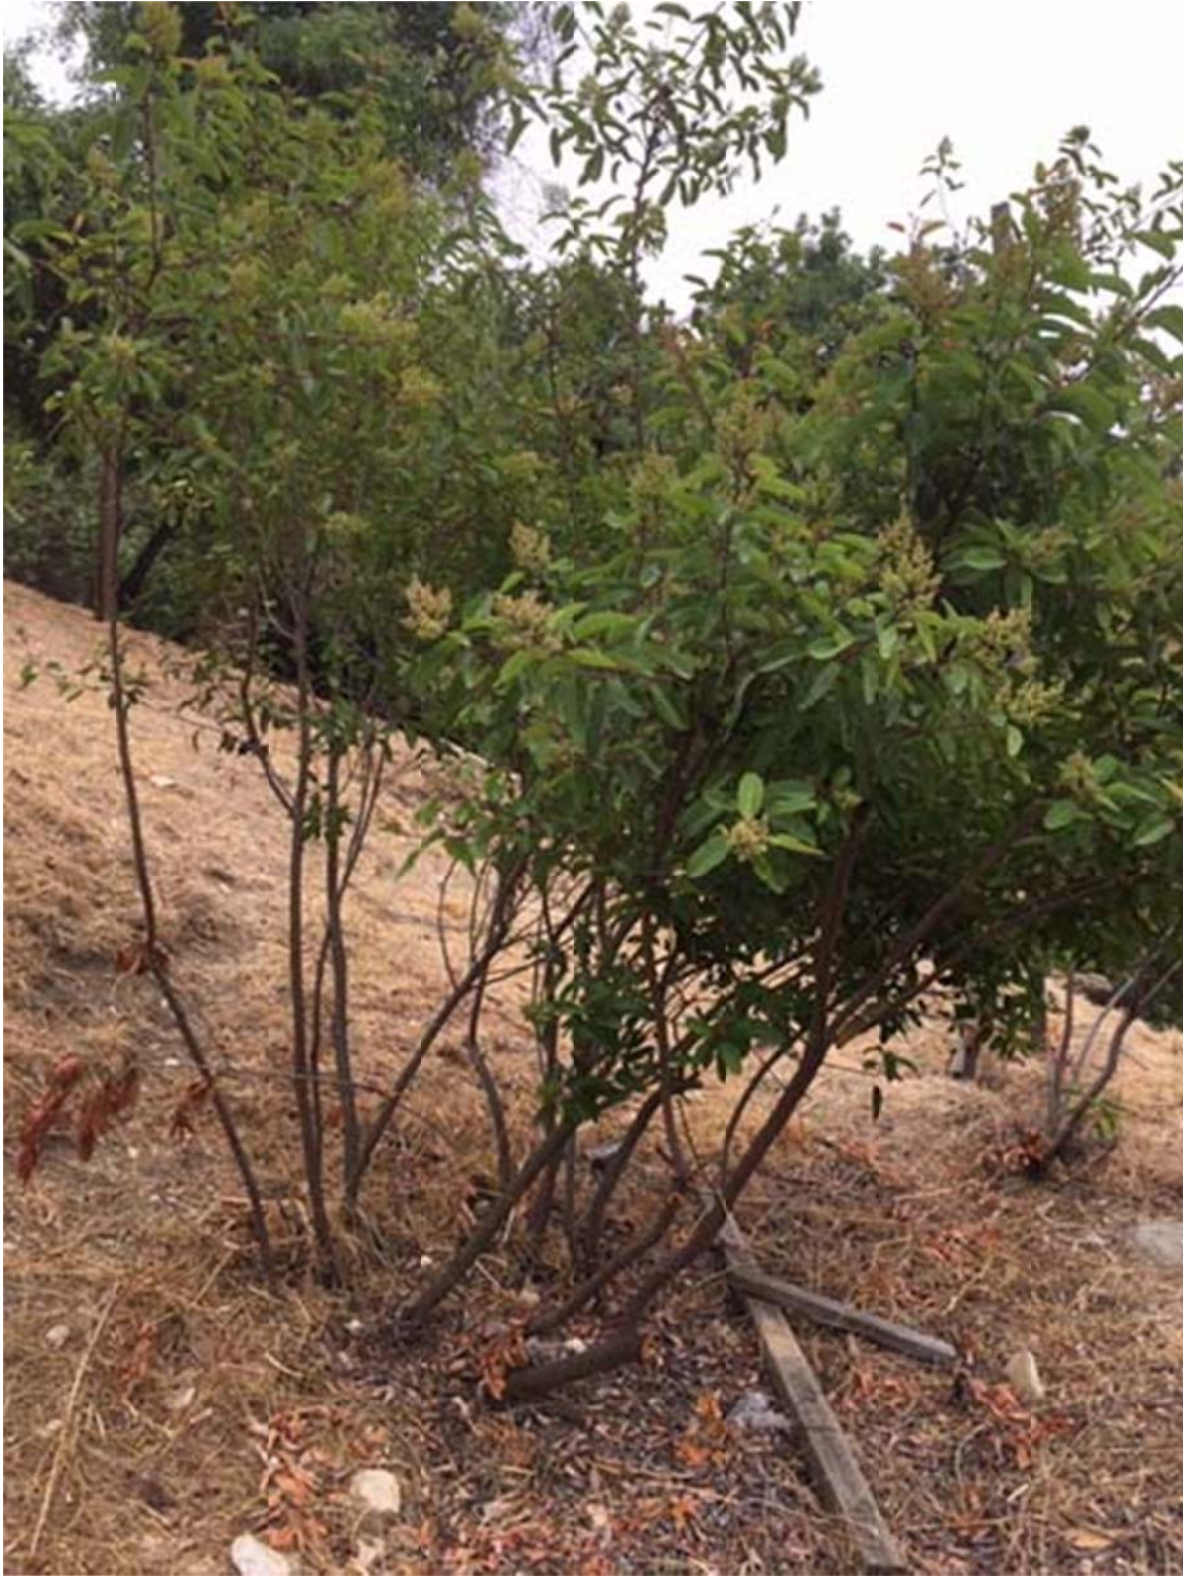
Figure 20: Tree 18

<p>Tree 18 <i>Malosma laurina</i> – Laurel Sumac</p> <p>This tree is not protected by ordinance. It will be retained in the landscape.</p>

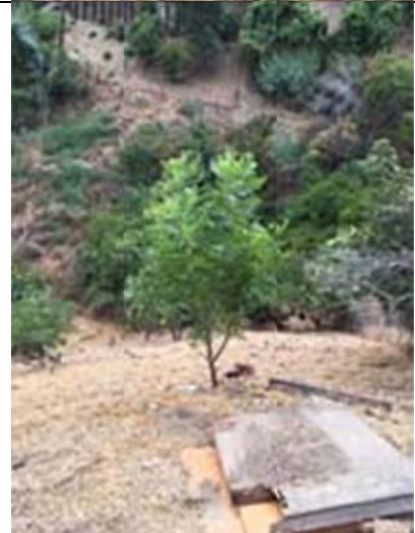
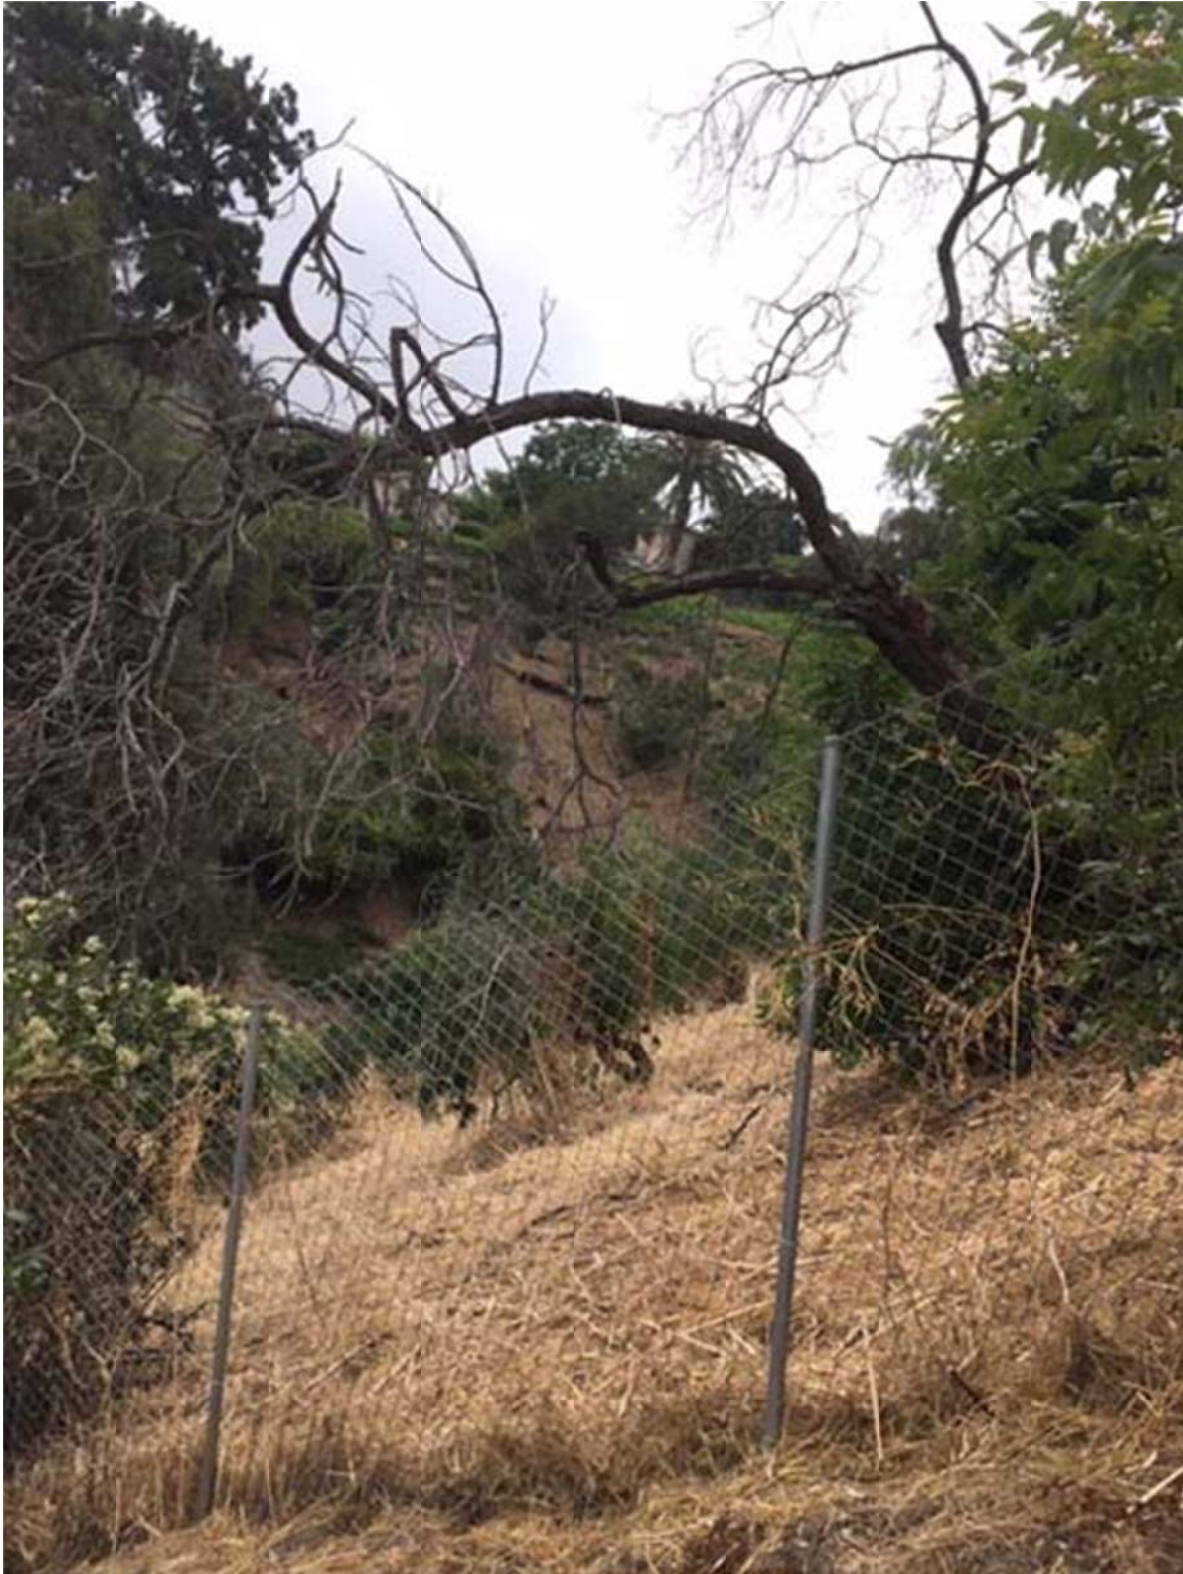
Figure 21: Tree 19

<p>Tree OP19 <i>Juglans californica</i> – California Black Walnut</p> <p>This tree is protected by ordinance. It is growing on the property to the northeast. Half of the canopy is dead. This tree will not likely be impacted by the proposed construction activity.</p>

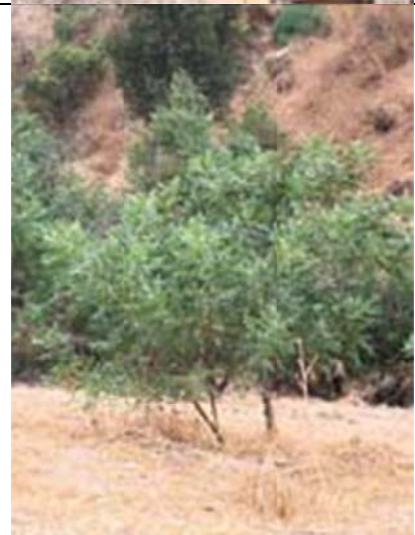
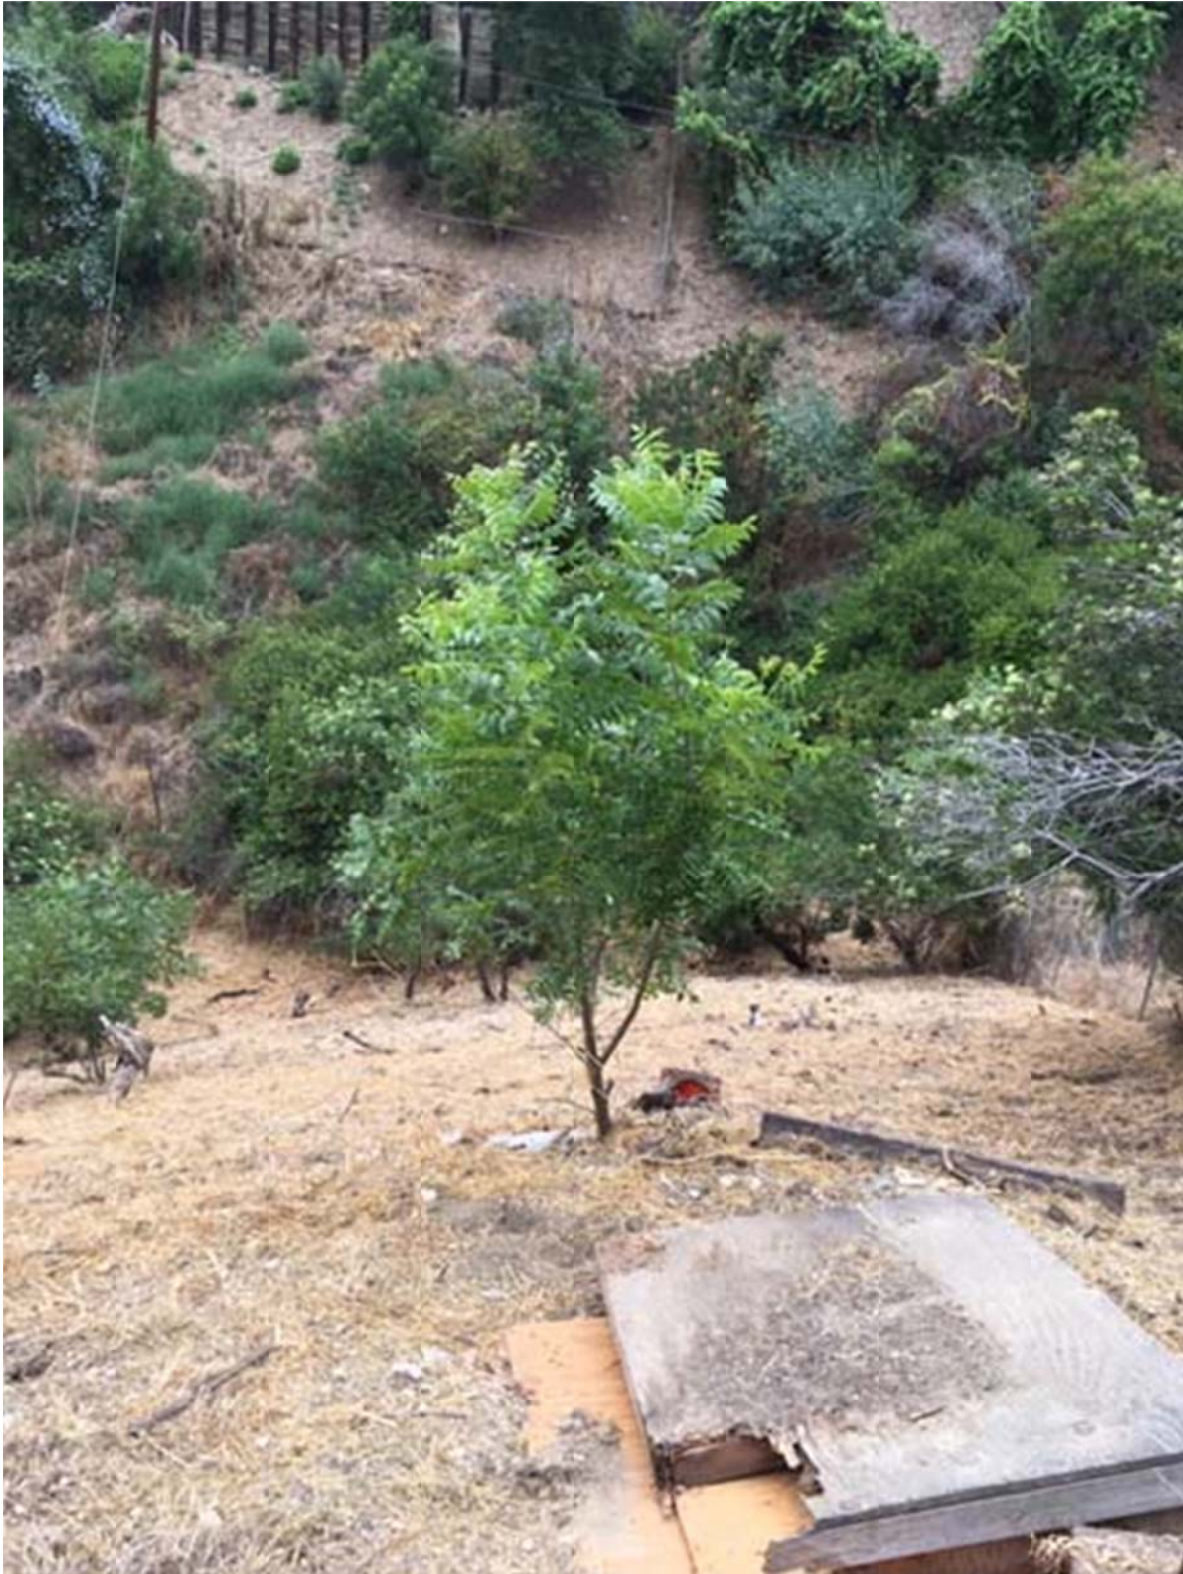
Figure 22: Tree 20

<p>Tree 20 <i>Juglans californica</i> – California Black Walnut</p> <p>This tree is too small to be protected by ordinance. It is intended to be preserved in the landscape. It consists of stump sprouts from a former walnut tree.</p>

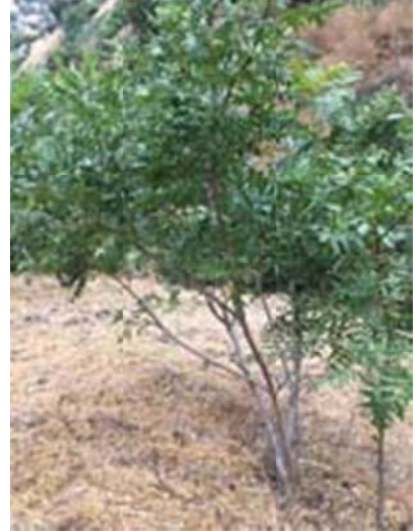
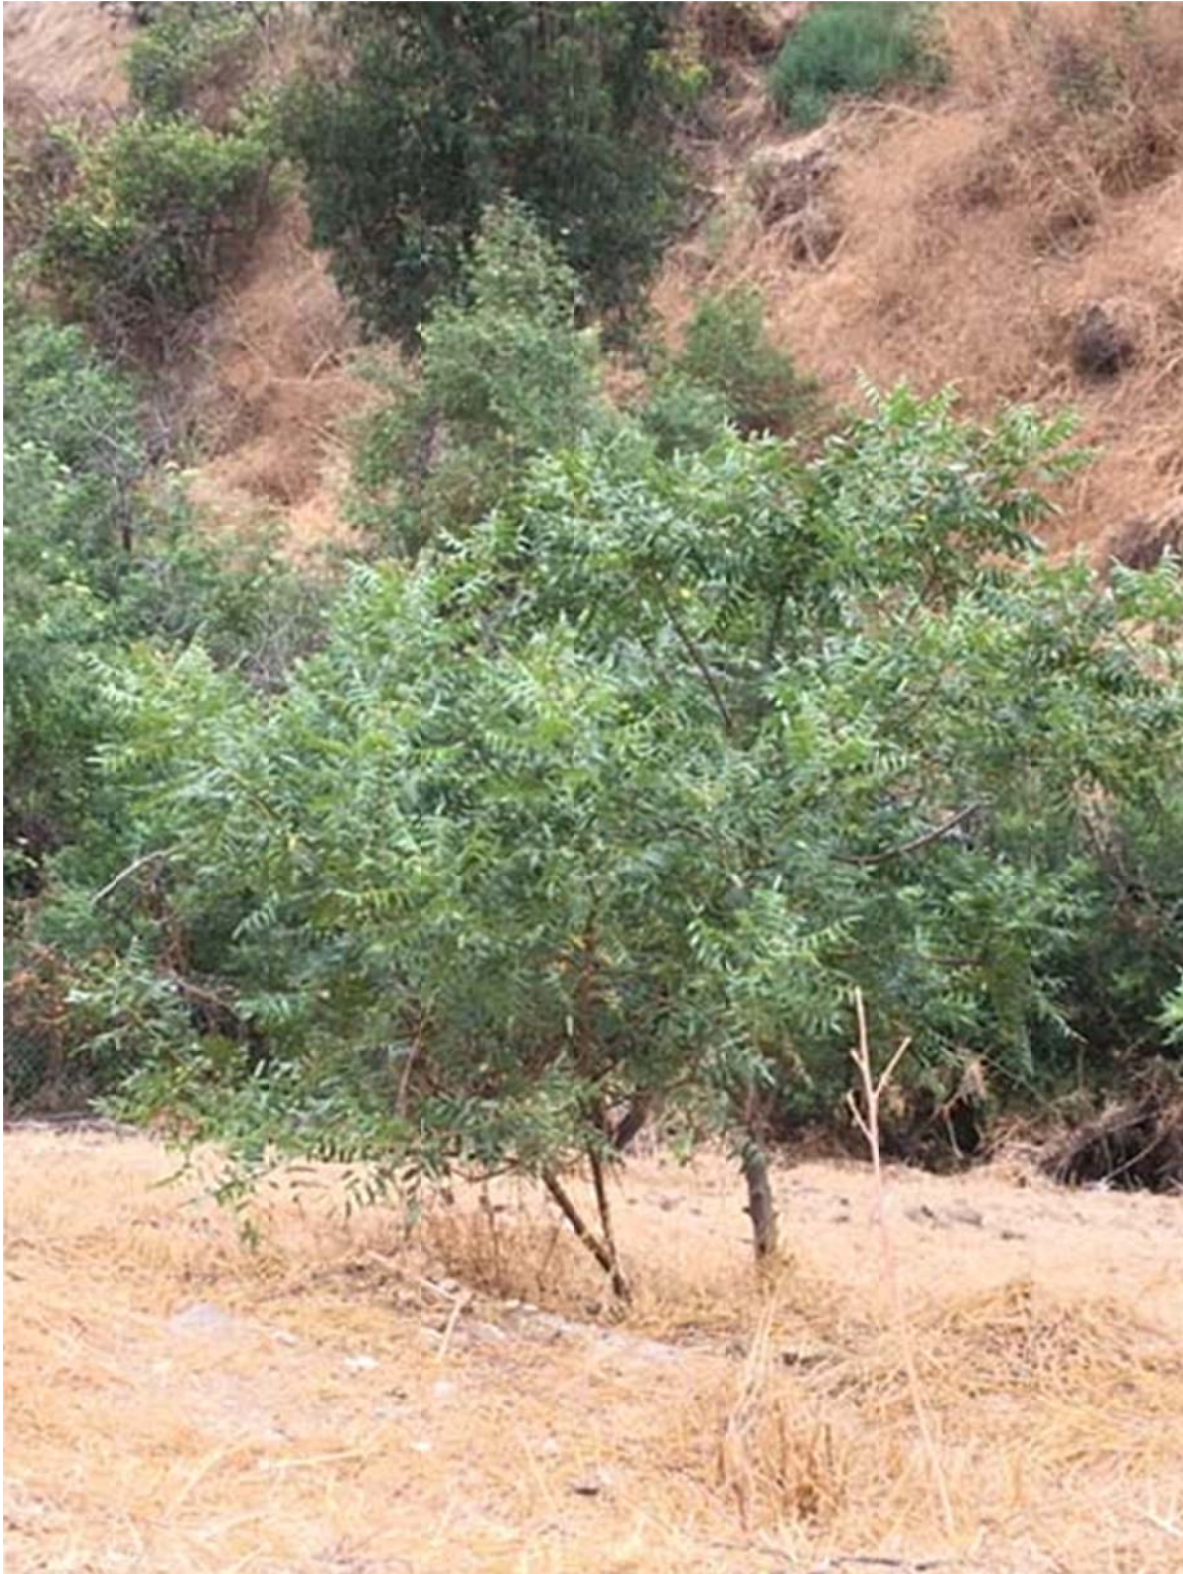
Figure 23: Tree 21

<p>Tree 21 <i>Juglans californica</i> – California Black Walnut</p> <p>This tree is protected by ordinance. It consists of healthy stump sprouts from an older base. This tree will not likely be affected by the proposed construction if the tree protection fencing is not crossed.</p>

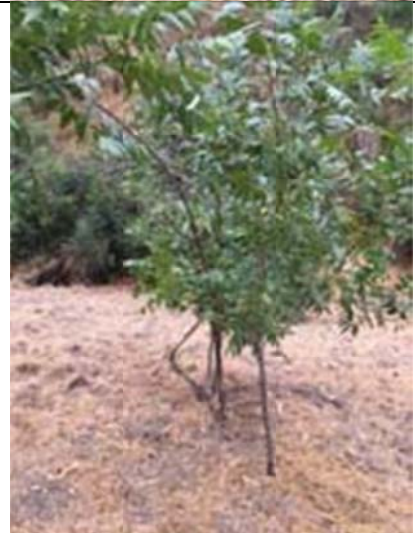
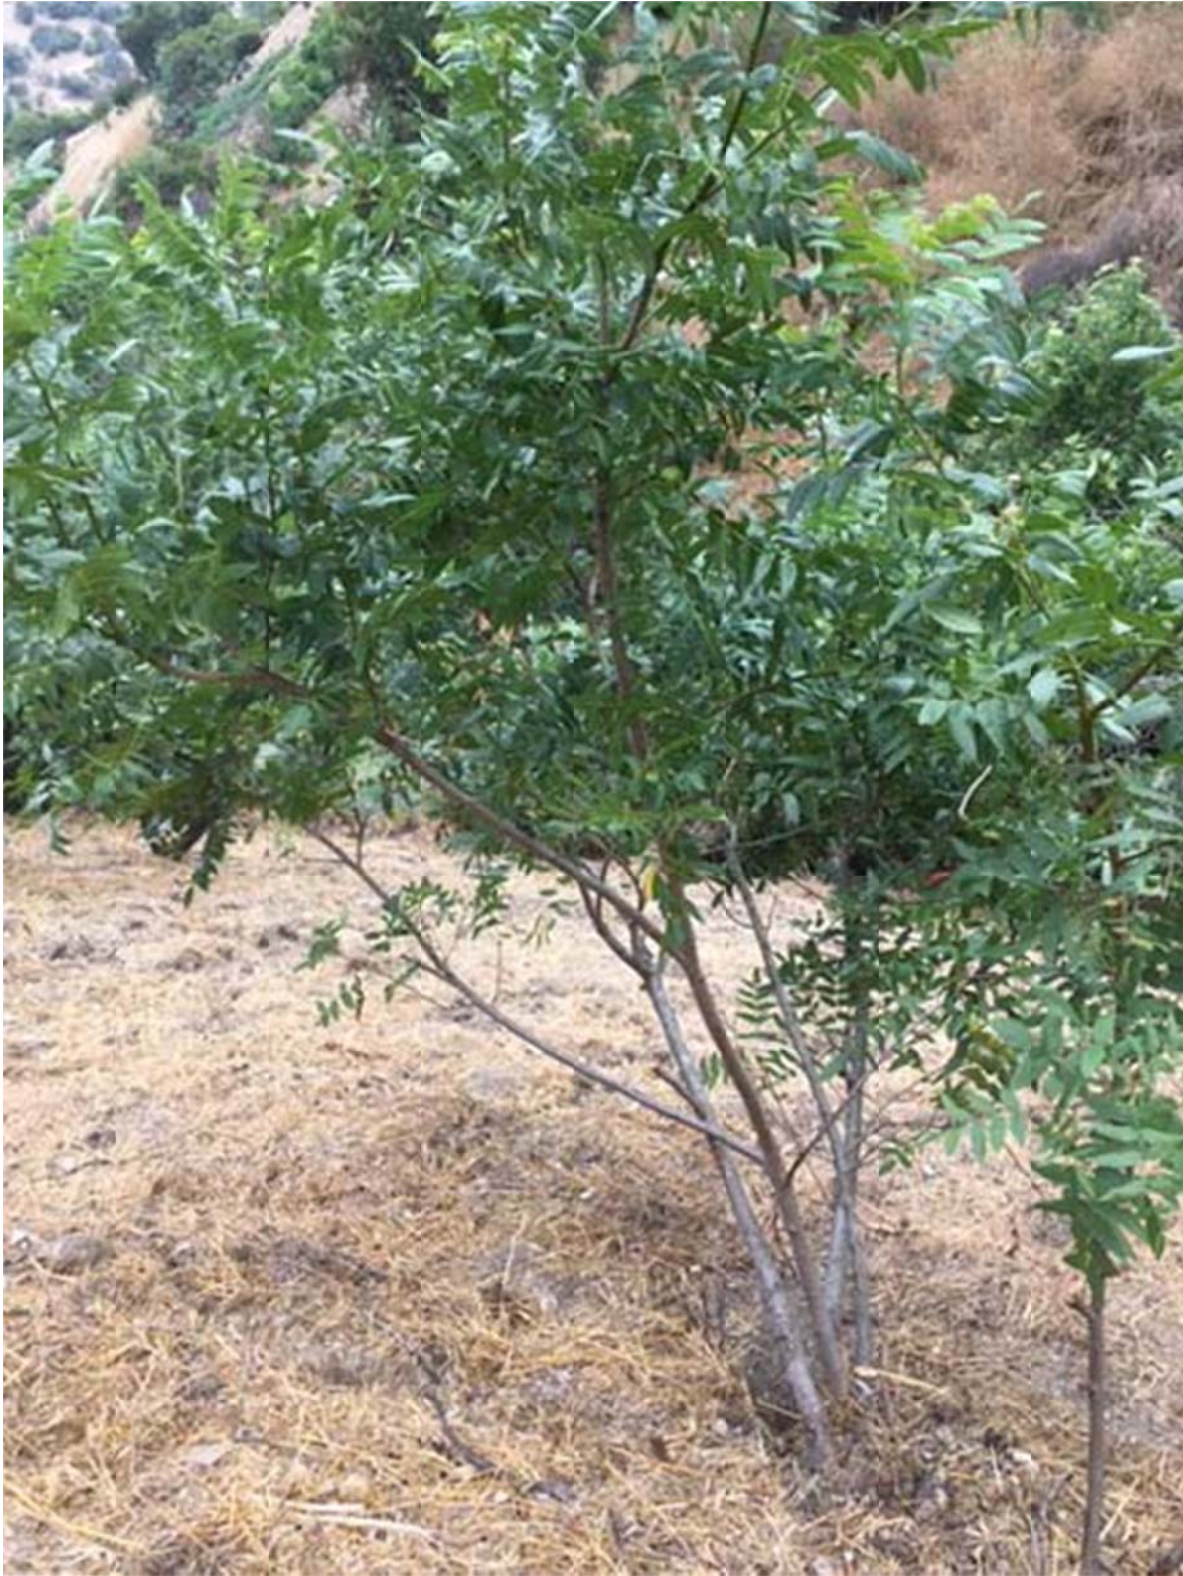
Figure 24: Tree 22

<p>Tree 22 <i>Juglans californica</i> – California Black Walnut</p> <p>This tree is protected by ordinance. It consists of stump sprouts from an older base. If the tree protection fencing is not crossed, it is unlikely this tree will be affected by construction activity.</p>

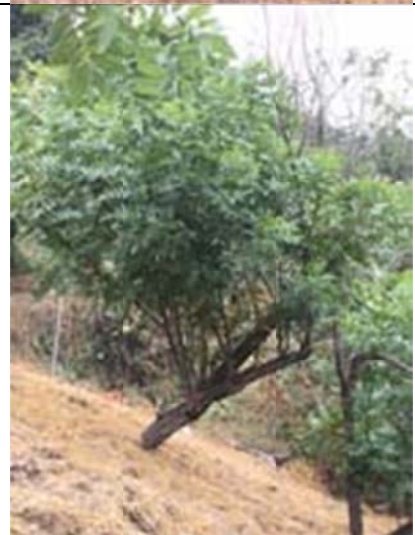
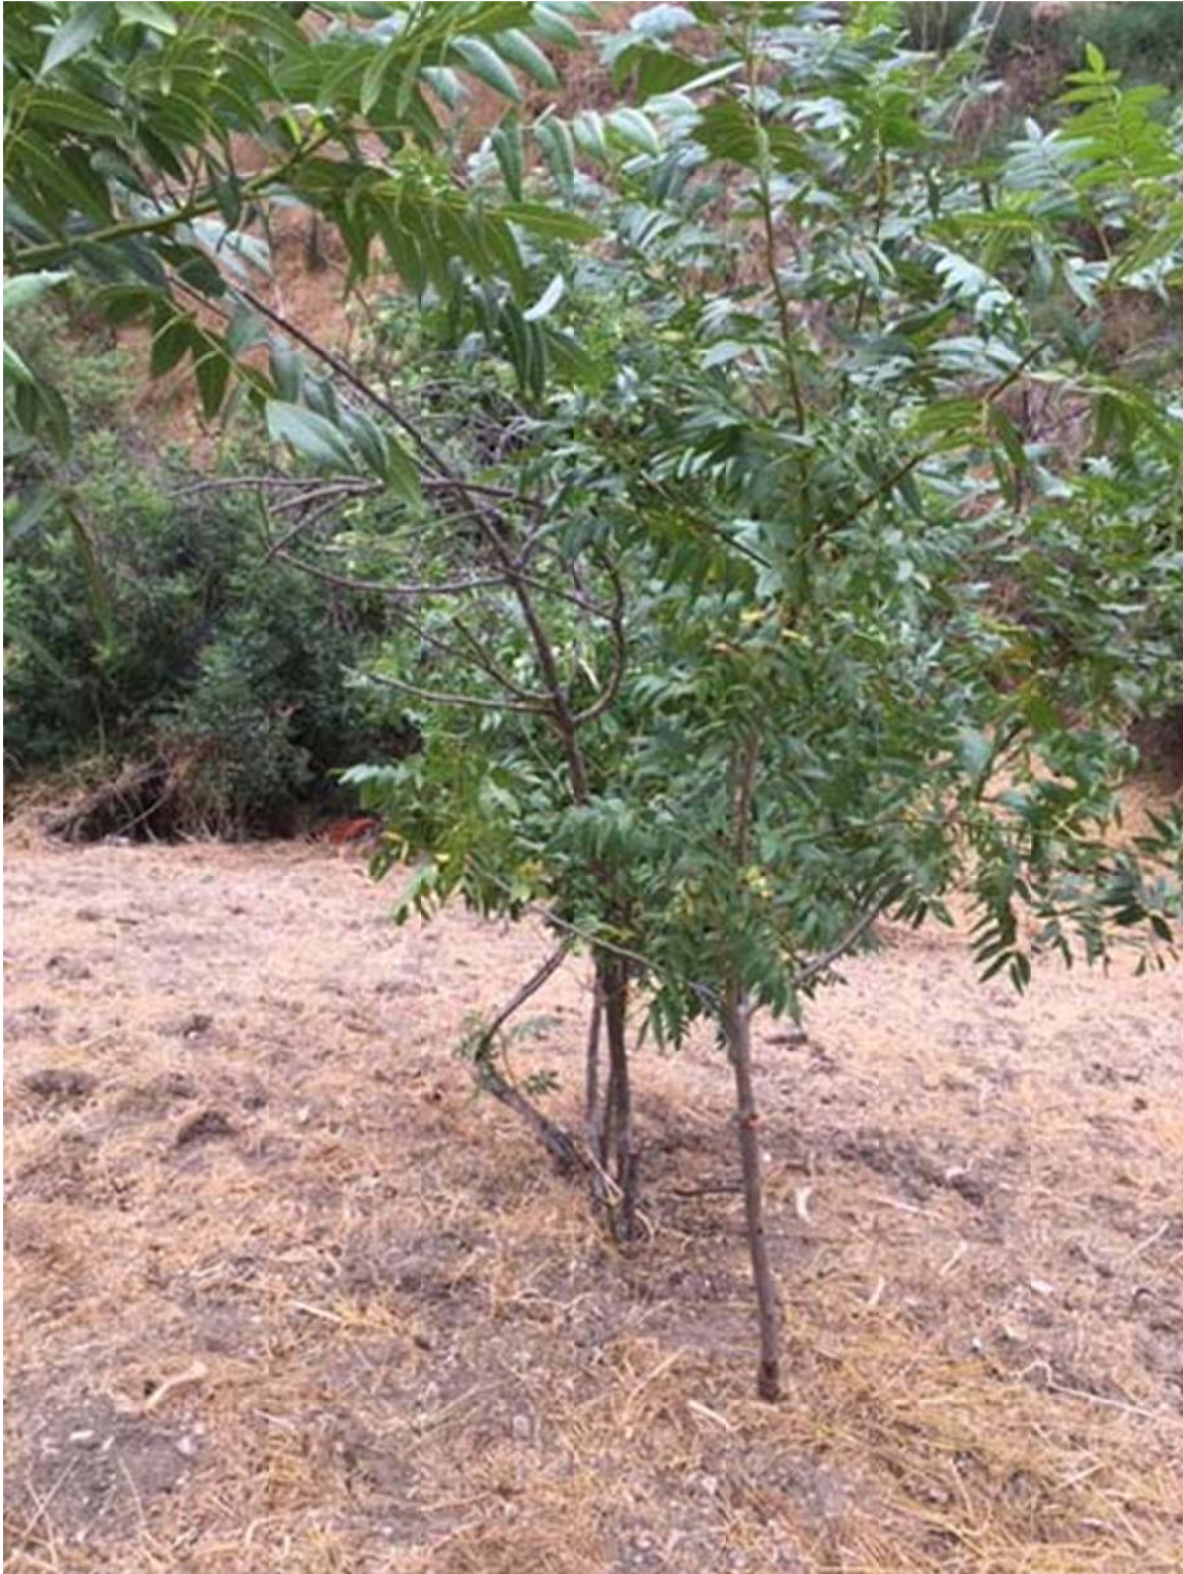
Figure 25: Tree 23

<p>Tree 23 <i>Juglans californica</i> – California Black Walnut</p> <p>This tree is protected by ordinance. It is healthy. It will not likely be affected by the proposed construction if the tree protection fencing is not crossed.</p>

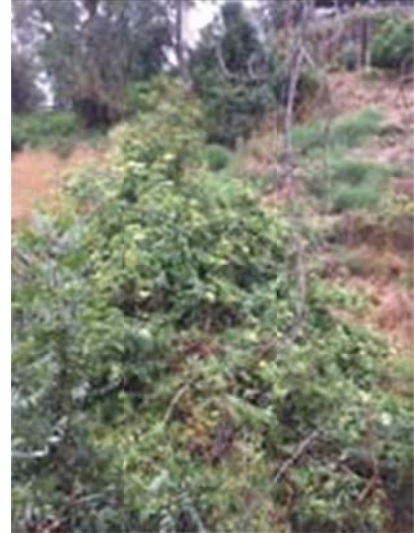
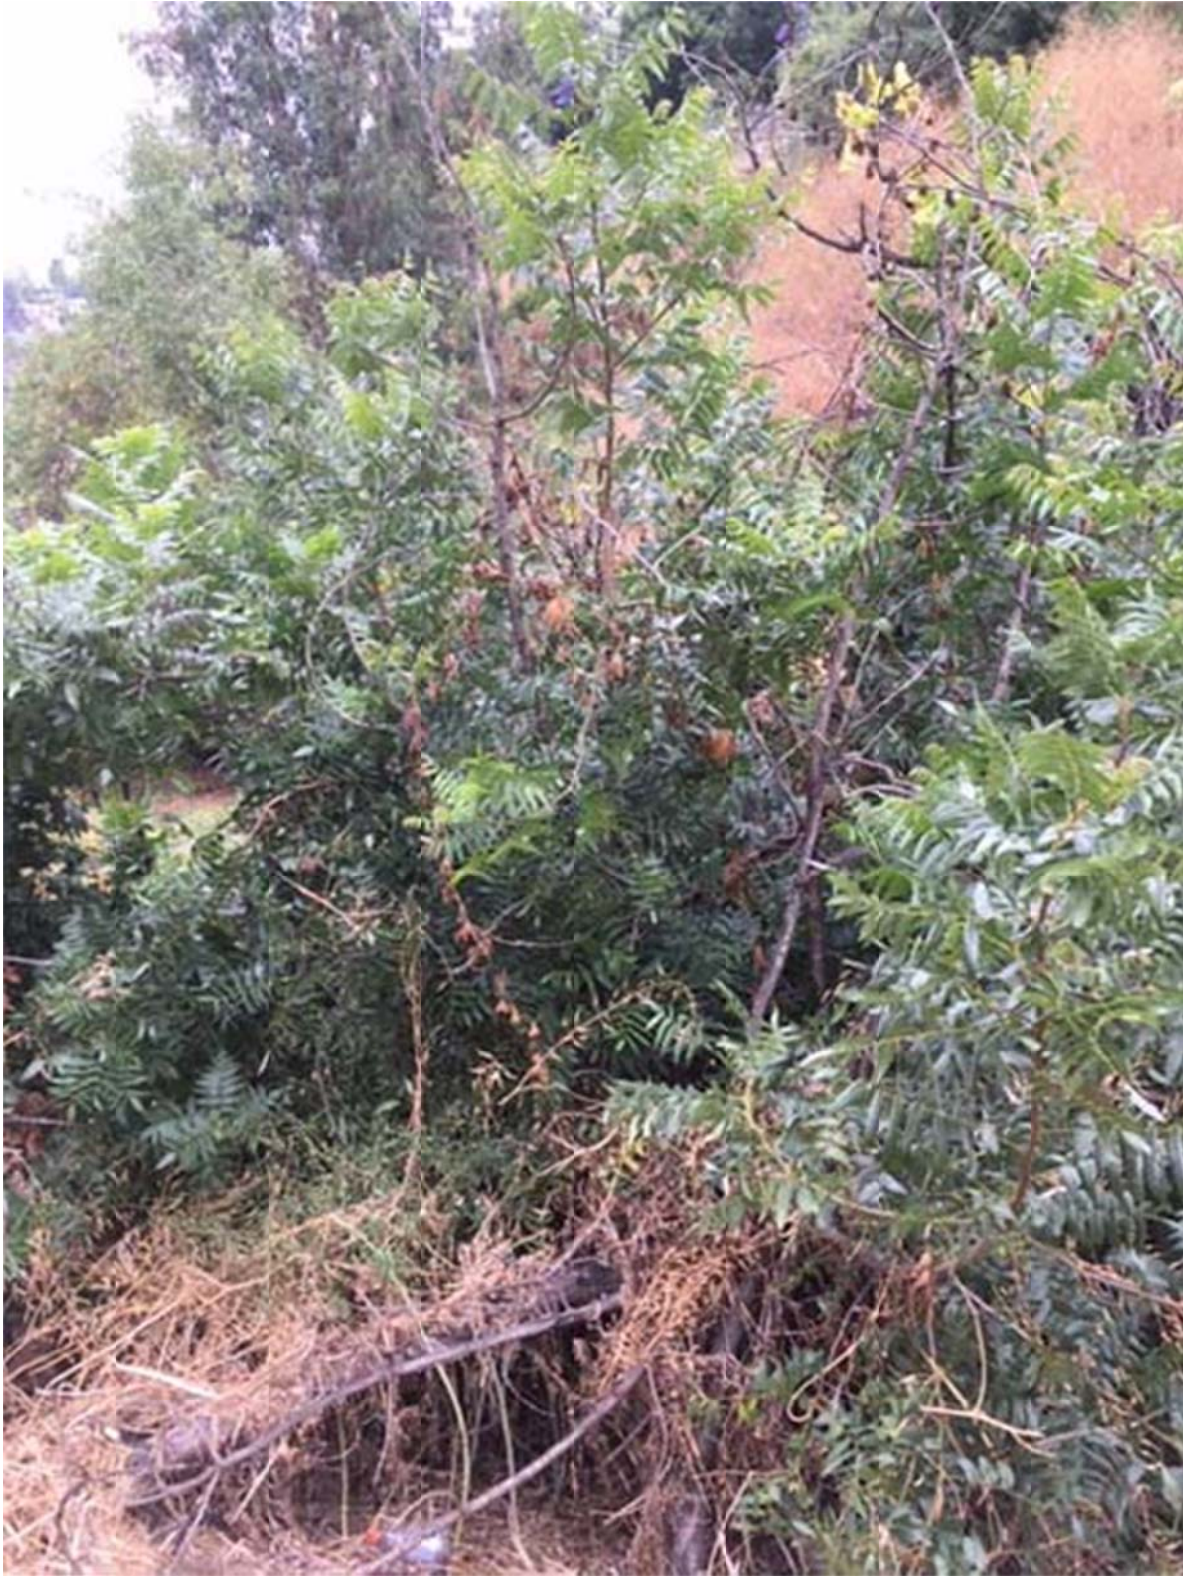
Figure 29: Tree 27

<p>Tree 27 <i>Juglans californica</i> – California Black Walnut</p> <p>This tree is protected by ordinance. It is showing signs of drought stress. If the tree protection fencing shown in this report is not crossed, it is unlikely this tree will be affected by construction activity.</p>
