Example Mt. Washington Arborist Report

Prepared by James Komen

Class One Arboriculture

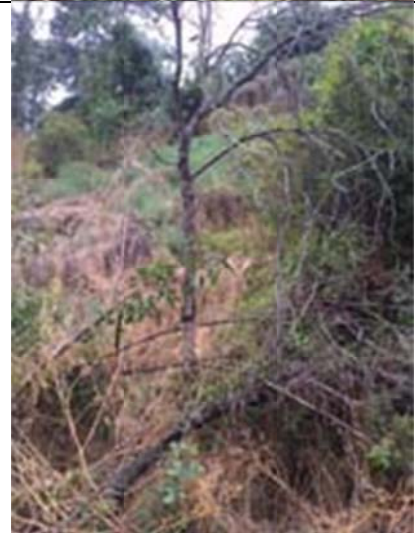
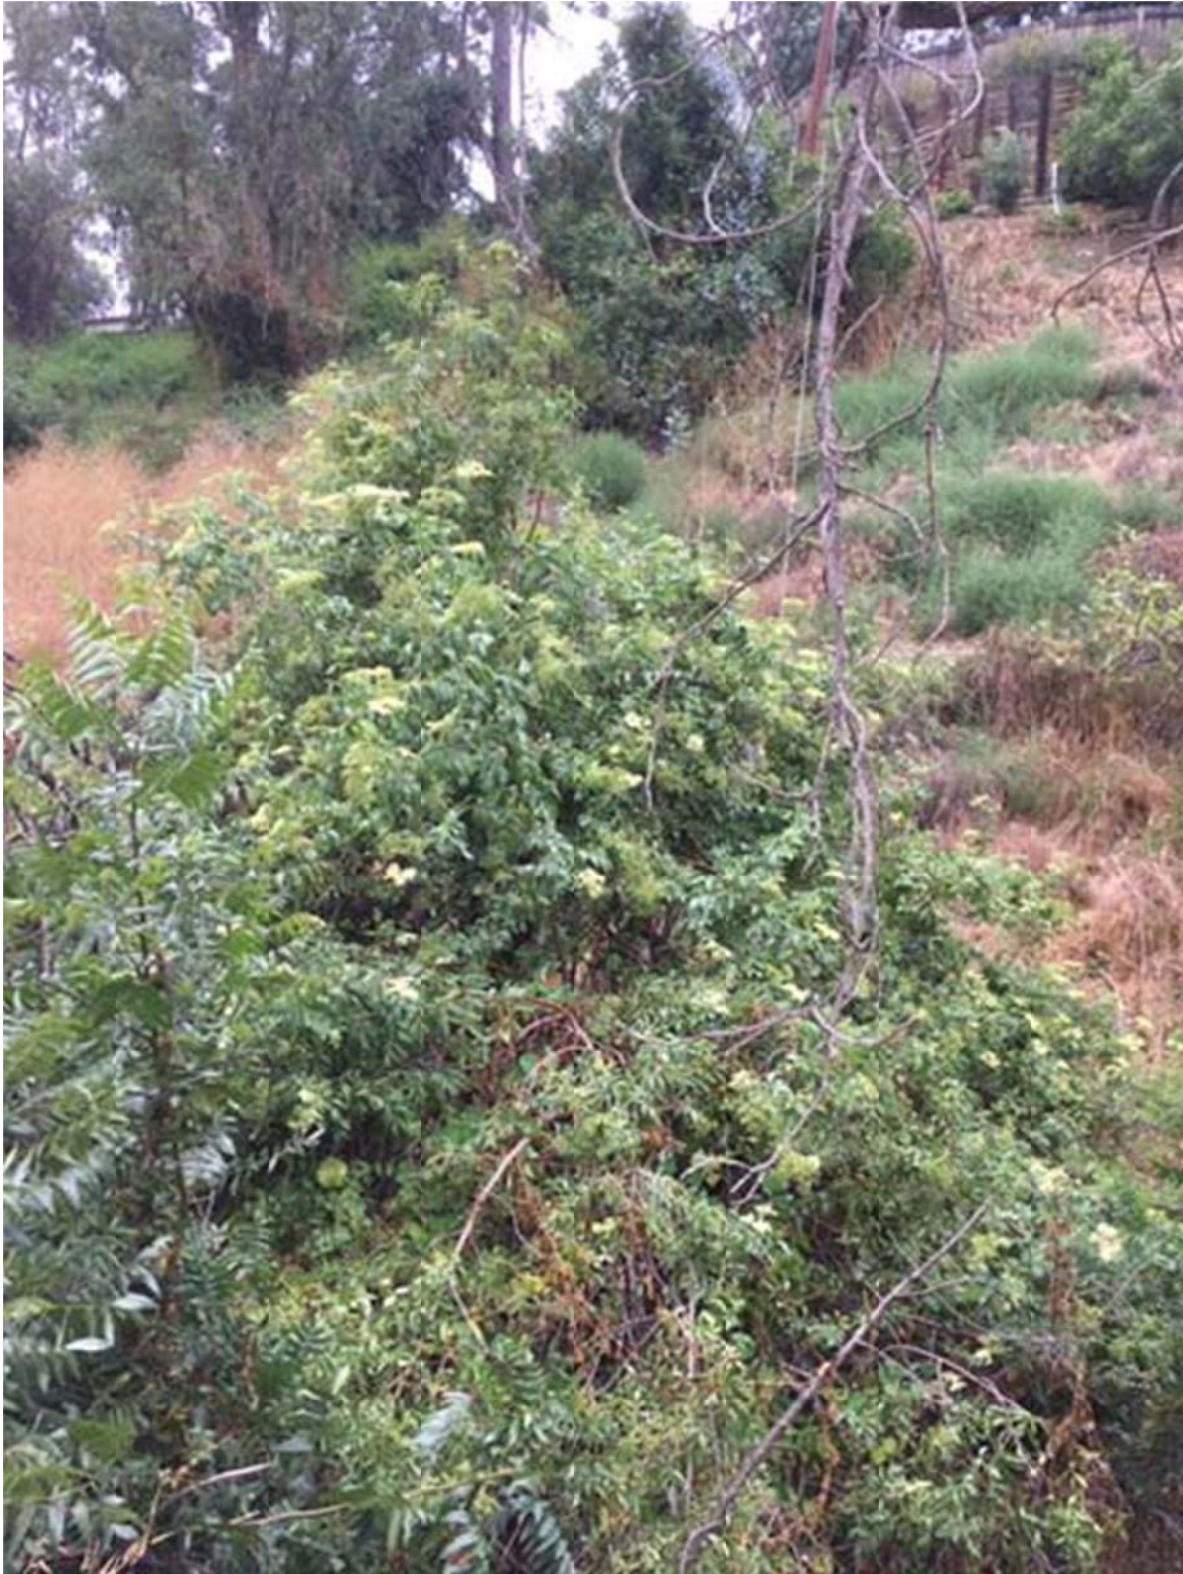
Figure 30: Tree 28

<p>Tree 28 <i>Sambucus mexicana</i> – Mexican Elderberry</p> <p>This tree is not protected by ordinance. It will be retained in the landscape.</p>

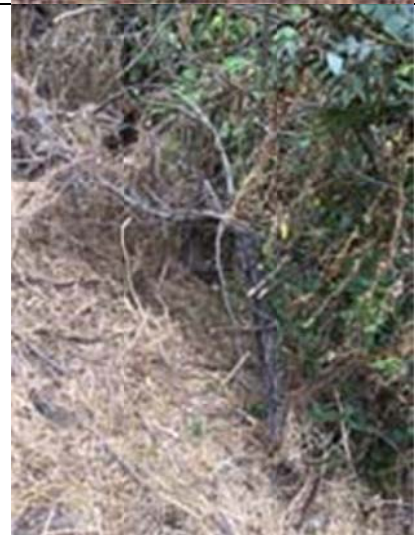
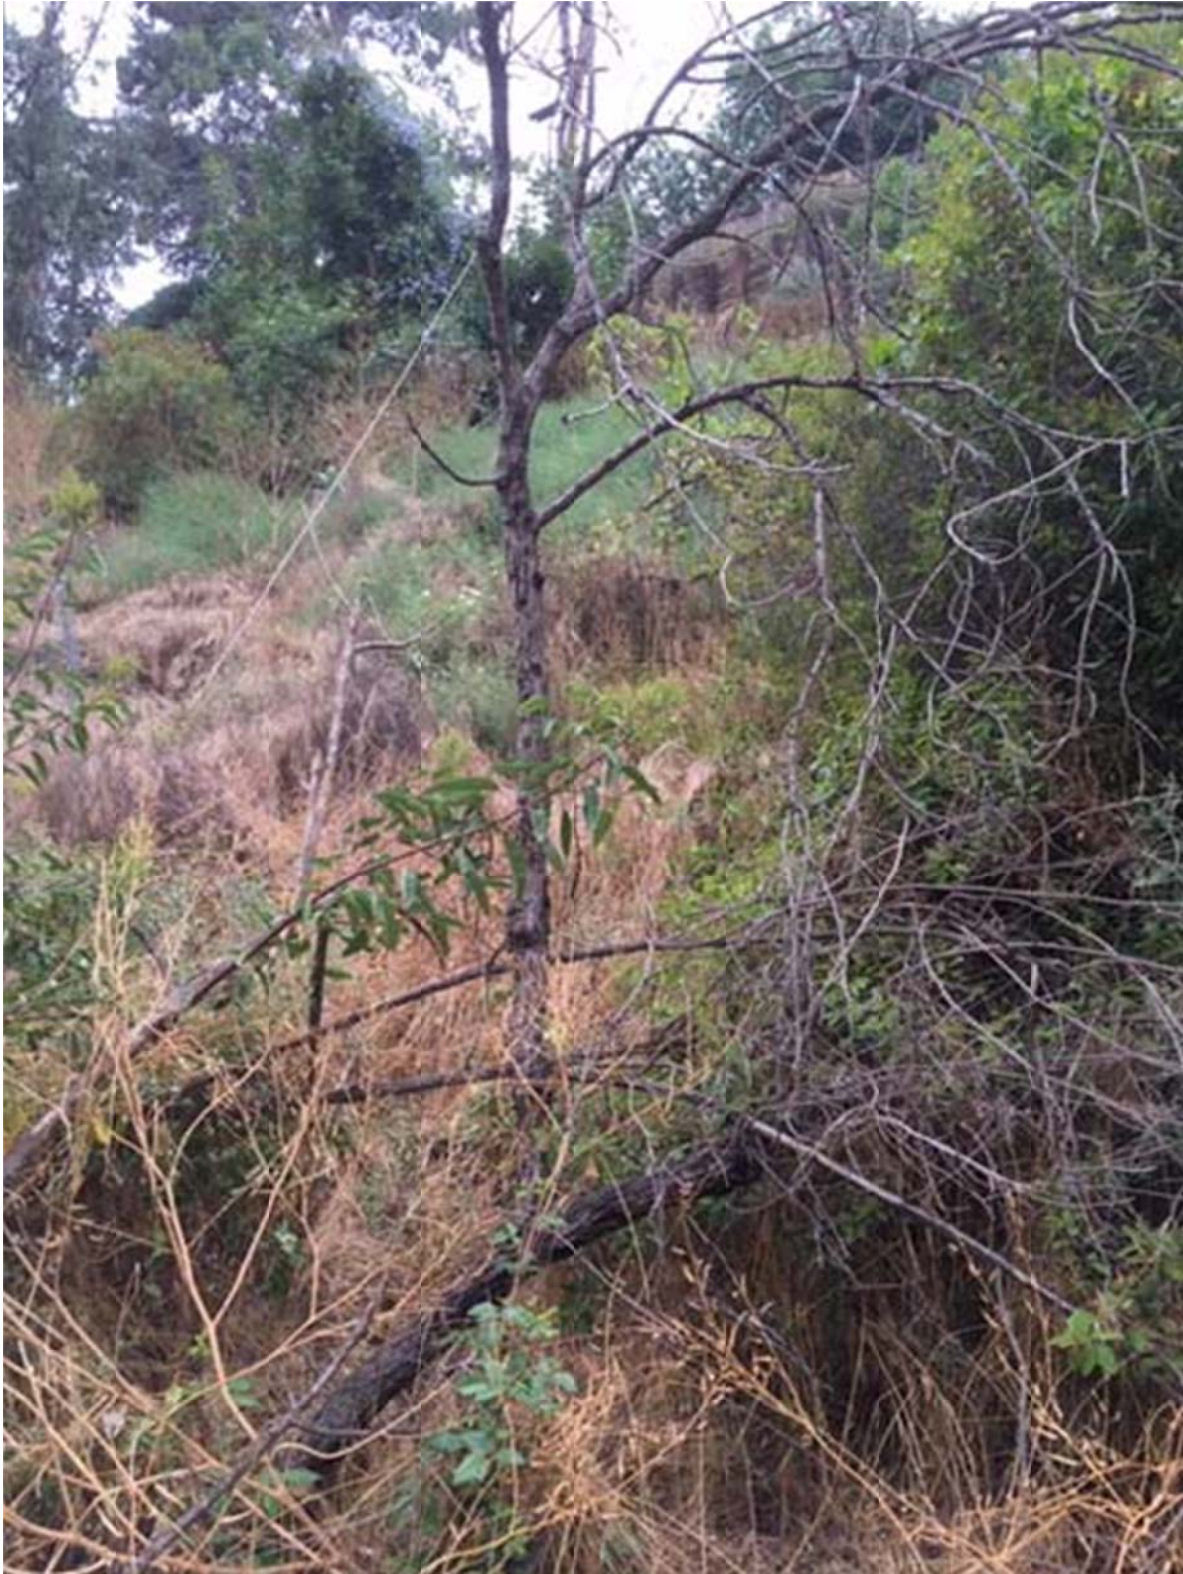
Figure 31: Tree 29

<p>Tree 29 <i>Juglans californica</i> – California Black Walnut</p> <p>This tree is protected by ordinance. It is dead. It will be retained in the landscape as wildlife habitat.</p>

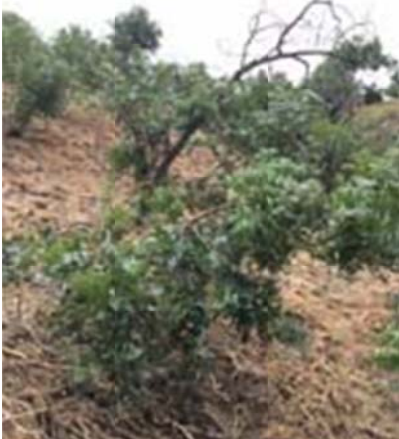
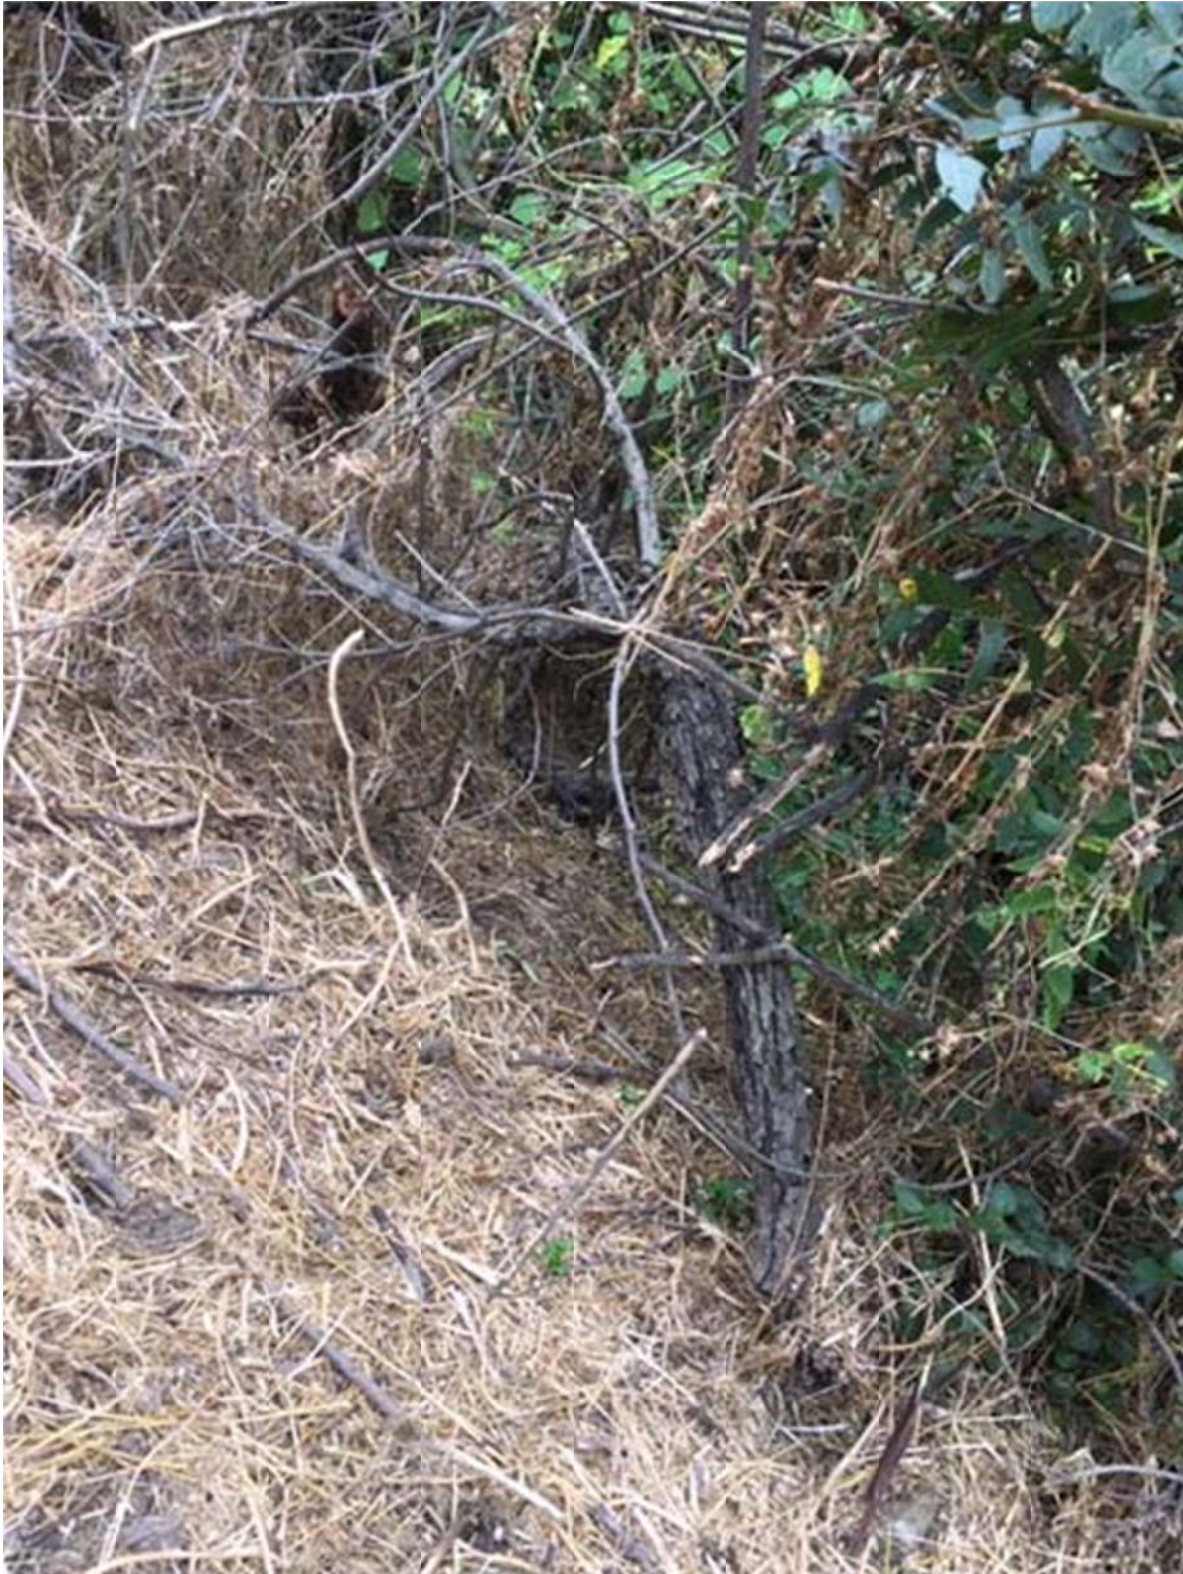
Figure 32: Tree 30

<p>Tree 30 <i>Juglans californica</i> – California Black Walnut</p> <p>This tree is protected by ordinance. It is dead. It will be retained in the landscape as wildlife habitat.</p>

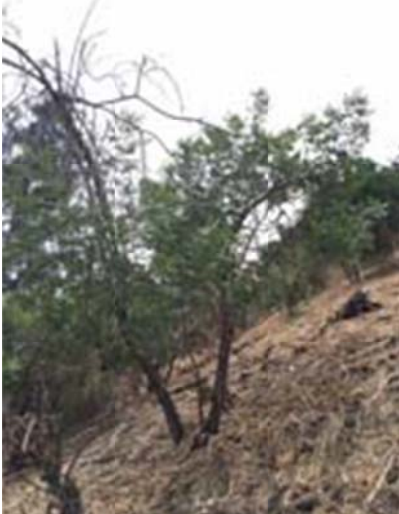
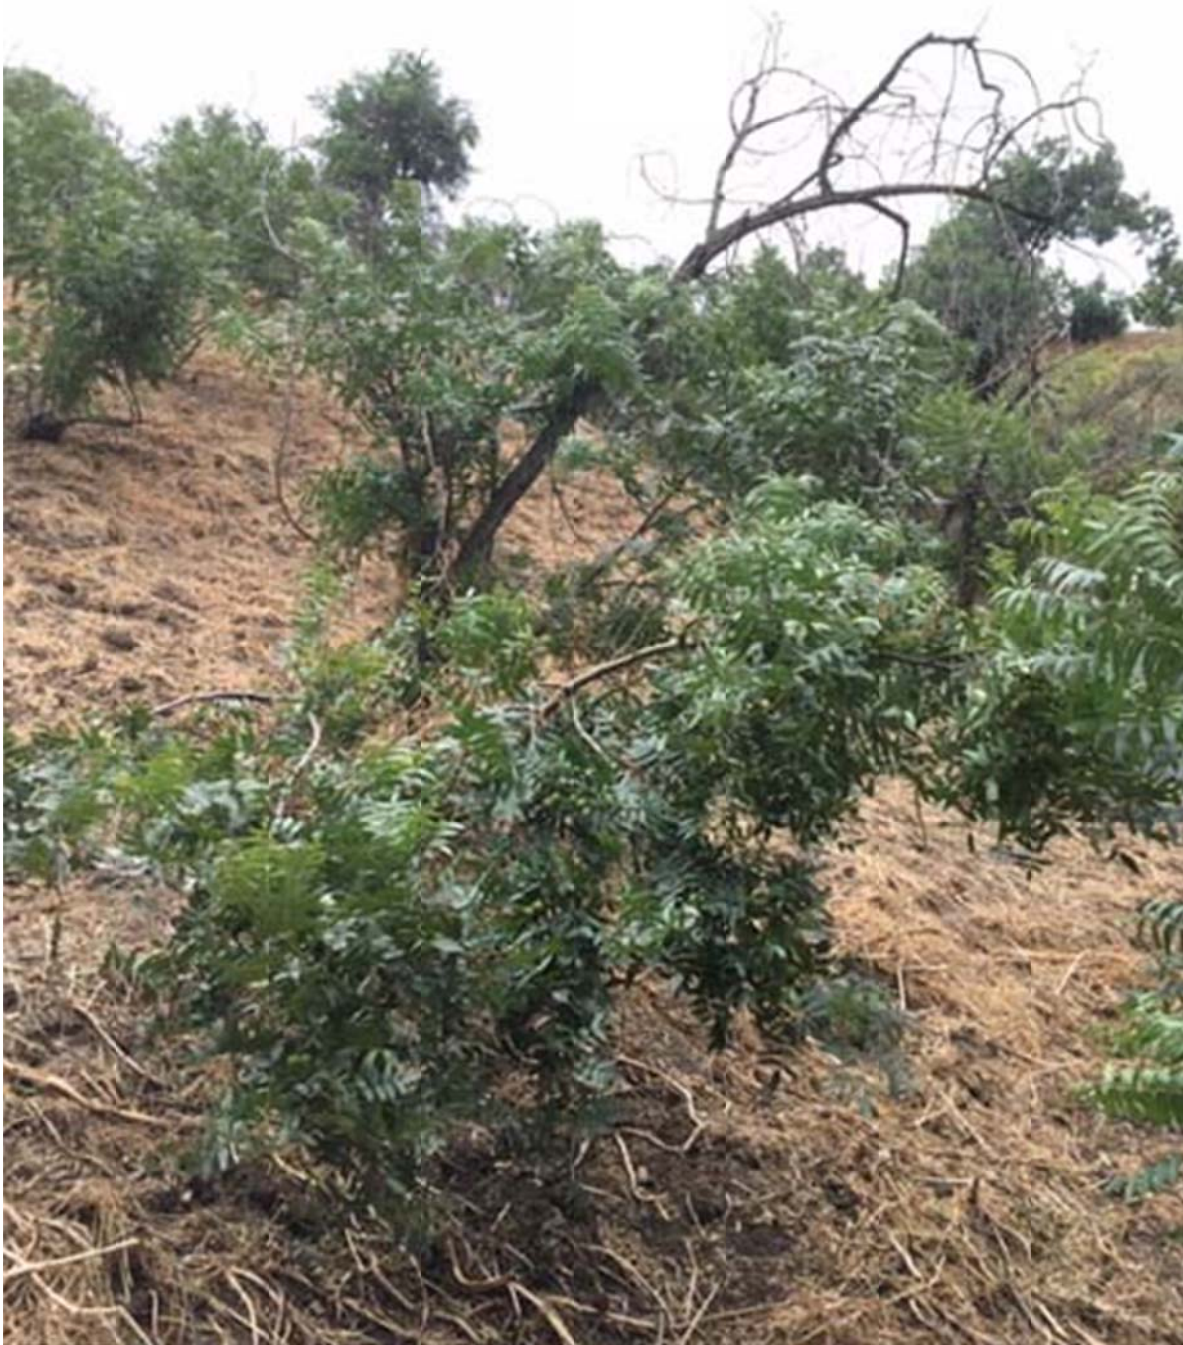
Figure 33: Tree 31

<p>Tree 31 <i>Juglans californica</i> – California Black Walnut</p> <p>This tree is protected by ordinance. It is half dead, but its condition is improving. If the tree protection fencing shown in this report is not crossed, it is unlikely this tree will be affected by construction activity.</p>

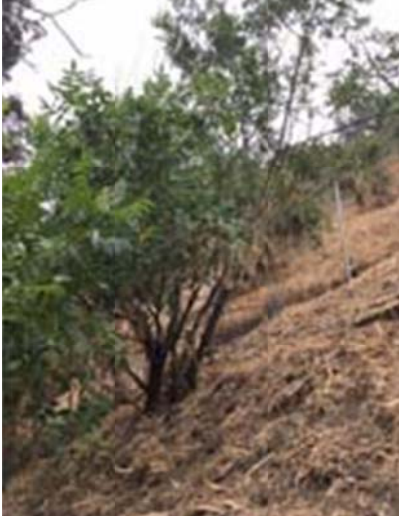
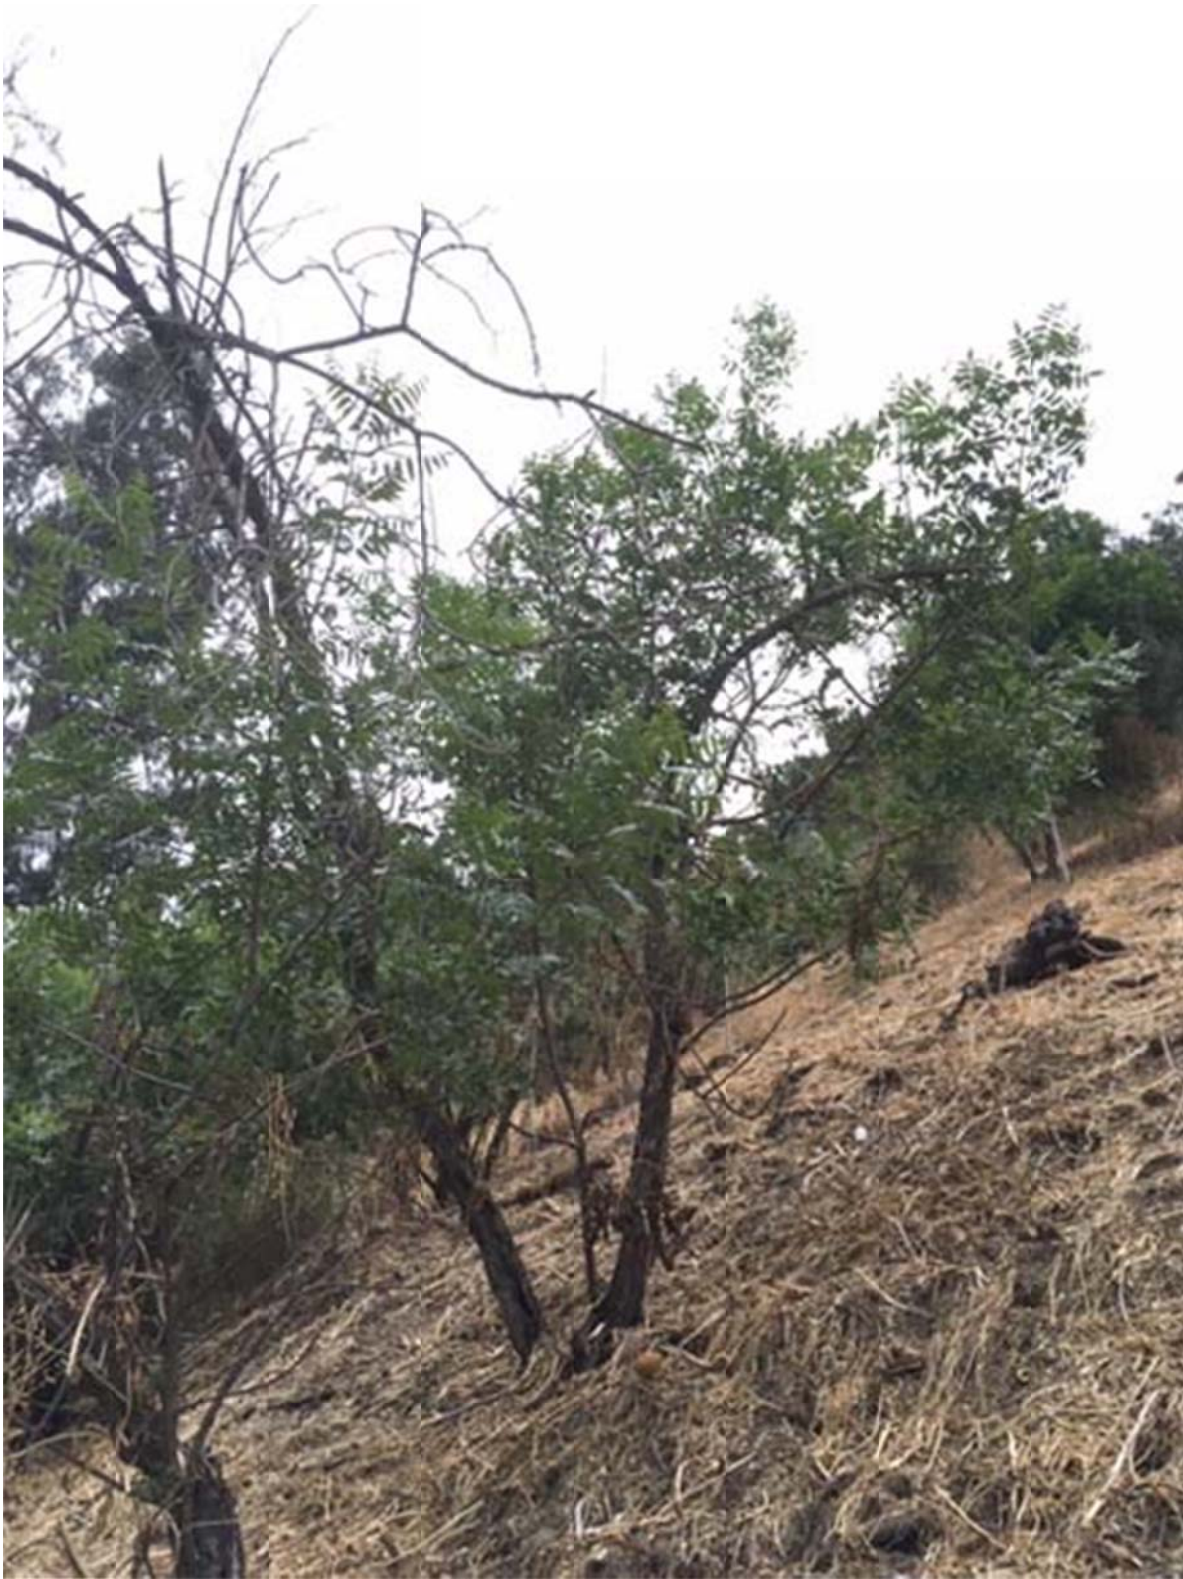
Figure 34: Tree 32

<p>Tree 32 <i>Juglans californica</i> – California Black Walnut</p> <p>This tree is protected by ordinance. It is half dead, but its condition is improving. If the tree protection fencing shown in this report is not crossed, it is unlikely this tree will be affected by construction activity.</p>

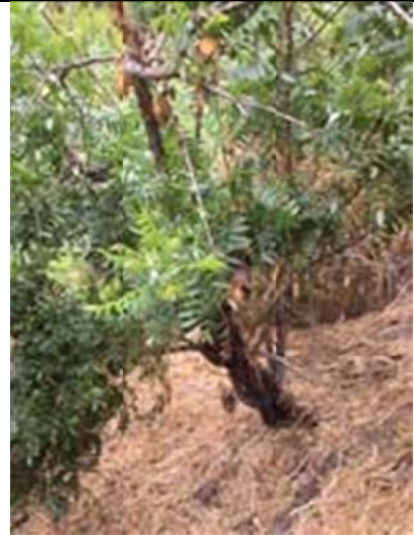
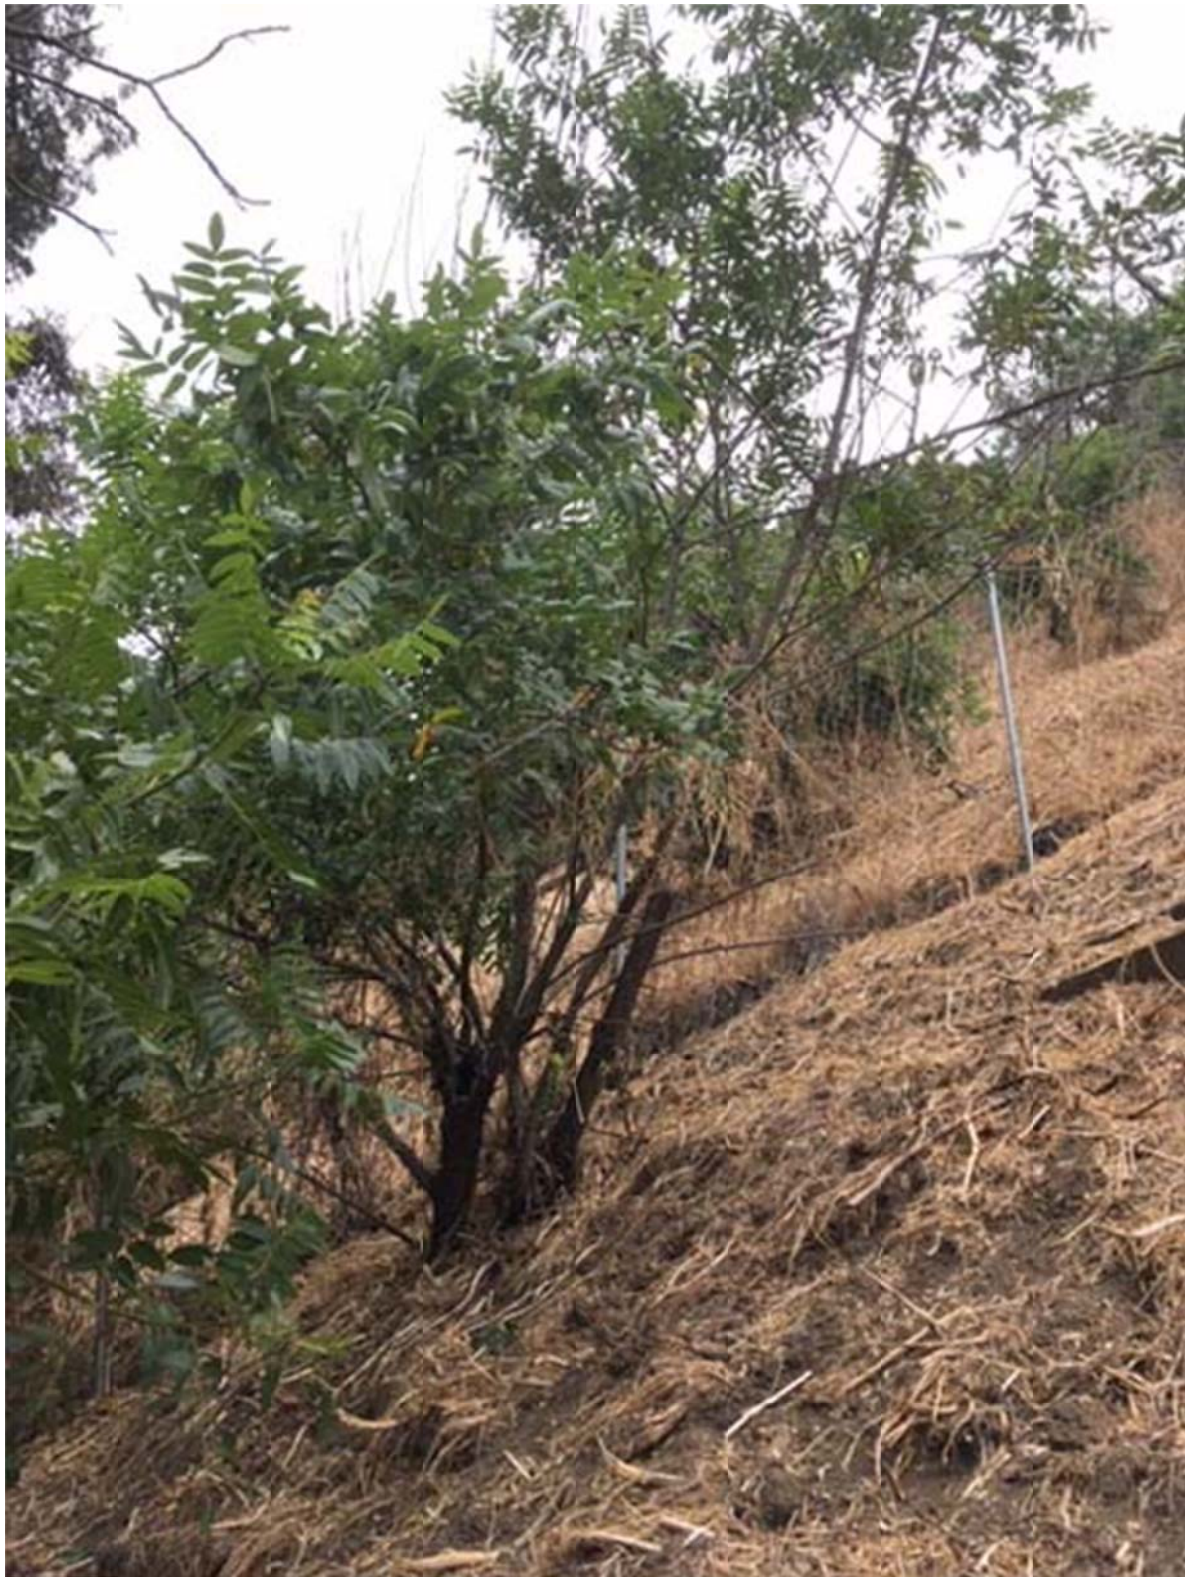
Figure 35: Tree 33

<p>Tree 33 <i>Juglans californica</i> – California Black Walnut</p> <p>This tree is protected by ordinance. It is drought stressed, but its condition is improving. If the tree protection fencing shown in this report is not crossed, it is unlikely this tree will be affected by construction activity.</p>

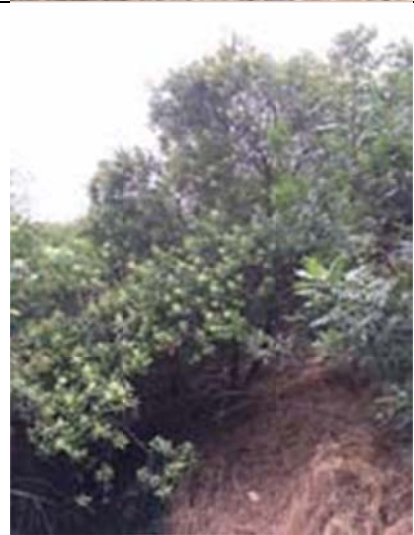
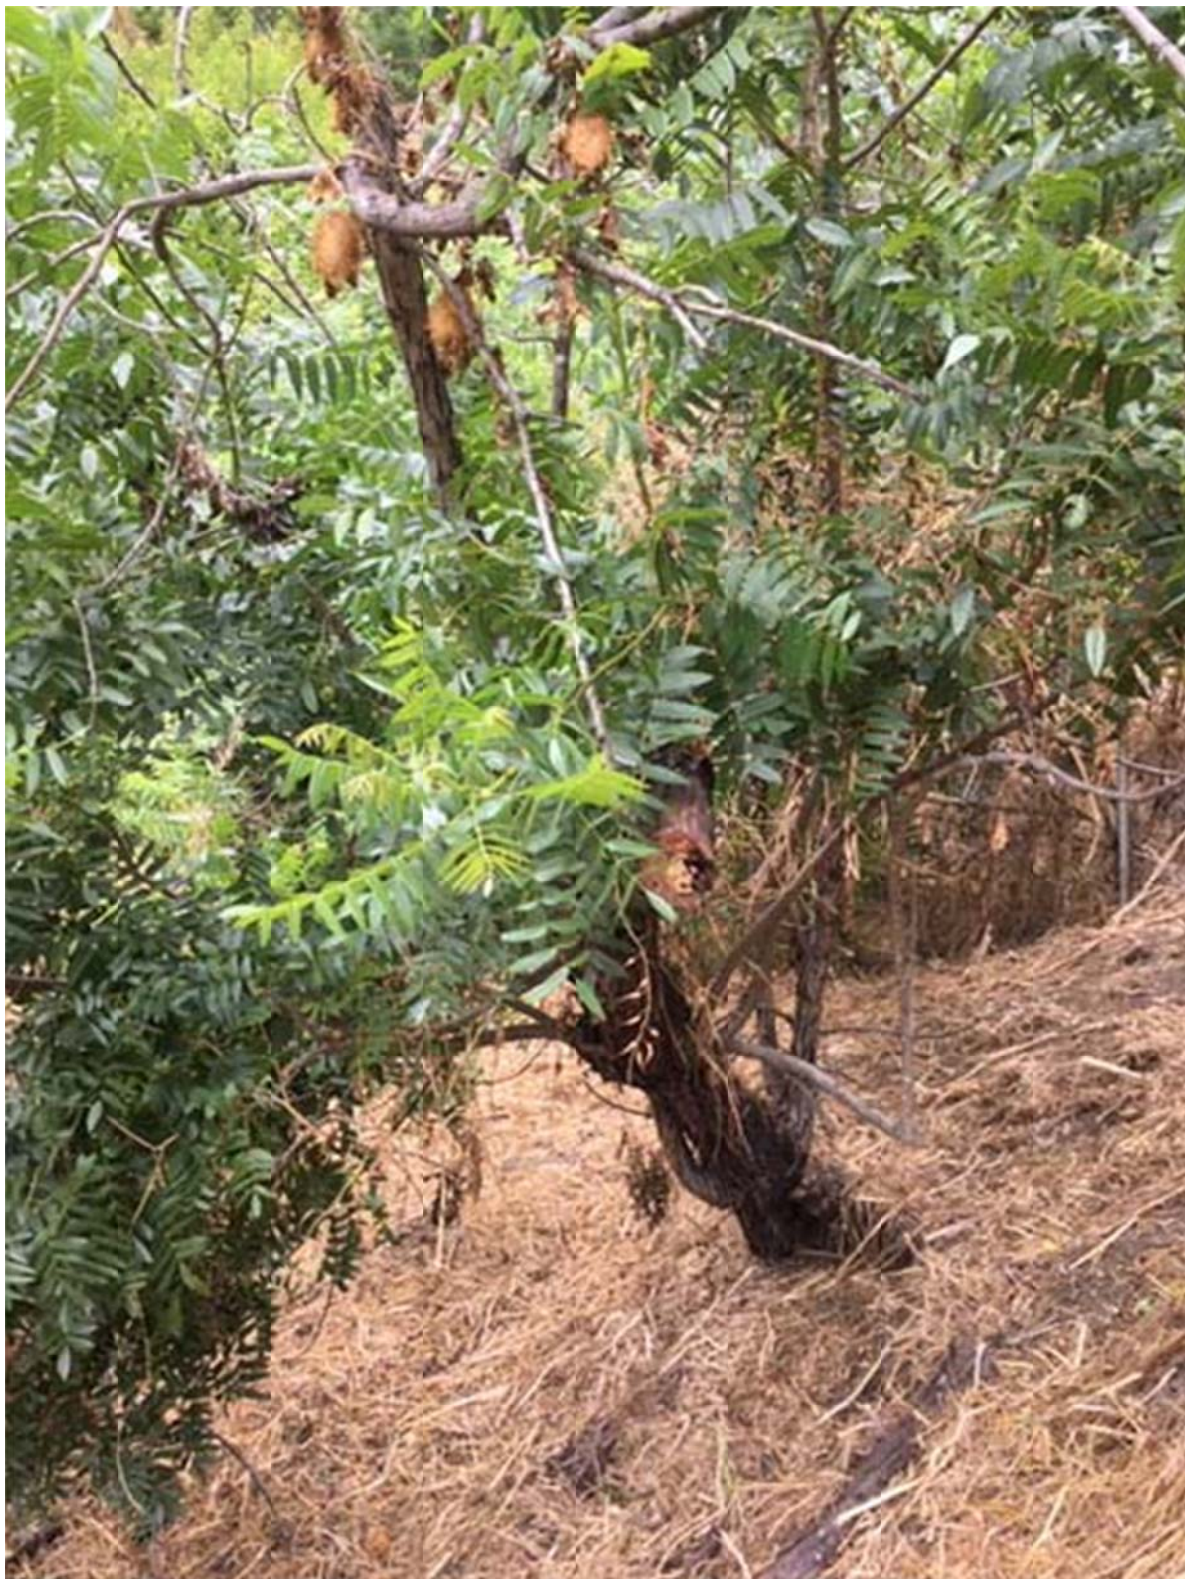
Figure 36: Tree 34

<p>Tree 34 <i>Juglans californica</i> – California Black Walnut</p> <p>This tree is protected by ordinance. It is showing signs of drought stress. If the tree protection fencing shown in this report is not crossed, it is unlikely this tree will be affected by construction activity.</p>

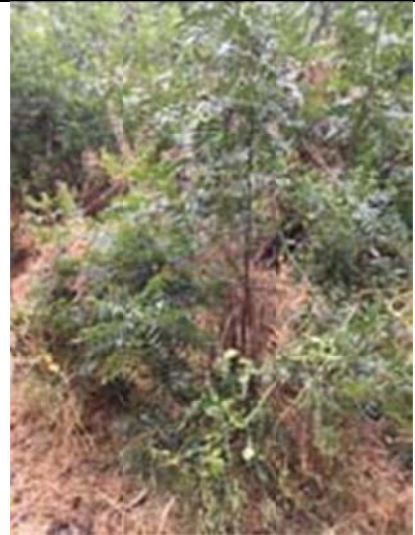
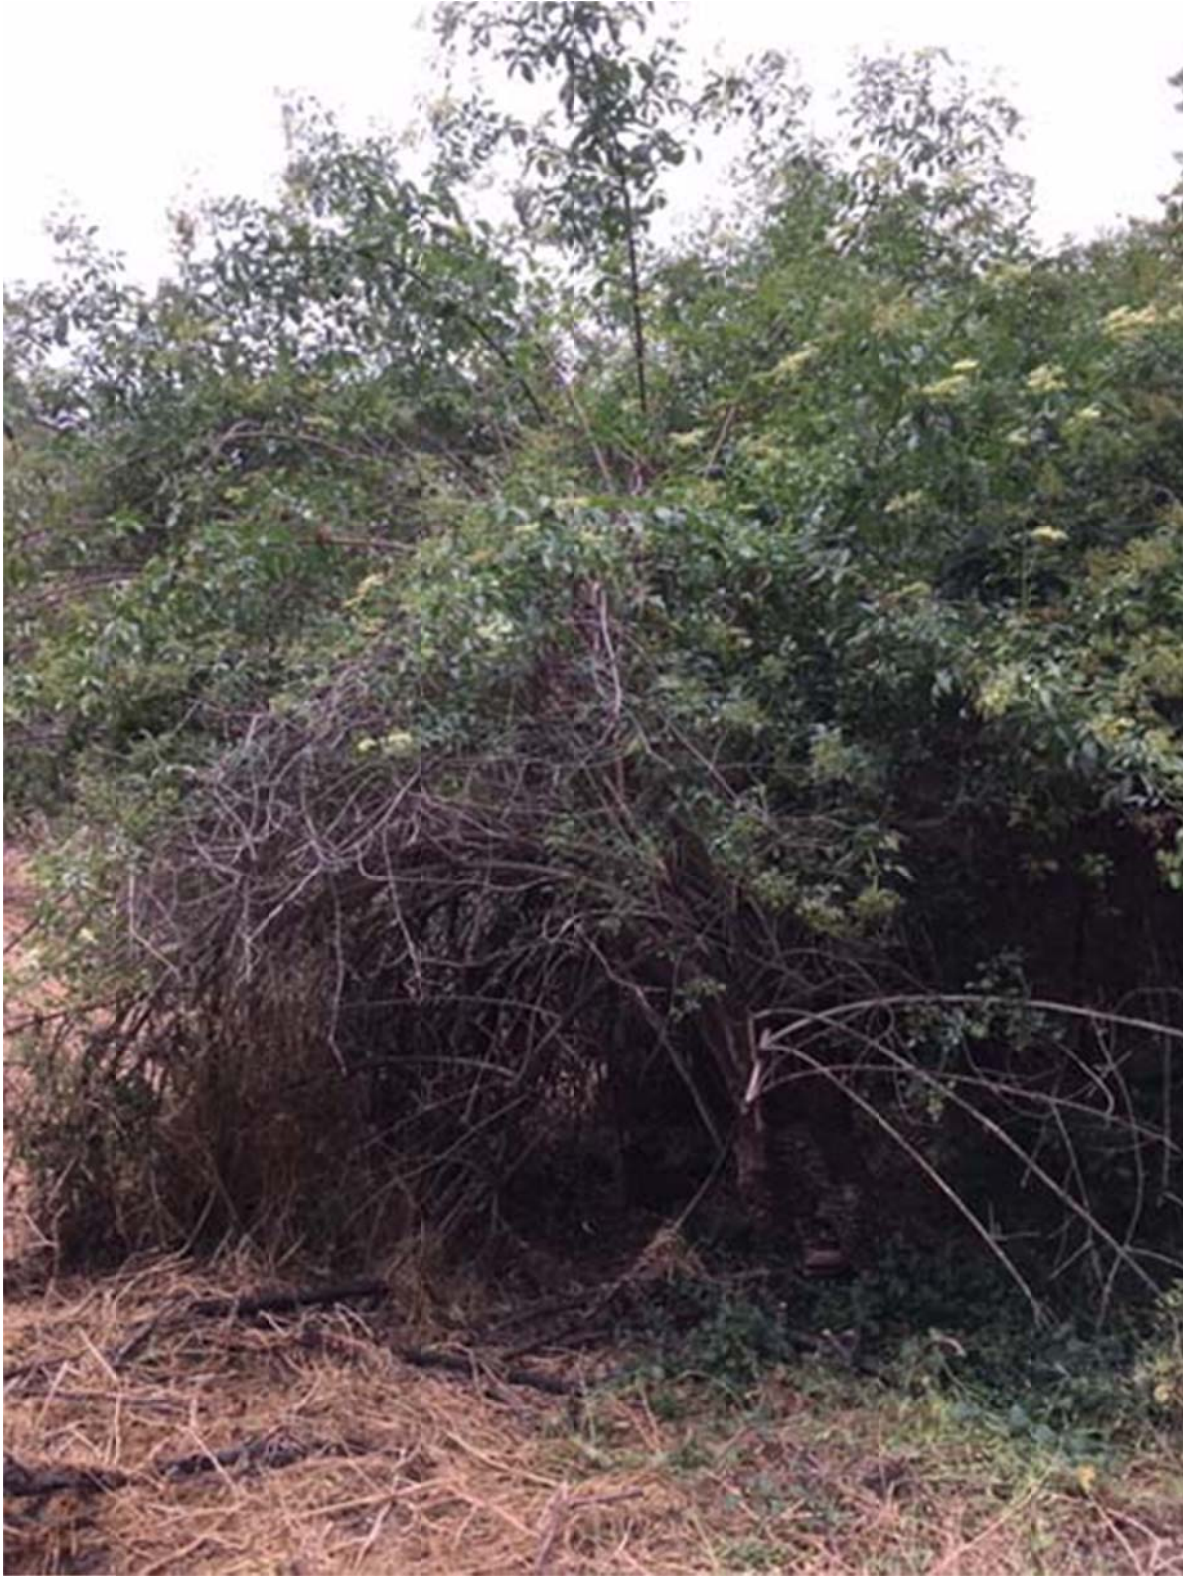
Figure 38: Tree 36

<p>Tree 36 <i>Sambucus mexicana</i> – Mexican Elderberry</p> <p>This tree is not protected by ordinance. It will be retained in the landscape.</p>

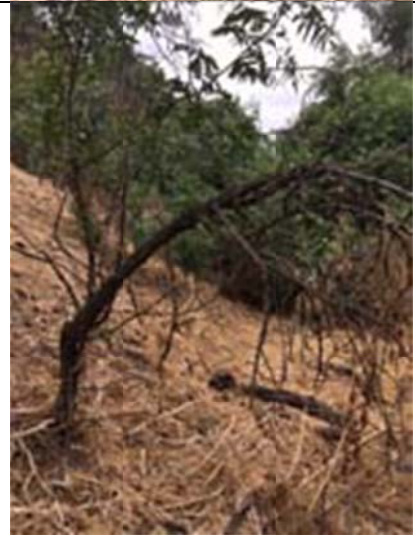
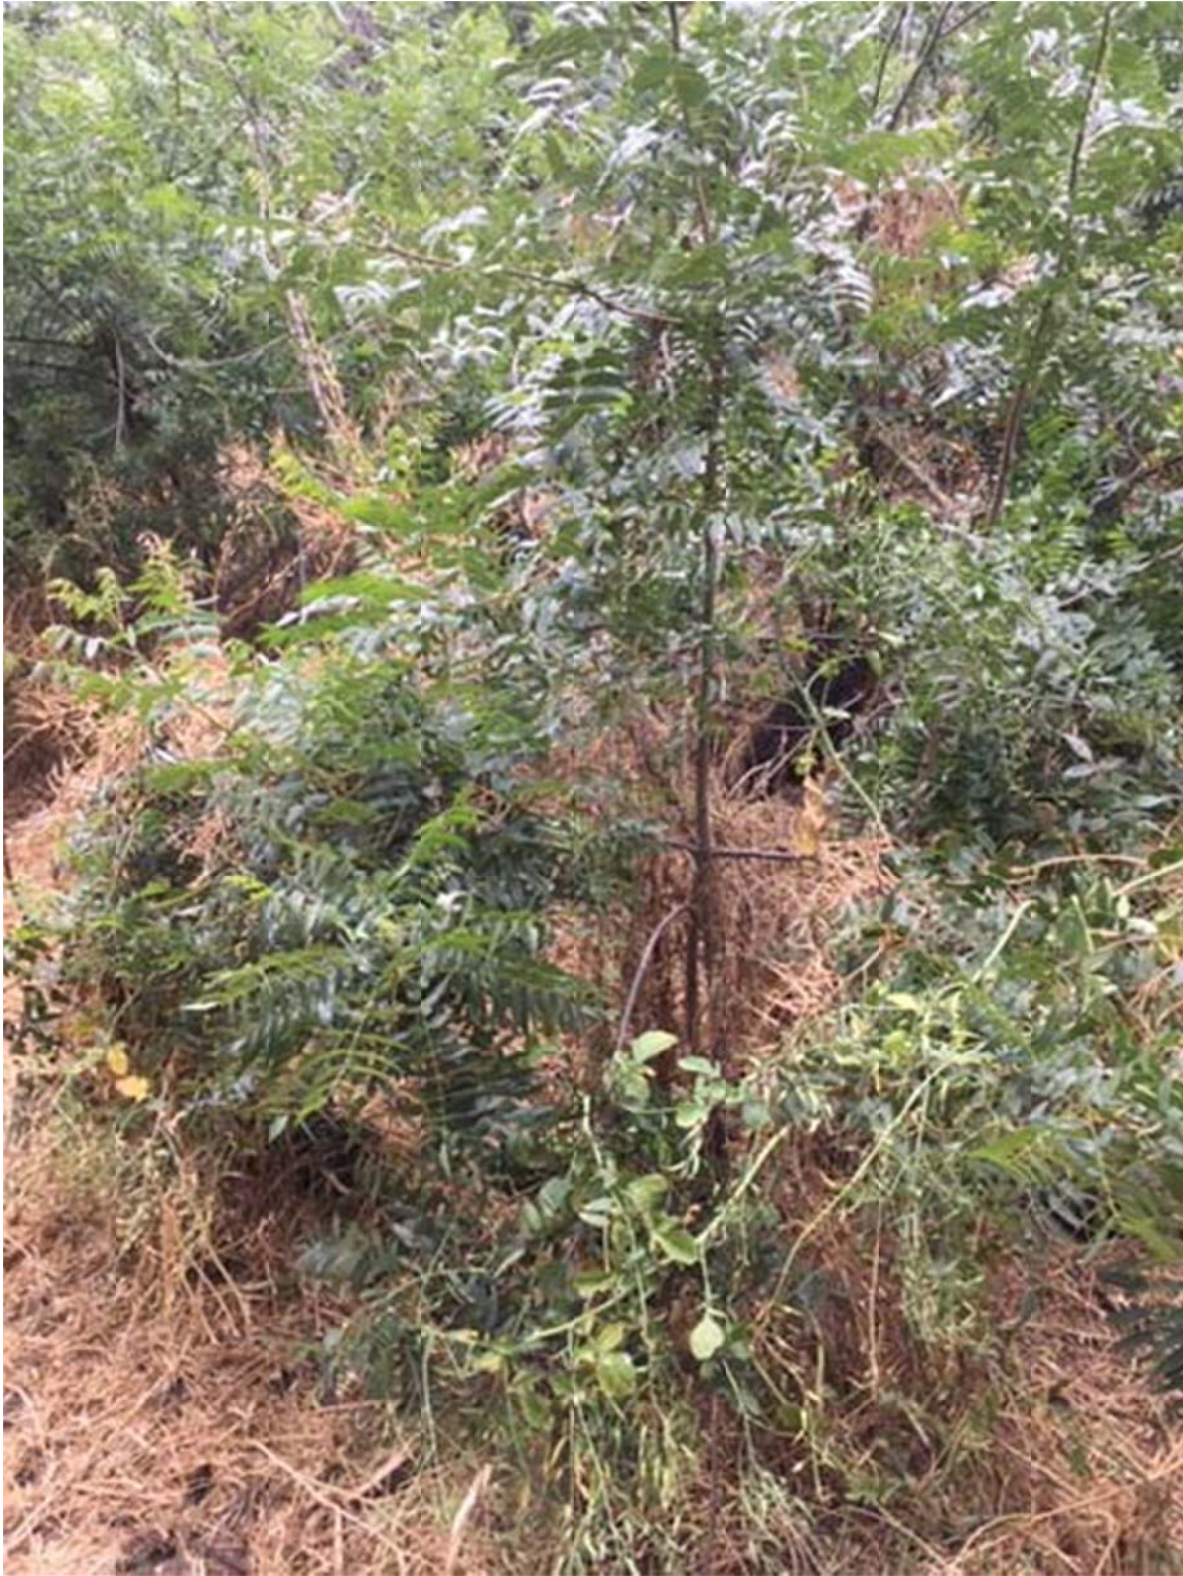
Figure 39: Tree 37

<p>Tree 37 <i>Juglans californica</i> – California Black Walnut</p> <p>This tree is too small to be protected by ordinance. It will be retained in the landscape.</p>

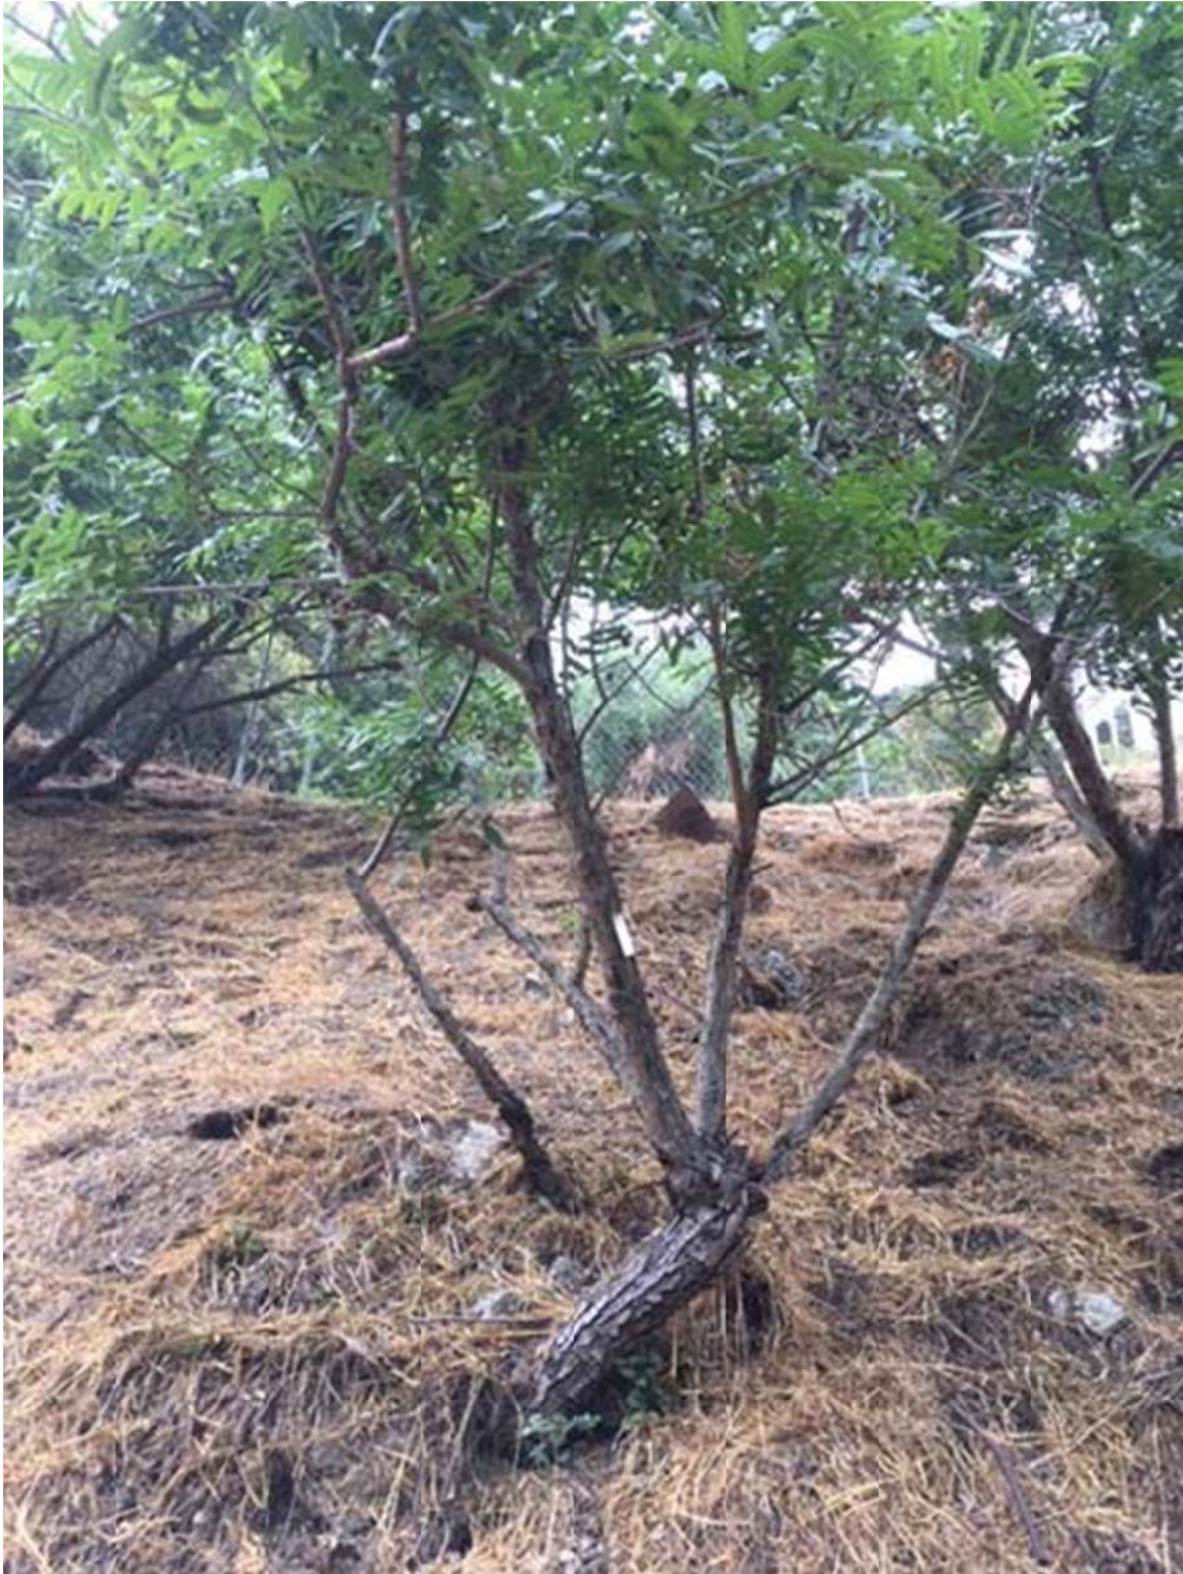
Figure 8: Tree 6

<p>Tree 6 <i>Juglans californica</i> – California Black Walnut</p> <p>This tree is protected by ordinance. It must be removed because its trunk is growing within the footprint of the proposed driveway. Protecting this tree would preclude the reasonable development of the property.</p>

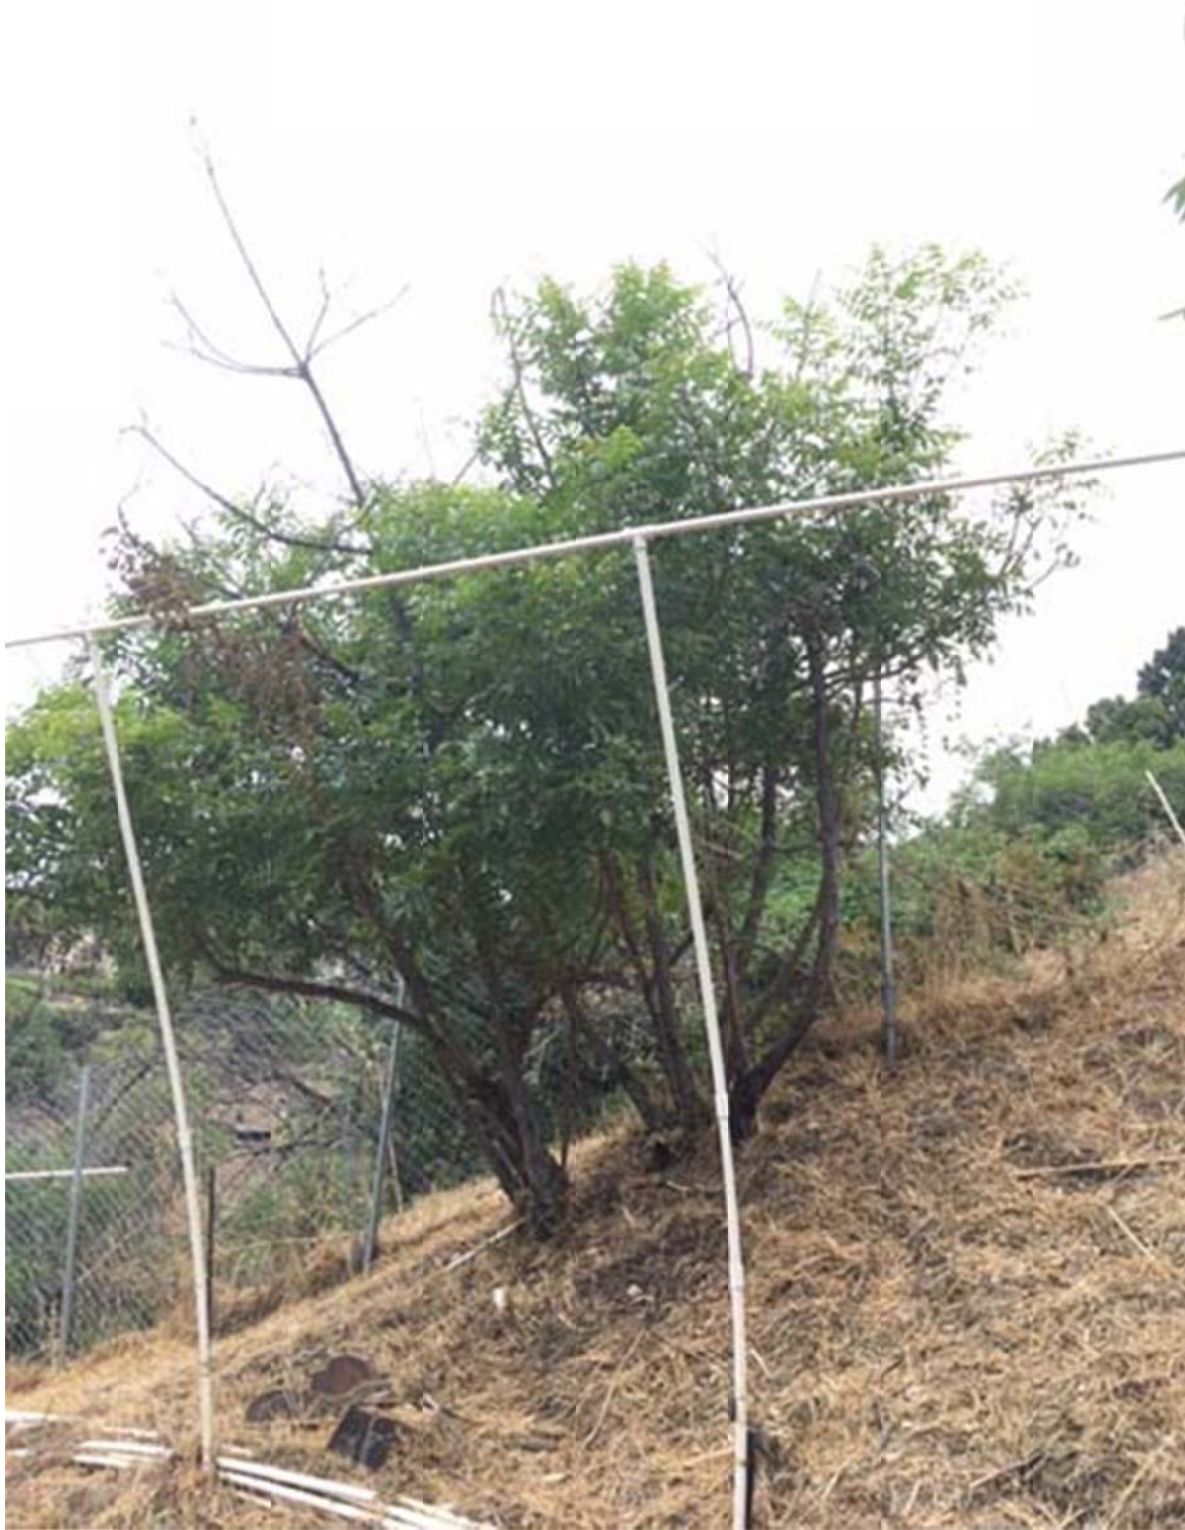
Figure 11: Tree 9

<p>Tree 9 <i>Juglans californica</i> – California Black Walnut</p> <p>This tree is protected by ordinance. This tree must be removed because it is within the footprint of the proposed garage deck.</p>
