Example Mt. Washington Arborist Report

Prepared by James Komen

Class One Arboriculture

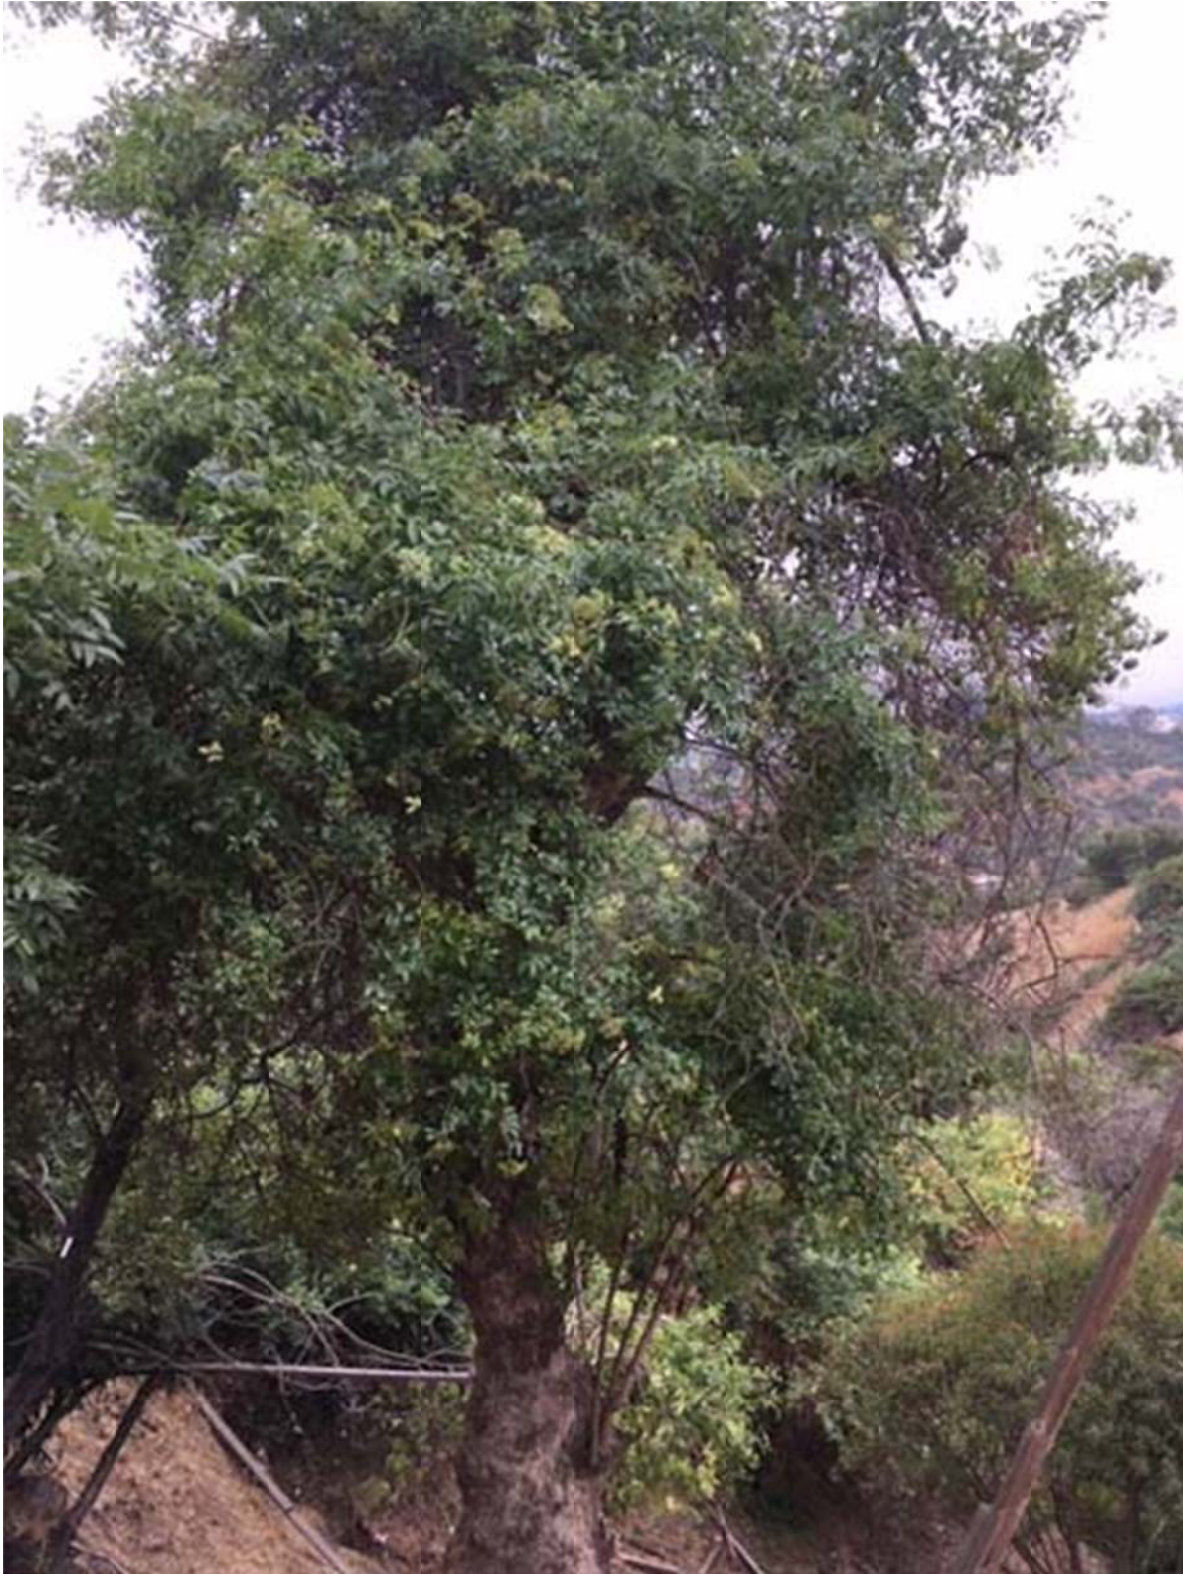
Figure 12: Tree 10

<p>Tree 10 <i>Sambucus mexicana</i> – Mexican Elderberry</p> <p>This is a significant tree, protected for its 12” trunk diameter by the Mt. Washington specific plan. This tree must be removed because it is within the footprint of the proposed construction.</p>

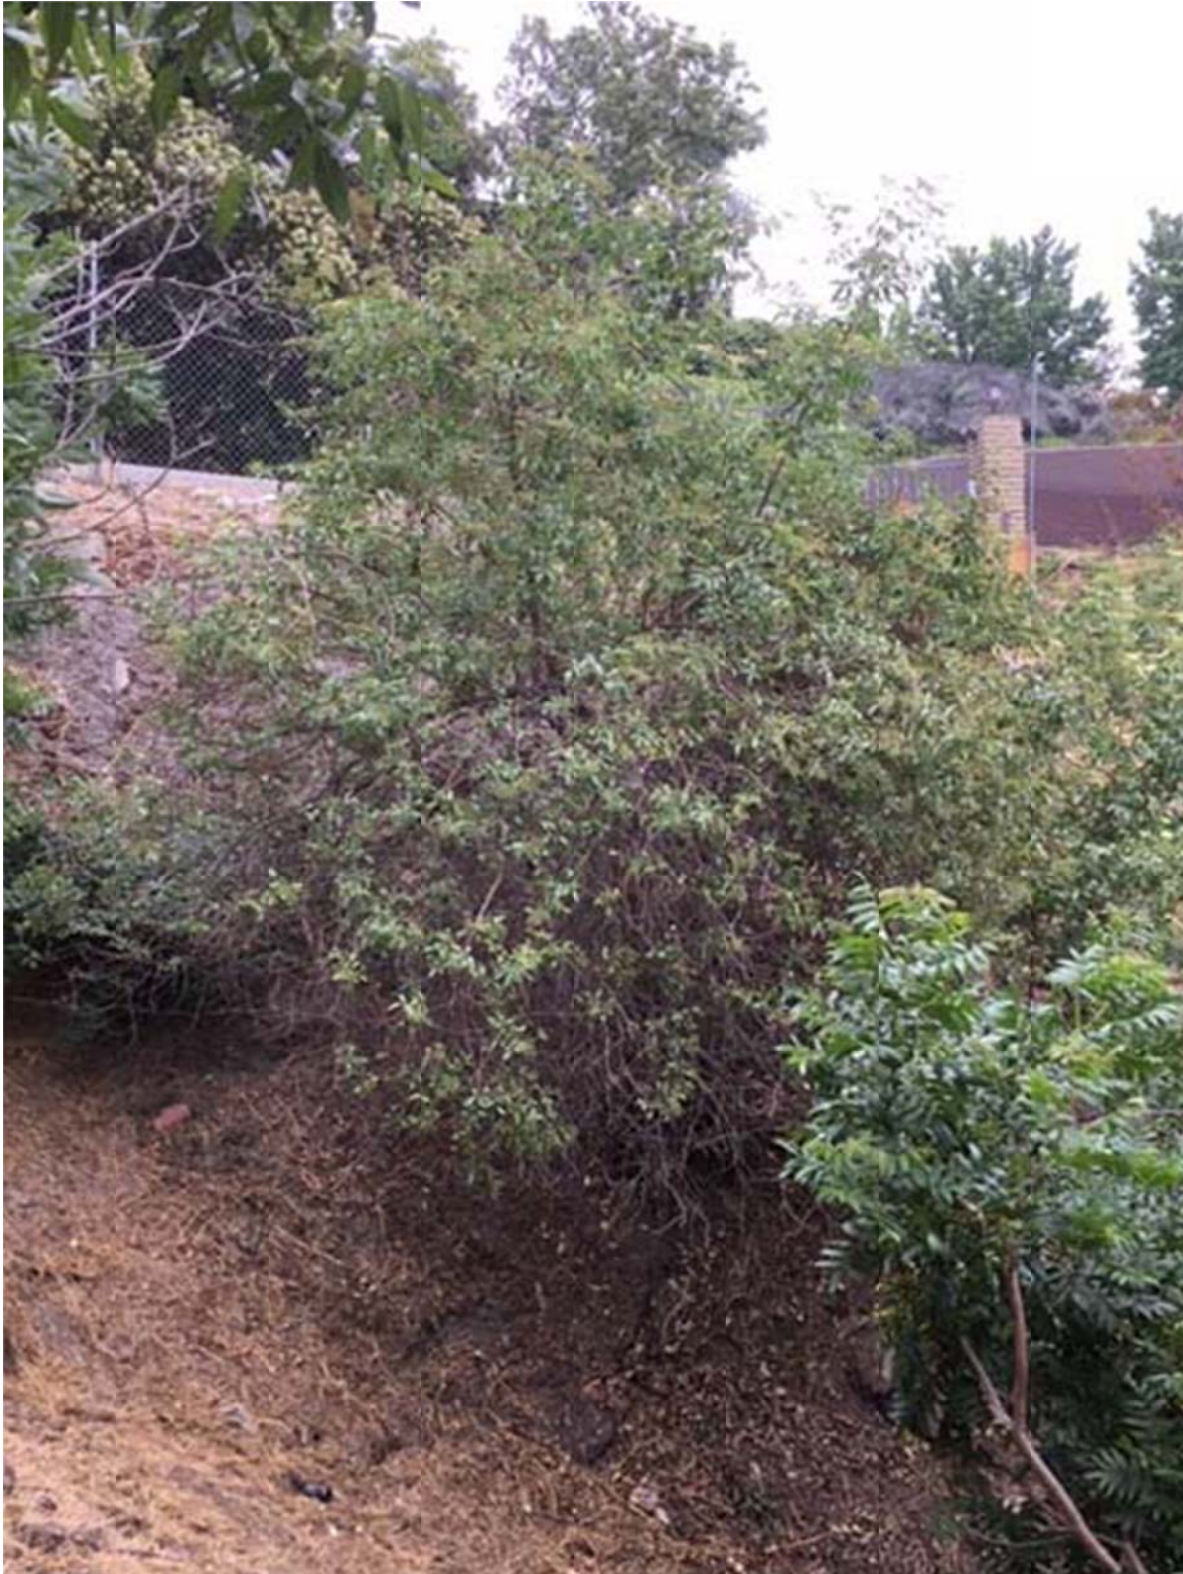
Figure 16: Tree 14

<p>Tree 14 <i>Sambucus mexicana</i> – Mexican Elderberry</p> <p>This tree is not protected by ordinance. It must be removed because it is within the footprint of the proposed construction.</p>

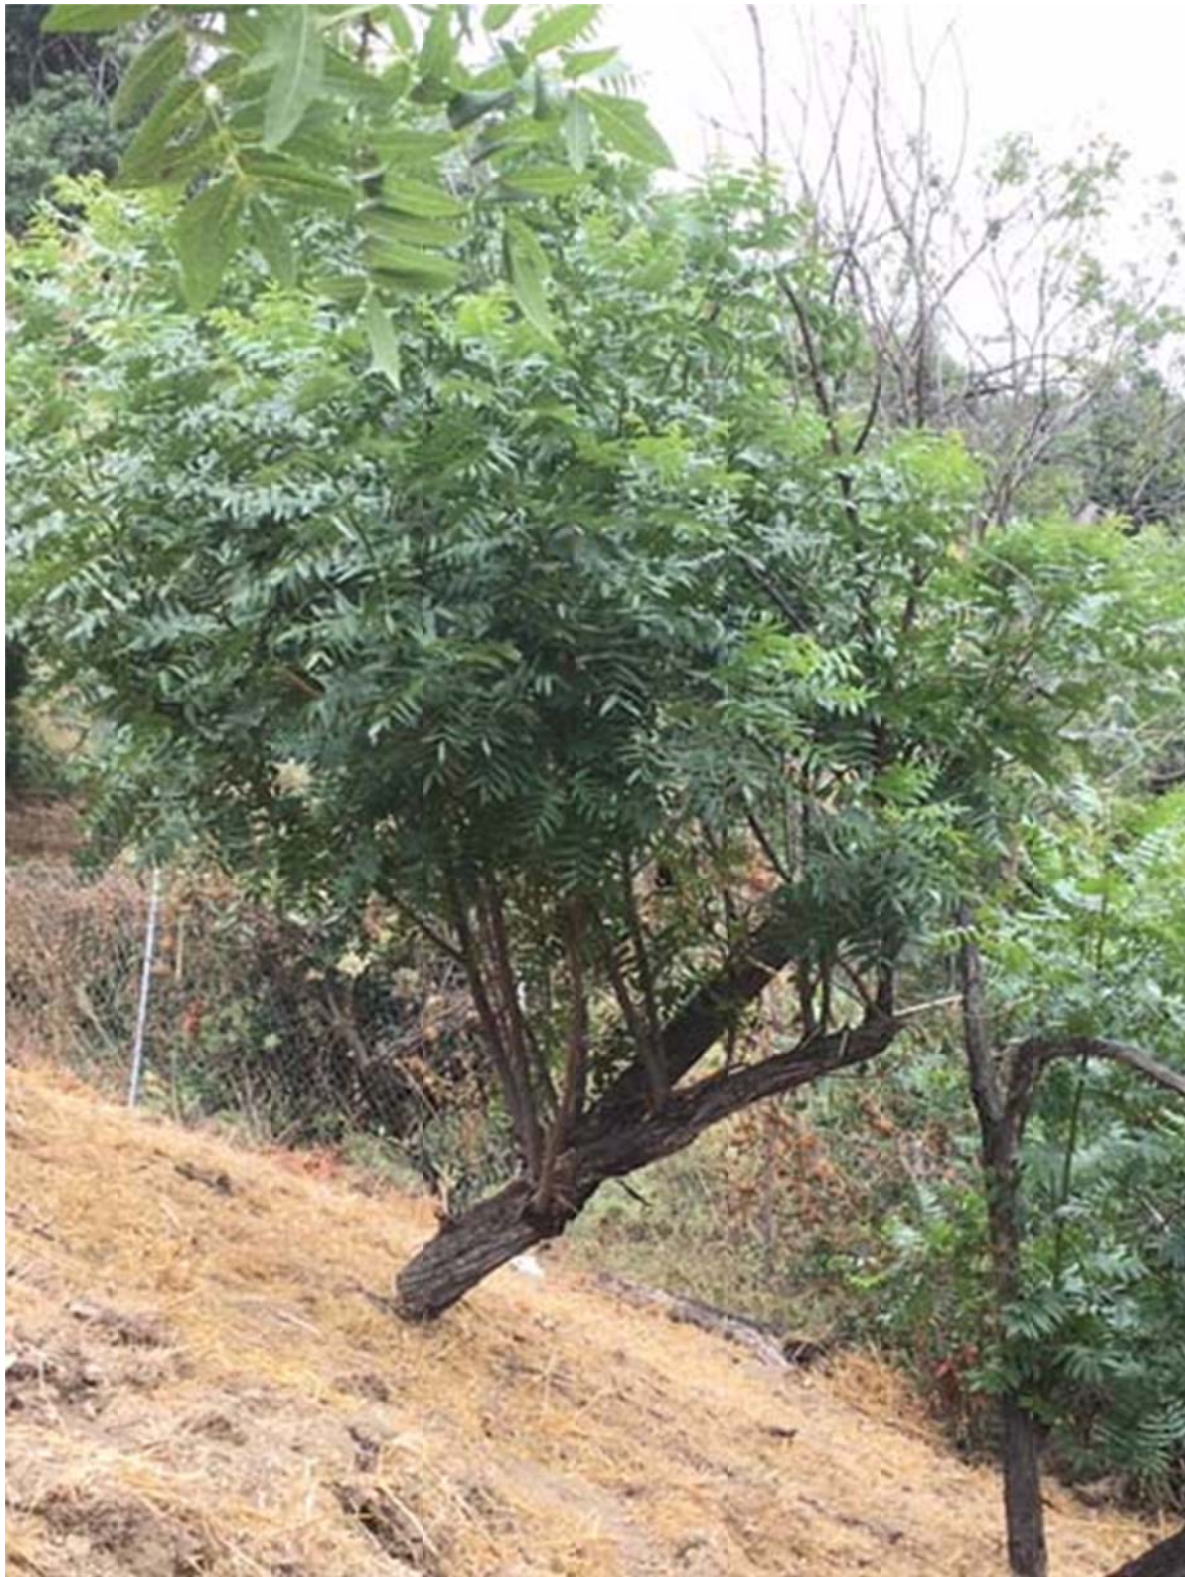
Figure 26: Tree 24

<p>Tree 24 <i>Juglans californica</i> – California Black Walnut</p> <p>This tree is protected by ordinance. It is showing signs of drought stress. If the tree protection fencing shown in this report is not crossed, it is unlikely this tree will be affected by construction activity.</p>

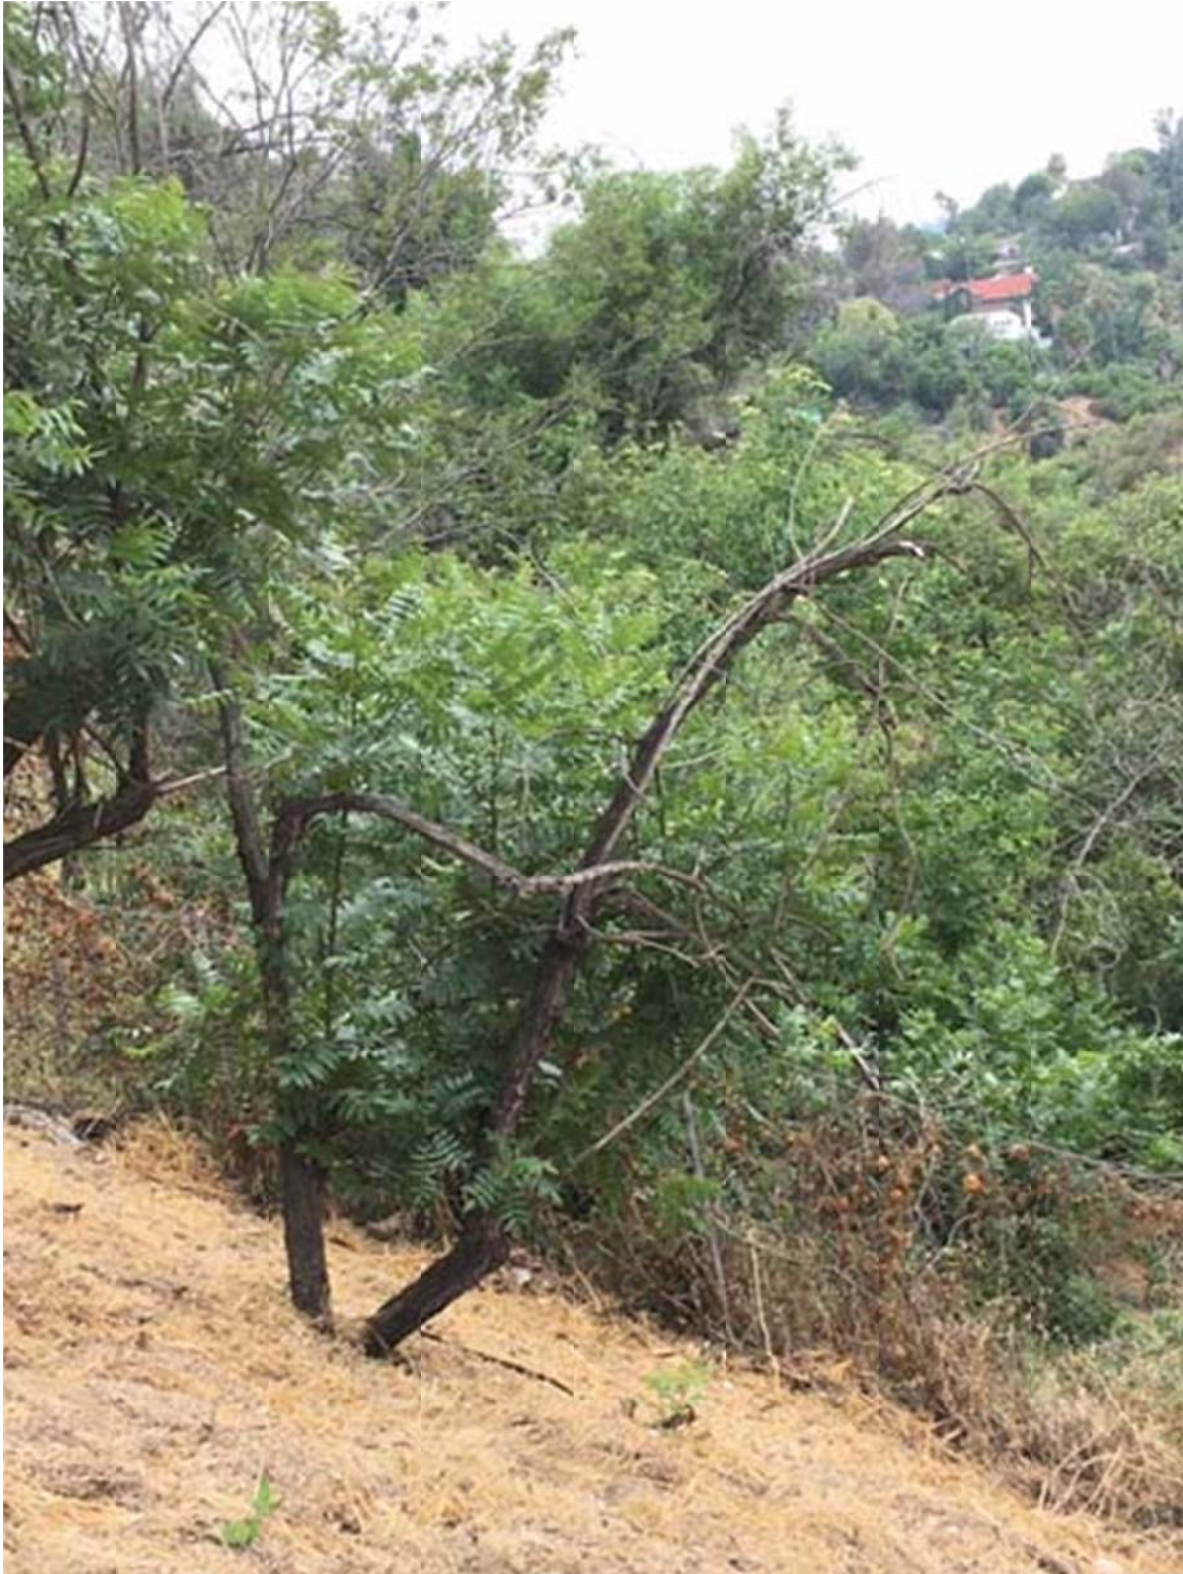
Figure 27: Tree 25

<p>Tree 25 <i>Juglans californica</i> – California Black Walnut</p> <p>This tree is protected by ordinance. It is showing signs of drought stress. If the tree protection fencing shown in this report is not crossed, it is unlikely this tree will be affected by construction activity.</p>

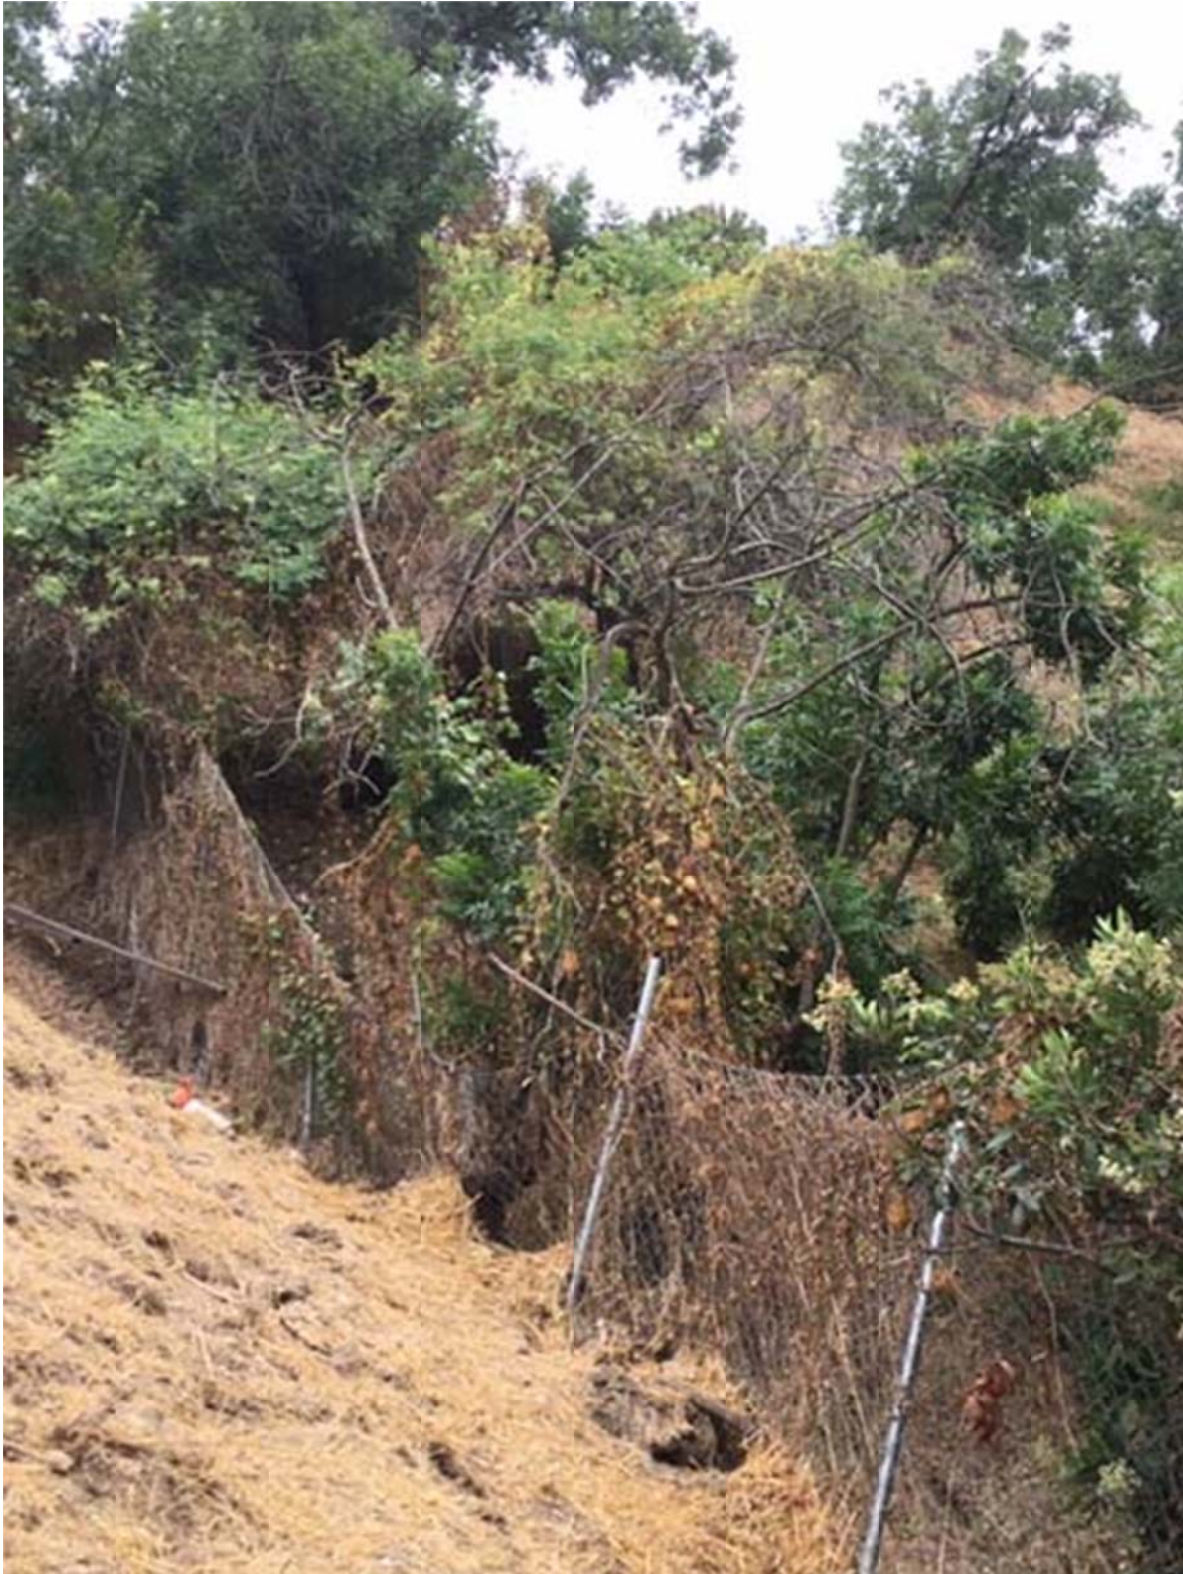
Figure 28: Tree 26

<p>Tree OP26 <i>Juglans californica</i> – California Black Walnut</p> <p>This tree is protected by ordinance. It is nearly dead. If the tree protection fencing shown in this report is not crossed, it is unlikely this tree will be affected by construction activity.</p>

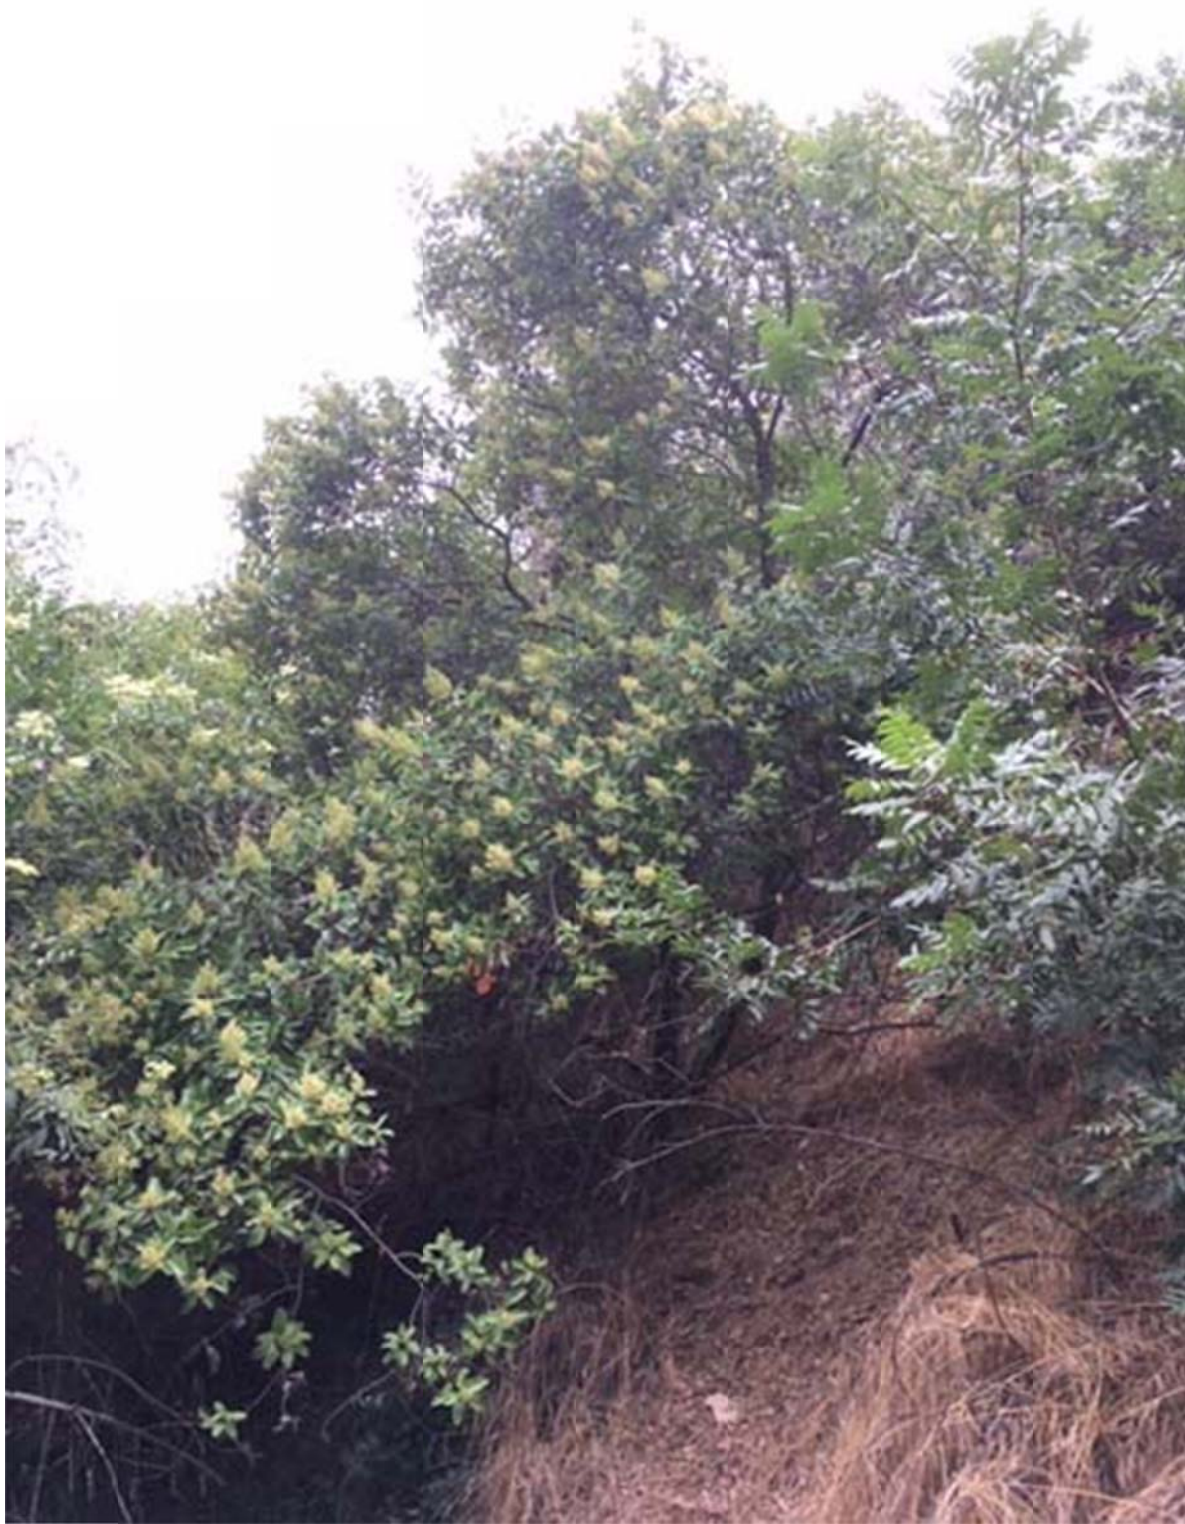
Figure 37: Tree 35

<p>Tree 35 <i>Sambucus mexicana</i> – Mexican Elderberry</p> <p>This tree is not protected by ordinance. It will be retained in the landscape.</p>

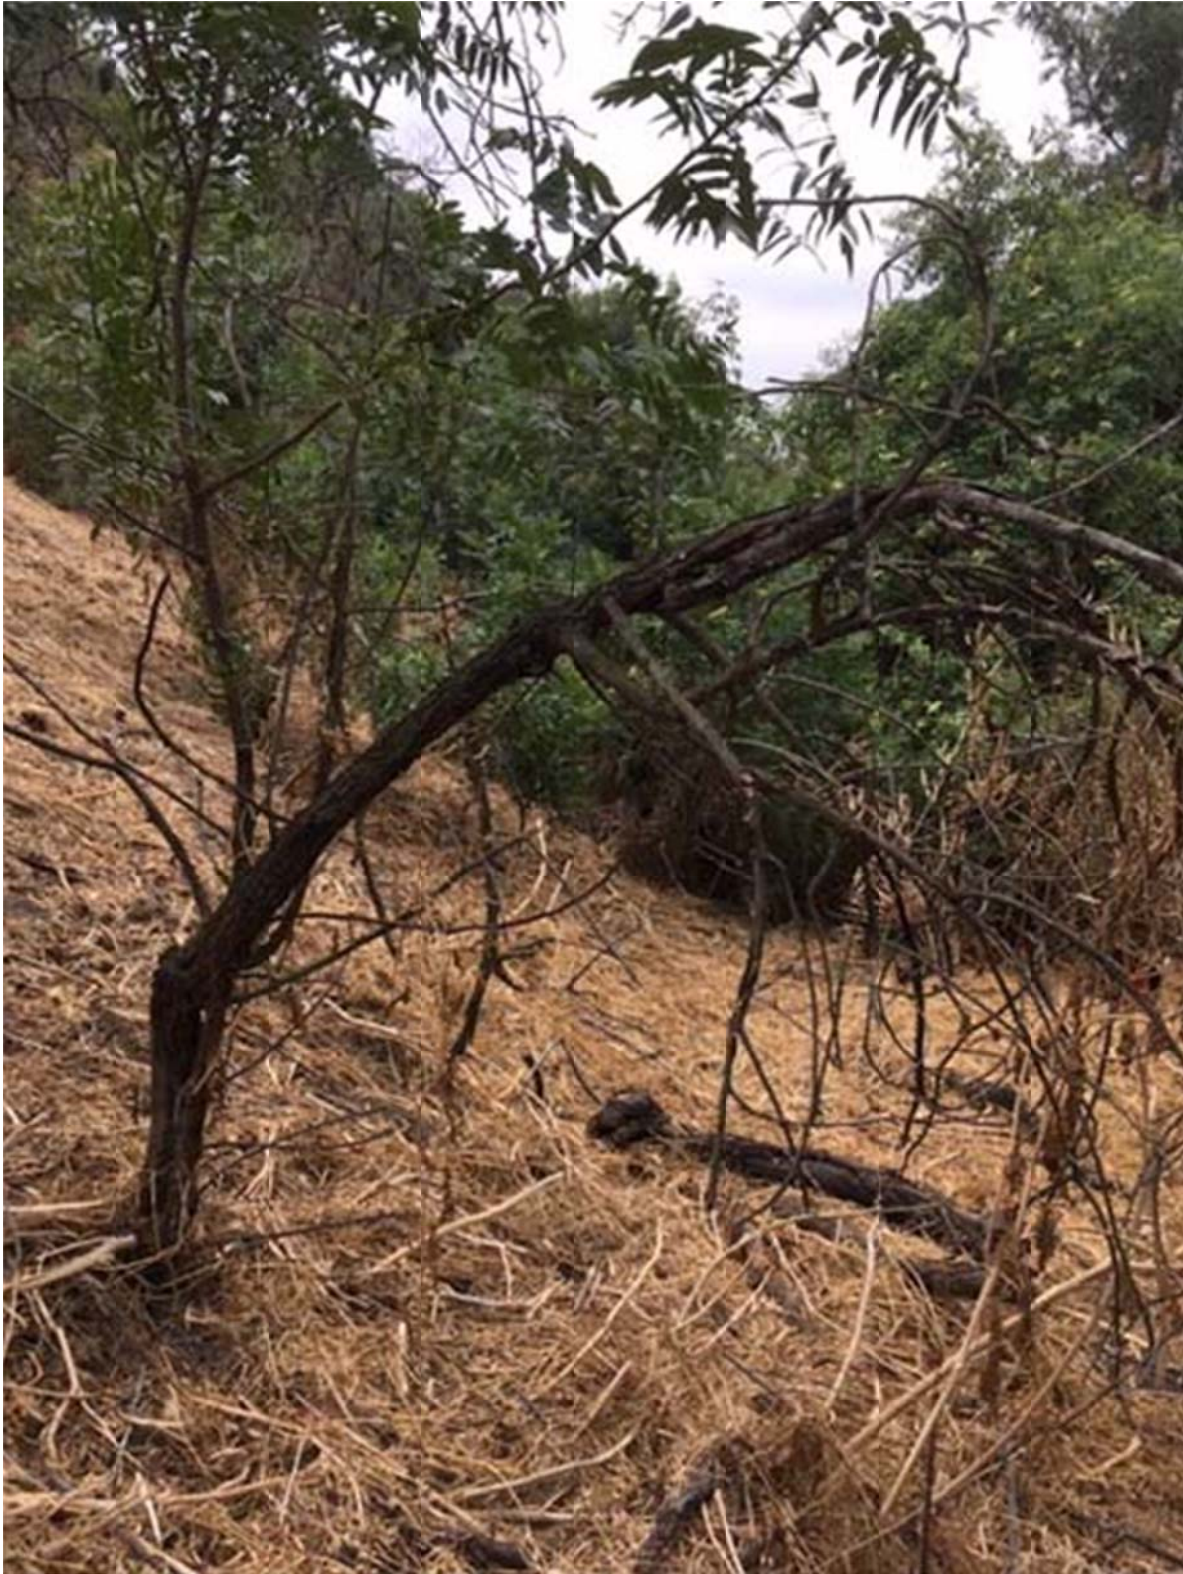
Figure 40: Tree 38

<p>Tree 38 <i>Juglans californica</i> – California Black Walnut</p> <p>This tree is protected by ordinance. It is nearly dead. If the tree protection fencing shown in this report is not crossed, it is unlikely this tree will be affected by construction activity.</p>

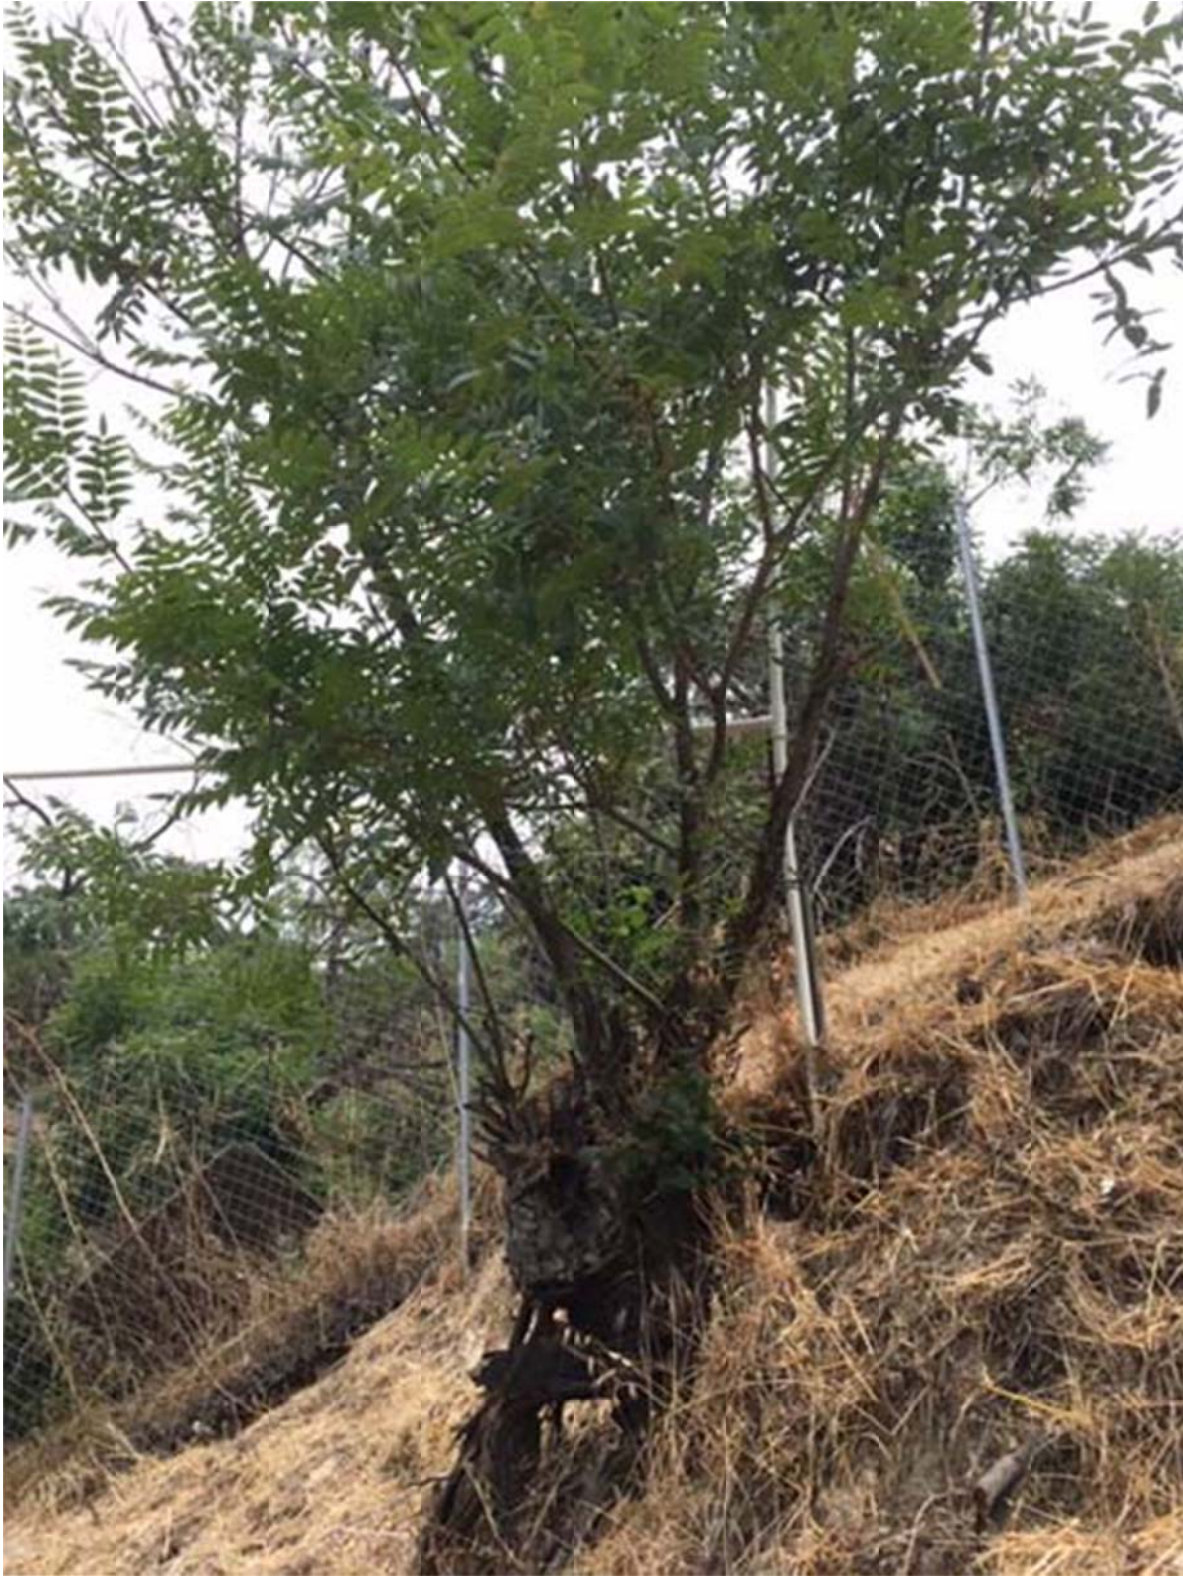
Figure 41: Tree 39

<p>Tree 39 <i>Juglans californica</i> – California Black Walnut</p> <p>This tree is protected by ordinance. This tree must be removed because it is growing within the footprint of the proposed garage deck.</p>
