Class One Arboriculture Inc.

***** Ave. – TREE RISK ASSESSMENT

James Komen, Class One Arboriculture Inc.

September 6, 2021

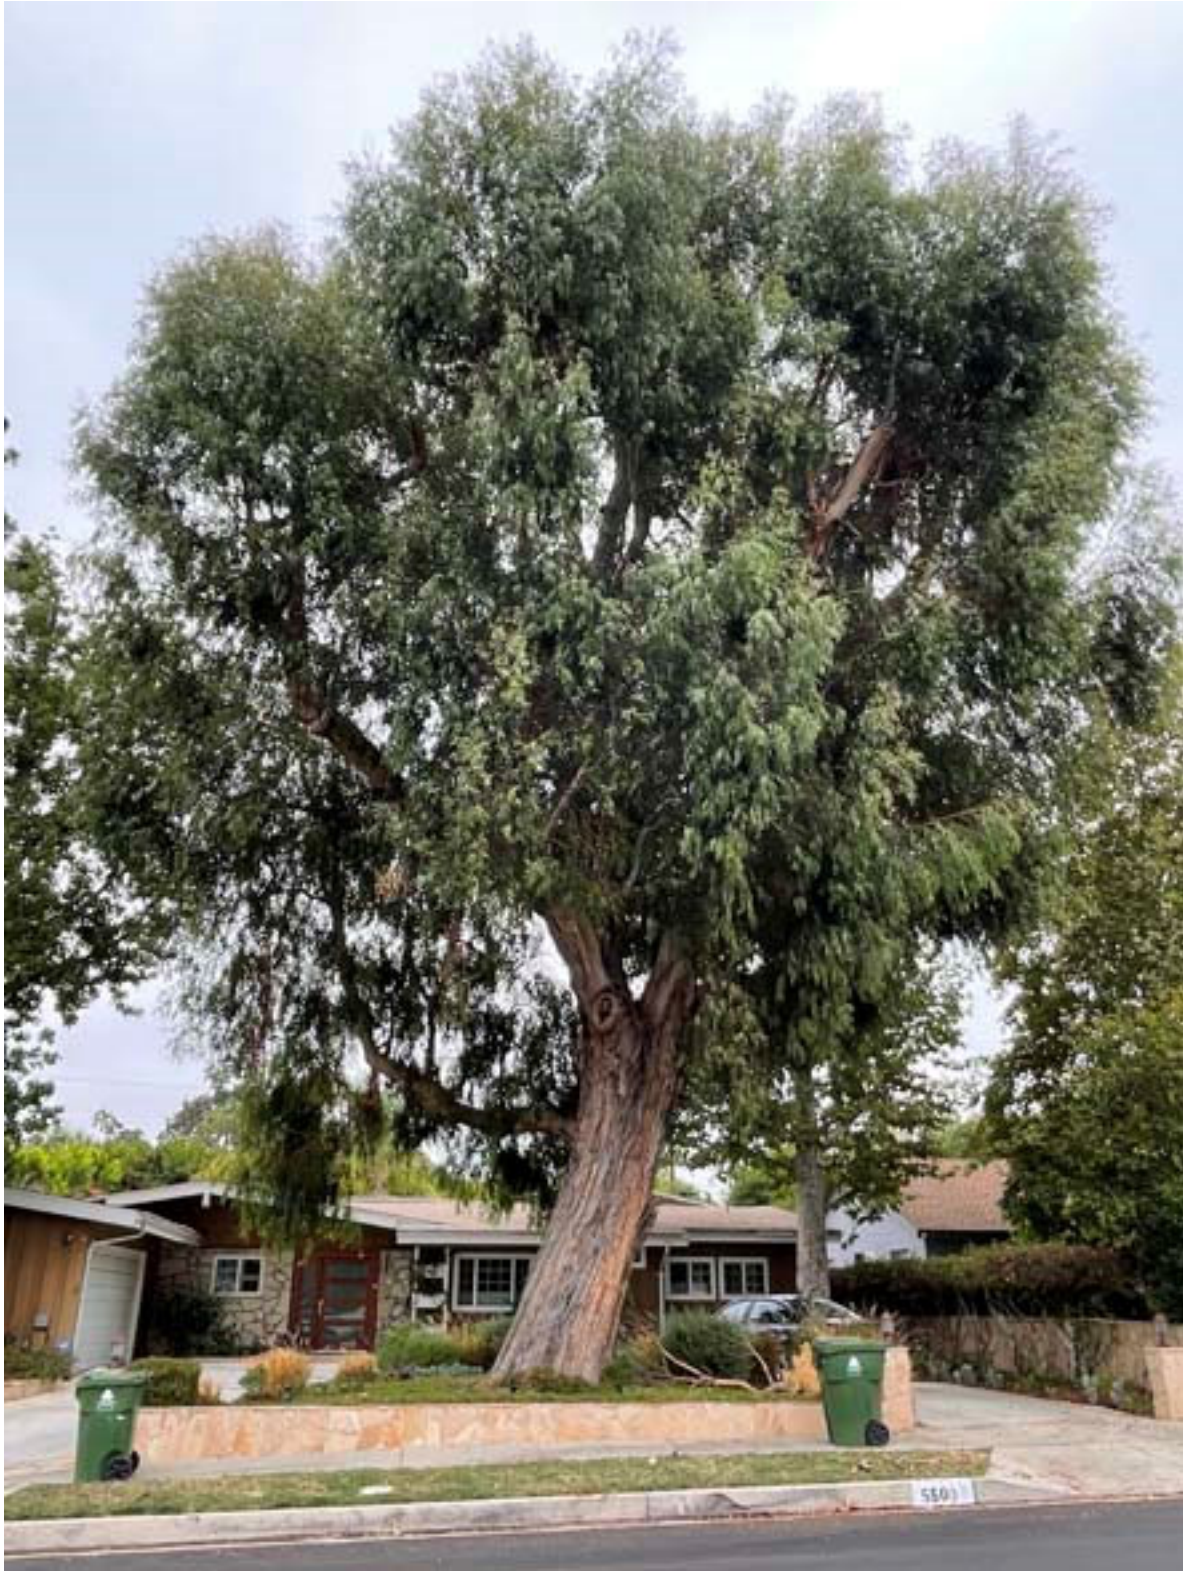
At the time of my site visit, the turfgrass around the base of the subject tree had been replaced by drought-tolerant plants (Figure 5). But even though the turfgrass had been removed, irrigation still sprayed the area for several minutes every other day.

Figure 5: Looking east at the subject tree. I took this image on September 2, 2021.

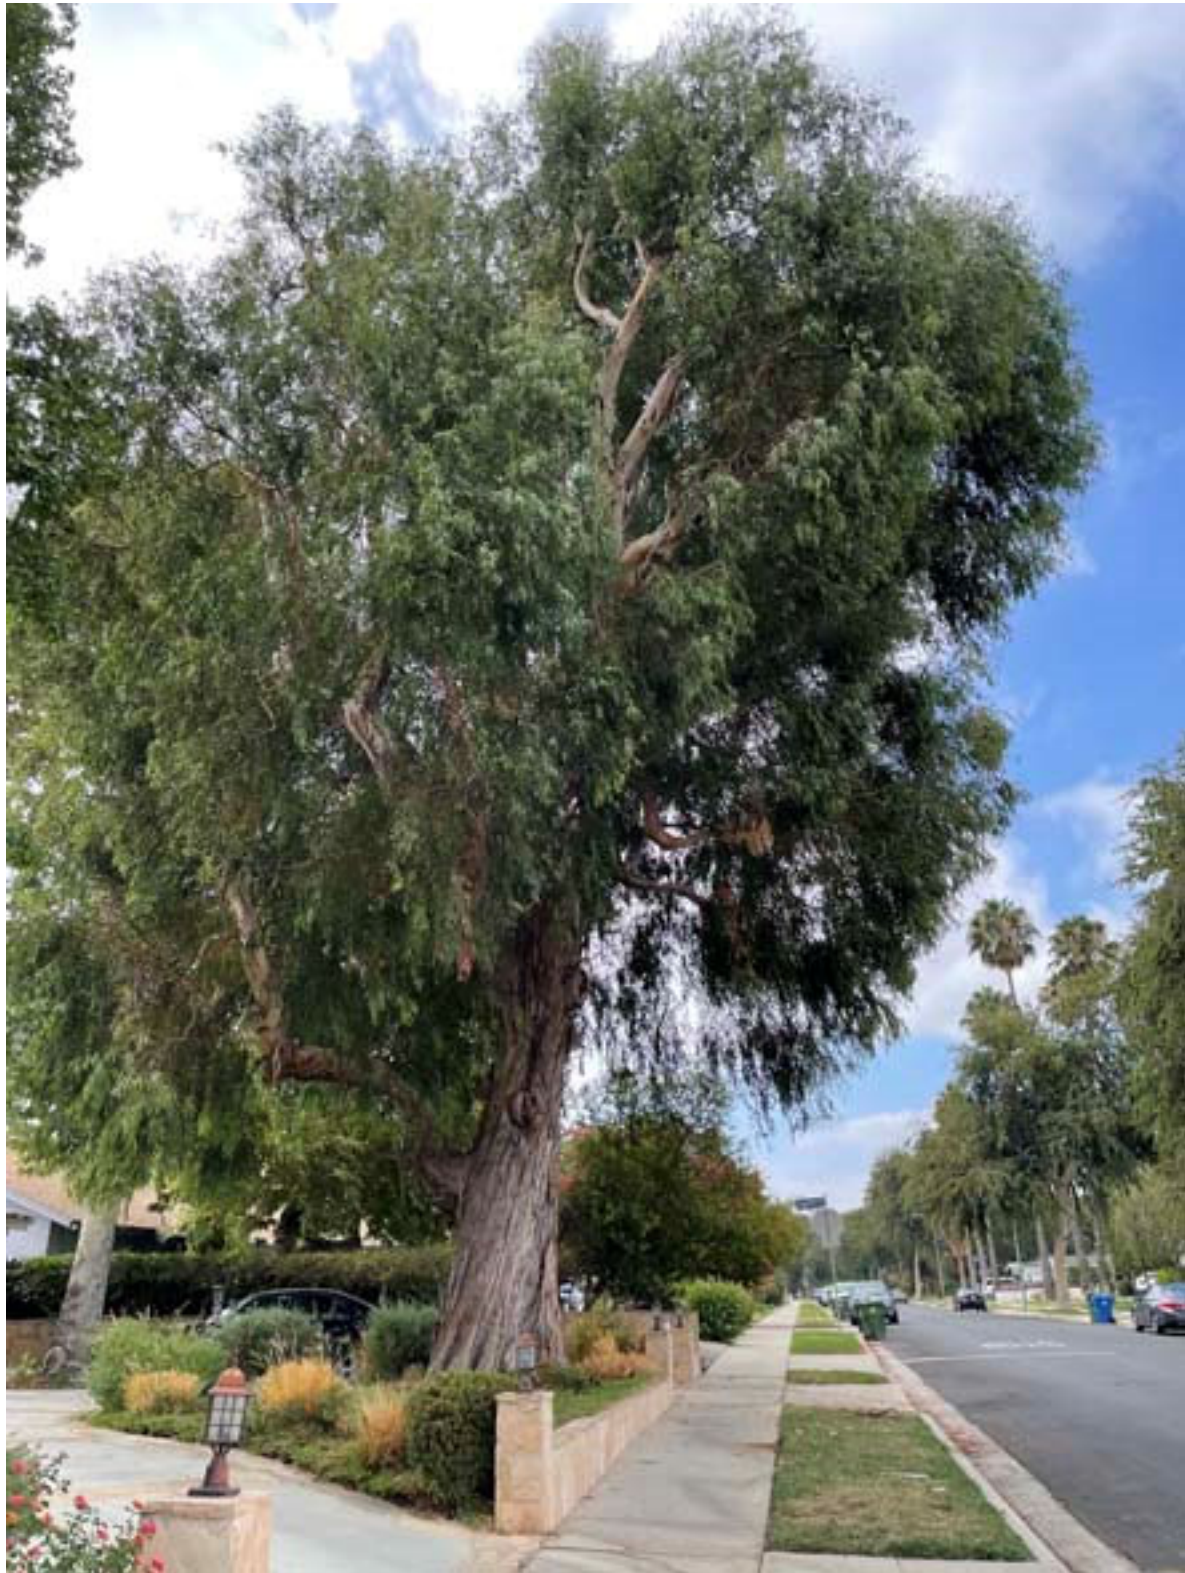
Figure 6: Looking south at the subject tree. I took this image on September 2, 2021.

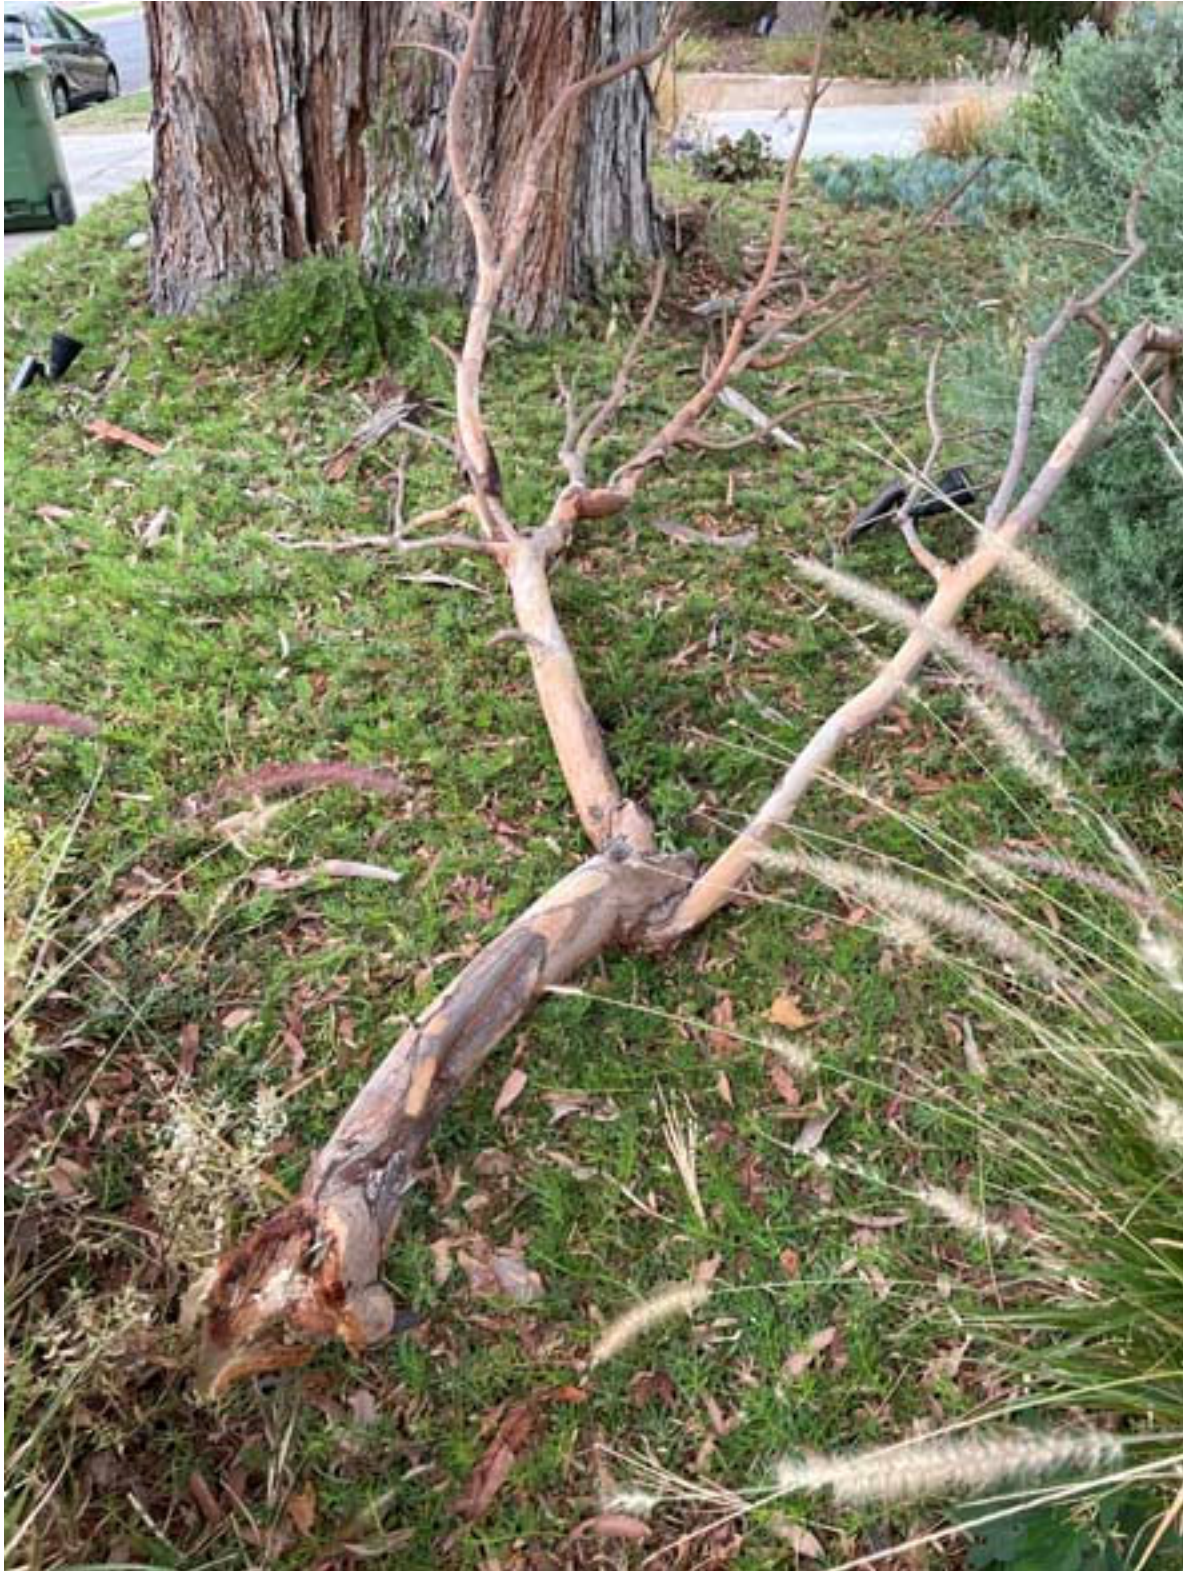
One of these weakly-attached branches failed shortly before my site visit (Figure 7). I observed the failed portion had not developed sufficient union wood due to the included bark (Figure 8). Moreover, there was a history of wood decay organisms further compromising the attachment union, so there was relatively little sound wood remaining at the time of failure.

Eucalyptus trees are one of several species known for dropping branches during times of high temperatures and little wind in a phenomenon known as summer branch drop. Although the direct causal mechanism of summer branch drop is not fully understood, many arborists have observed trees drop branches during periods of high temperatures, often in the late afternoon of a hot summer day. The branch that failed shortly before my site visit failed at some point in the afternoon on a hot summer day. It was predisposed to failure due to its weak attachment union; its catalyst was likely the afternoon heat.

Figure 7: The branch that had failed shortly before my site visit.

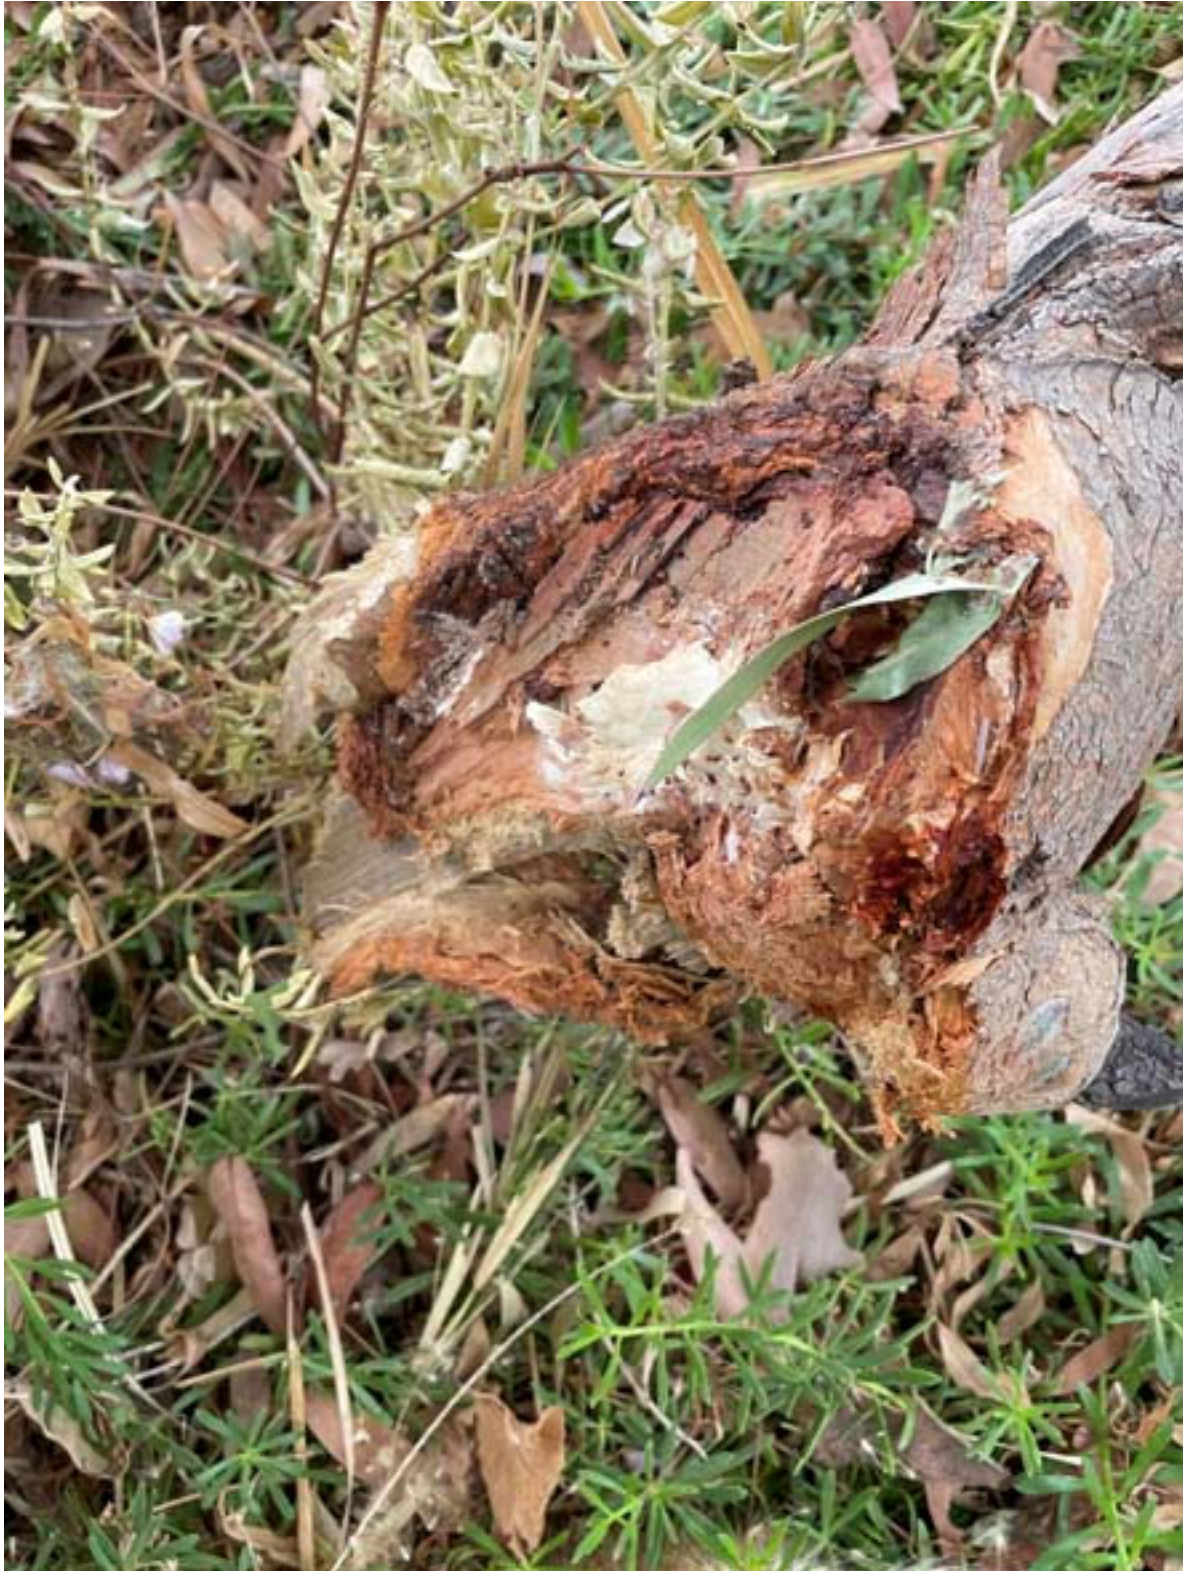
Figure 8: The weak attachment union from the failed branch had included bark and decay.

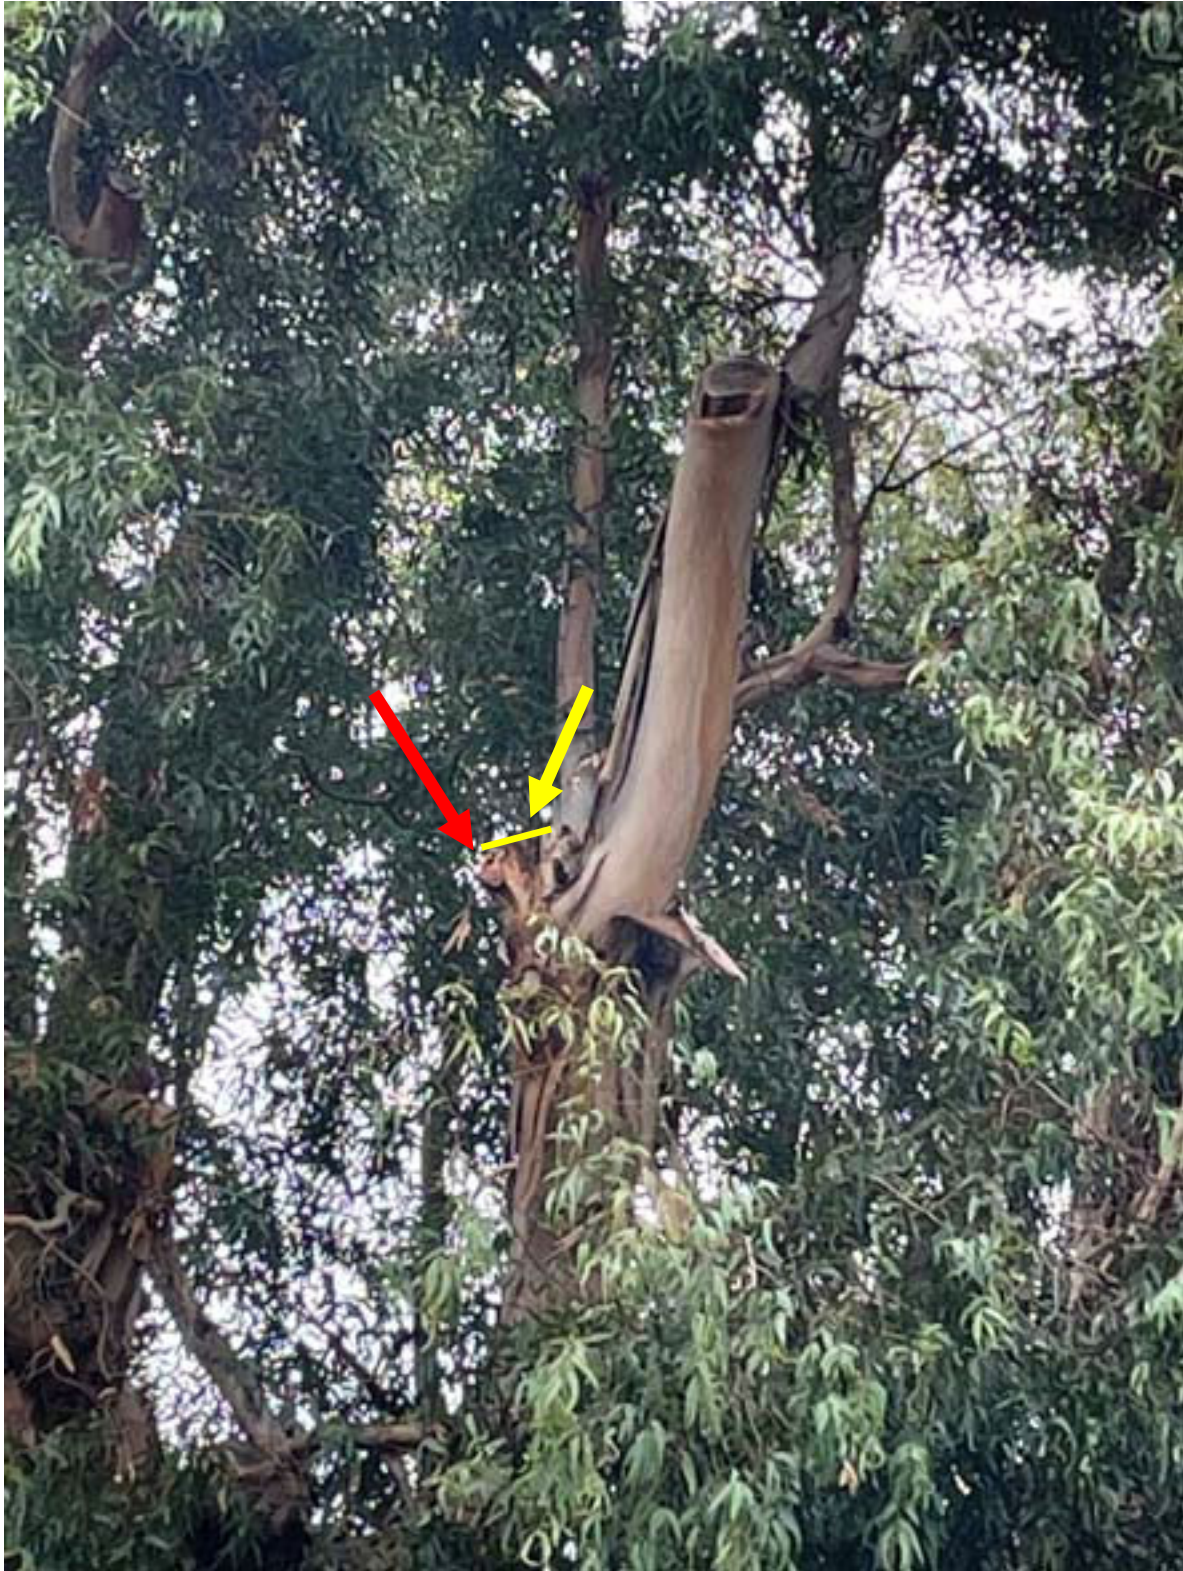
I observed other branch unions in the canopy that developed in a similar pattern of growth after the 2014 topping (Figure 9). I did not observe the presence or absence of decay at these unions because I did not perform an aerial inspection, but I did observe that the branch unions had grown out of the perimeters of the 2014 topping cuts, which likely predisposed them to an elevated likelihood of failure.

Figure 9: Location on the tree from where the failed branch fell (red arrow). This branch was a response growth shoot growing out from the perimeter of a topping cut from 2014 (yellow arrow).

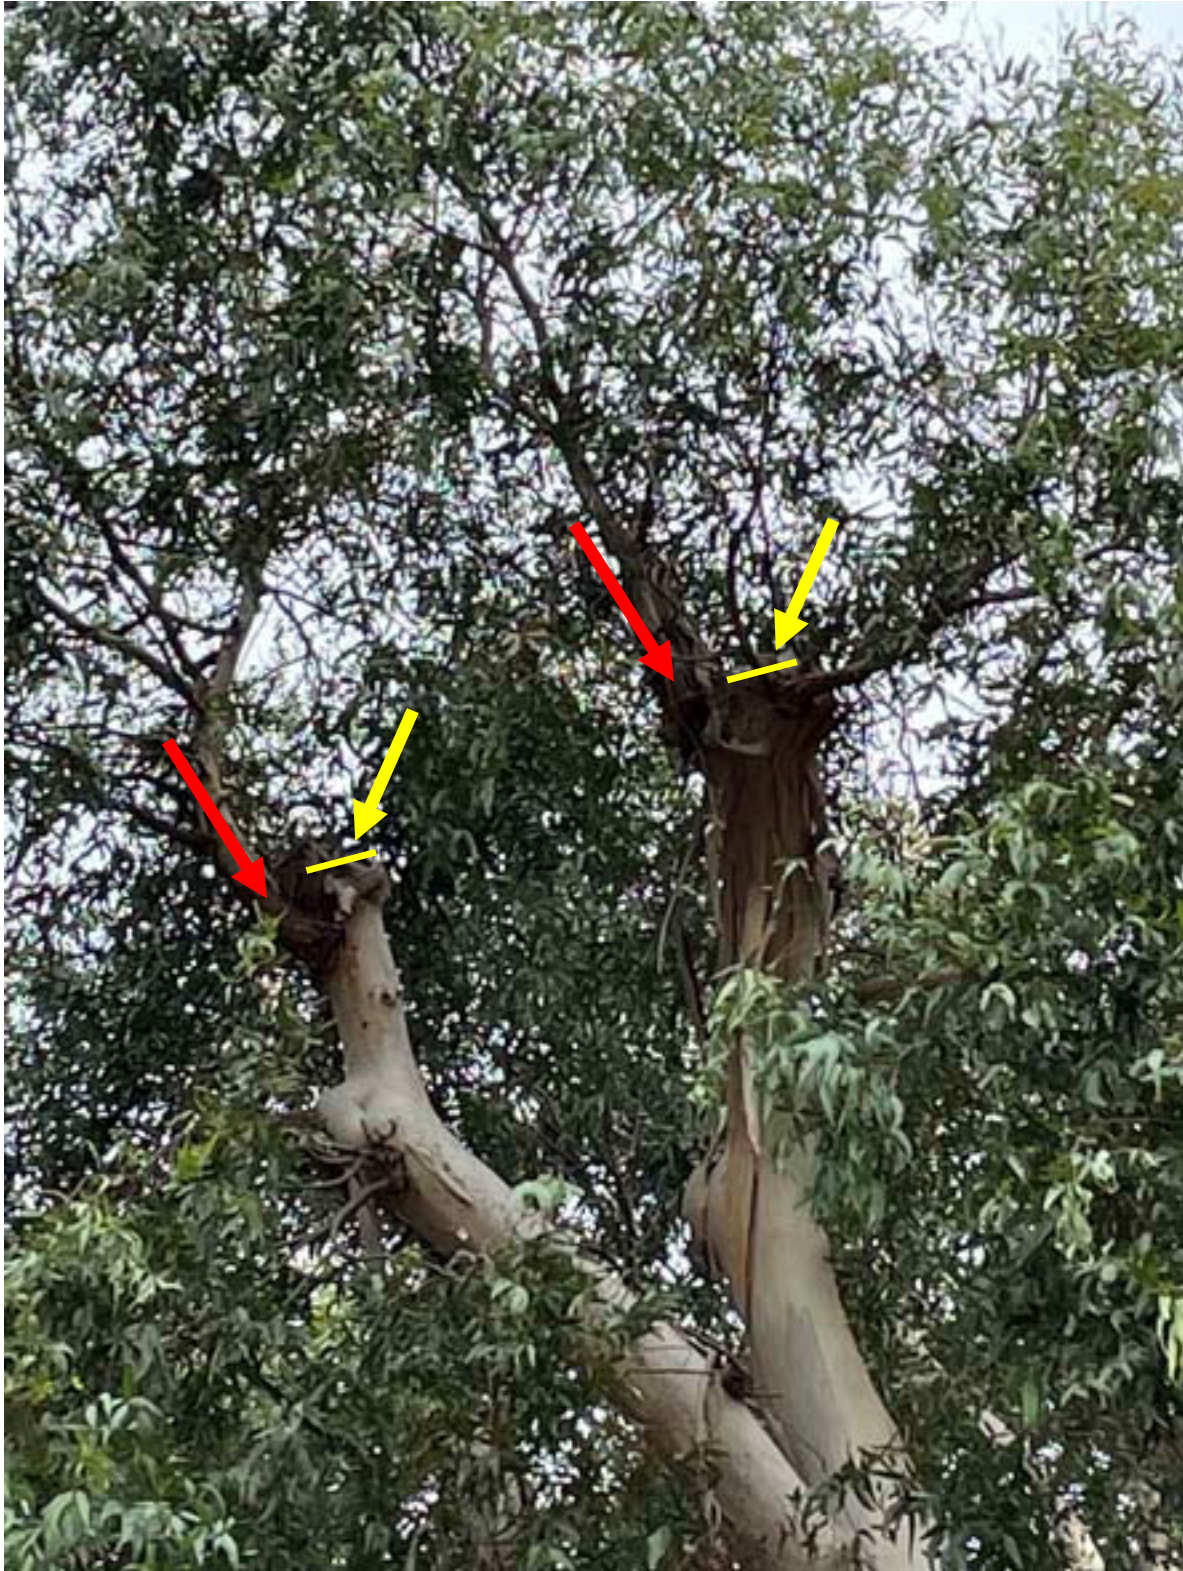
On the subject tree, the 7 year-old branches that grew after the 2014 topping are weakly attached to their parent stems, which predisposes them to failure. But if these identifiable defects were removed from the tree, most of the tree's canopy would be lost. However, as discussed below, the risk posed by branch failure onto each of the five targets assessed is *low* within the next one year time frame.

Figure 10: Branch unions similar to the one that failed are present on the tree. A response growth shoot (red arrow) grew out of the side of a 2014 topping cut (yellow arrow). These branches are weakly attached and have a *possible* likelihood of failure in the next one year time frame.

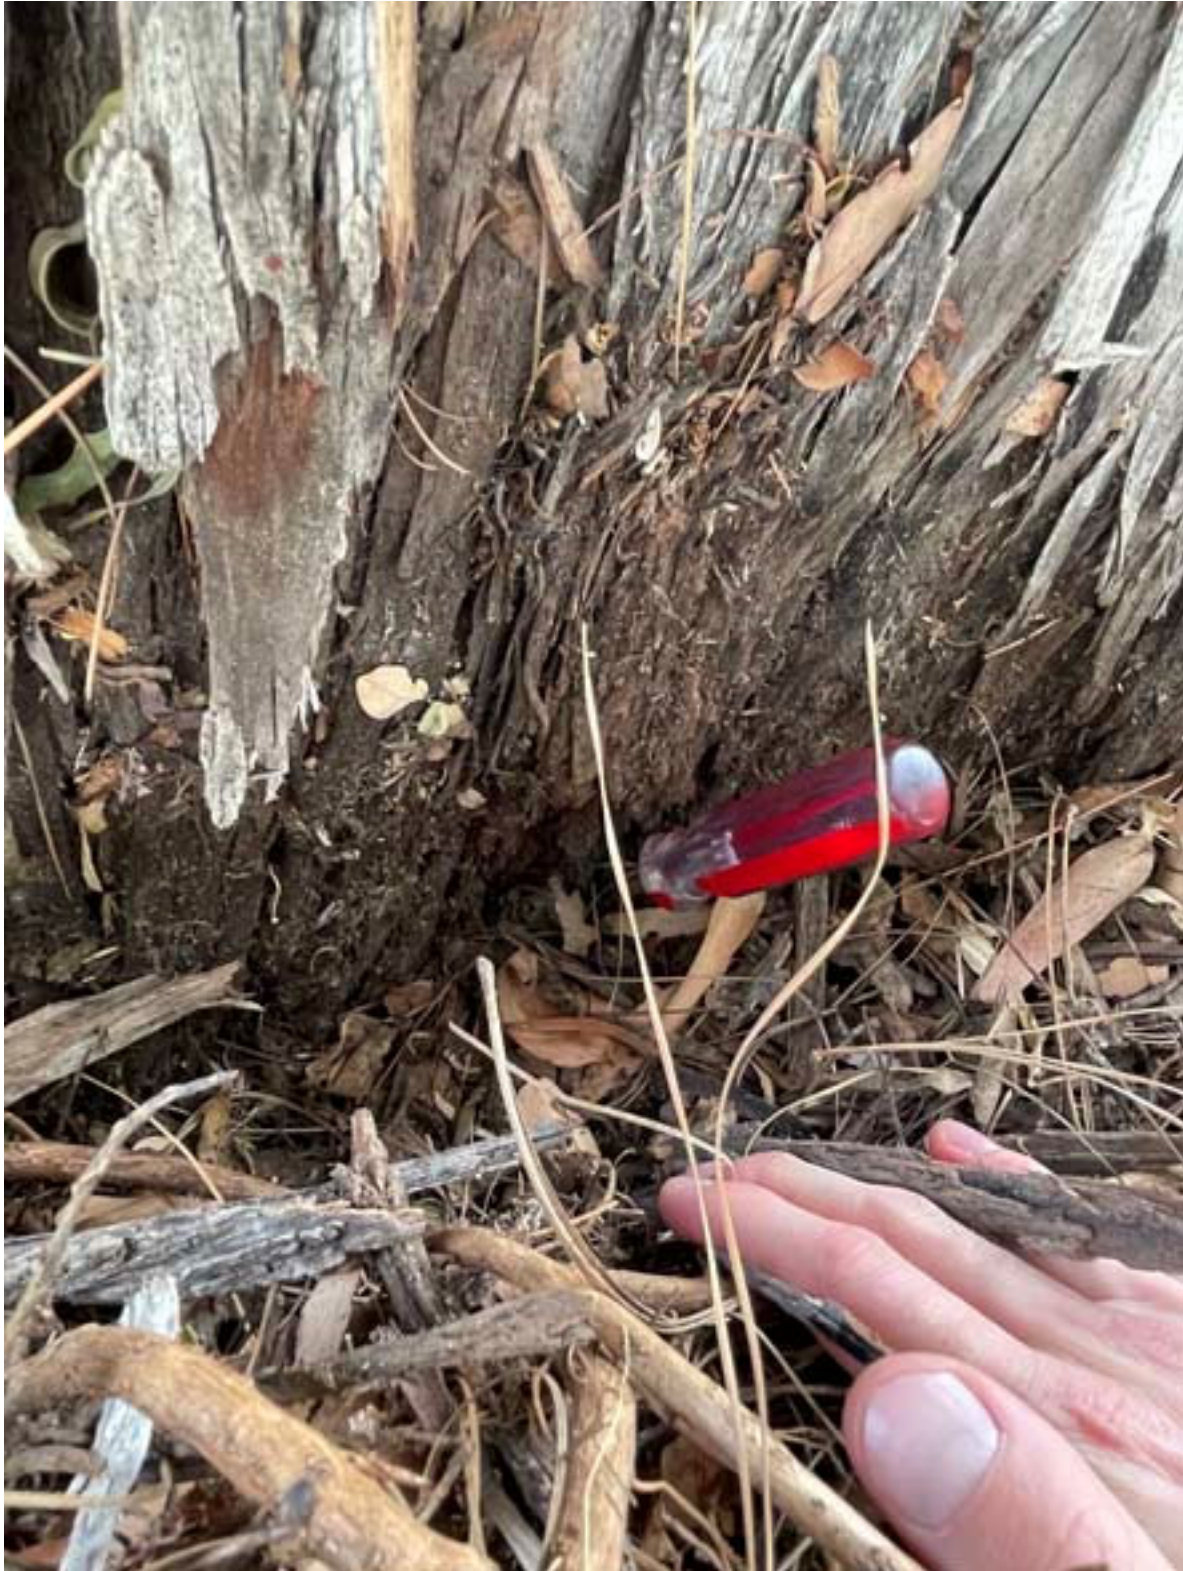
Here, it appears that roughly 6-8 inches of fill soil was added around the base of the tree at some point between 2007 and 2012. Using a flathead screwdriver as a probe, I tested several areas around the root crown of the tree by pressing the probe into the trunk and then into the adjacent soil. On the eastern side of the root crown, I was able to insert the probe into the trunk a few inches after applying some force (Figure 11). This indicates that some decay is present, but that the decay is not at an advanced stage. In the other areas I tested, I was not able to insert my probe into the trunk below the bark.

I observed that the root crown transition zone was buried. Ordinarily, the area where the trunk transitions into horizontal roots should be found partially above grade. Here, it was buried by soil. When I inserted my probe into the soil parallel to the trunk, I did not contact buttress roots within the top few inches of the soil. As part of the scope of this inspection, I did not perform a root collar excavation, so I did not determine the depth of the fill soil. However, my observations from the Google Street View imagery from 2007 and 2012 indicate that the fill soil is approximately 6-8 inches deep.

- *Whole Tree*: The likelihood of the whole tree failing within a one year time frame is *possible*. It is unlikely to fail in normal weather, but it may fail in extreme weather conditions. I observed there was decay present at the base of the tree, likely resulting from the fill soil applied between 2007 and 2012 and the history of turfgrass irrigation. Based on my observation of sound wood within about 2 inches of the surface, I determined that the decay was not in advanced stages.
- *4" to 6" Branch*: After the 2014 topping, new response growth emerging from the topping cuts was weakly attached. These 7 year-old weakly attached branches are approximately 4"-6" in diameter. The likelihood of one of these branches failing within the next one year is *possible*. One of these branches is unlikely to fail in normal weather conditions, but one could fail in extreme weather.

Figure 11: I was able to insert a probe approximately 2 inches into the root crown of the tree. This indicates the presence of some amount of decay at the base of the tree.

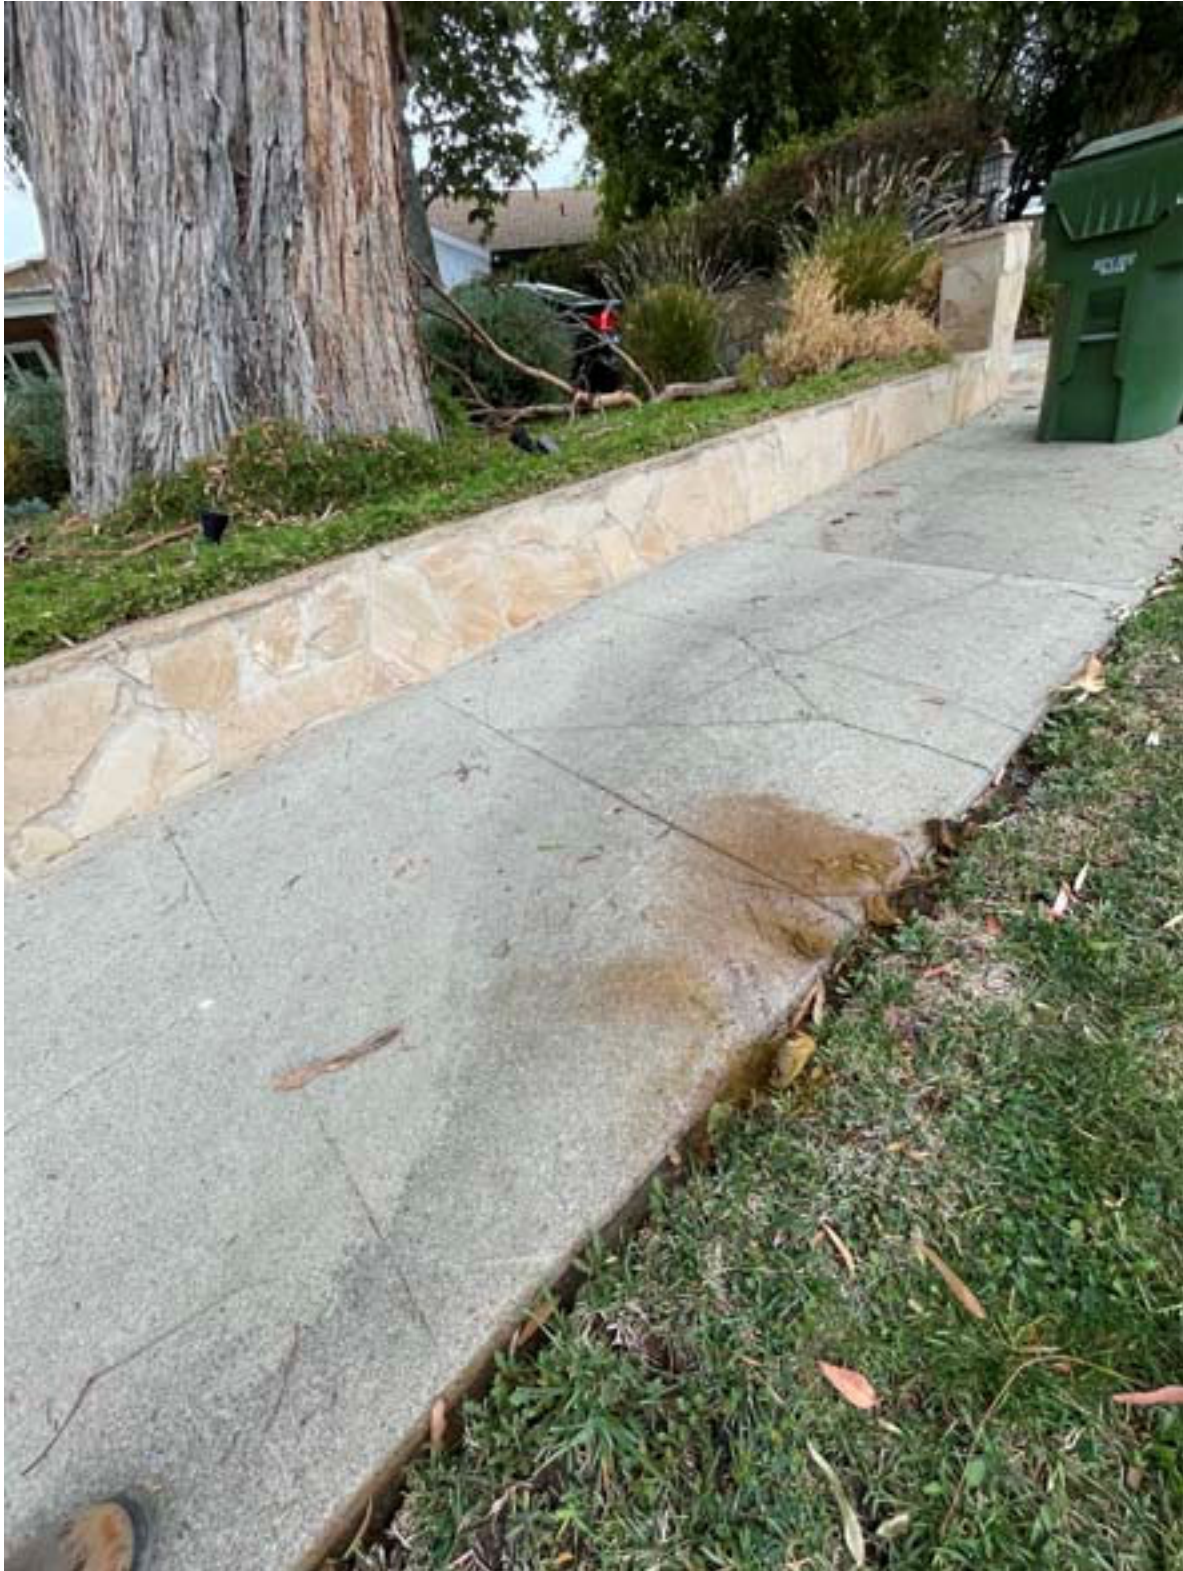
At three places around the tree within 12 feet of the trunk, I observed fungal fruiting bodies of *Pisolithus tinctorius*, the “dead man’s foot” fungus (Figures 12 and 13). This fungus is not a harmful a root rot fungus. Rather, it is a beneficial mycorrhizal fungus that has a symbiotic relationship with tree roots. The fungus colonizes small feeder roots and helps them absorb water and minerals from the soil; then the tree provides photosynthates for the fungus. The presence of this fungus did not affect the outcome of the risk assessment for this tree.

Figure 12: I observed three fungal fruiting bodies of *Pisolithus tinctorius* fungus within about 12 feet of the trunk of the tree.

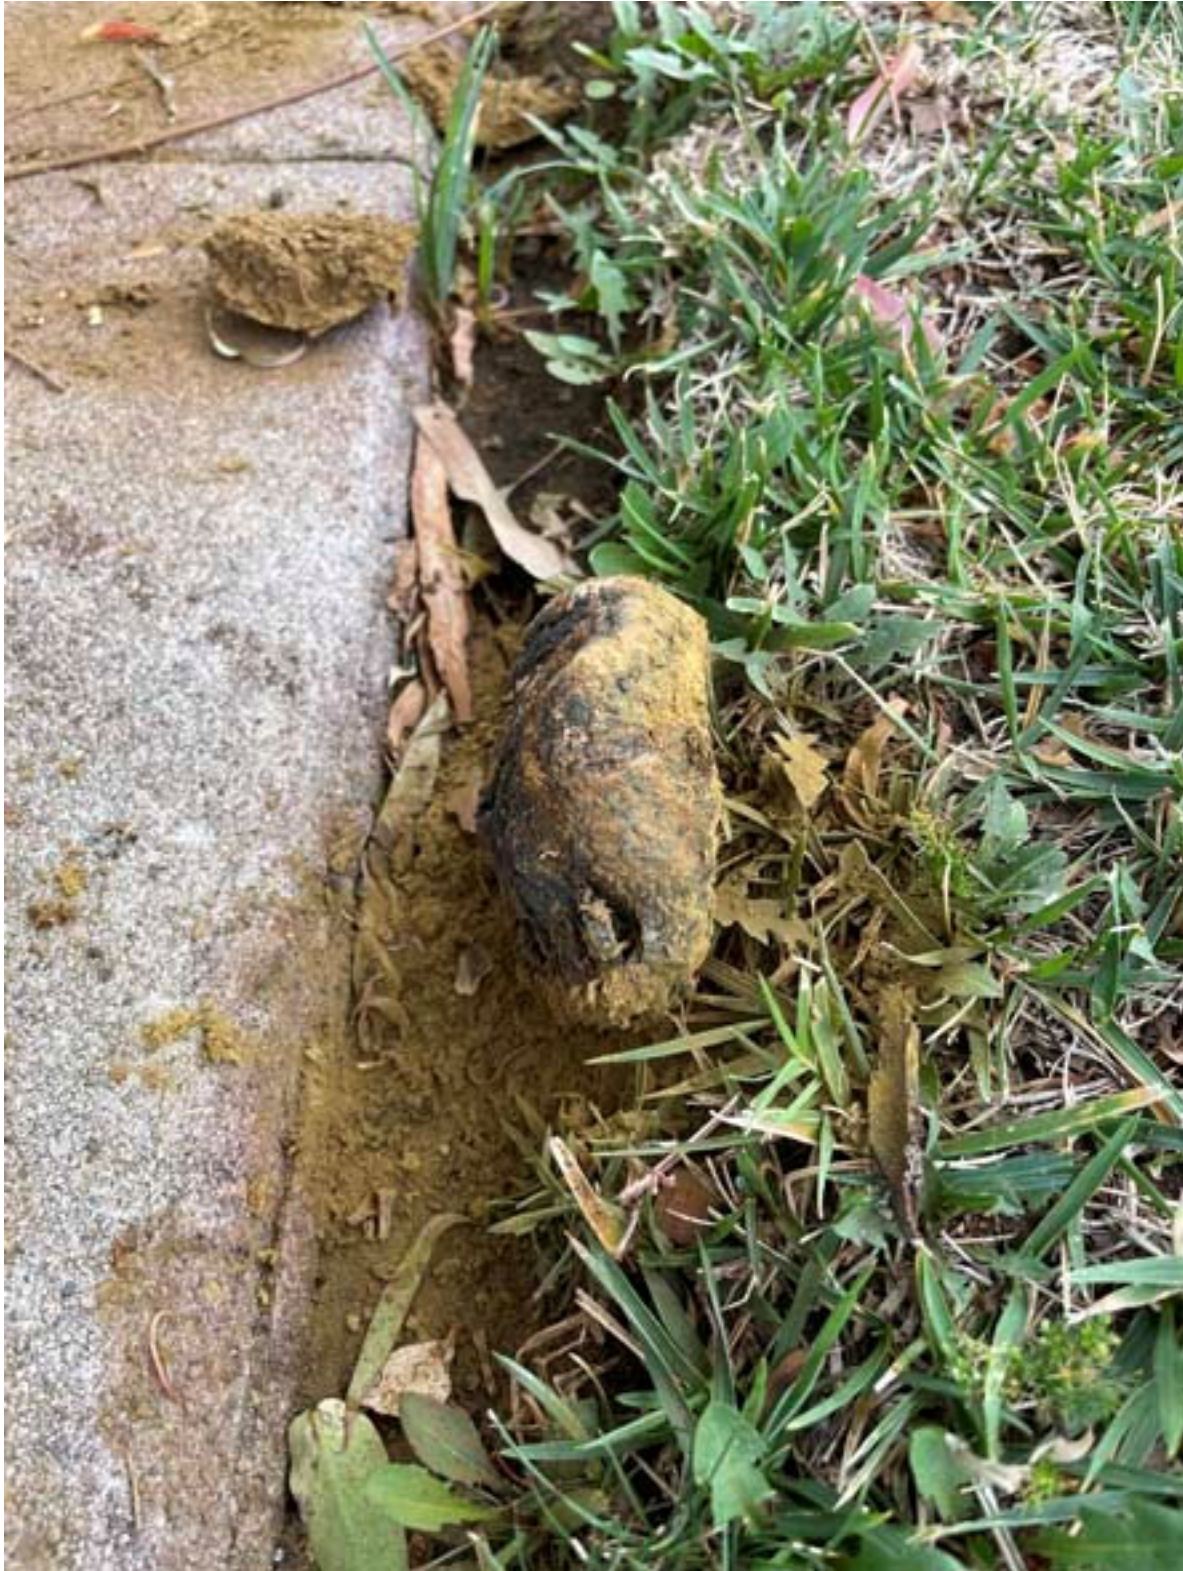
Figure 13: Close up of one of the fungal fruiting bodies I observed.

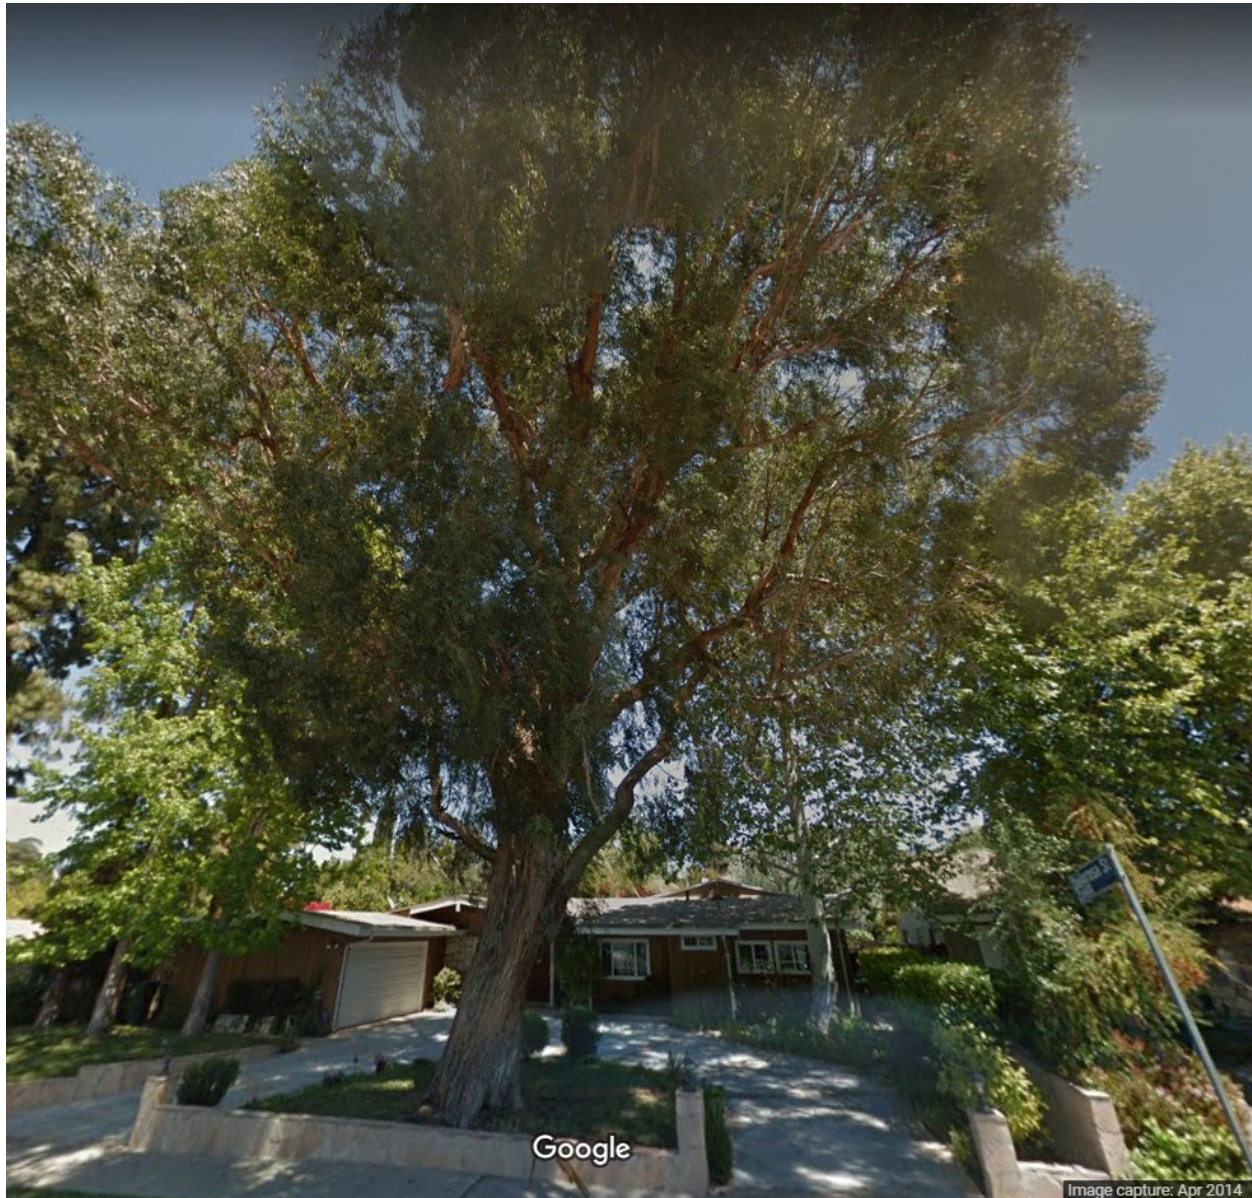
At some point between April and August of 2014, the tree was topped by a prior owner at a height of approximately 40 feet. I observed Google Maps Street View imagery of the tree on each of those dates, and the tree had been topped in the August imagery (Figure 15) and not in the April imagery (Figure 14). Over the following seven years, the tree resprouted from the 2014 topping cuts. The response growth shoots grew out of the perimeter of the parent branches, resulting in weak attachments (Figures 9 and 10). Instead of developing alternating and interlocking layers of new wood at their unions, they pressed up against the stubs of the parent stems. New union wood did not develop in this area of contact between the two stems, resulting in weak attachments. This process occurred in many parts of the trees as a direct result of the 2014 topping cuts.

Figure 14: Google Street View image of the subject property, taken in April 2014, before the topping cuts.

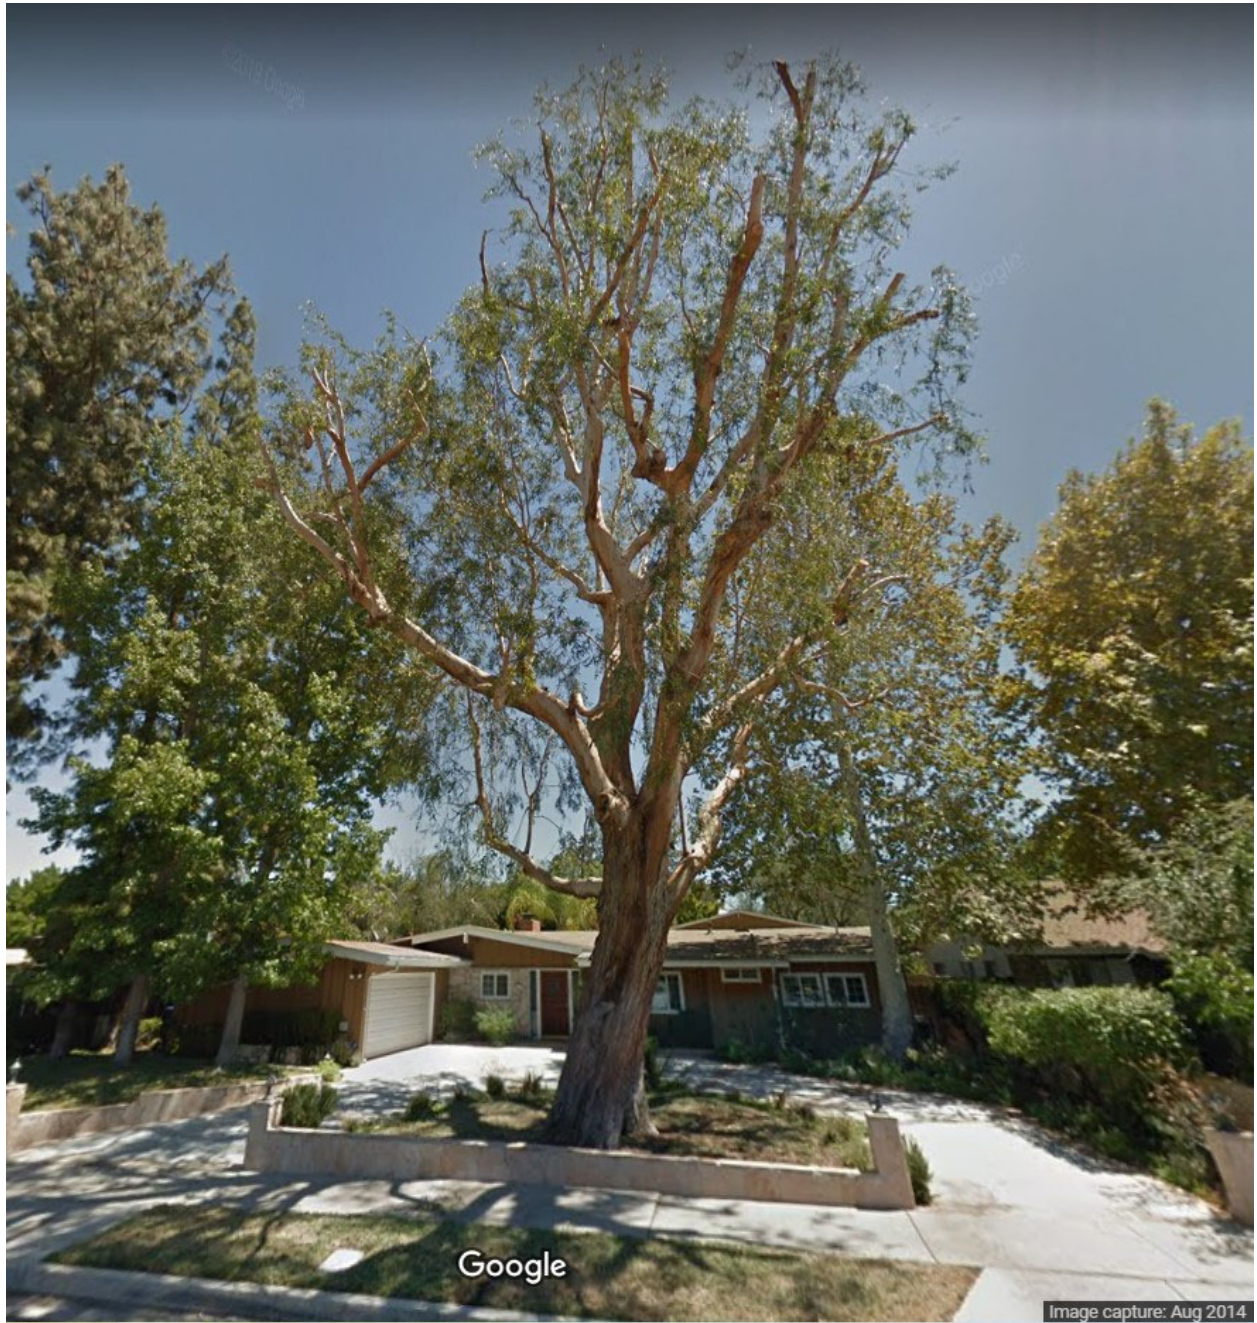
Figure 15: Google Street View image of the subject property, taken in August 2014, after the topping cuts.

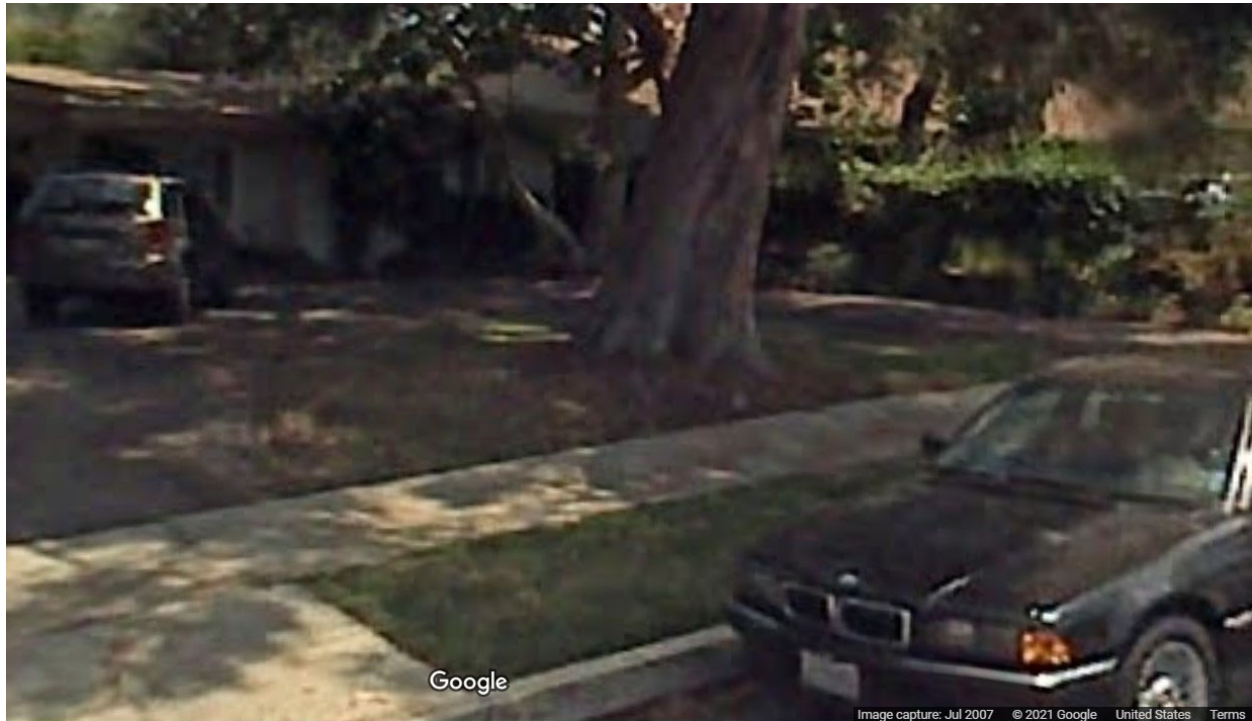
The tree had a history of disturbances around its base. I observed that landscape improvements were made in the yard between 2007 and 2012 by inspecting Google Maps Street View imagery. In July 2007, the front yard did not have a garden wall, and the soil was relatively level with the sidewalk (Figure 16), but in July 2012, the front yard had been raised by the addition of fill soil, and a garden wall had been erected along the front sidewalk (Figure 17). Moreover, the turfgrass appeared greener, indicating more frequent irrigation. Turfgrass irrigation was maintained through at least March of 2019, which was the most recent Google Street View image of the tree, showing healthy grass.

Figure 16: Google Street View image of the subject property, taken in July 2007, before landscaping and fill soil were added around the base of the tree.
