Class One Arboriculture Inc.

***** Ave. – TREE RISK ASSESSMENT

James Komen, Class One Arboriculture Inc.

September 6, 2021

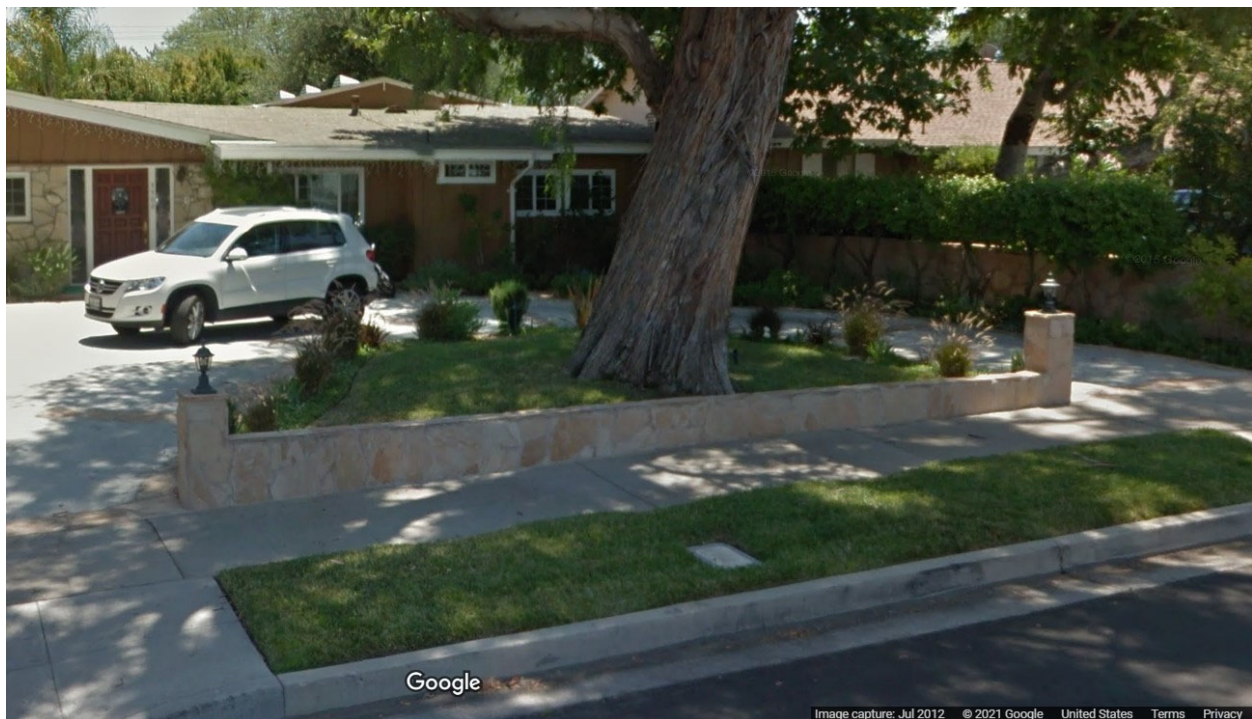
The tree had a history of disturbances around its base. I observed that landscape improvements were made in the yard between 2007 and 2012 by inspecting Google Maps Street View imagery. In July 2007, the front yard did not have a garden wall, and the soil was relatively level with the sidewalk (Figure 16), but in July 2012, the front yard had been raised by the addition of fill soil, and a garden wall had been erected along the front sidewalk (Figure 17). Moreover, the turfgrass appeared greener, indicating more frequent irrigation. Turfgrass irrigation was maintained through at least March of 2019, which was the most recent Google Street View image of the tree, showing healthy grass.

Here, it appears that roughly 6-8 inches of fill soil was added around the base of the tree at some point between 2007 and 2012. Using a flathead screwdriver as a probe, I tested several areas around the root crown of the tree by pressing the probe into the trunk and then into the adjacent soil. On the eastern side of the root crown, I was able to insert the probe into the trunk a few inches after applying some force (Figure 11). This indicates that some decay is present, but that the decay is not at an advanced stage. In the other areas I tested, I was not able to insert my probe into the trunk below the bark.

Figure 17: Google Street View image of the subject property, taken in July 2012, after landscaping and fill soil were added around the base of the tree.
