Class One Arboriculture CA Lic. #982988 2832 Manhattan Ave Glendale, CA 91214 Phone: (818) 495-5344

April 11, 2017

Per your request, I have prepared a tree risk assessment of the Coast Live Oak (*Quercus agrifolia*) along the northeast property line at 2861 Piedmont Ave., Glendale, CA 91214. I have concluded that *the risk posed by the tree over the next three year time frame is low*.

2861 Piedmont Ave. – TREE RISK ASSESSMENT James Komen, Class One Arboriculture Inc. April 11, 2017

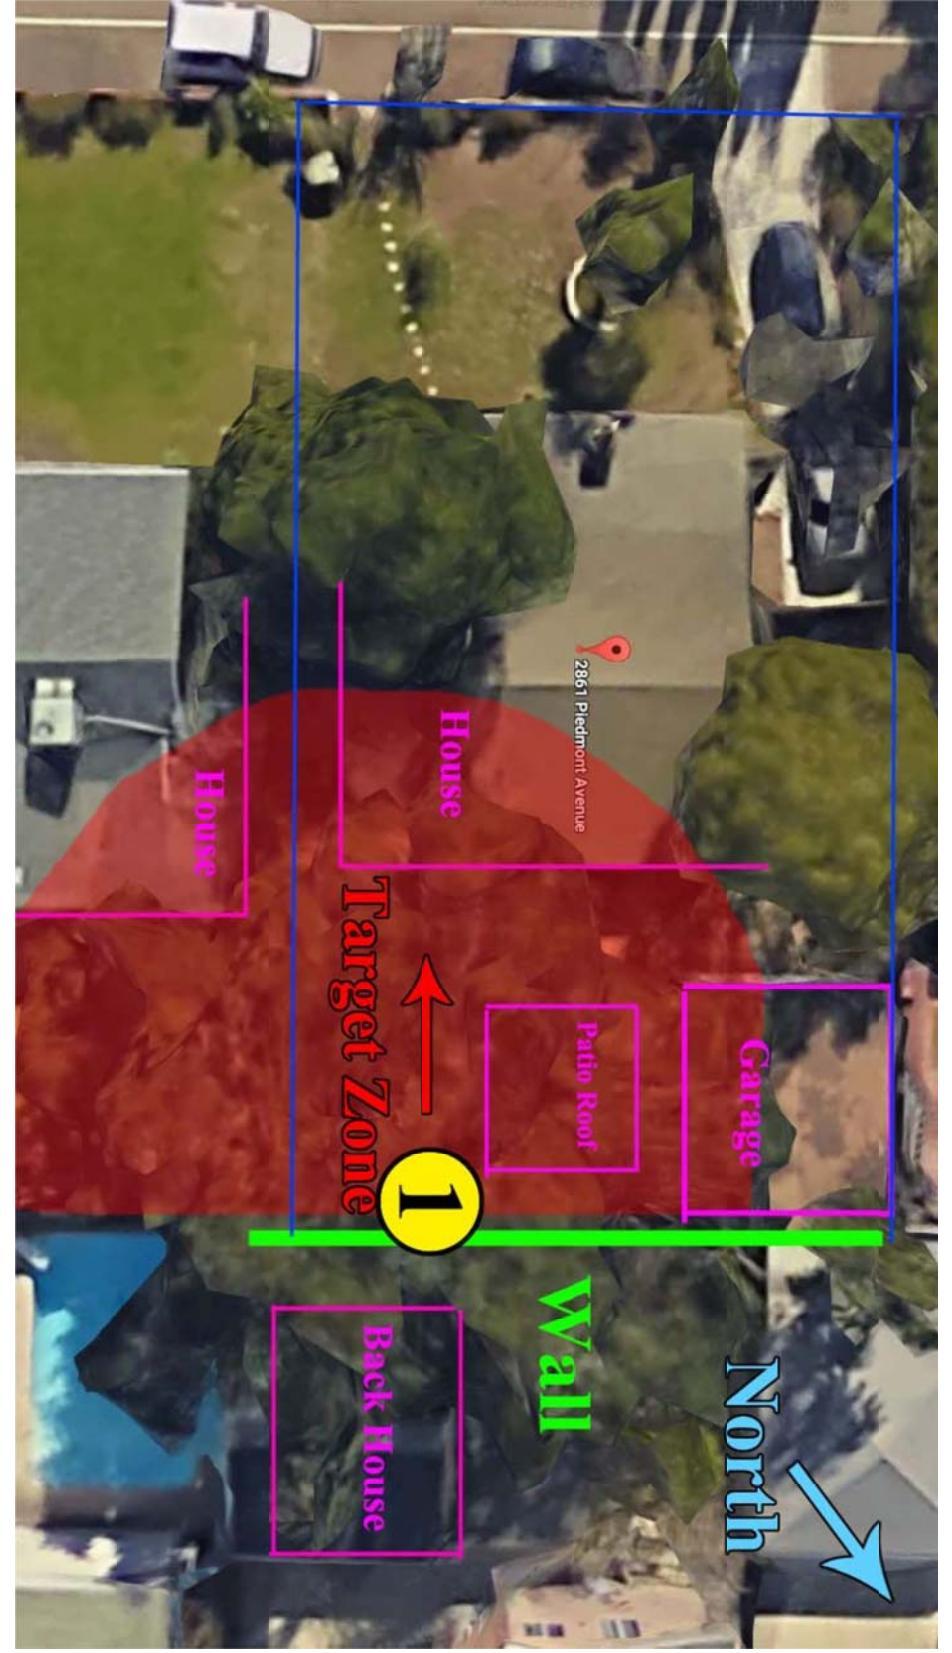
The likelihood of the whole tree impacting your house and the house to the southeast if the tree were to fail is *high*. If it were to fail, the tree may be expected to impact these targets. The direction of fall is determined by the prevailing lean and center of gravity to the southwest. The likelihood of a 4" branch impacting your house if it were to fail is *high*. The scaffold branches I assessed are growing directly over the house, and they may be expected to impact the house if they were to fail. The likelihood of a 2" dead branch impacting the back house to the northeast is *medium*. The deadwood is approximately distributed between 50% over the back house and 50% not over the back house, so if a dead branch were to fail, it would be about equally as likely to impact the back house as not.

Figure 3: Site map showing the subject tree, surrounding structures, and anticipated target zone.

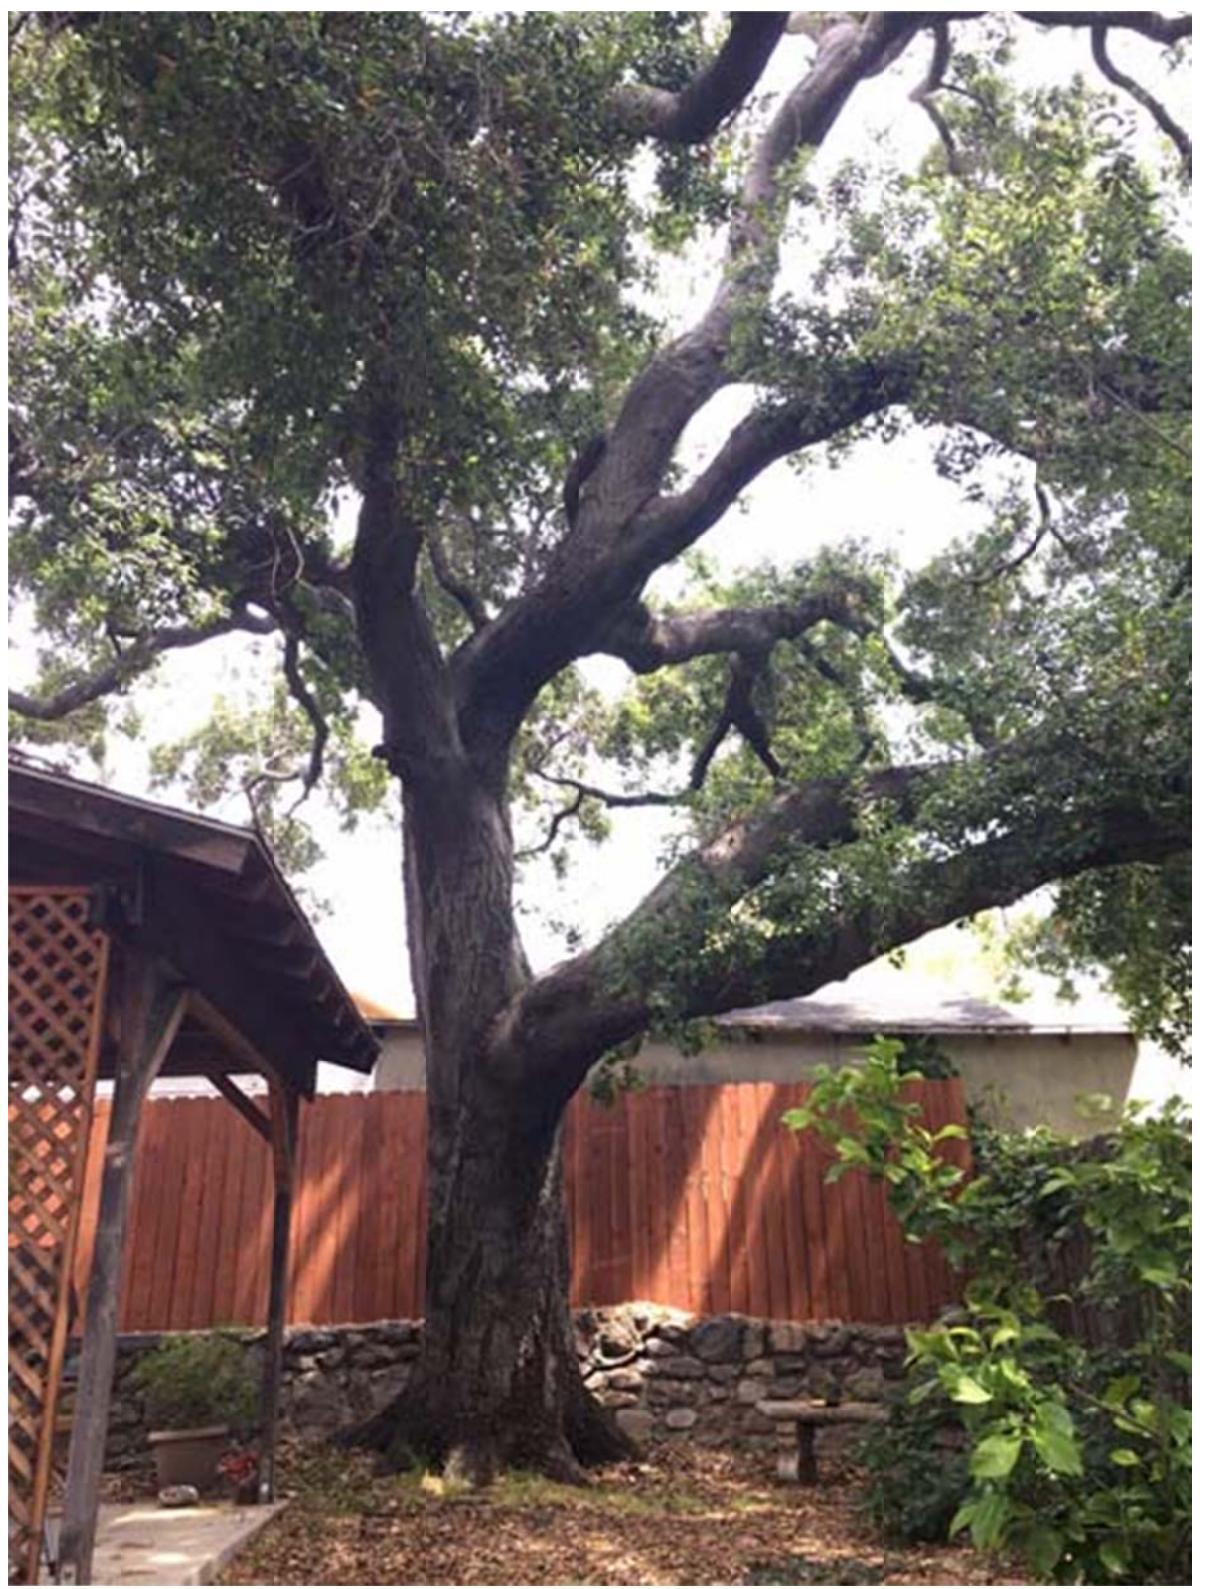
The tree is healthy. There are growth cracks along the trunk and scaffold branches. They appear as brownish to reddish colored cracks, indicating an area of rapid tissue deposition. The canopy is dense, and there is ample new growth. It has a prevailing lean to the southwest, away from the old stone retaining wall and towards your house. The spread of the canopy is so broad that it spans both your roof and part of the roof of the house to the southeast.

Figure 5: Looking northeast at the subject tree. It has a healthy canopy with a broad drip line over several structures.

- Continue to regularly prune the subject tree for clearance over the roofs of all surrounding structures. Clearance should be at least 5 vertical feet above the roof, per City of Glendale fire code. Pruning should take place once every 1-4 years as needed, and cuts should be smaller than 2 inches in diameter. Pruning should be directly supervised by a Certified Arborist.
- 2) If the cracks in the old stone wall behind the tree become aesthetically unattractive, consider repairing the cracks rather than replacing the wall. Repairing the cracks will have a negligible impact on the health and structure of the tree, but replacing the wall may have an impact on both.

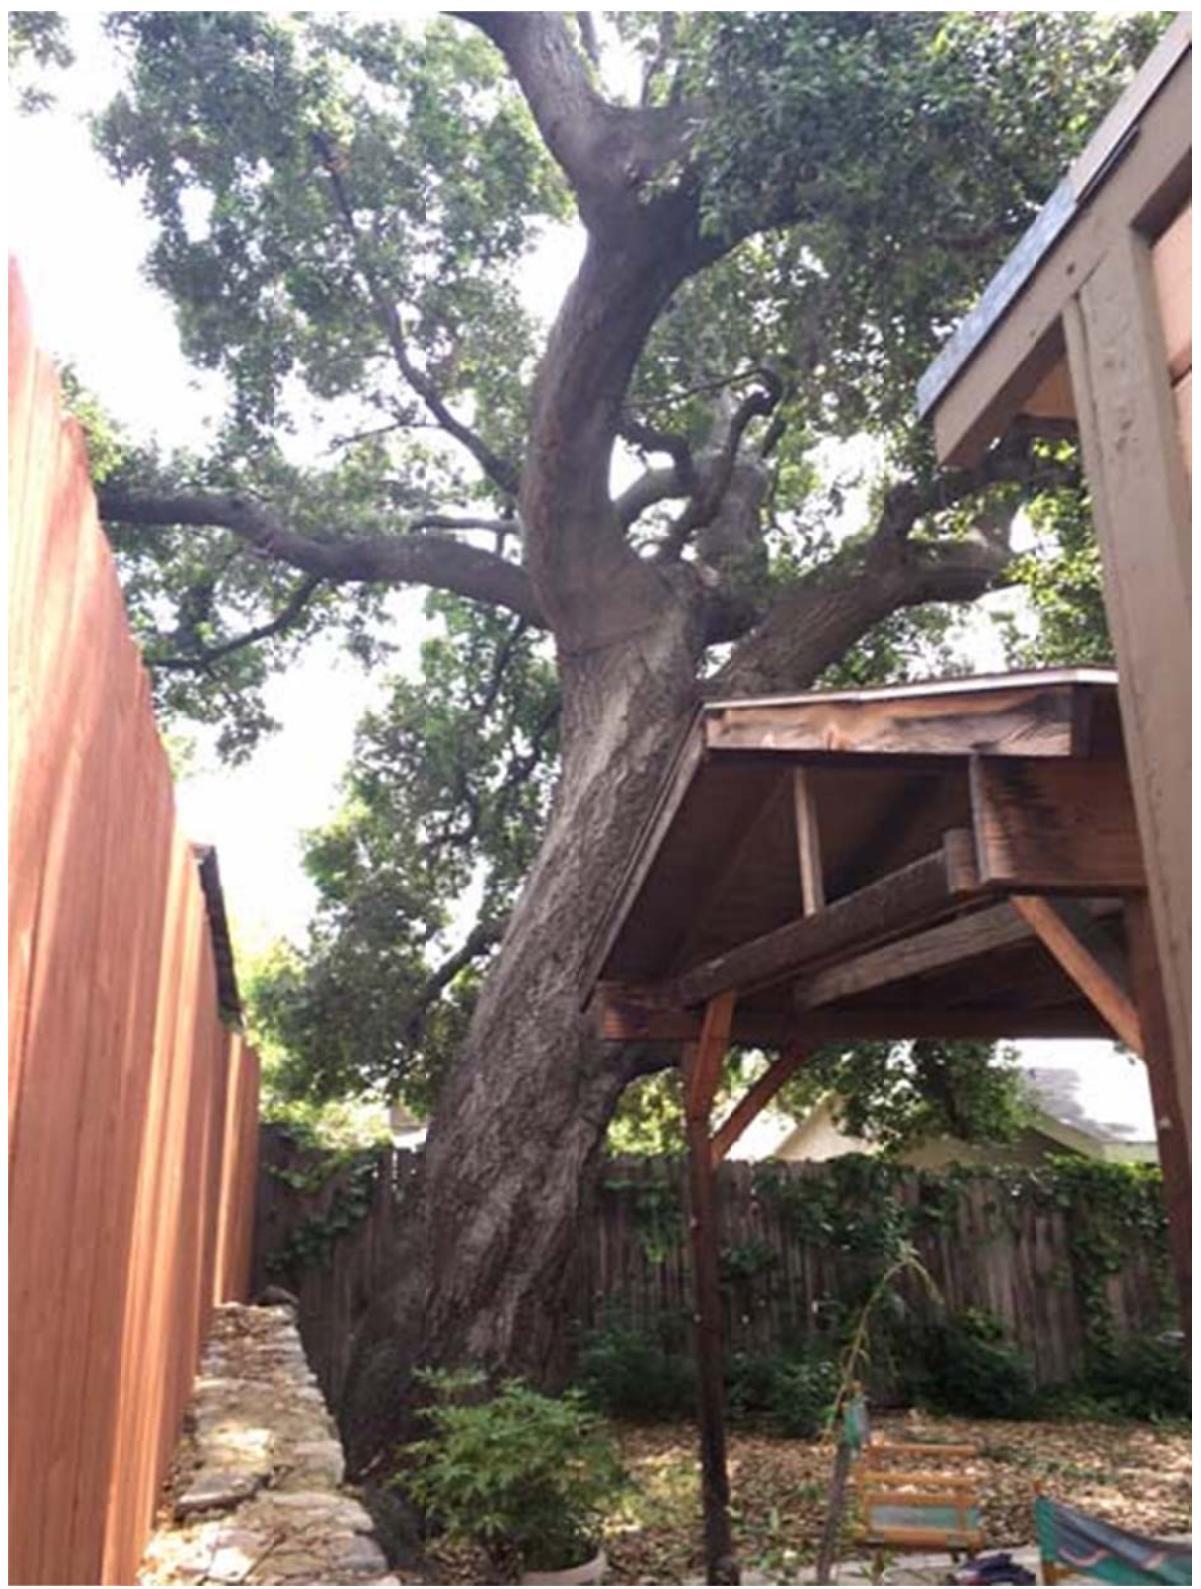
Figure 6: Looking southeast at the subject tree. It is growing in close proximity to an old stone retaining wall. It has a prevailing lean to the southwest.

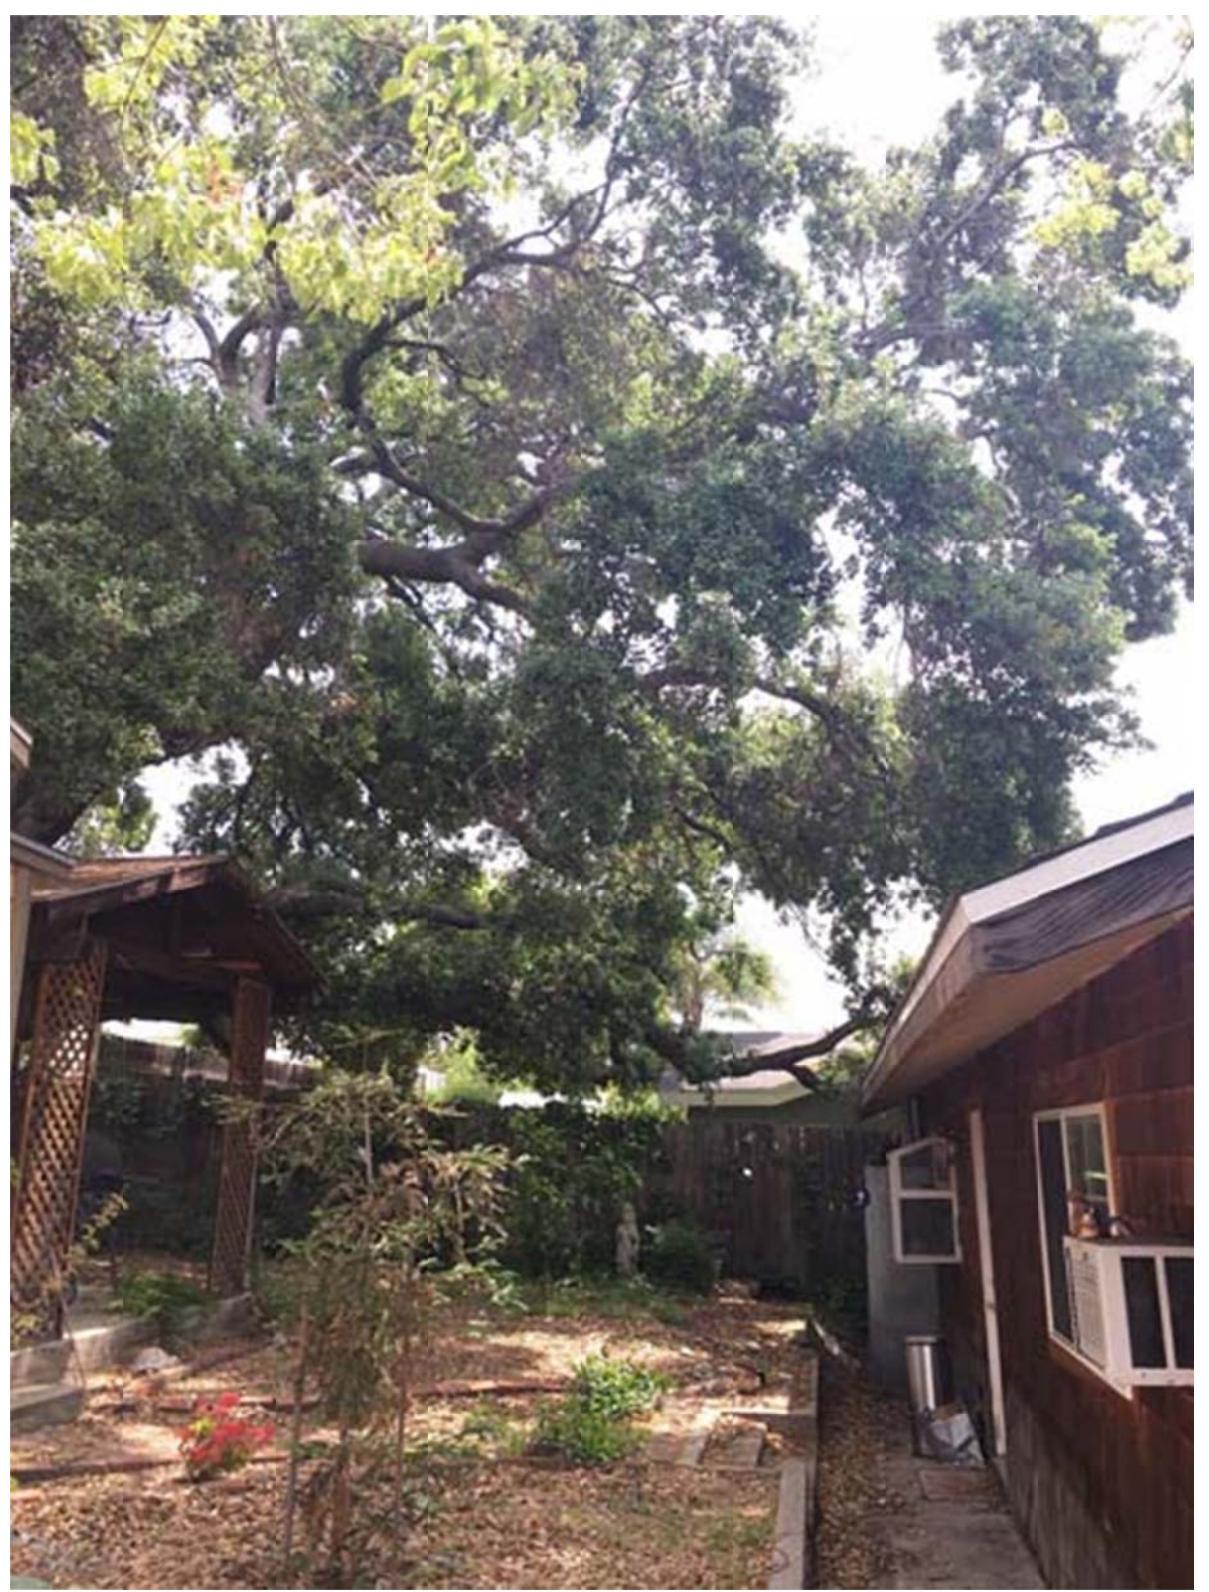
Branches at the extreme southwestern edge of the canopy have begun to grow downward from the lengthy cantilever and rapid recent growth. A few small branches are resting on the roof of your house. It is possible that one or more of the 4" size branches could fail within the next 3 years as a result of recent rapid growth. While weight reduction may reduce likelihood of branch failure, it would also significantly reduce the health of the branches due to loss of foliage. Therefore, I don't recommend this mitigation option. The consequence of such a branch impacting your house would be *minor*.

- *4" Branch*: I rated the likelihood of failure of a 4" branch in the southwestern portion of the canopy as *possible*. There is ample new growth at the extreme southwestern tips, and the rapid increase in canopy weight could potentially cause one of these branches to fail. However, the amount of cantilever within the canopy is well within the tolerable range for the species profile of Coast Live Oak. The consequence of a 4" branch impacting your house would be *minor* property damage. The consequence of impacting a person in the backyard would be *severe*.

Figure 7: Looking southeast at the canopy that overhangs the house at 2861 Piedmont.

- 2) Weight Reduction Pruning: To reduce the likelihood of failure of a 4" branch over your house, you may prune some of the weight off of them. However, a risk mitigation action must take the overall condition of the tree into account. Since the foliage is generally found at the tips of these branches, removing enough foliage to significantly reduce likelihood of failure would cause a significant reduction in the health of those branches. Therefore, this mitigation action is not recommended.

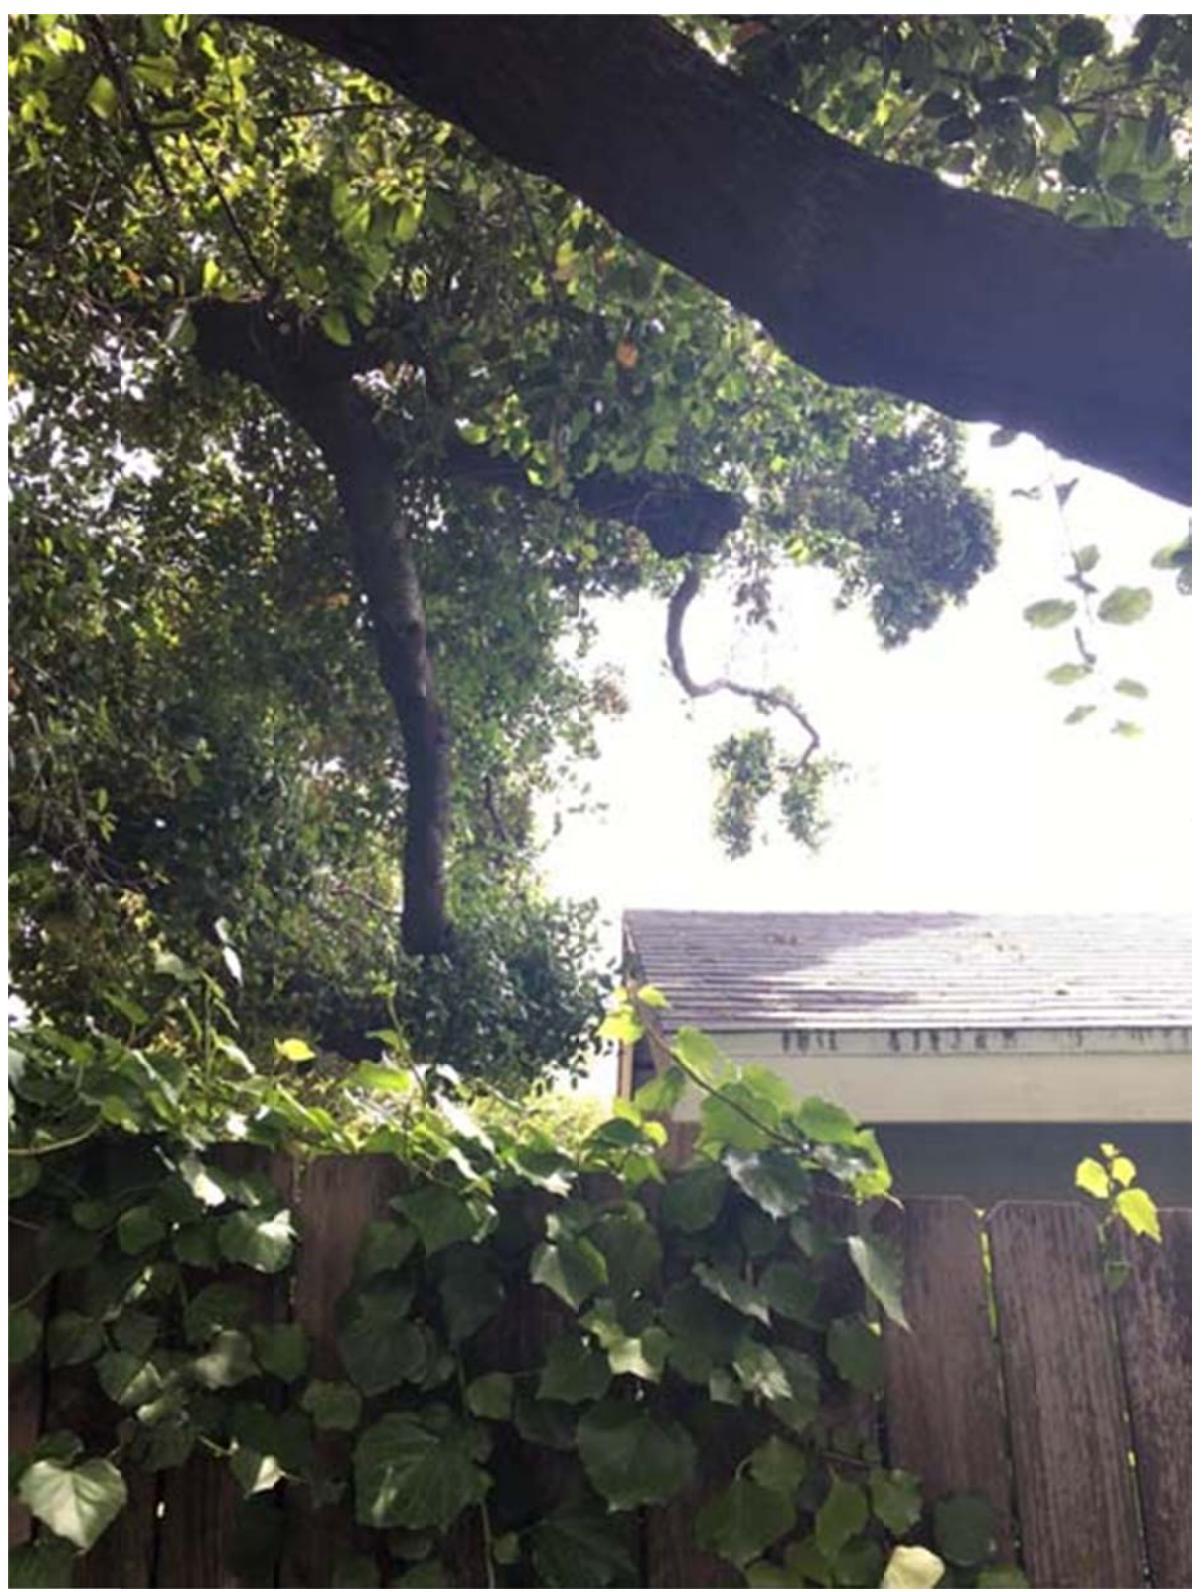
Figure 8: Looking southeast at the canopy that overhangs the house on the property to the southeast.

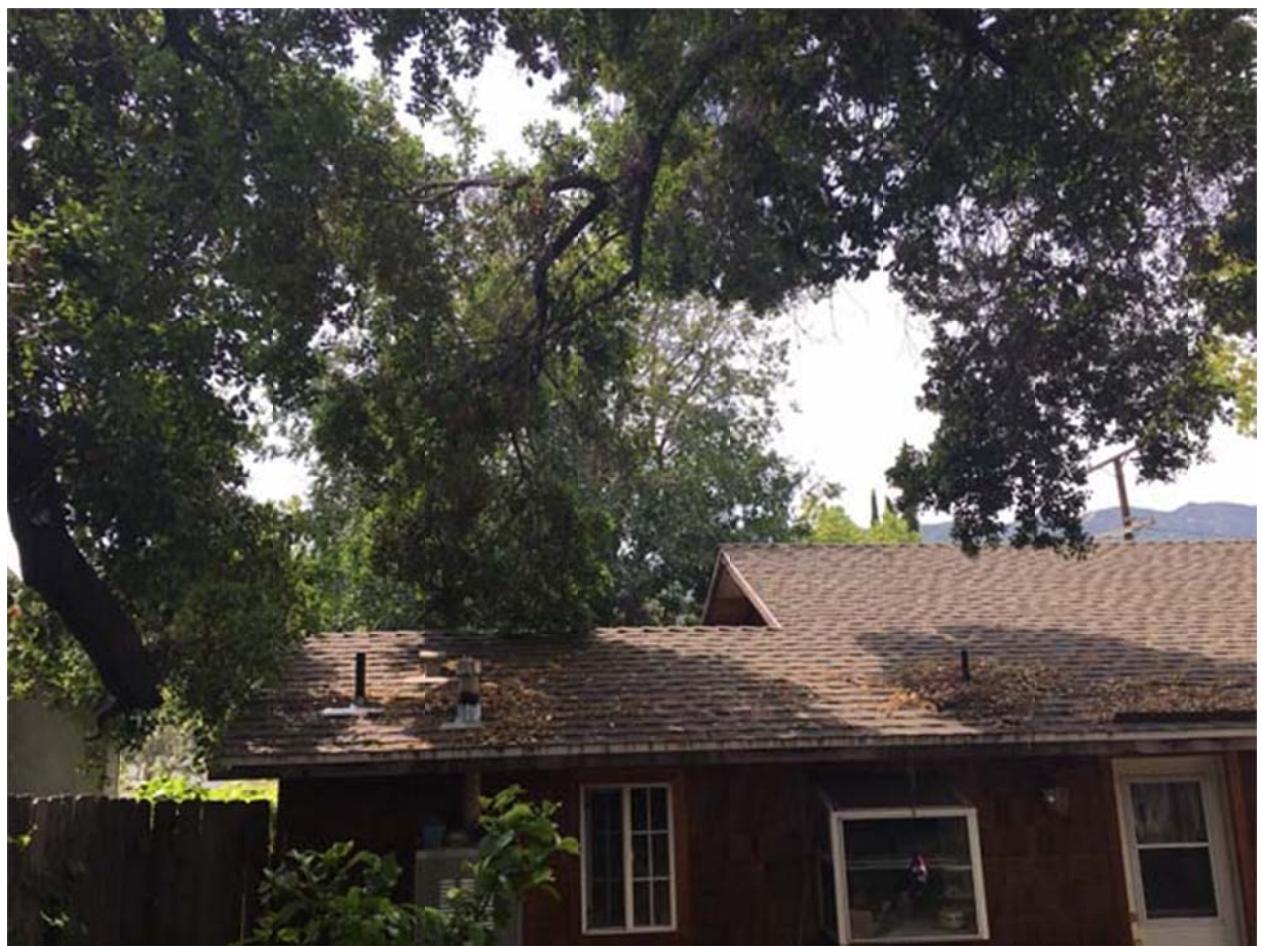
If the whole tree were to fail and impact your house and the neighboring house to the southeast, the consequences would likely be *significant* property damage. The distance of fall for the whole tree would be about 15-20 feet because there are many low branches in the canopy that would cushion the fall and reduce the force of impact. If the whole tree were to fail and impact a person, the consequences would be *severe* personal injury. If a 4" branch were to fail and impact a a person in the backyard, the consequences would be *severe* personal injury. If it were to fail and impact the house, the consequences would be *minor* property damage. If a 2" dead branch were to fail and impact a structure, the consequences would be *negligible* because of the small part size. If it were to fail and impact a person, the consequences would be *minor* personal injury.

Figure 9: Looking southwest from the trunk of the subject tree at the branches overhanging the roof of the house at 2861 Piedmont Ave. If the whole tree were to fall, the distance of fall would be about 15-20 feet.

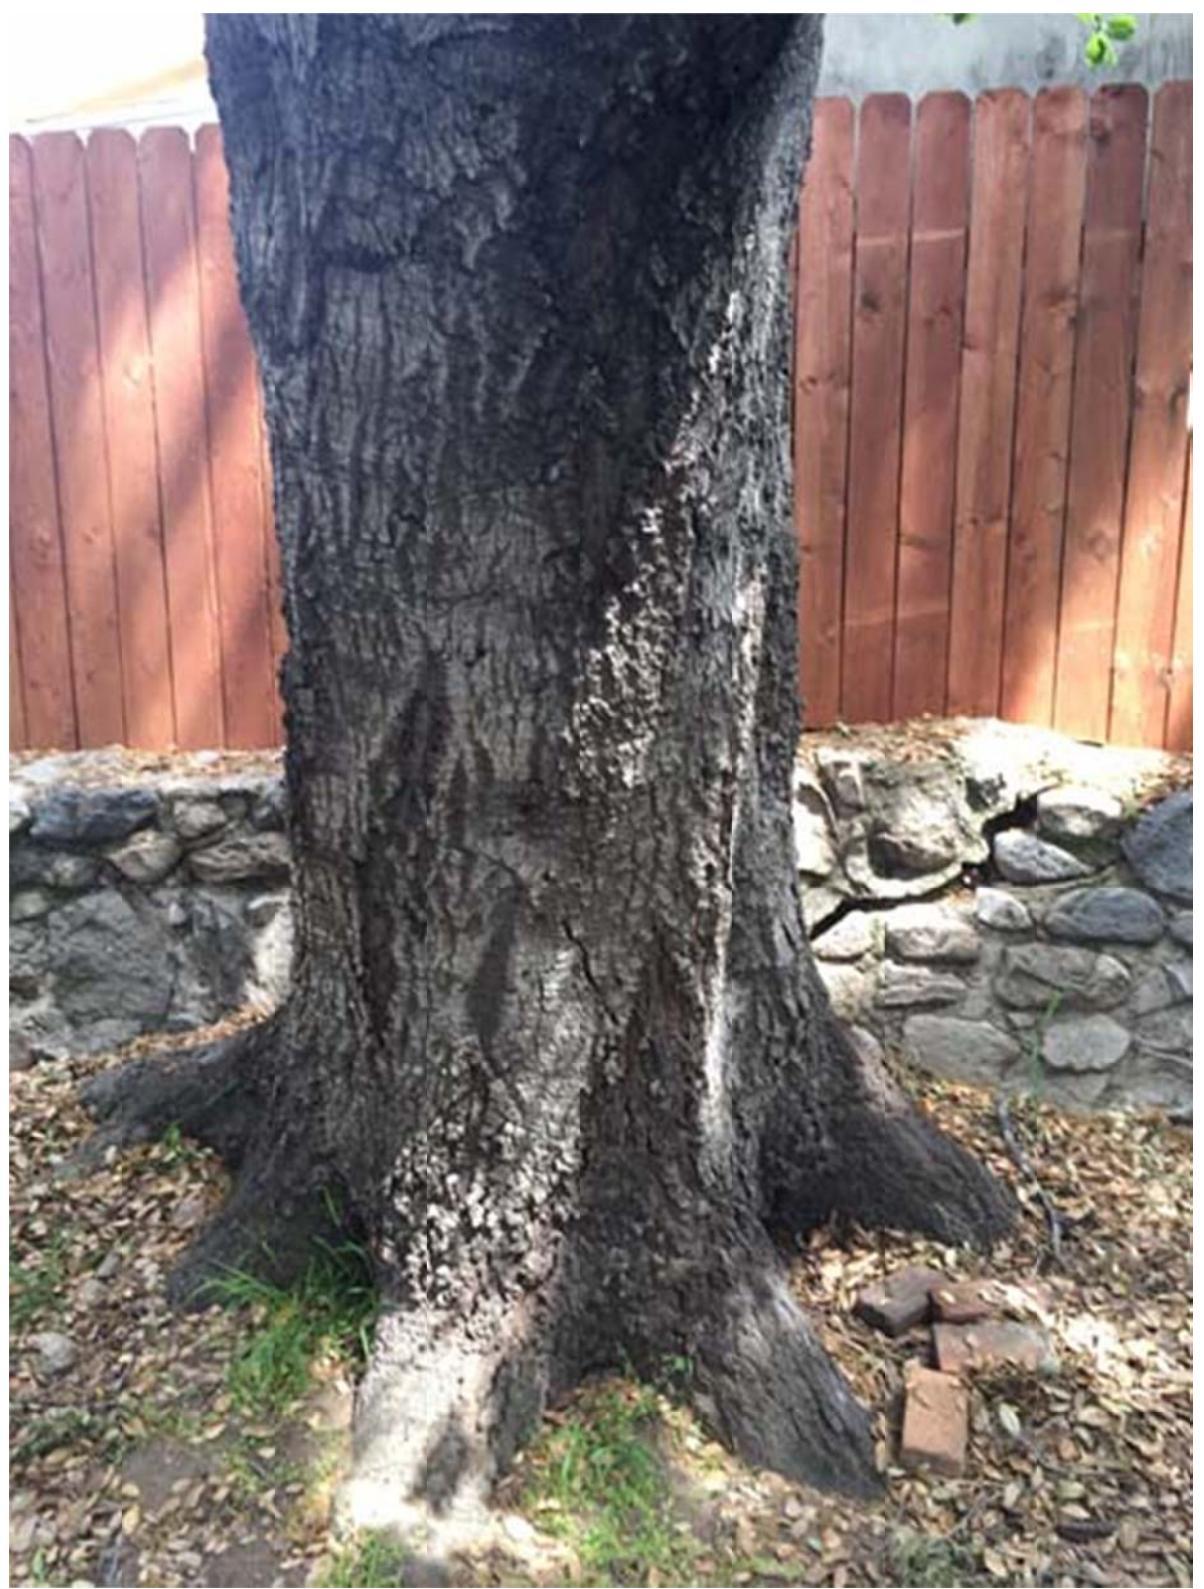
There are several buttress roots on the south and western portions of the root crown that are showing evidence of rapid growth. The additional tissue that the tree is depositing is a response to the static loads applied from its prevailing lean to the southwest. Response growth such as this compression wood reduces the tree's likelihood of failure.

- Whole Tree: I rated the likelihood of whole tree failure at the root crown as *improbable*. It is not likely to fail within the assessed time frame, even in extreme weather conditions. There is significant response growth around the trunk, reducing the likelihood of failure. The consequence of impacting a structure would be *significant*, and the consequence of impacting a person would be *severe*.

Figure 10: Looking northeast at the trunk of the tree. Buttress roots are showing evidence of compression wood in response to the static loading of the weight of the tree, reducing the likelihood of whole tree failure.

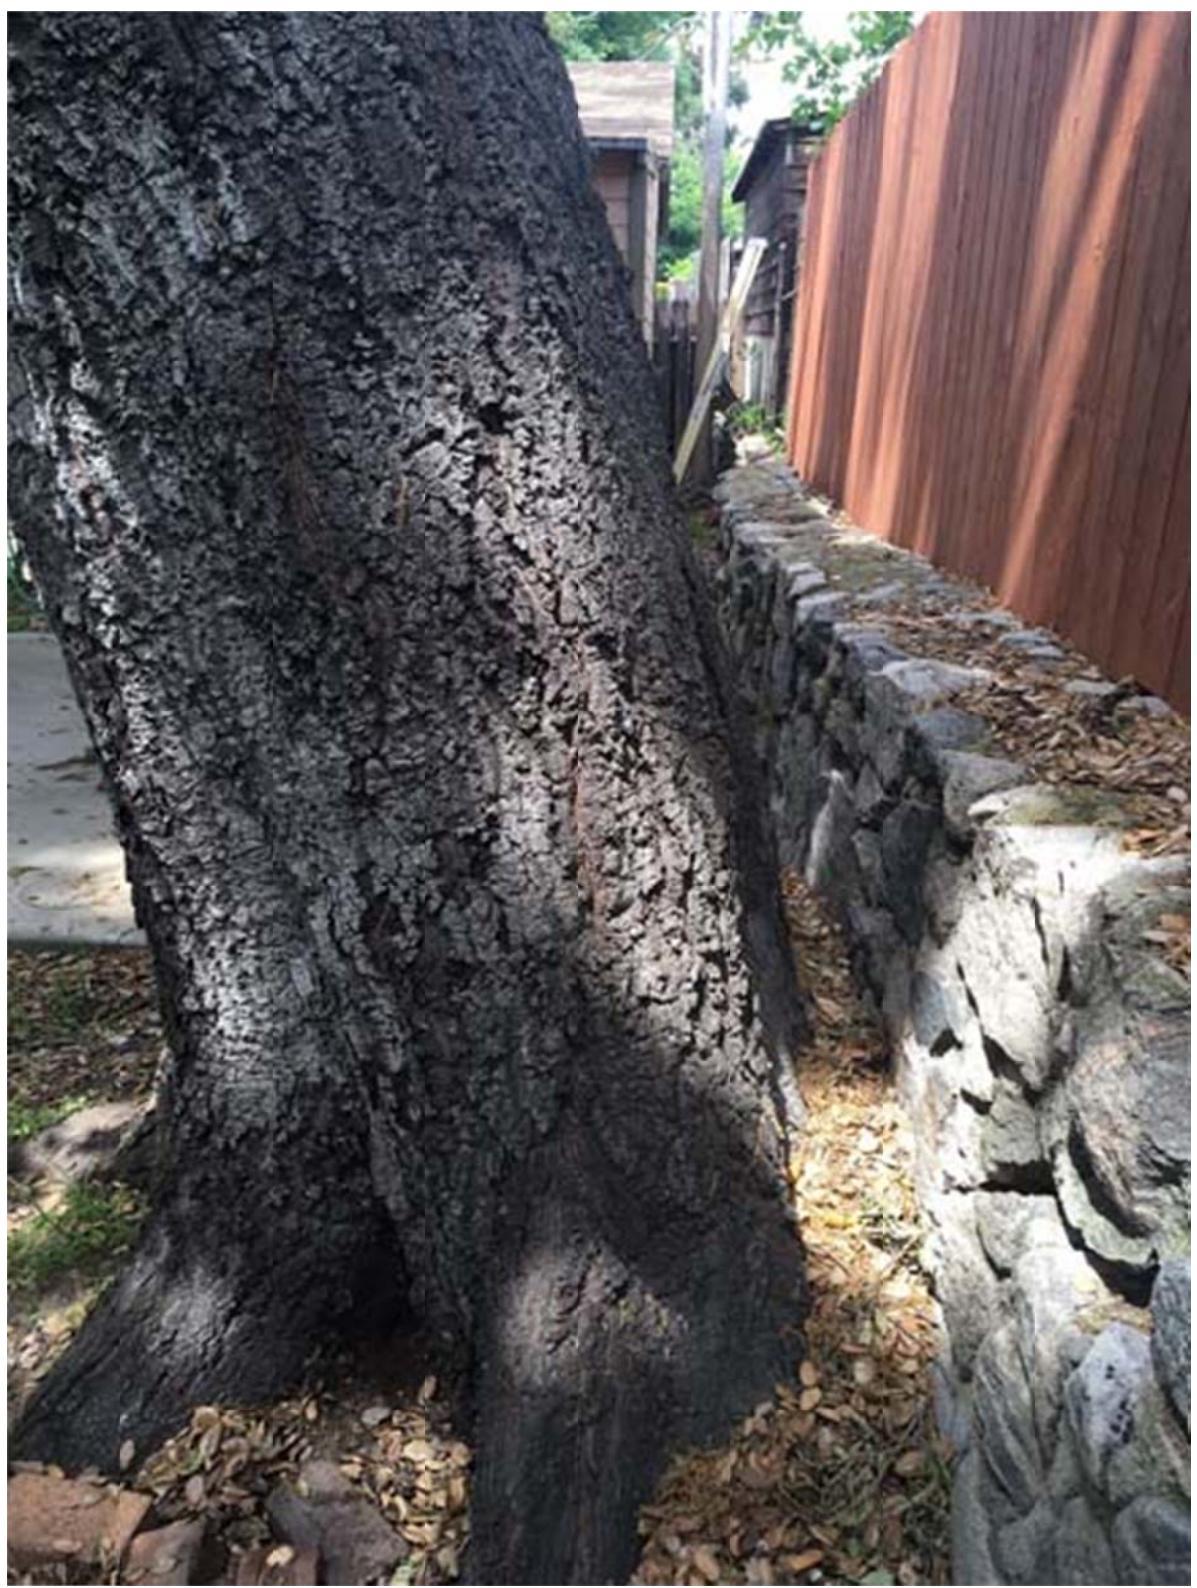
The expansion of the trunk and root crown over time has caused the old stone retaining wall northeast of the tree to crack. The cracking is evidence of the presence of roots under and around the wall's footing. The more healthy structural roots that are present on the northeast side of the wall, the lower the likelihood of whole tree failure at the root crown. Although I did not perform any excavation, I estimated that the roots of the subject tree are growing under the retaining wall and into the property to the north, anchoring the tree with static forces opposing its prevailing lean.

Figure 11: Looking northwest at the trunk of the subject tree. It is within six inches of an old stone retaining wall. The wall is cracking from the expansion of the trunk and root crown.

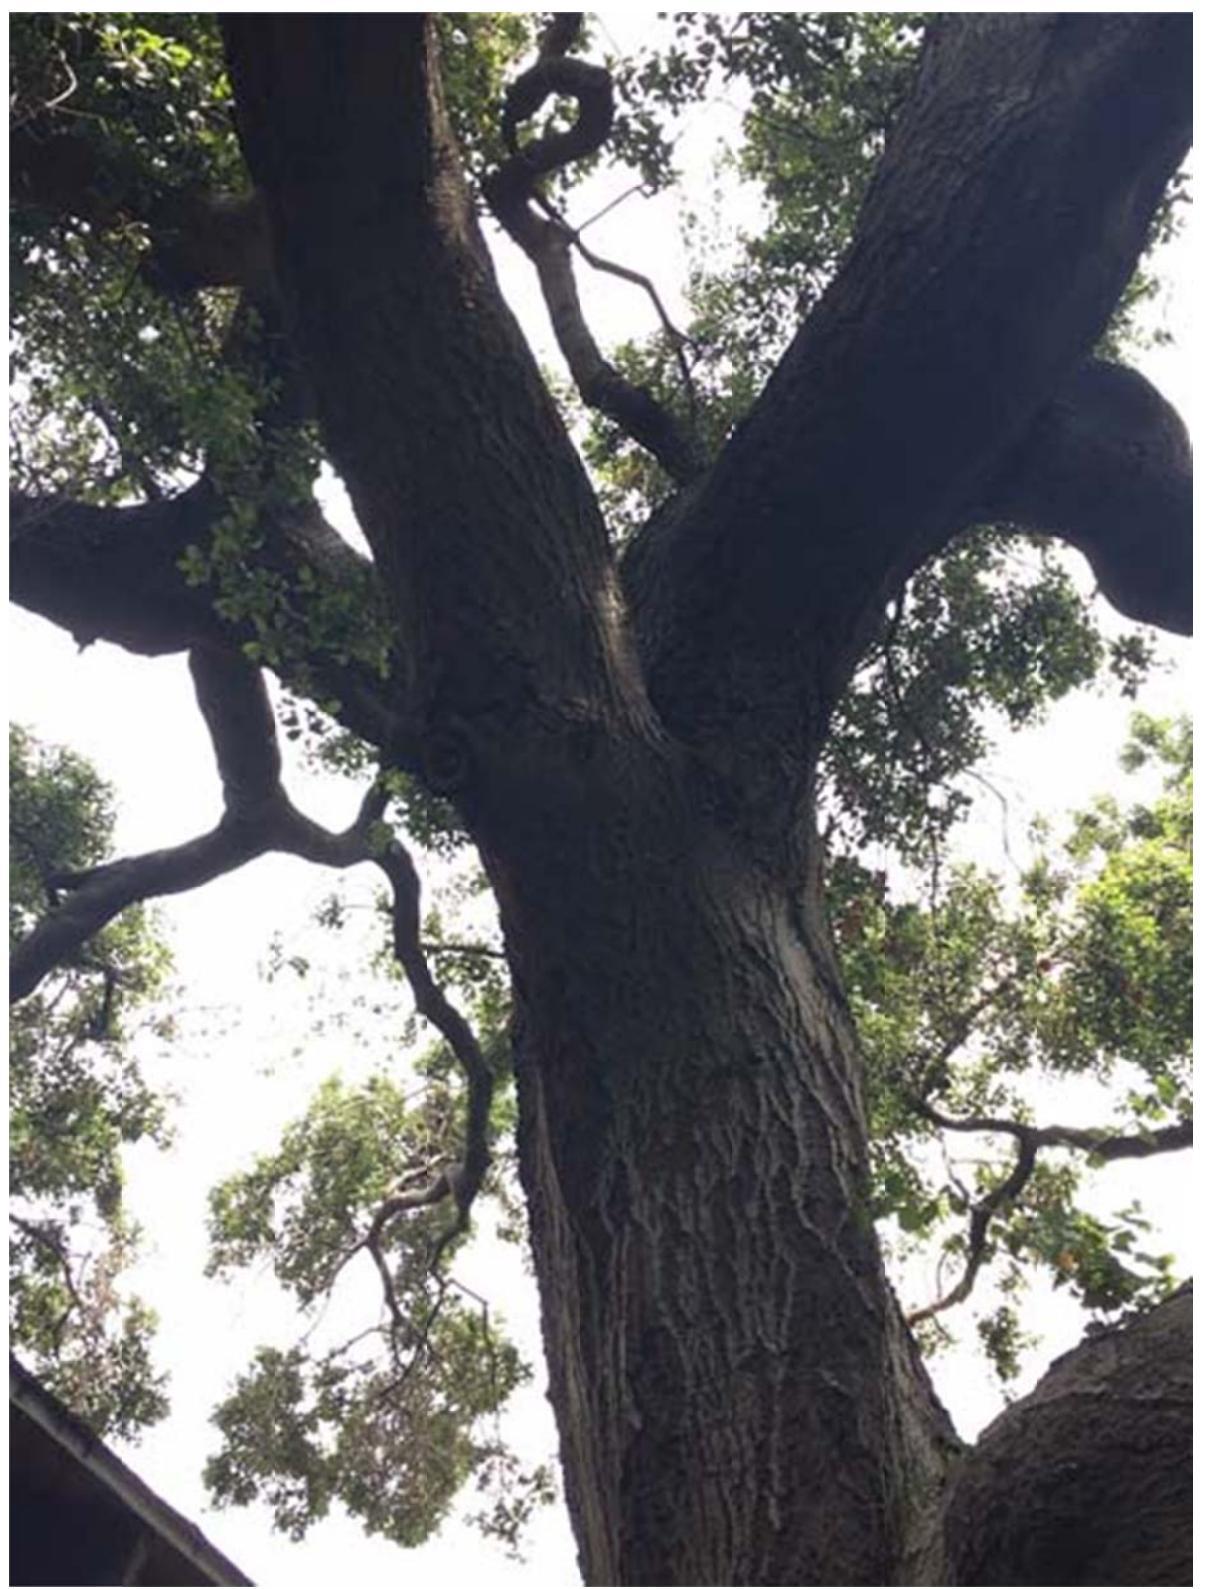
Figure 12: Looking up at a southwest-facing scaffold branch. There are many growth cracks on the branch, indicating the tree is healthy.
