Class One Arboriculture CA Lic. #982988 2832 Manhattan Ave Glendale, CA 91214 Phone: (818) 495-5344

April 10, 2017

I am writing to summarize the results of my site visit to \*Redacted\*. After viewing 17 trees along the western side of the subject property, I can conclude that *Tree 15 poses a moderate risk* within a one year time frame, and *the other assessed trees have a low risk rating*.

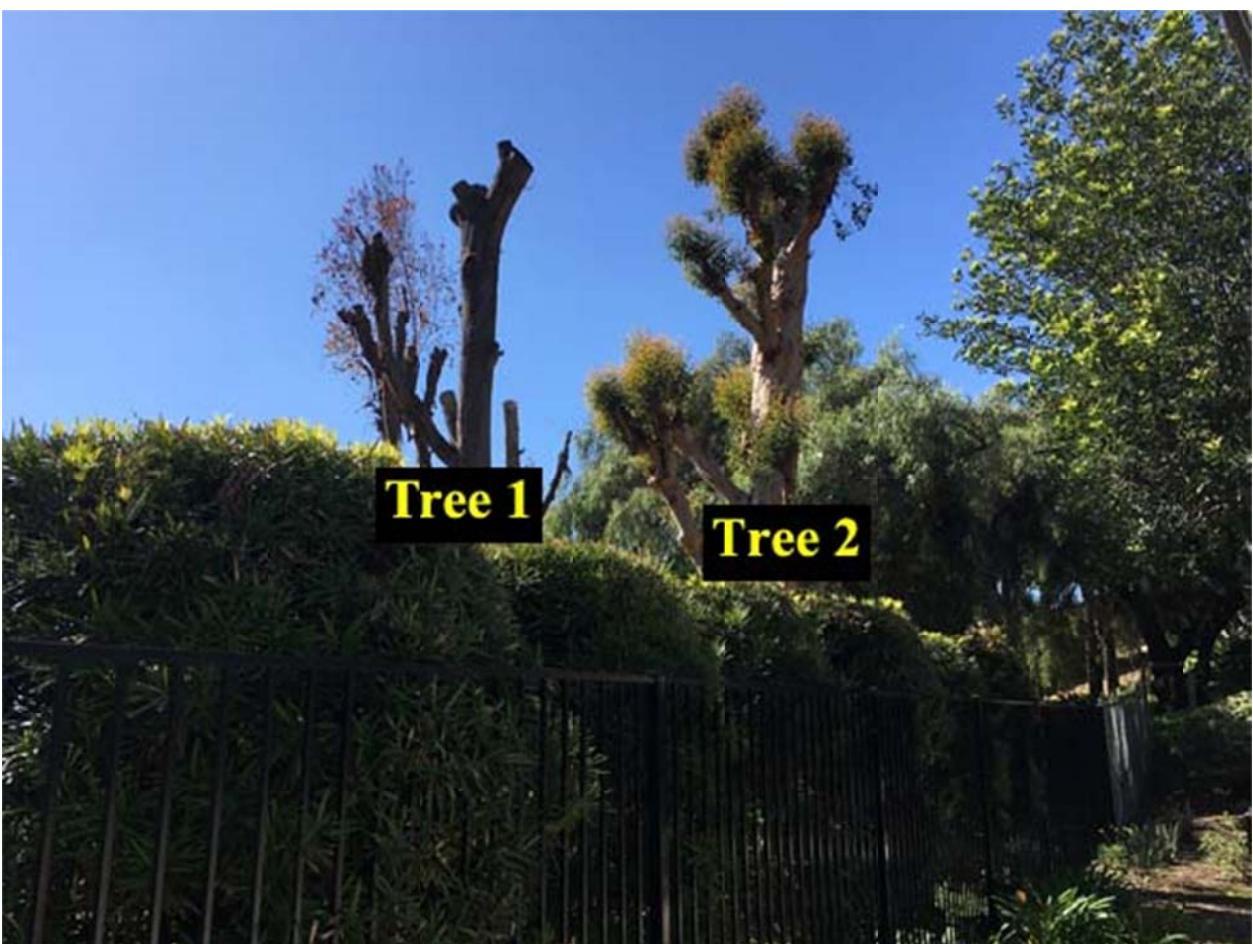
Tree 1 Tree 2	Tree 1 <i>Eucalyptus globulus</i> – Blue Gum Eucalyptus This tree was recently topped severely. Most of its scaffold branches were pruned to stumps. The direction of fall for this tree is not known; it may fail to the north or to the south. If it were to fail to the north, it could potentially impact the building or a person. Since people have an occasional occupancy rate on site, the likelihood of impacting a person is low if the tree were to fail. Since the tree may fall to the north or the south, the likelihood of impacting the building is medium if it were to fail.
Tree 1 Tree 2	Tree 2 <i>Eucalyptus globulus</i> – Blue Gum Eucalyptus This tree was recently topped severely. Most of its scaffold branches were pruned back to stumps. This tree has a prevailing lean to the south, and the likelihood of it impacting a target on the subject property is low.

**Figure 5**: Looking southwest at Tree 1 and Tree 2. Although they are on the south side of the fence, the survey I was provided indicated that these trees were growing on the subject property. They have both been severely topped in the past.

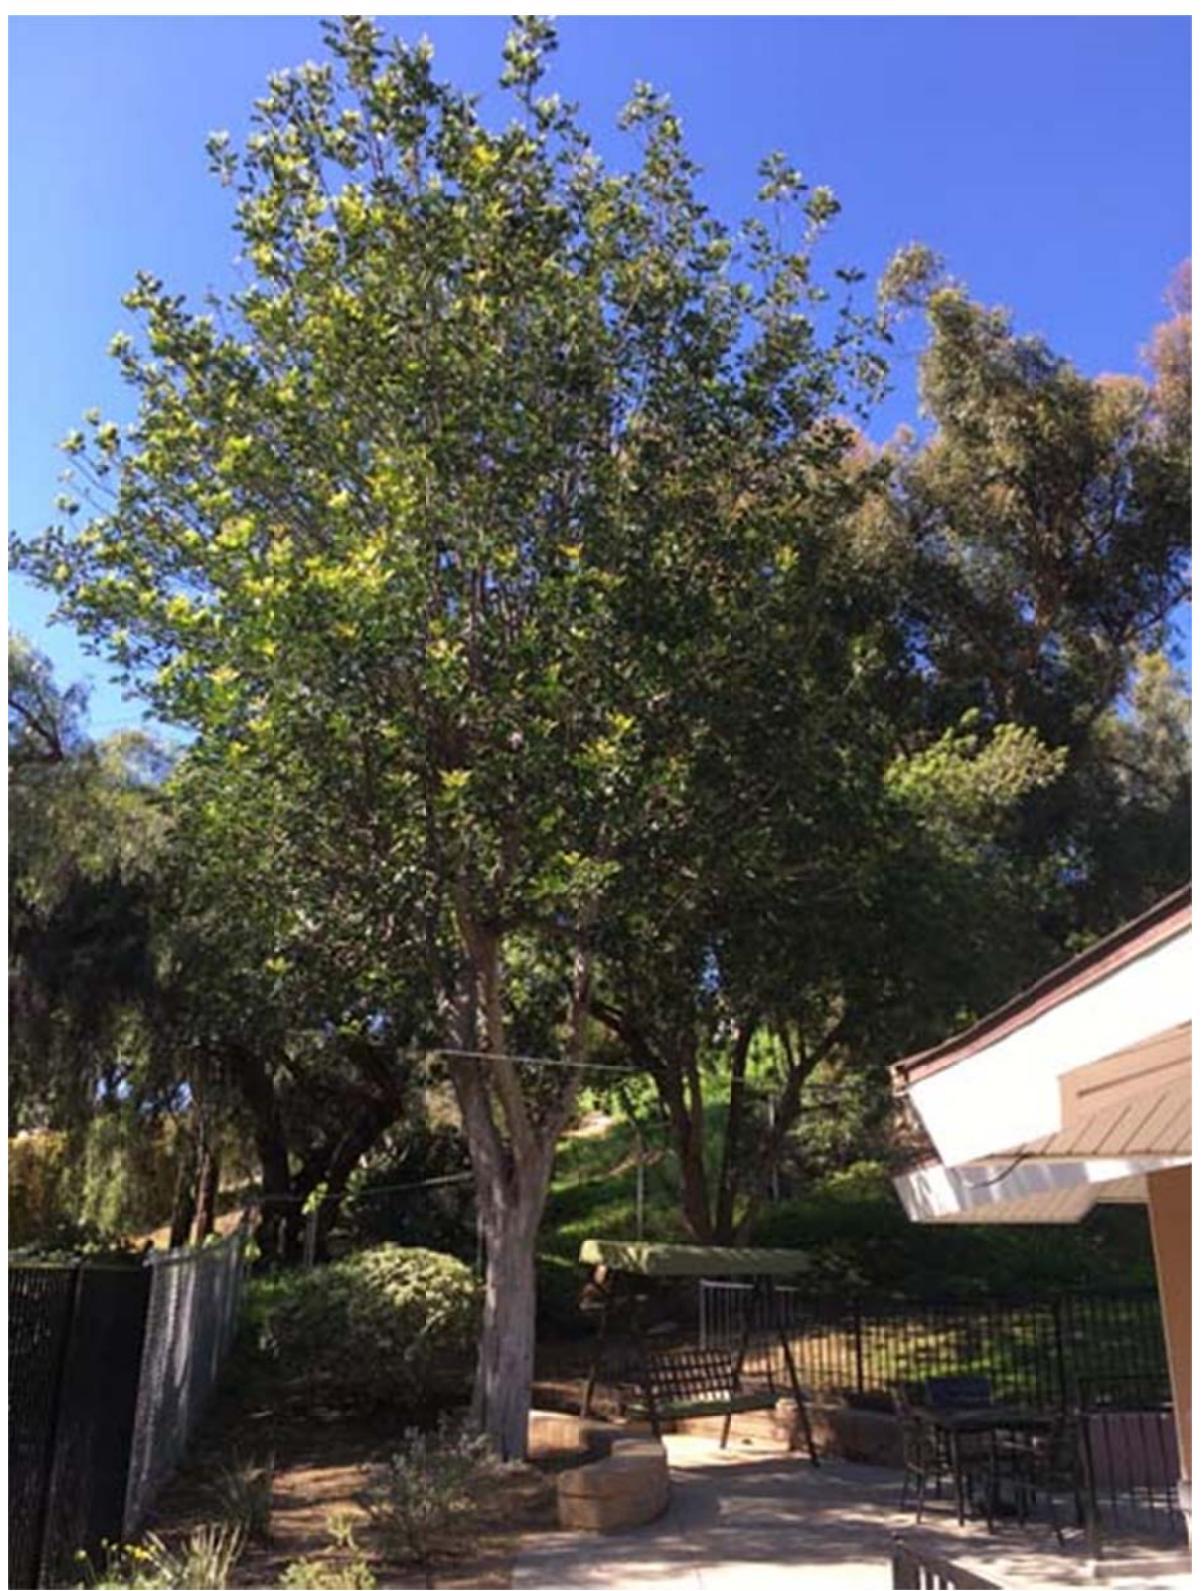
A Company	Tree 3 <i>Cupaniopsis anacardioides</i> – Carrotwood This juvenile Carrotwood provides desirable shade for the adjacent porch swing. From my observation of the tree,
	there are no significant defects in the trunk, so I rated the likelihood of whole tree failure as improbable. I rated branches as a possible likelihood of failure given the species failure profile of Carrotwood trees.
	If the whole tree were to fail, some of the upper branches could potentially impact the roof of the primary residence structure. However, because the direction of fall is not known, the tree may fail in a direction that does not impact the structure. Therefore, the likelihood of the whole tree impacting the structure is medium.
	The consequence of impacting the adjacent structure would be minor. Branches may strike the roof tiles, requiring a minor repair job. The repair cost would likely total no more than \$1,000.

People have an occasional occupancy rate in the backyard, so the likelihood of impacting a person is low.
State of the second	Tree 4 Schinus molle – California Pepper
	This tree is growing on the southern side of the fence, but according to the survey I was provided, it is growing on the subject property. It has a prevailing lean to the south. The likelihood of this tree's failure is improbable.
Carlos and the	I made all of my observations of the subject tree from the northern side of the existing fence.
	If it were to fail, the likelihood of this tree impacting a target on the subject property is very low because it has a prevailing lean to the south and the occupancy rate of its target zone is rare.

**Figure 6**: Looking west at Tree 3. This is a healthy juvenile carrotwood tree that provides shade for the adjacent porch swing. It has an improbable likelihood of failure.

- 5) *Prune the co-dominant stem defects out of Tree 3*: this would reduce the likelihood of branch failure and improve the aesthetic appearance of the tree, but it would not change the overall risk rating of the tree. It is not possible to have a risk rating lower than low unless the tree is removed.

- 7) *Remove Tree 3*: Removing this tree would reduce its risk from low to zero. It would also remove the benefits provided by the tree, including aesthetic appeal and shade for the porch swing.

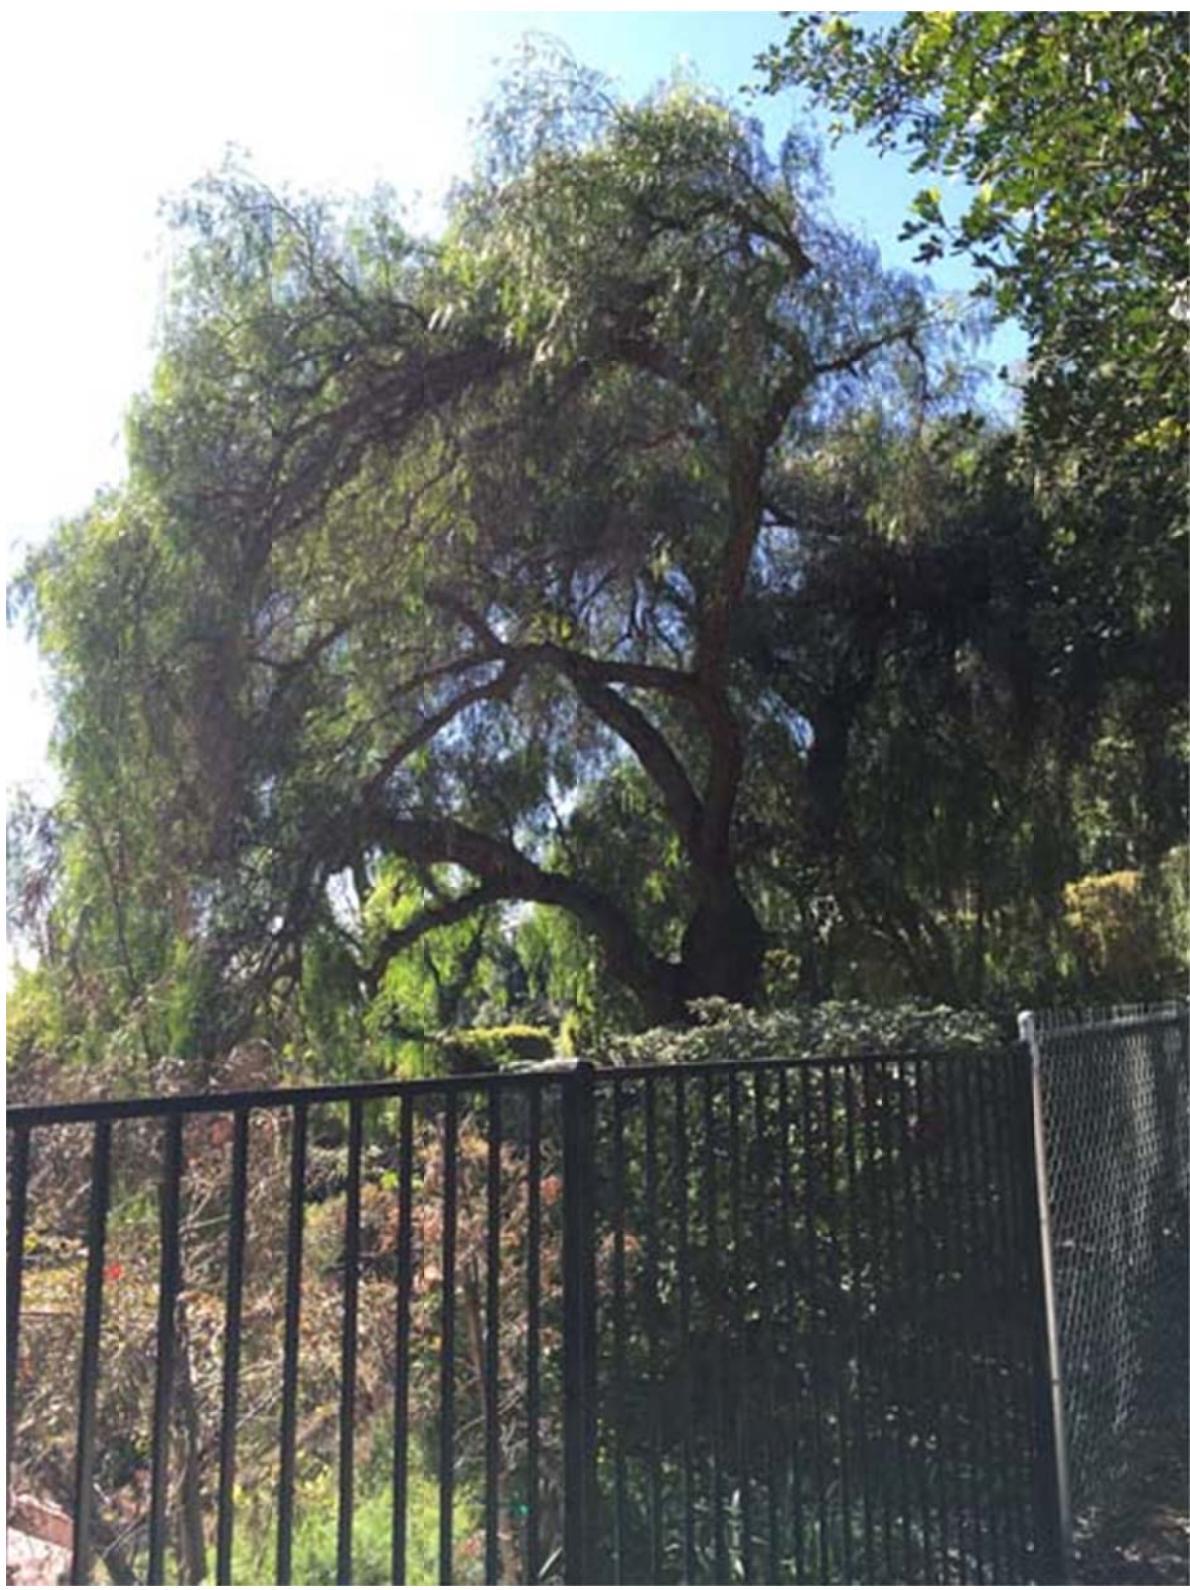
**Figure 7**: Looking southwest at Tree 4. This tree is growing to the south of the fence, but according to the survey I was provided, it is growing on the subject property. If it were to fail, the likelihood of impacting a target on the subject property is very low.

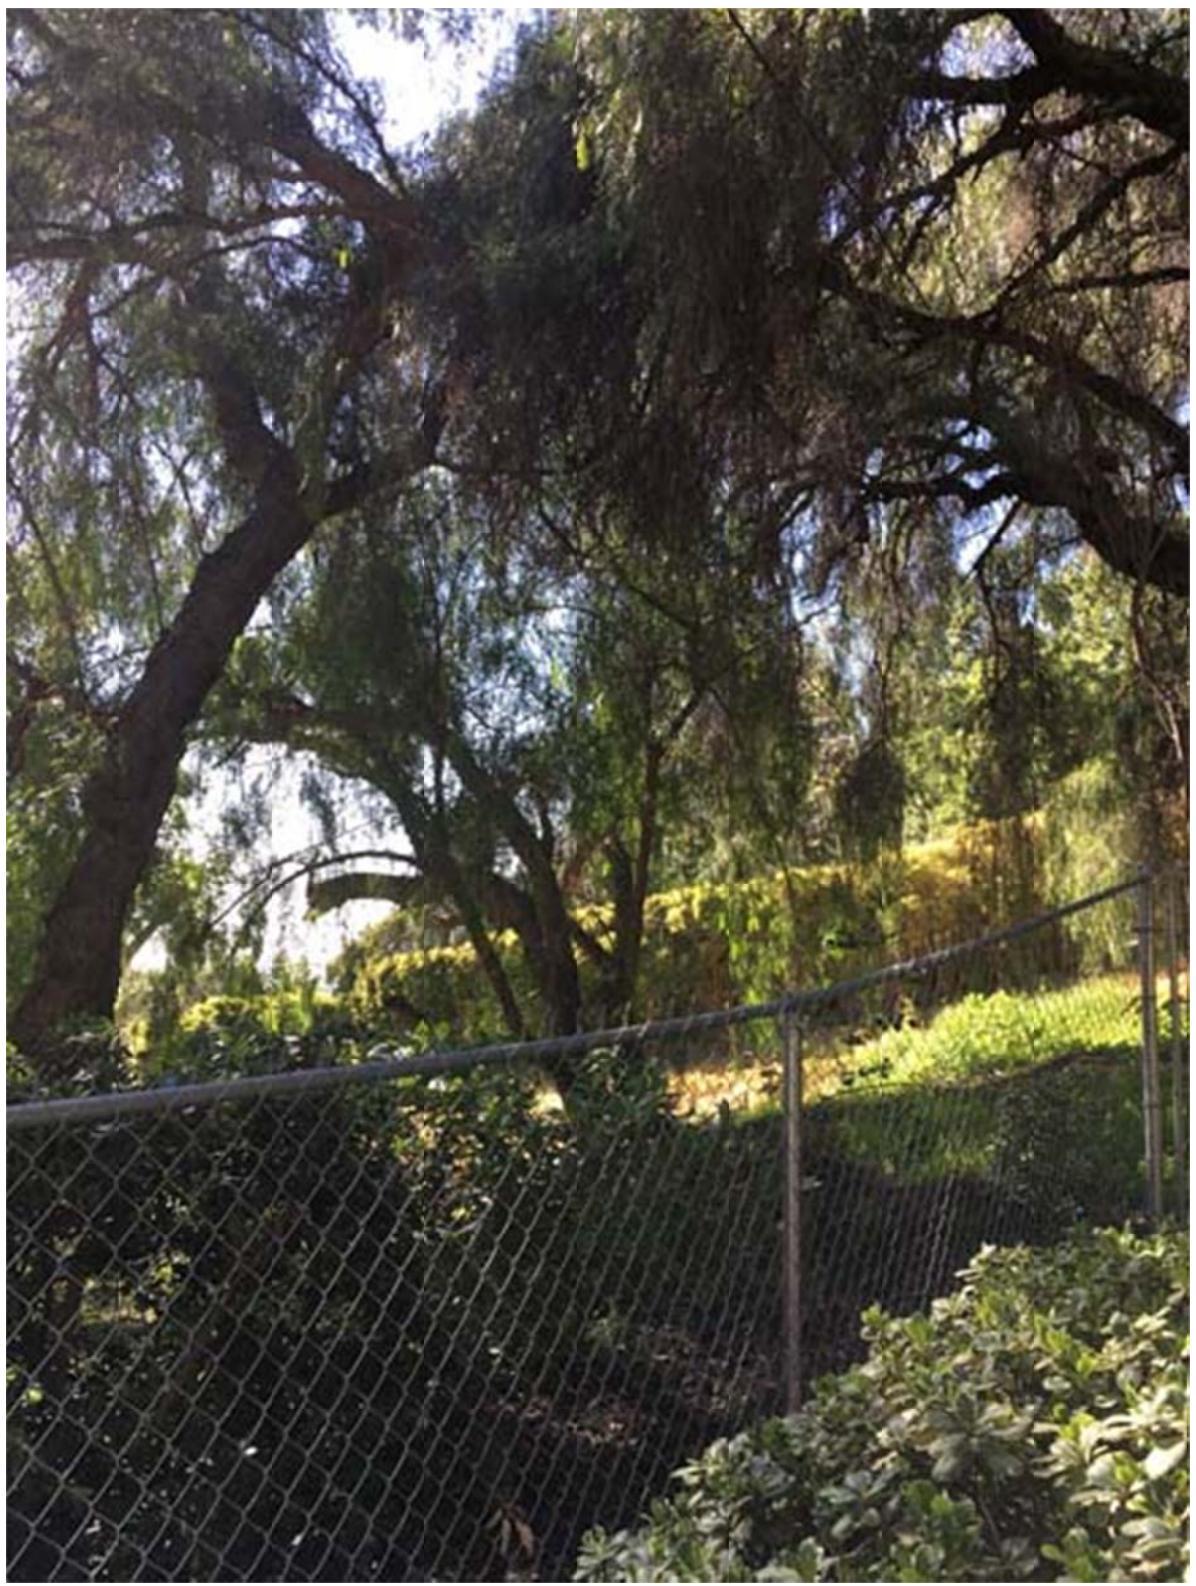
Tree 5 Schinus molle – California Pepper This tree is smaller than its neighbor Tree 4. If it were to fail, the likelihood of this tree impacting a target on the subject property is very low because it has a prevailing lean to the south and the occupancy rate of its target zone is rare.
<ul> <li>Tree 6 Schinus molle – California Pepper</li> <li>The likelihood of this tree failing is improbable. I did not observe any trunk or root defects from my perspective on the eastern side of the fence.</li> <li>The direction of fall is not known. If this tree were to fail, it could fail to the east or to the west. If it were to fail, the likelihood of impacting the porch swing is medium. People have an occasional occupancy rate in the backyard, so the likelihood of impacting a person is low.</li> <li>The consequence of impact the porch swing is minor. If a branch were to impact the porch swing, it may cause some damage, but it would cost less than \$1,000 to repair.</li> </ul>

**Figure 8:** Looking southwest at Tree 5. This tree is growing to the south of the fence, but according to the survey I was provided, it is growing on the subject property. If it were to fail, the likelihood of impacting a target on the subject property is very low.

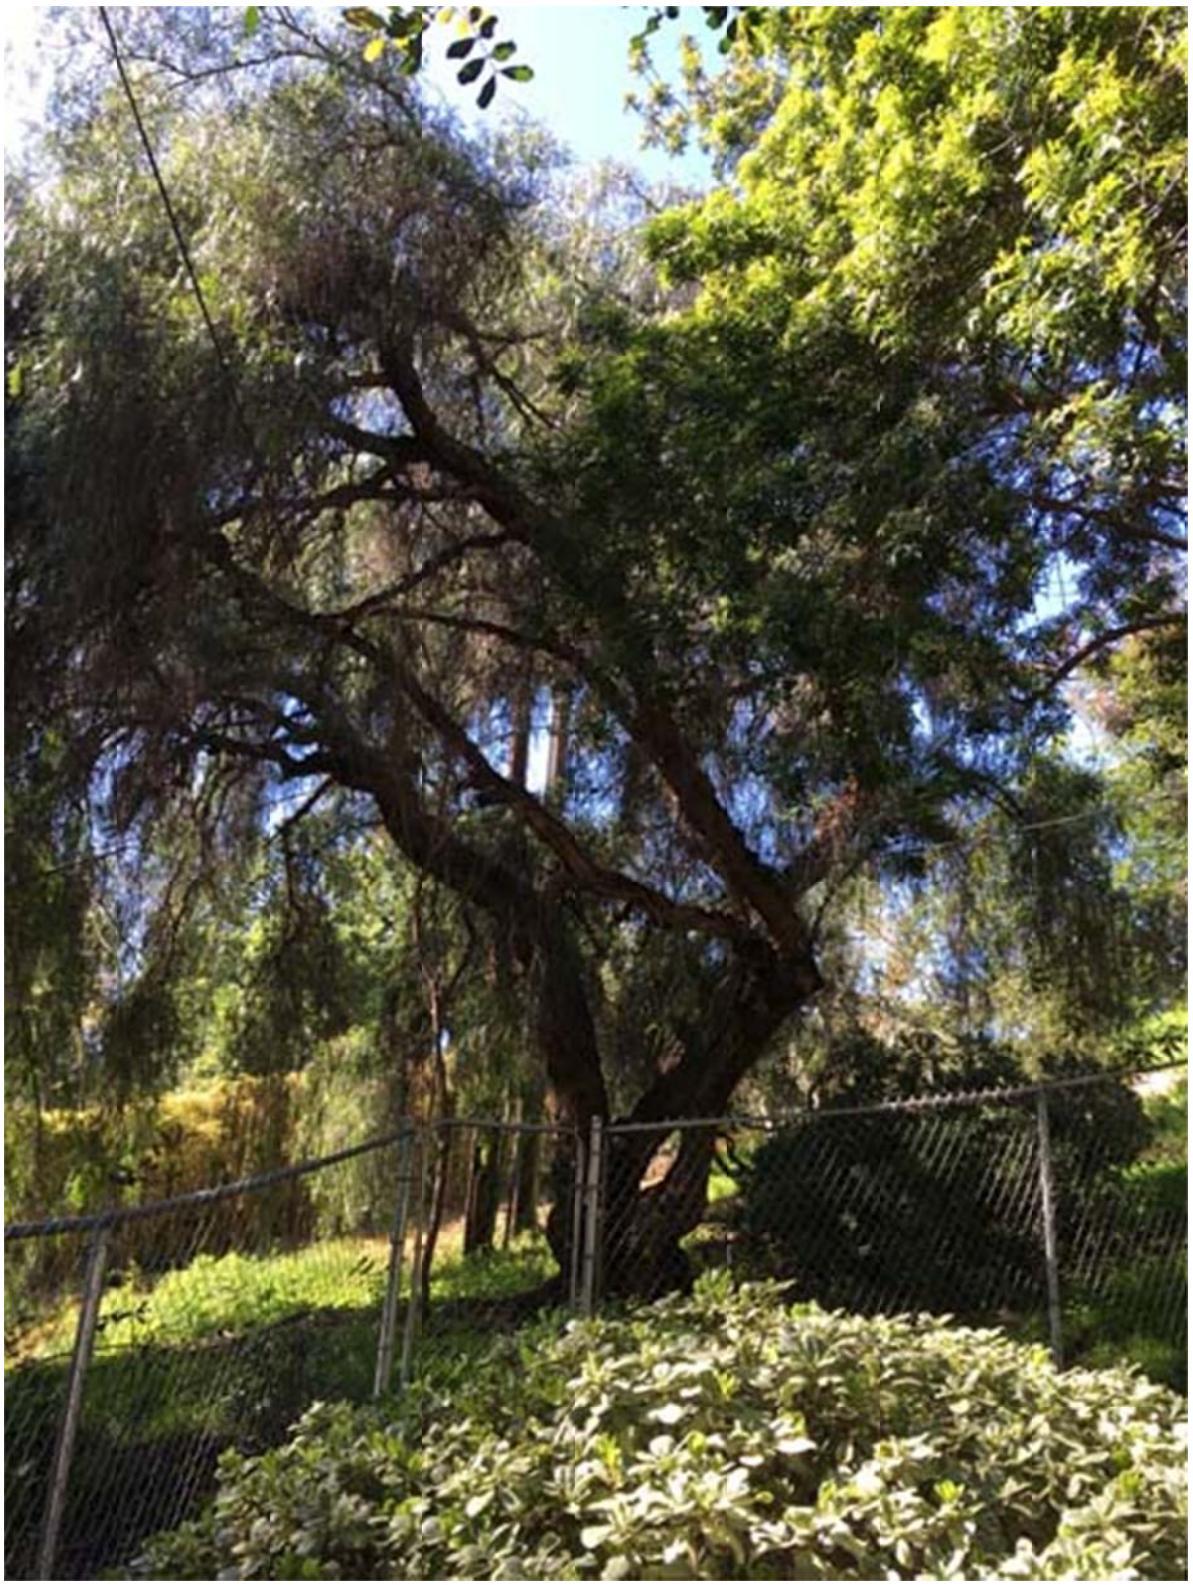
**Figure 9**: Looking southwest at Tree 6. This tree is growing to the southwest of the fence, but according to the survey I was provided, it is growing on the subject property. If it were to fail, the likelihood of impacting a person on the subject property is very low. It has a medium likelihood of imapcting the porch swing (out of frame, right).

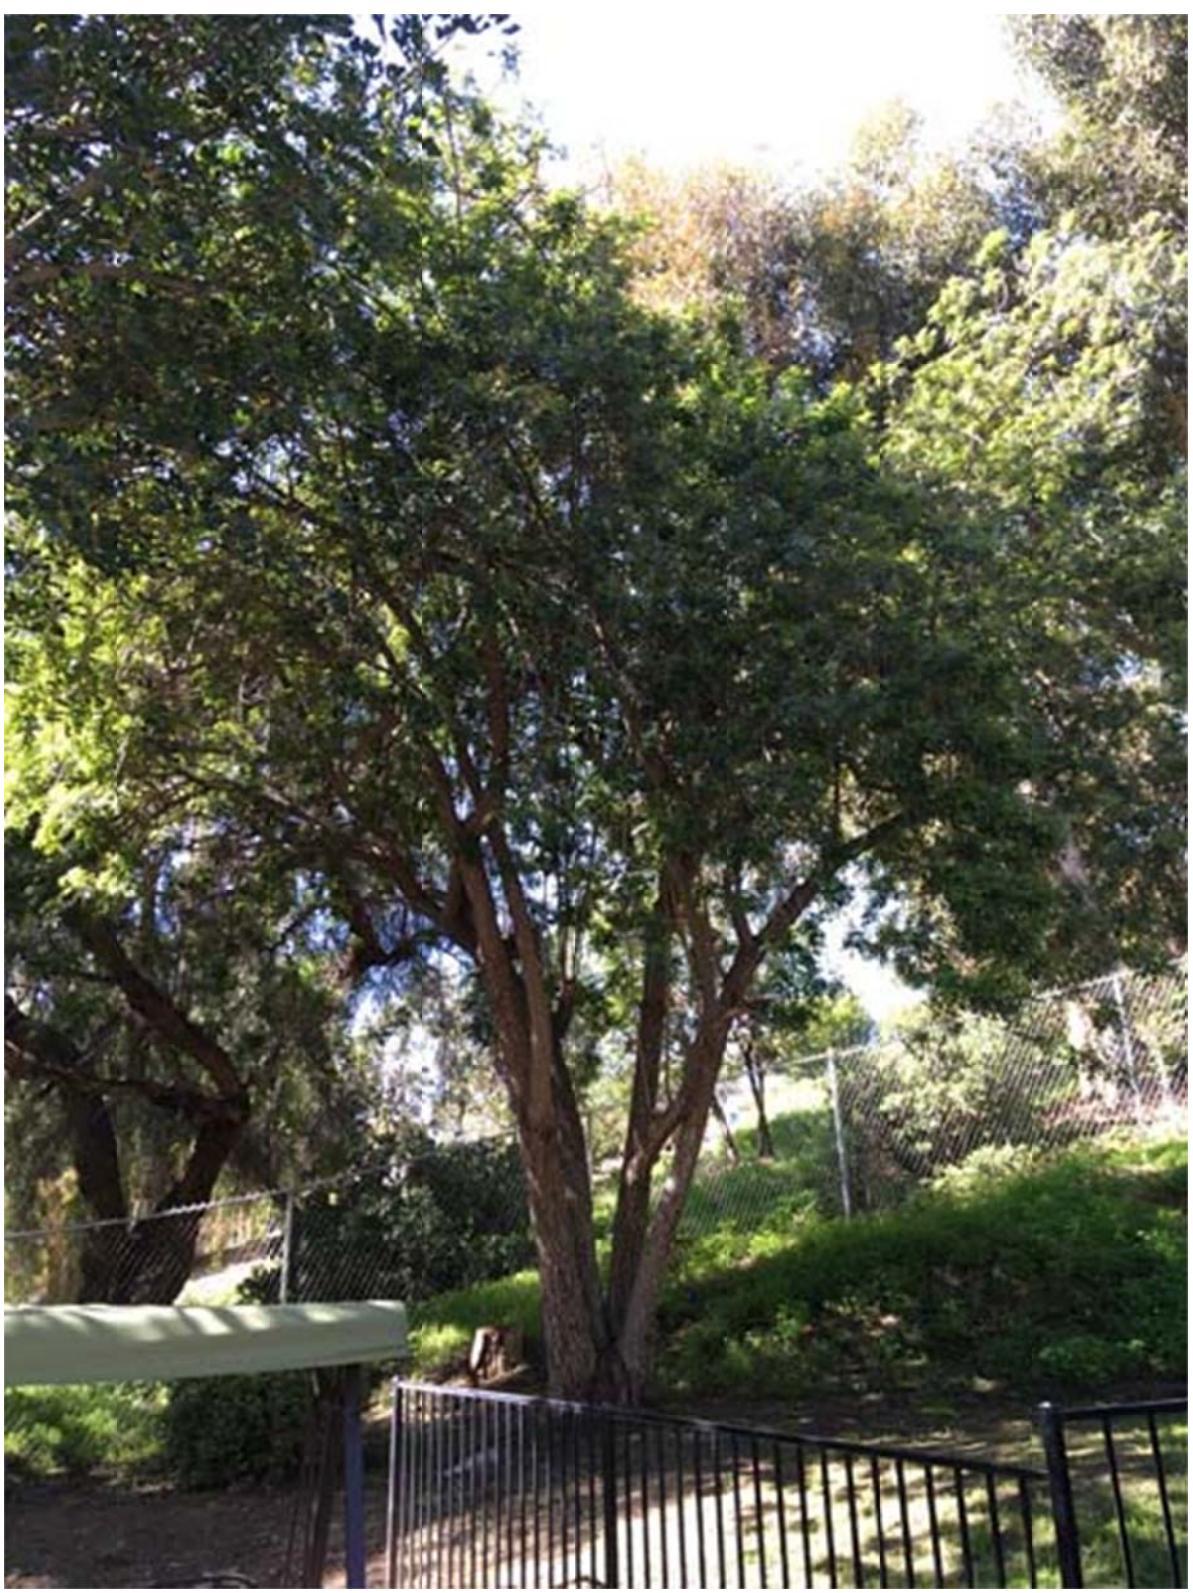
<ul> <li>Tree 7 Schinus terebinthifolius – California Pepper</li> <li>This juvenile tree is healthy and vigorous. It has several co- dominant branch defects, and the likelihood of one of them tearing out is possible. The likelihood of the whole tree failing is improbable.</li> <li>The likelihood of a branch impacting the porch swing is medium because the porch swing only occupies a portion of the target zone. The likelihood of a branch impacting a person is low because of the low occupancy rate of people in the backyard. The direction of fall of this tree is not known, so if it were to fail, it could potentially fall in any direction.</li> <li>The consequence of a branch failing and impacting the porch swing would be minor. The consequence of a branch failing and impacting a person would be severe. The consequence of the whole tree failing and impacting a person would be severe.</li> </ul>

**Figure 10**: Looking west at Tree 7. This healthy pepper tree has some co-dominant branch defects that could potentially be pruned off to reduce the likelihood of branch failure. The likelihood of whole tree failure is improbable. If a branch were to fail, it may impact the porch swing (below left).

- 6) *Remove Tree 7*: Removing this tree would reduce its risk from low to zero. It would also remove the benefits provided by the tree, including aesthetic appeal and shade for the porch swing.

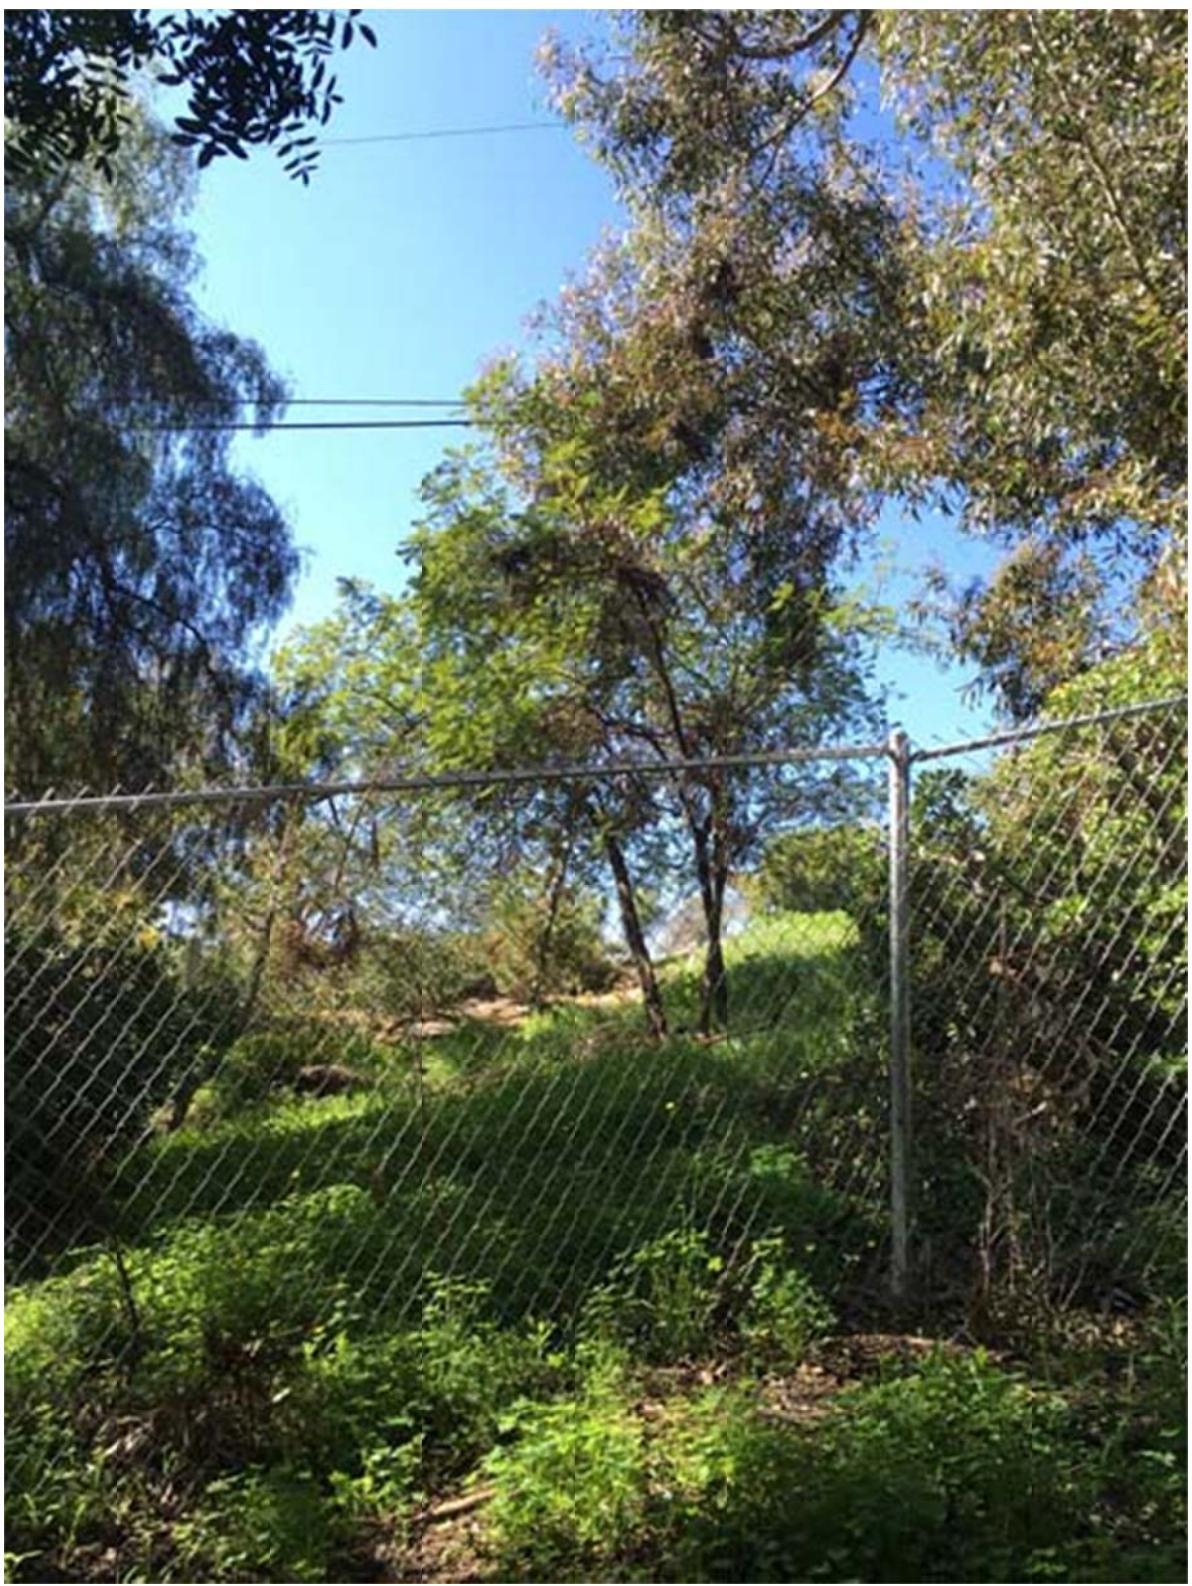
Tree 8 Jacaranda mimosifolia – Mimosa Tree This tree has an improbable likelihood of failure. It is a young tree that has good structure and good vigor. If it were to fail, the likelihood of this tree impacting a target on the subject property is very low because the occupancy rate of its target zone is rare. The consequence of the tree failing and impacting a person would be significant.

**Figure 11**: Looking southwest at Tree 8. This tree is growing to the west of the fence, but according to the survey I was provided, it is growing on the subject property. If it were to fail, the likelihood of impacting a target on the subject property is very low.

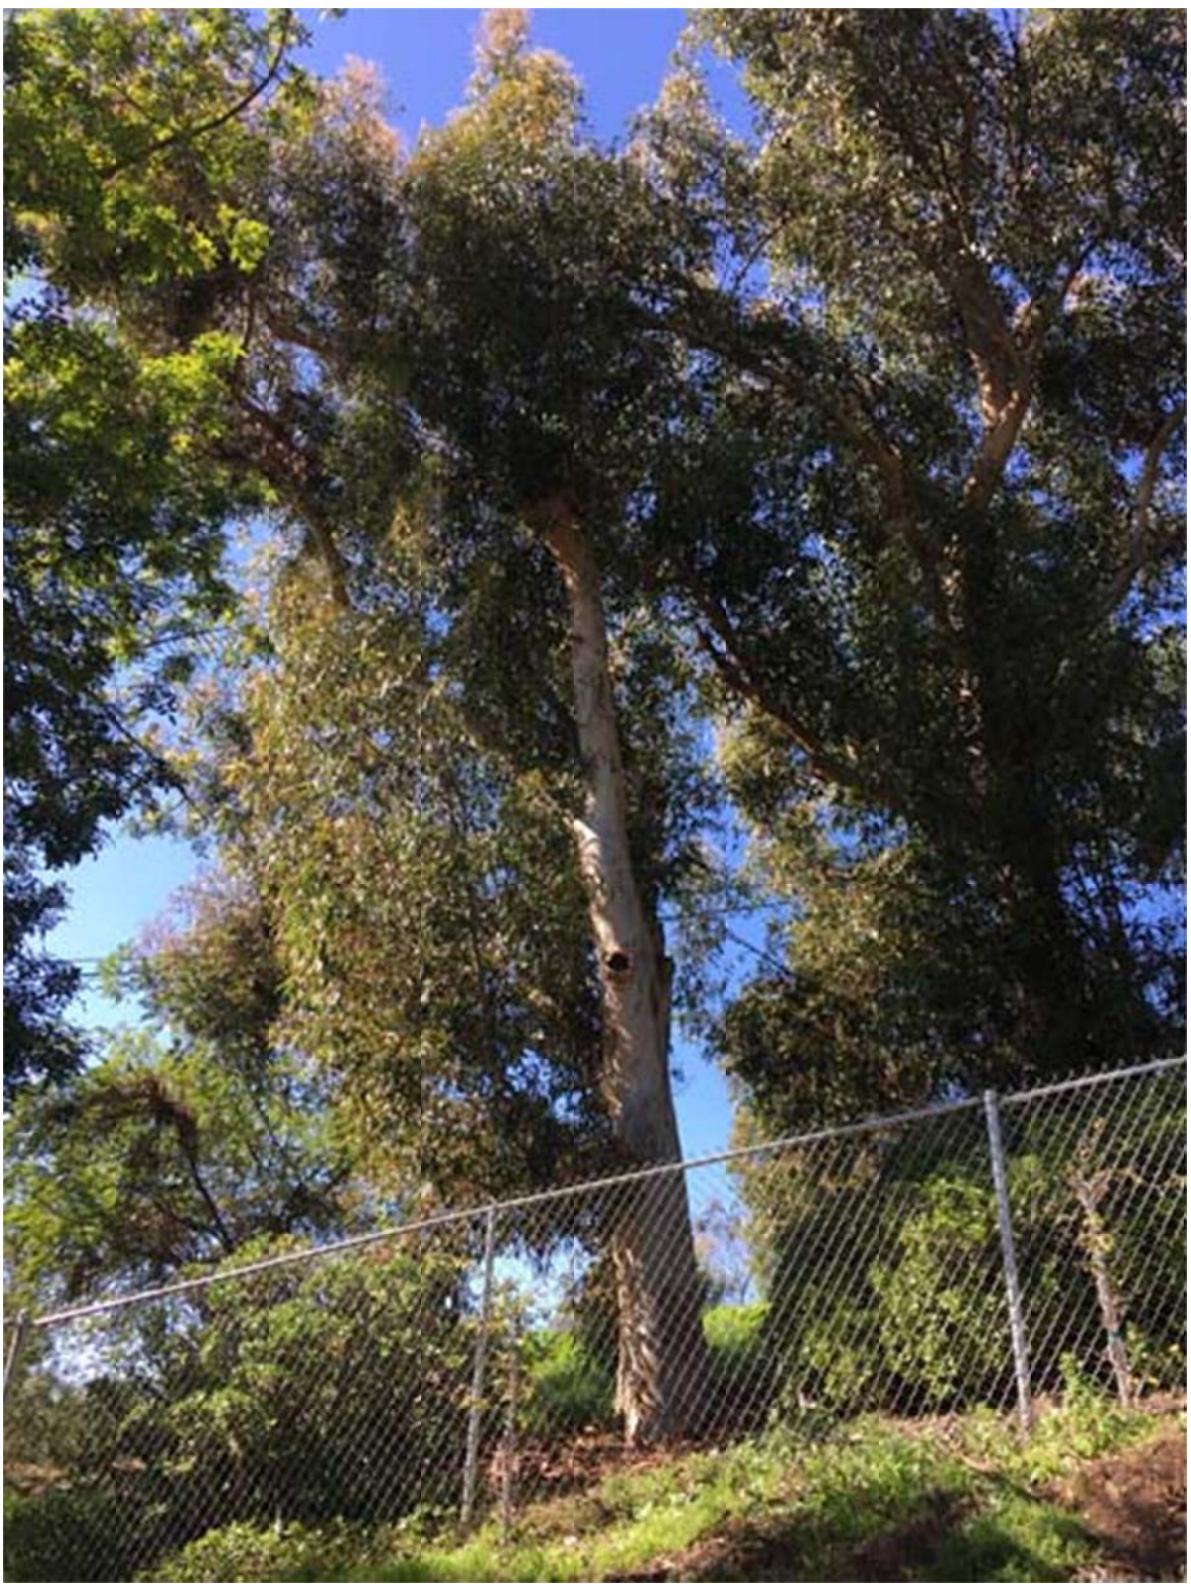
<ul> <li>Tree 9 <i>Eucalyptus globulus</i> – Blue Gum Eucalyptus</li> <li>This tree has been topped in the past, but it does not appear to have been pruned for some time. It has a prevailing lean to the east. The grassy area of the yard is within the target zone of this tree, but the primary residence structure is not.</li> <li>The likelihood of failure of this tree is improbable. I did not observe any defects that would indicate an elevated likelihood of failure. I only observed this tree from the eastern side of the fence.</li> <li>The likelihood of impacting a person is low because of the occasional occupancy rate of the backyard. The consequence of impacting a person would be severe.</li> </ul>
Tree 10 <i>Eucalyptus globulus</i> – Blue Gum Eucalyptus There was some gumming of the trunk of this tree that was partially obscured by some bushes between the tree and my point of observation at the fence. Using the information I had available, I assessed the likelihood of this tree's failure as possible because the gumming could potentially indicate a structural inadequacy. More data would be necessary to make a better determination of likelihood of failure. The likelihood of impacting a person is low because of the occasional occupancy rate of the backyard. The consequence of impacting a person would be severe.

**Figure 12**: Looking west at Tree 9. This tree is growing on the western side of the fence. This tree has been topped in the past, but it does not appear to have been pruned for some time. It has a prevailing lean to the east. The grassy area of the yard is within the target zone of this tree, but the primary residence structure is not.

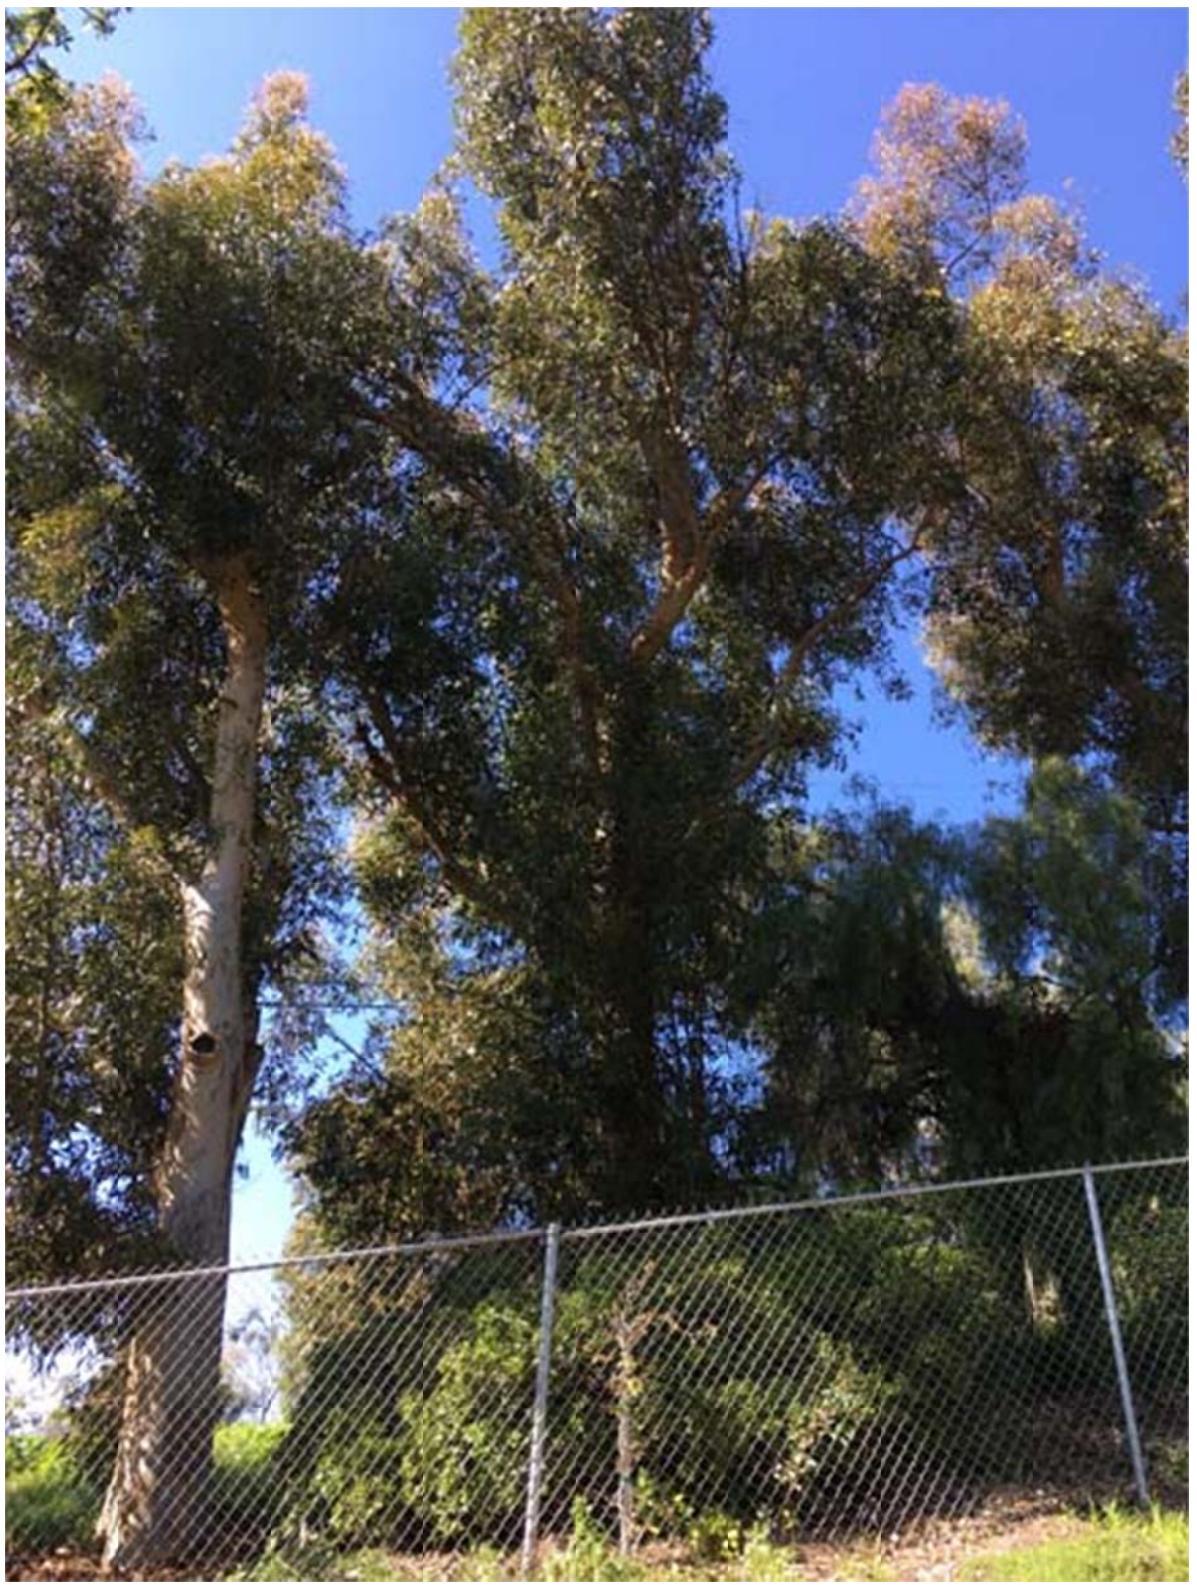
**Figure 13**: Looking west at Tree 10. There was some gumming of the trunk of this tree that was partially obscured by some bushes between the tree and my point of observation at the fence. The likelihood of impacting a person is low because of the occasional occupancy rate of the backyard.

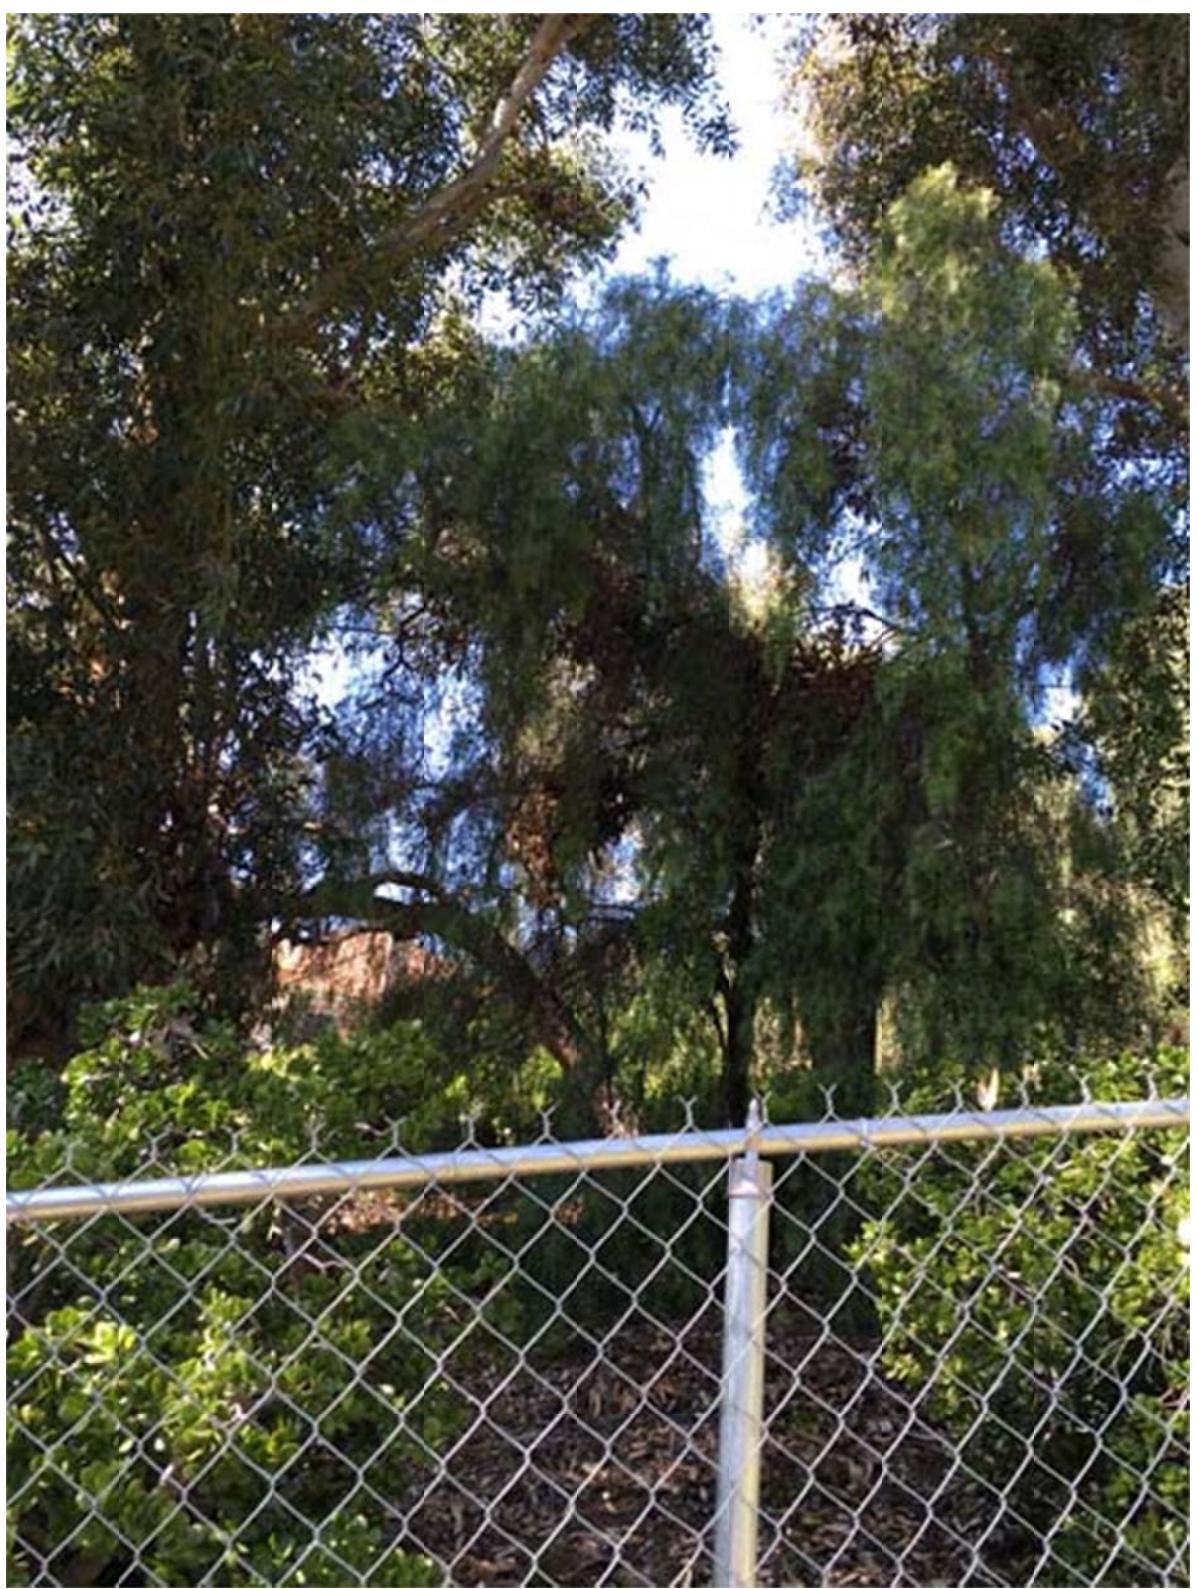
<ul> <li>Tree 11 Schinus molle – California Pepper</li> <li>The likelihood of this tree's failure is improbable. I only observed this tree from the eastern side of the fence.</li> <li>If it were to fail, the likelihood of this tree impacting a target on the subject property is very low because the occupancy rate of its target zone is rare.</li> </ul>

**Figure 14**: Looking south at Tree 11. This tree is growing to the west of the fence. If it were to fail, the likelihood of impacting a target on the subject property is very low.

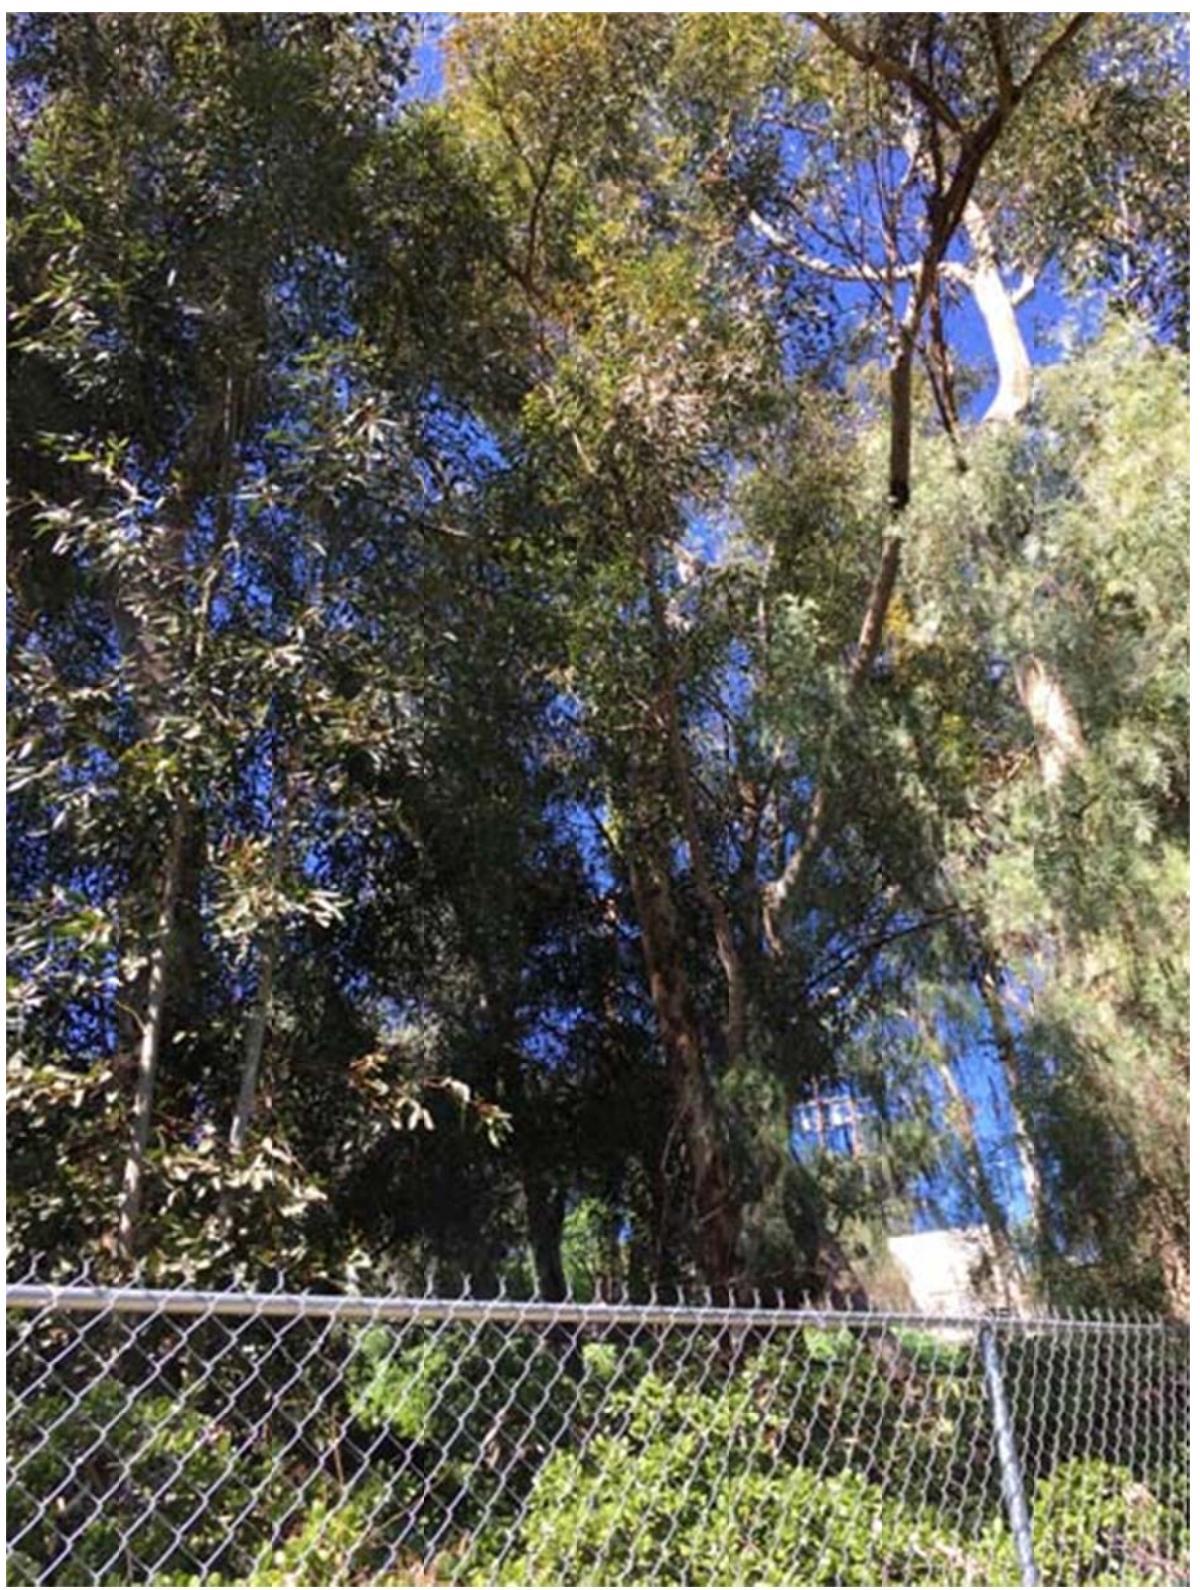
**Figure 16**: Looking northwest at Tree 13. This tree is growing on the western side of the fence. The grassy area of the yard is within the target zone of this tree, but the primary residence structure is not. The likelihood of impacting a person is low because of the occasional occupancy rate.
