Class One Arboriculture CA Lic. #982988 2832 Manhattan Ave Glendale, CA 91214 Phone: (818) 495-5344

April 10, 2017

I am writing to summarize the results of my site visit to \*Redacted\*. After viewing 17 trees along the western side of the subject property, I can conclude that *Tree 15 poses a moderate risk* within a one year time frame, and *the other assessed trees have a low risk rating*.

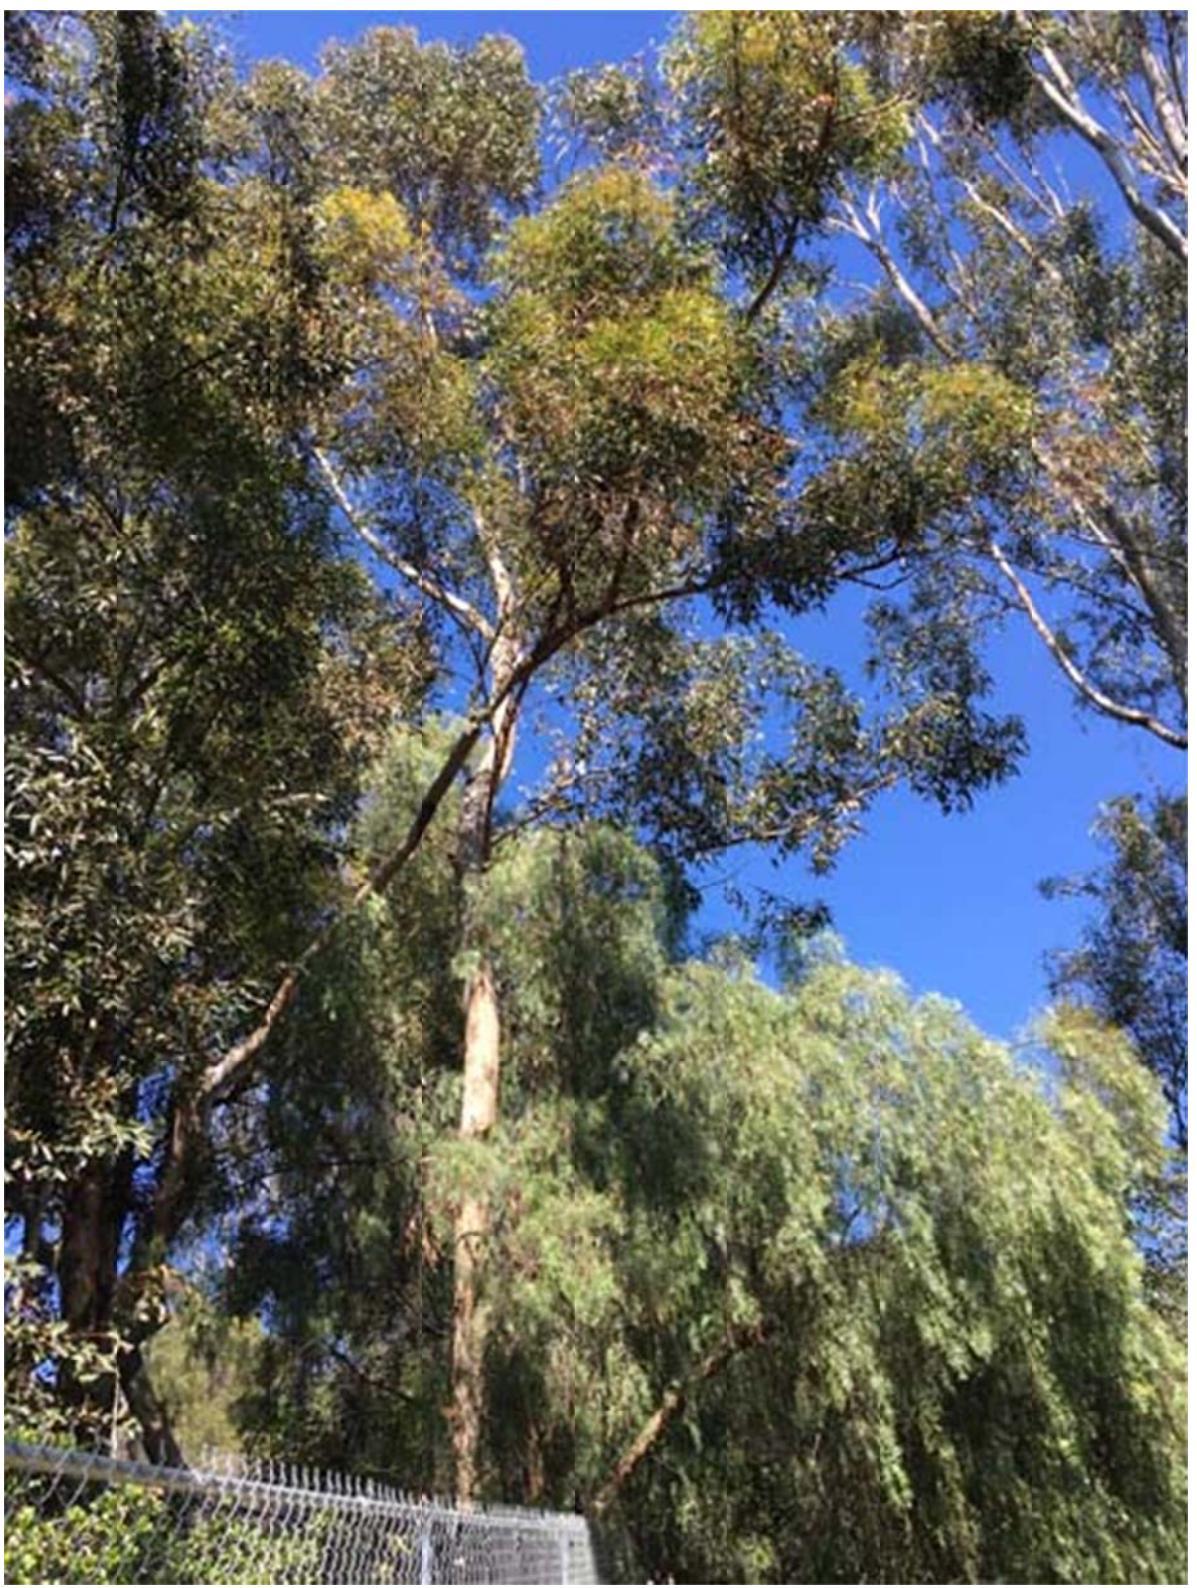
**Figure 17**: Looking northwest at Tree 14. This tree is growing on the western side of the fence. The grassy area of the yard is within the target zone of this tree, but the primary residence structure is not. The likelihood of impacting a person is low because of the occasional occupancy rate.

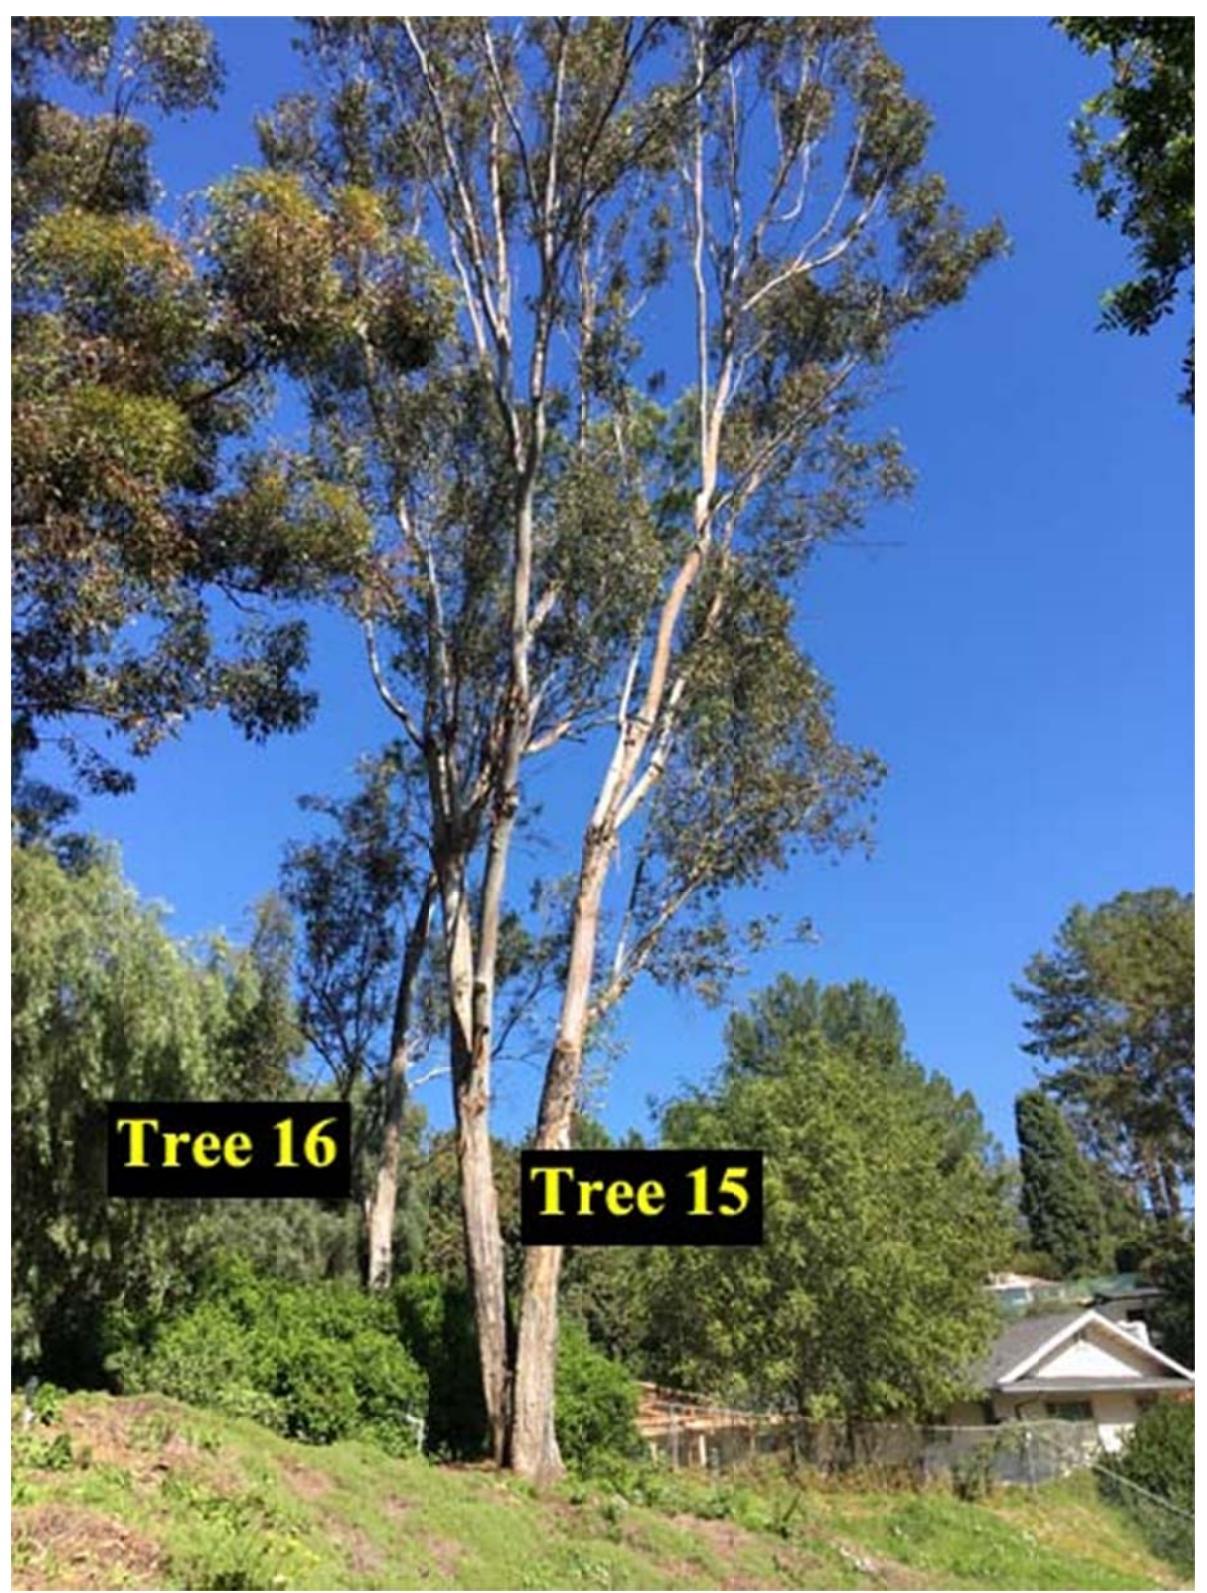
Tree 16 Tree 15	Tree 15 <i>Eucalyptus globulus</i> – Blue Gum Eucalyptus This tree has a co-dominant stem defect. Two parallel trunks emerge from the base of this tree with a relatively narrow angle of attachment. This defect is known to have a possible likelihood of failure. Eucalyptus trees are known for their species failure profile to drop branches in the absence of defects. I rated the likelihood of a branch failure as possible. The tree has a trunk with a prevailing lean towards the subject property. If it were to fail, this trunk may be expected to impact the primary residence structure, so the likelihood of impact is high. The likelihood of either the co- dominant trunk or a branch impacting a person is low due to
	<ul> <li>the occasional occupancy rate of the backyard.</li> <li>The consequence of a co-dominant trunk impacting the structure would be severe. The consequence of a co-dominant trunk impacting a person would be severe. The consequence of a branch impacting a person would be severe due to the distance of fall.</li> <li>The overall risk rating of this tree is moderate. The only effective way to reduce this risk to low or zero is to remove the tree.</li> </ul>

Tree 16 Tree 15	<ul> <li>Tree 16 <i>Eucalyptus globulus</i> – Blue Gum Eucalyptus</li> <li>This tree is growing on the north side of the fence along the northern property line. The likelihood of whole tree failure is possible.</li> <li>If Tree 16 were to fail to the south or southeast, Tree 15 would act as a protection factor and deflect Tree 16 to the east or east-southeast. This limits the target zone in which Tree 16 may be expected to fall if it were to fail. The likelihood of impacting the primary residence structure is medium. The likelihood of impacting a person is low due to the occasional occupancy rate of people in the backyard.</li> <li>If this tree were to fail and impact a person, the consequence would be severe. If it were to fail and impact the structure, the consequence would be severe.</li> </ul>

**Figure 18**: Looking north at Tree 15 and Tree 16. Tree 15 has a co-dominant stem defect and some deadwood present in the canopy. Tree 16 is growing to the north of the fence. If Tree 16 were to fail to the south, it may be deflected to the east or east-southeast by Tree 15.

- 1) *Prune dead branches out of Tree 15*: This would reduce the likelihood of branch failure, but it would not change the overall risk rating of the tree. The residual risk would still be moderate.

- 2) *Top Tree 15 at a height of 25 feet*: Reducing the height of Tree 15 to 25 feet would shrink its target zone. Doing so would reduce the likelihood of impacting the structure from high to low, thereby dropping the risk rating from moderate to low. However, topping an already stressed tree would likely predispose it to death in the years following the mitigation action. Ultimately, topping this tree would require its eventual removal anyway.

- 3) *Remove Tree 15*: Removing this tree would reduce its risk from low to zero. The residual risk of all the remaining trees assessed in this report would have a low risk rating. This is the only effective mitigation strategy that would reduce the risk posed by Tree 15 below moderate.

- 4) *Remove Tree 16:* Removing this tree would reduce its risk from low to zero. The primary residence structure is in the target zone of Tree 16, so removing this tree would eliminate the possibility that Tree 16 could fail and impact the structure. Since this tree is growing on the adjacent property to the north, you will need to obtain permission from the property owner before removing it.

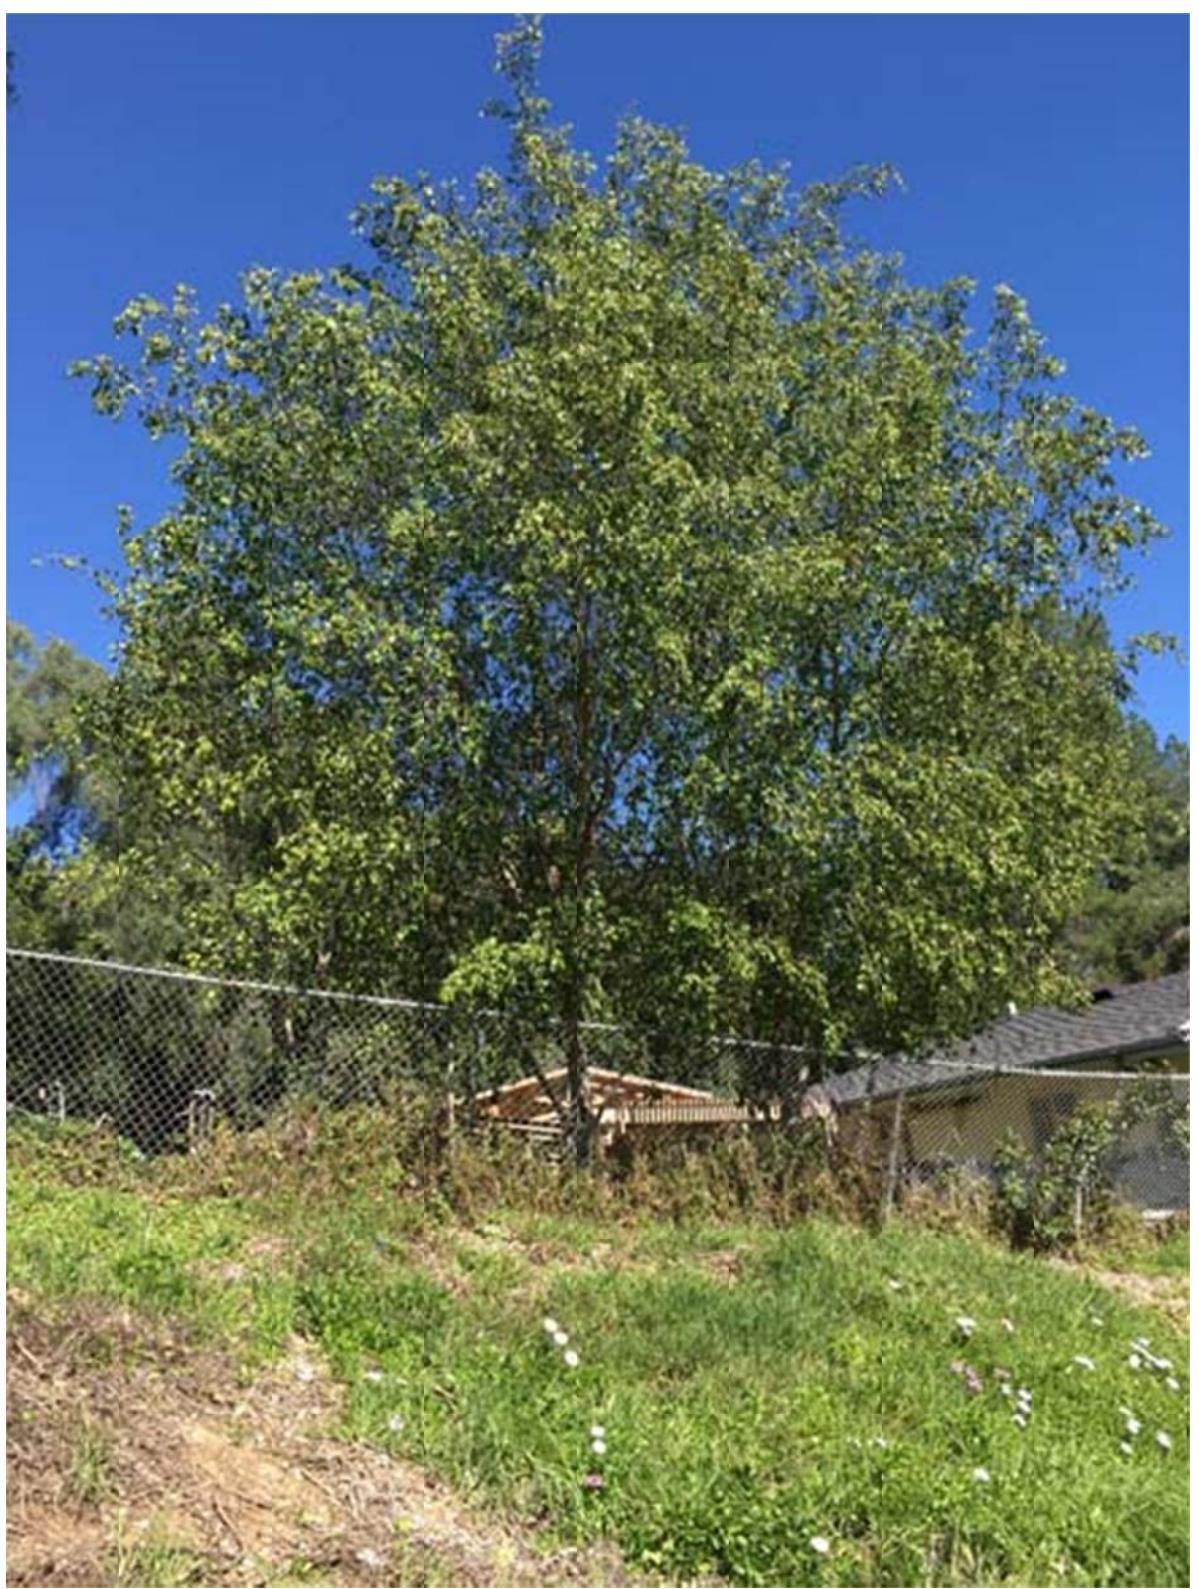
It appears that this tree is growing on the neighboring property to the north. It is a healthy young tree. The likelihood of failure is improbable. The likelihood of impacting a person is low. The primary residence structure is not likely to be impacted because it is outside the target zone of this tree. The consequence of the whole tree failing and impacting a person would be severe.

**Figure 19**: Looking north at Tree 17. This is a healthy Weeping Fig. I rated the likelihood of failure as improbable. The building is not within its target zone. People are rarely within its target zone.

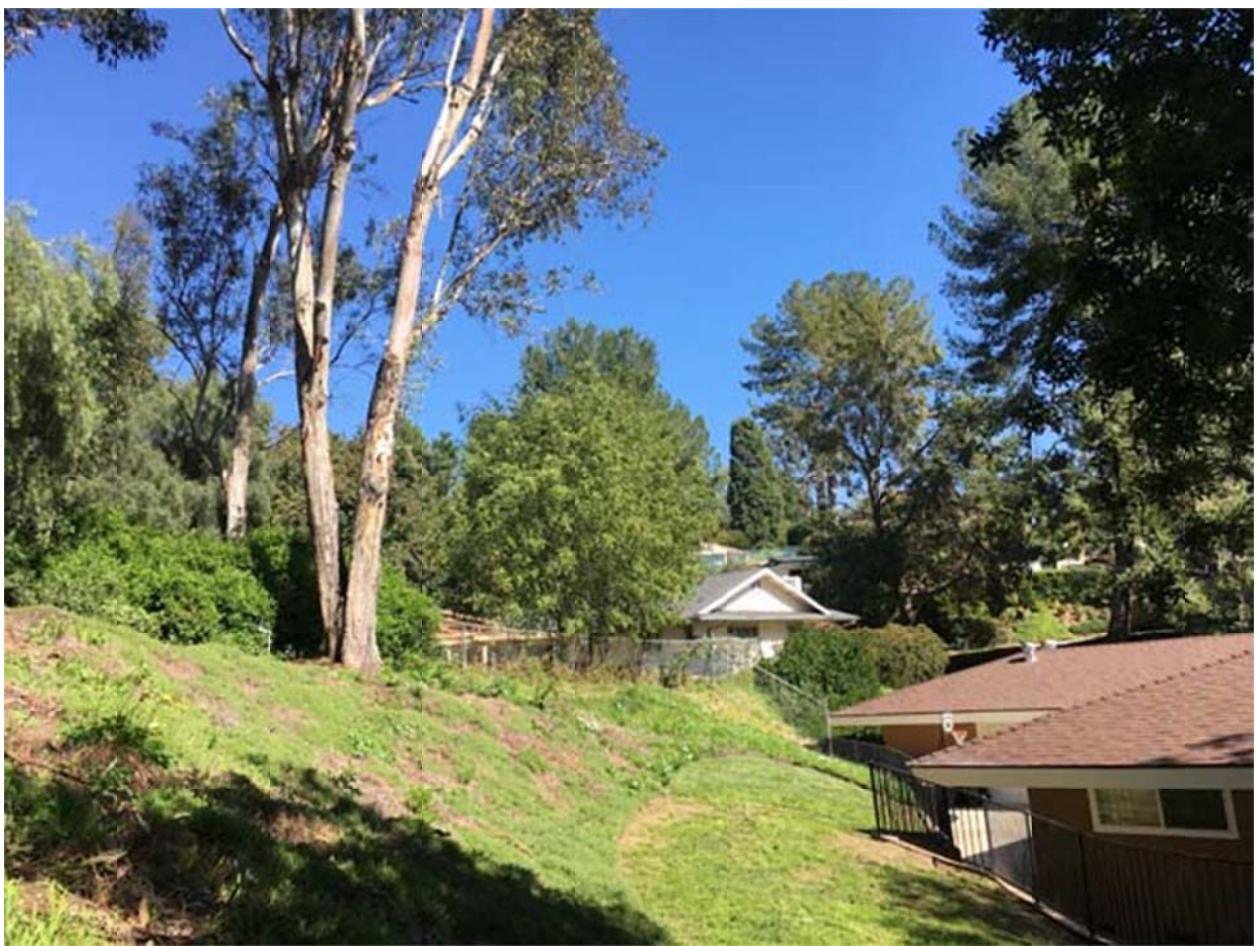
**Figure 20**: Looking northeast at the target zone for Tree 15 and Tree 16. The primary residence structure is within the target zone. The southern co-dominant trunk of Tree 15 has a high likelihood of impacting the structure if it were to fail. Tree 16 has a medium likelihood of impacting the structure because it could potentially be deflected by Tree 15 or fail away from the structure.

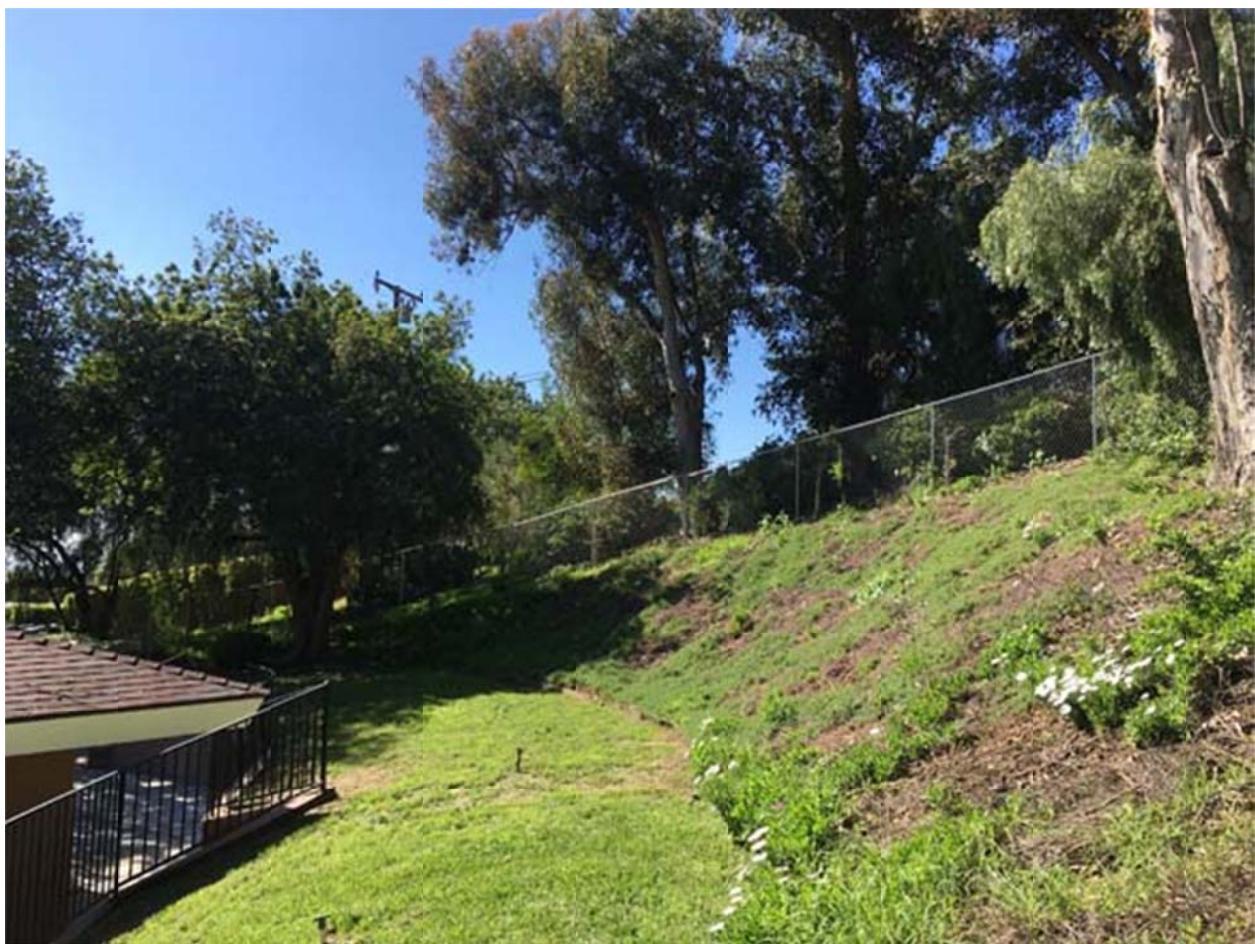
**Figure 21**: Looking southwest at the target zone for Tree 15 (upper right of frame). People in the grassy area of the yard have an occasional occupancy rate. The building is within the target zone of Tree 15.
