# DETECTIVE DENDRO THE DIAGNOSTIC SLEUTH

## The Case of the Mystery Driveway

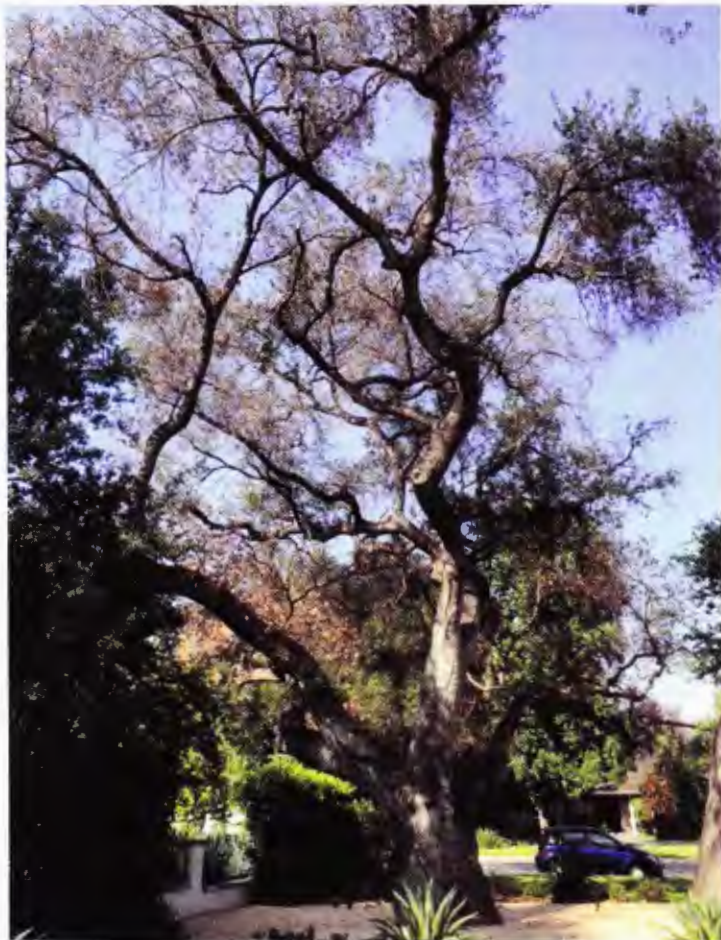
The subject tree has declined rapidly in condition over the past few months. What could have caused the decline?

Interestingly, I didn't see any symptoms of *Phytophthora* root rot on the subject tree. I identified a part of the tree with some old bark loss, likely from many years ago, and there was also evidence of some benign bark beetle activity. I observed several small suckers growing from the base of the tree as well.

Nothing aboveground appeared to be severe enough to cause the decline of the tree over such a short period of time. What was going on?

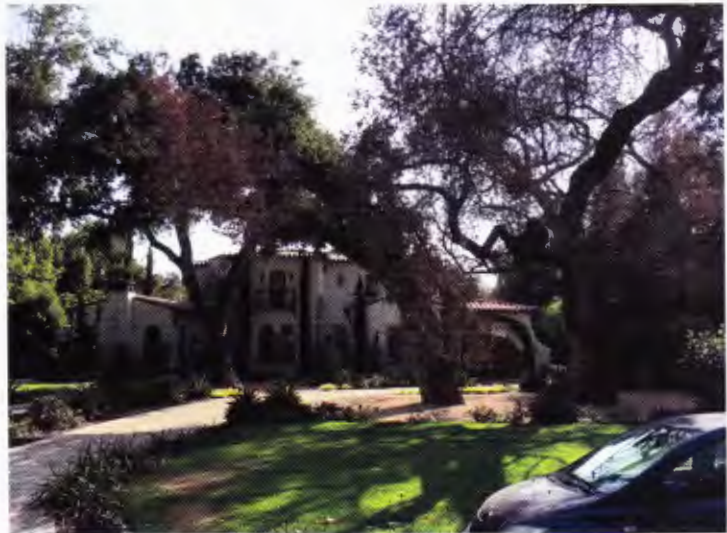
Most notably, an asphalt driveway formerly ran right between the subject oak and one of its neighbors. From the historical photo, it was a tight fit, and it appeared that the two trees had begun to incorporate the asphalt into their heartwood. At present, the asphalt driveway was nowhere to be seen. Not only had the builder completely erased an asphalt driveway that was intimately connected with the subject tree, but they had built a new one across even more roots!

Dendro looks west, at the subject tree (right) and its neighbor (center). A driveway formerly ran between them, but that driveway was demolished and replaced with a new driveway (left).

It seems as though the arborist who prepared the initial report did not have an opportunity to review the new plans, and that detail must have been missed by the city planner when approving the project. Without strict guidelines to avoid excavation and soil compaction, the builder followed conventional demolition techniques and ultimately damaged the tree roots. Peer review was the missing link!

"Removing the soil along the length of the former driveway would reveal whether there were any substantial root cuts during the demolition phase. Such excavation could be performed by hand or by air excavator. The air-excavator technique is more costly than excavation by hand, but it is less damaging to the roots and can quickly reveal any exposed root ends. If large root cuts are revealed, then there would be strong supporting evidence that the driveway demolition was a contributing factor to the tree's decline. If no large cuts are revealed, then the test may provide evidence against the hypothesis presented in this report."

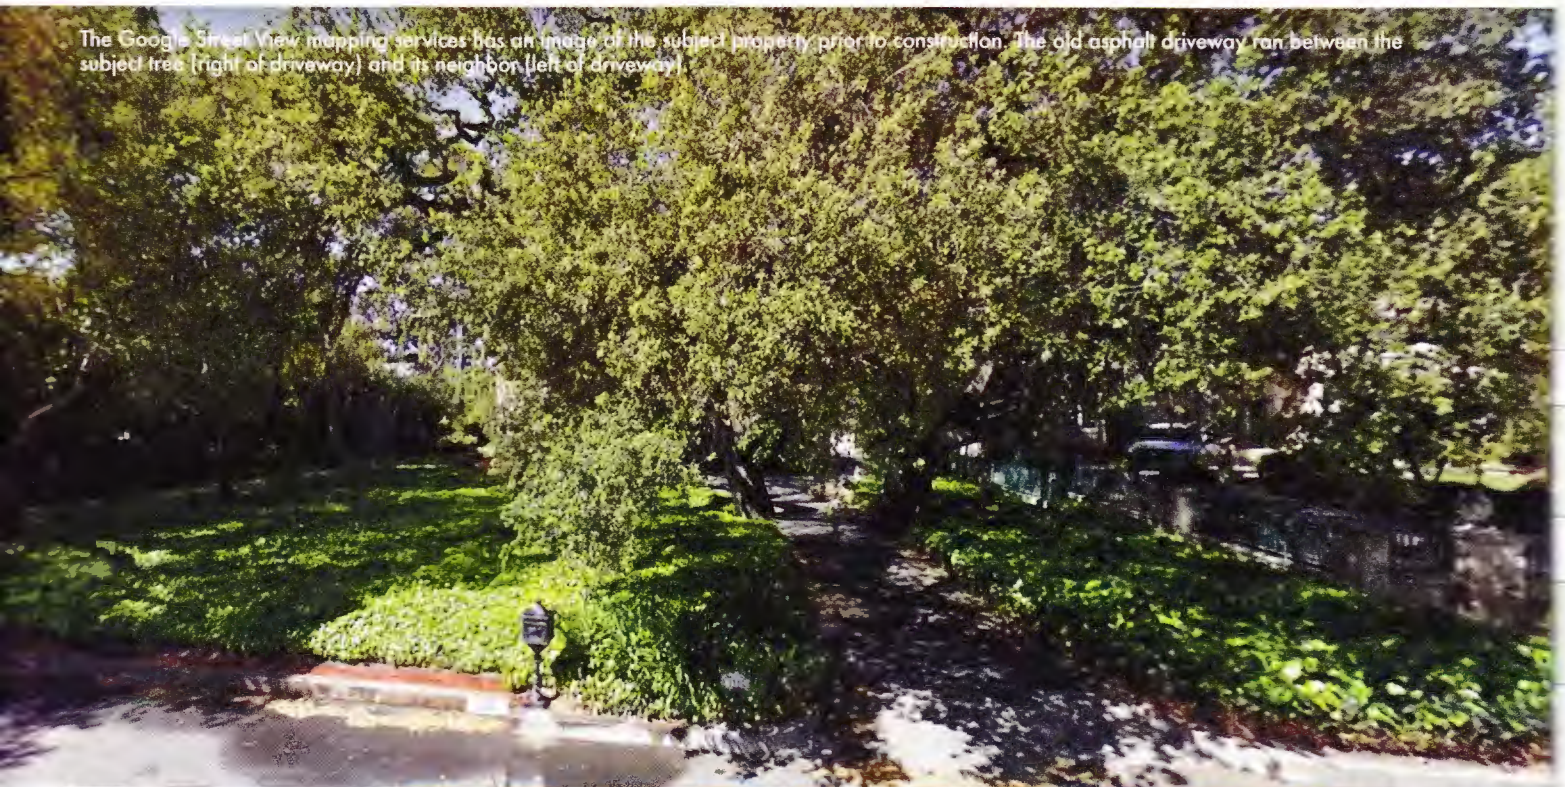
The Google Street View mapping services has an image of the subject property prior to construction. The old asphalt driveway ran between the subject tree (right of driveway) and its neighbor (left of driveway).
