Example Construction Impact Arborist Report

Prepared for *Client*

Prepared by James Komen

Class One Arboriculture Inc.

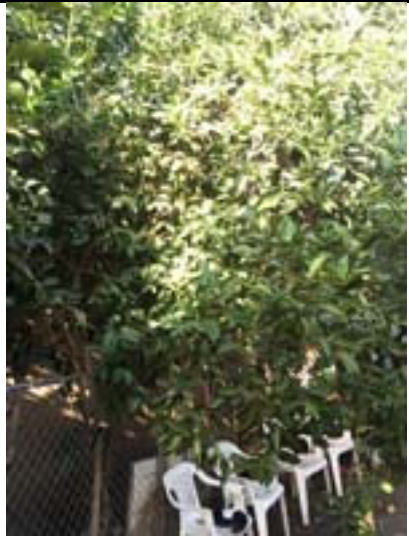
<p>Tree 1 <i>Psidium guajava</i> – Guava</p> <p>This tree is too small to be protected by ordinance. It will be removed as part of the proposed lot clearing.</p> <p>This tree has a history of past topping, but it is still vigorous. I assigned it a condition rating of 60%. I assigned it a functional limitations rating of 90% because of its messy fruit drop for part of the year.</p>
 	<p>Tree 2 <i>Eriobotrya japonica</i> – Loquat</p> <p>This tree is too small to be protected by ordinance. It will be removed as part of the proposed lot clearing.</p> <p>This tree has a history of past topping, but it is still vigorous. I assigned it a condition rating of 70%.</p>
 	<p>Tree 3 <i>Citrus sinensis</i> – Orange Tree</p> <p>This tree is too small to be protected by ordinance. It will be removed as part of the proposed lot clearing.</p> <p>This tree has minor leafminer damage. It is partly rootbound from its former pot. I assigned it a condition rating of 60%.</p>

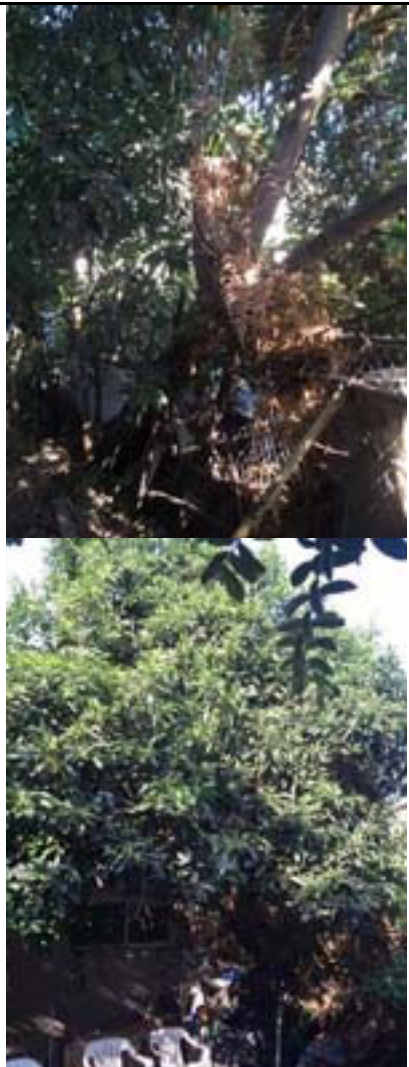
<p>Tree 4 <i>Citrus sp.</i> – Citrus</p> <p>This tree is too small to be protected by ordinance. It will be removed as part of the proposed lot clearing.</p> <p>This tree is rootbound from its prior container. It was formerly grown in a bucket laying on grade, but it broke through the bucket as it grew. I assigned it a condition rating of 40%.</p>

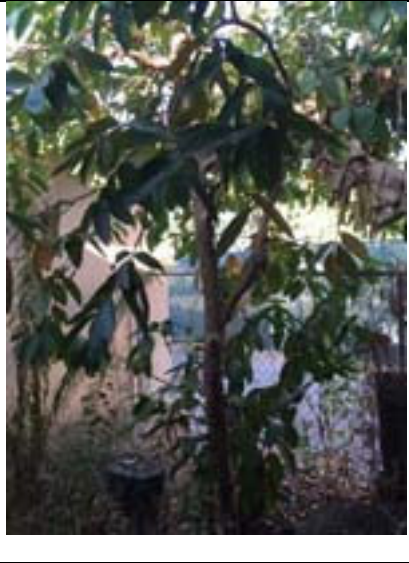
<p>Tree 5 <i>Persea americana</i> – Avocado</p> <p>This tree is a protected heritage tree by ordinance because its circumference is larger than 36 inches. It will be removed as part of the proposed lot clearing.</p> <p>This tree has a prevailing lean, but it is otherwise healthy. I assigned it a condition rating of 80%.</p>

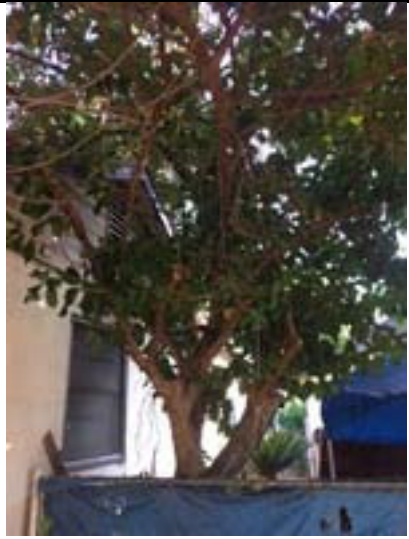
<p>Tree 8 <i>Persea americana</i> – Avocado</p> <p>This tree is too small to be protected by ordinance. It will be removed as part of the proposed lot clearing.</p> <p>This tree is partially suppressed by competition with its neighbors. I assigned it a condition rating of 70%.</p>

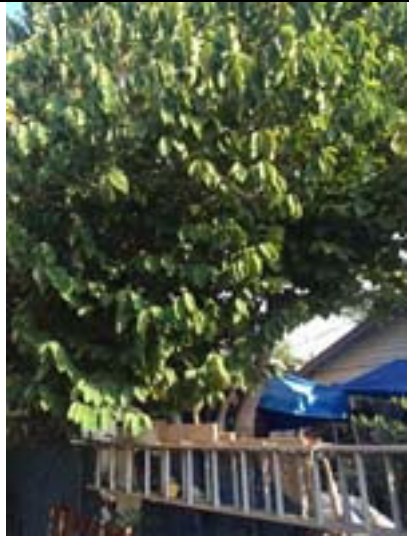
<p>Tree 9 <i>Psidium guajava</i> – Guava</p> <p>This tree is too small to be protected by ordinance. It will be removed as part of the proposed lot clearing.</p> <p>This tree has a history of past topping, but it is still vigorous. I assigned it a condition rating of 60%. I assigned it a functional limitations rating of 80% for its messy fruit drop for part of the year in close proximity to the adjacent home.</p>

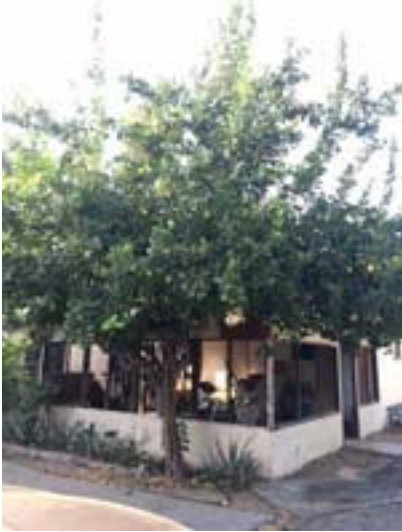
<p>Tree 12 <i>Citrus sp.</i> – Citrus</p> <p>This tree is too small to be protected by ordinance. It will be removed as part of the proposed lot clearing.</p> <p>This tree has co-dominant stem defects and minor leafminer damage, but it is overall in good condition. I assigned it a condition rating of 60%.</p>

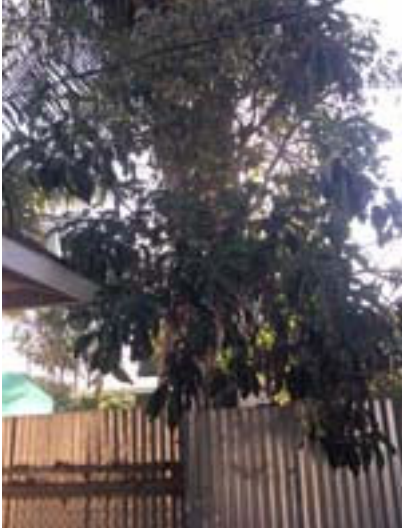
<p>Tree 15 <i>Psidium sp.</i> – Guava</p> <p>This tree is too small to be protected by ordinance. It will be removed as part of the proposed lot clearing.</p> <p>This tree has a history of past topping, but it is still vigorous. I assigned it a condition rating of 60%. I assigned it a functional limitations rating of 80% for its messy fruit drop for part of the year in close proximity to the adjacent home.</p>

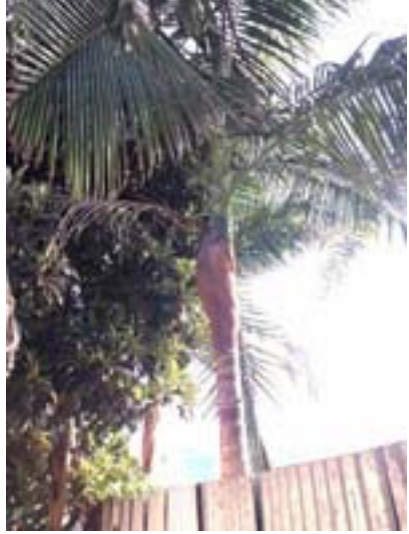
<p>Tree OP16 <i>Persea americana</i> – Avocado</p> <p>This tree is too small to be protected by ordinance. It is growing on the neighboring property to the east. It will be pruned for clearance over the subject property.</p> <p>This tree has symptoms of heat and drought stress. I assigned it a condition rating of 40%.</p> <p>If a CMU wall is built along the property line, then this tree's roots may be negatively impacted.</p>

- Pruning:
 - Obtain permission from the neighboring property owner to the east before pruning Tree OP16.
 - Prune the branches of Tree OP16 that encroach over the property and interfere with the proposed construction project, removing the minimum amount of foliage necessary to achieve clearance.

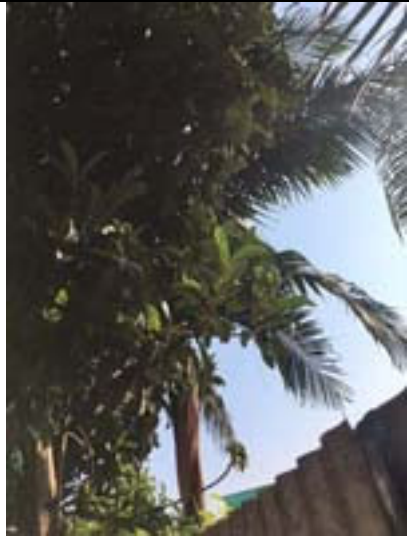
<p>Tree OP17 <i>Archontophoenix cunninghamiana</i> – King Palm</p> <p>This tree is too small to be protected by ordinance. It is growing on the neighboring property to the east. It is intended to be preserved through construction.</p> <p>This tree is healthy. I assigned it a condition rating of 90%.</p> <p>If a CMU wall is built along the property line, then this tree's roots may be negatively impacted.</p>

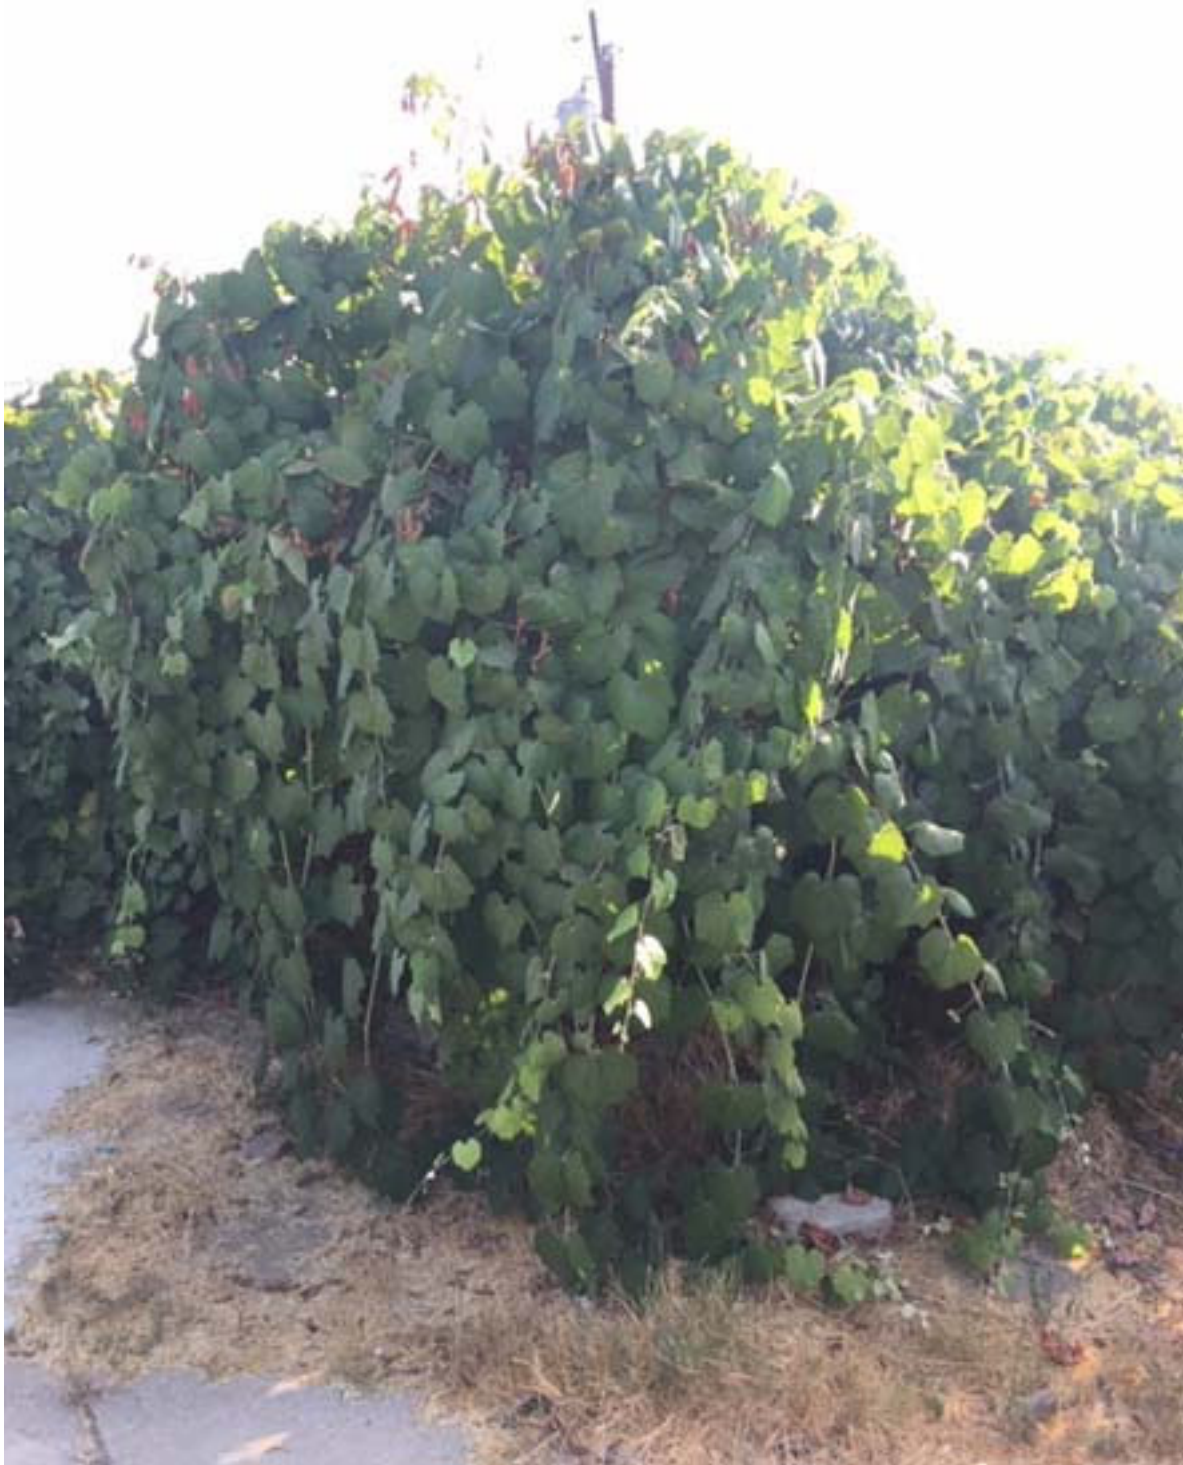
Figure 21: Tree 20

<p>Tree 20 <i>Psidium guajava</i> – Guava</p> <p>This tree is too small to be protected by ordinance. It will be removed as part of the proposed lot clearing.</p> <p>This tree is dead. It is covered in vines. I assigned it a condition rating of 0%.</p>
