Example Construction Impact Arborist Report

Prepared for ****CLIENT**

Prepared by James Komen

Class One Arboriculture Inc.

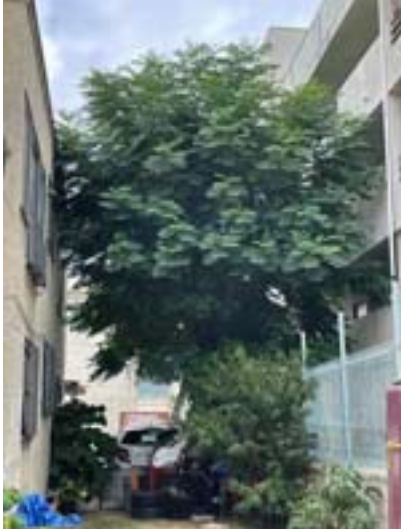
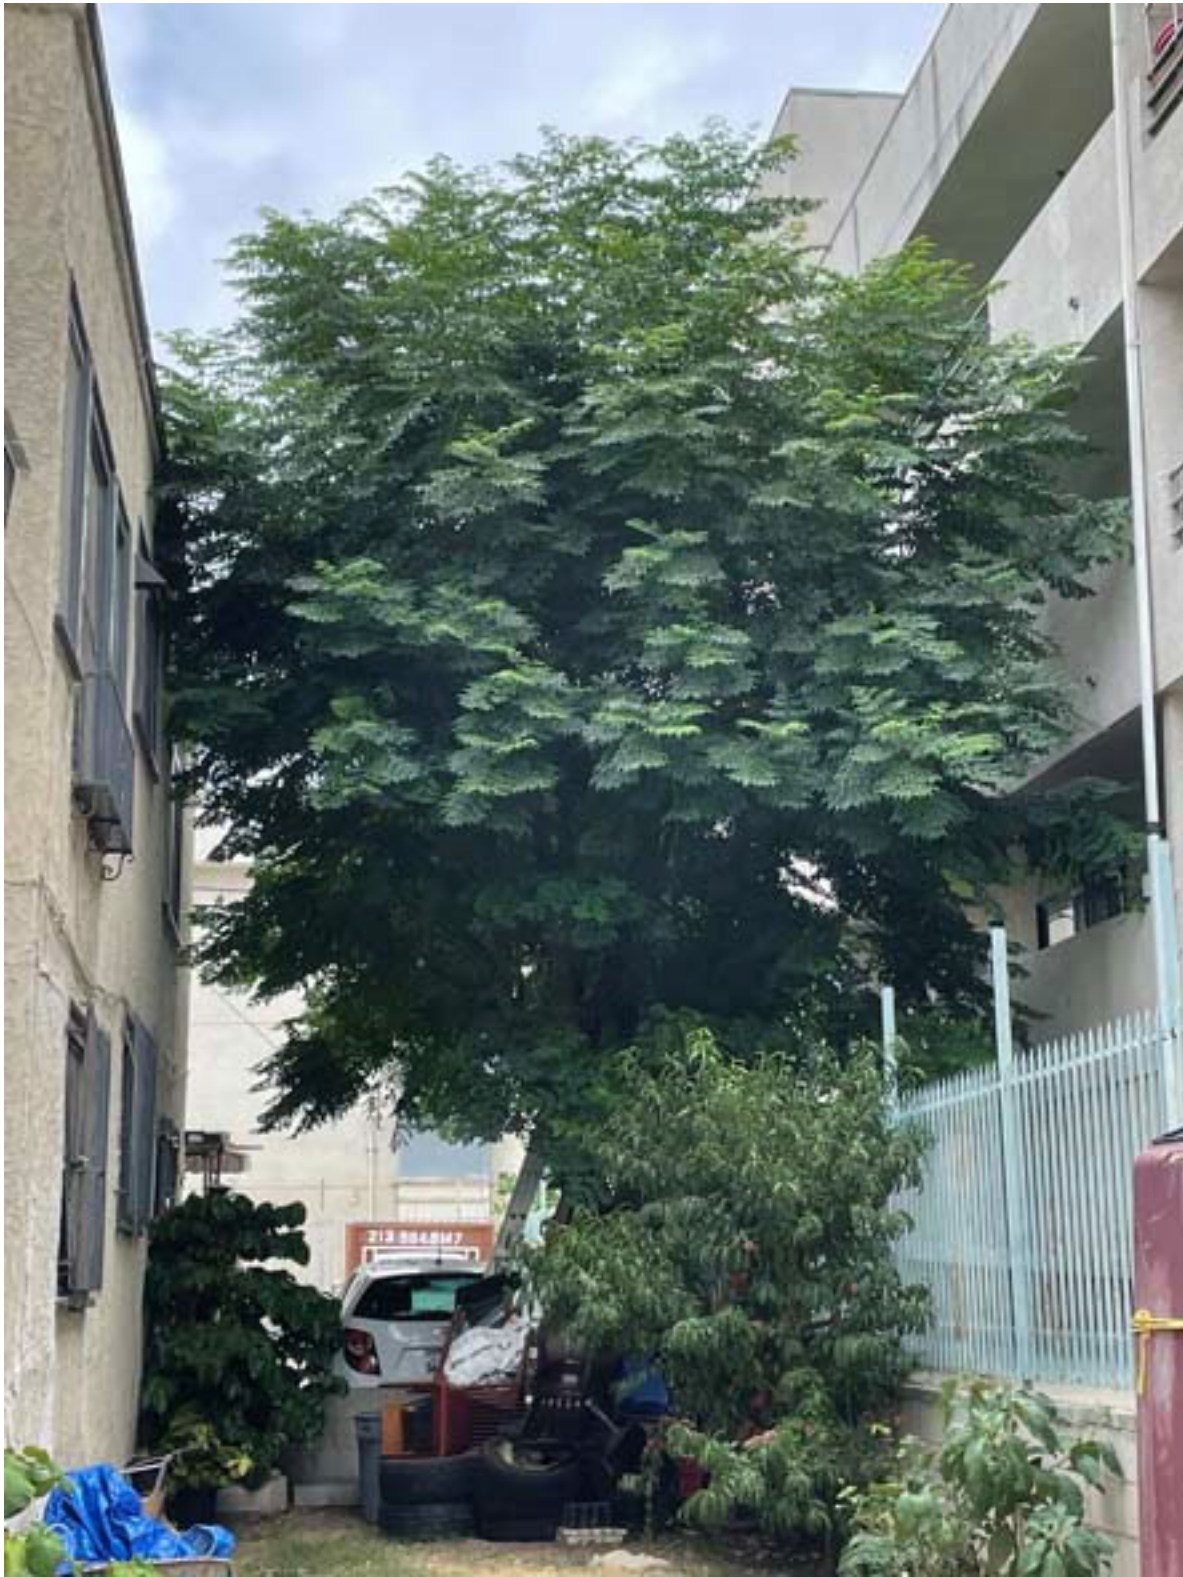
Figure 1: Tree 1

<p>Tree 1 <i>Melea azedarach</i> – Chinaberry</p> <p>This tree is not protected by ordinance. It will be removed because it is growing within the footprint of the proposed access walkway along the south side of the proposed building.</p> <p>This tree is healthy. I observed debris piled around its trunk, but the debris did not appear to have significantly affected the overall health or condition of the tree.</p>

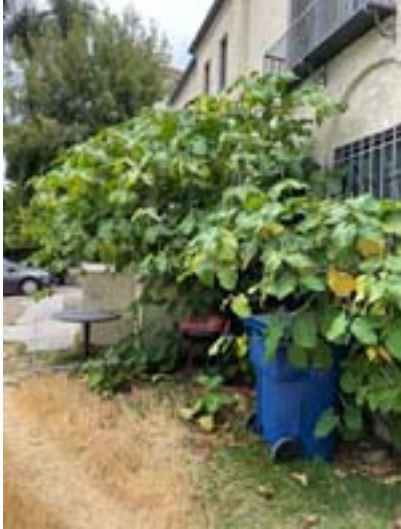
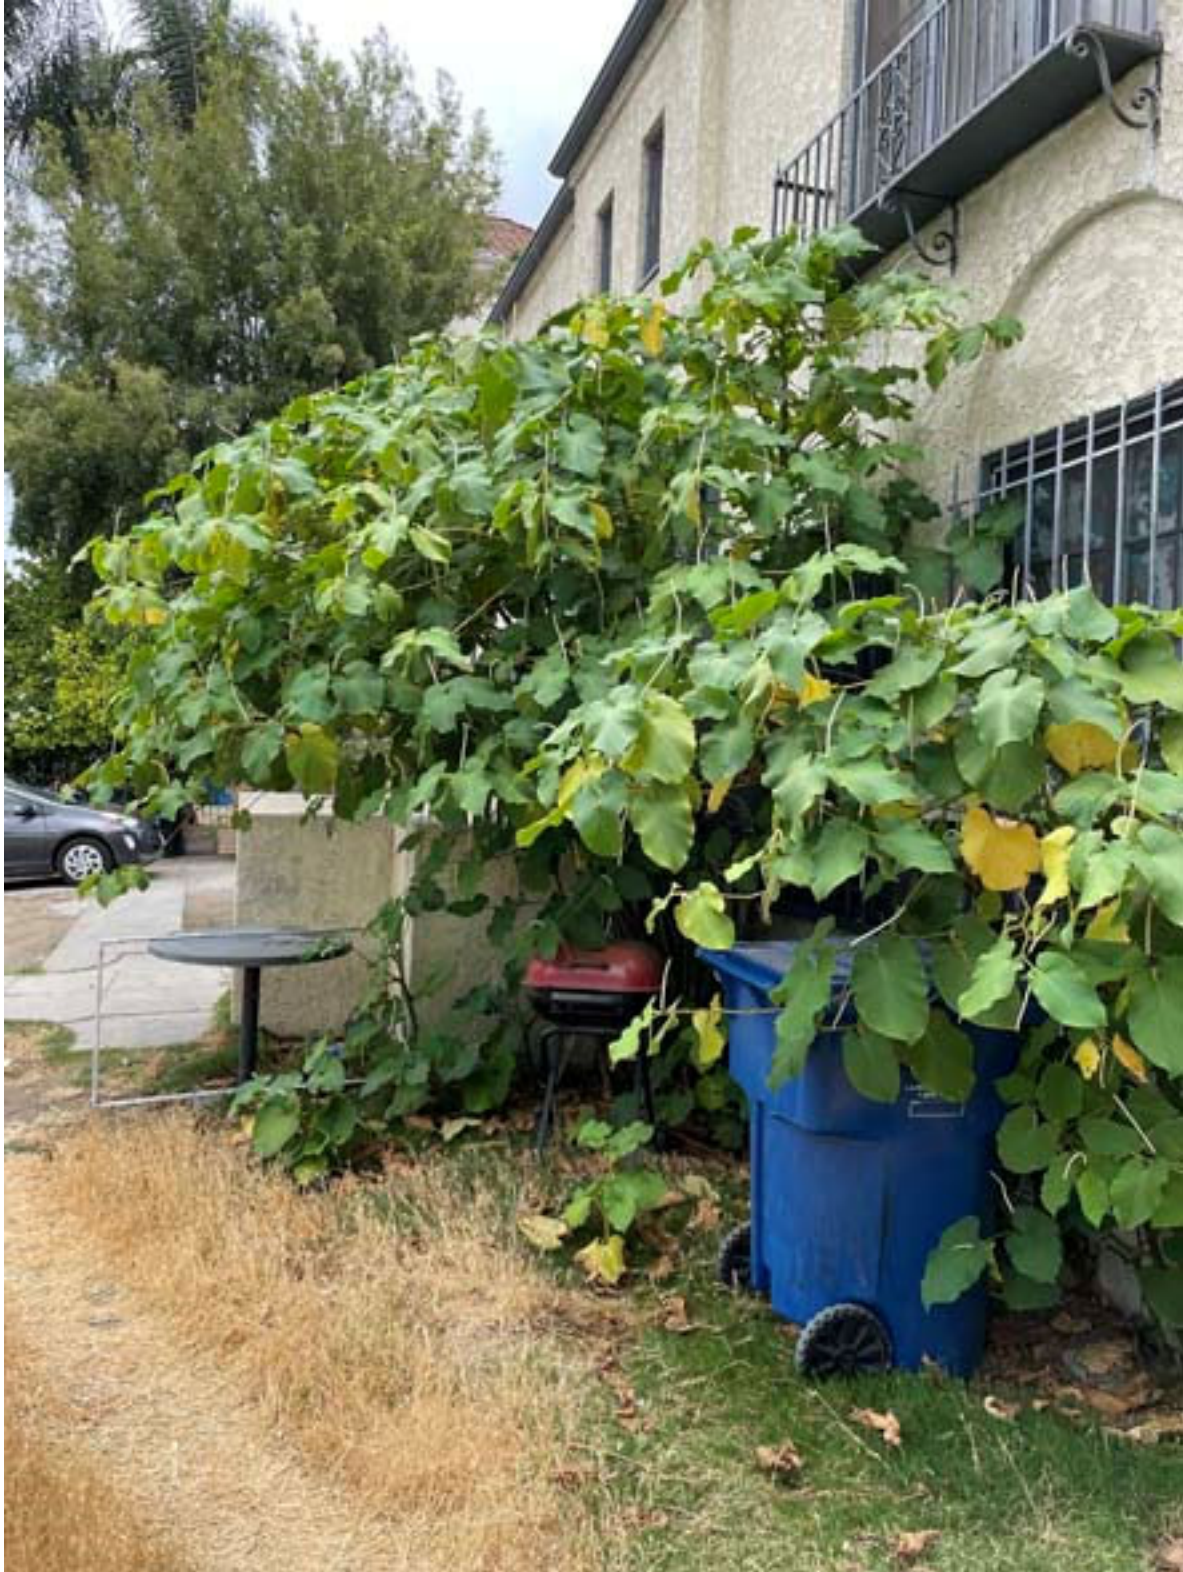
Figure 2: Tree 2

<p>Tree 2 <i>Brugmansia suaveolens</i> – Angel's Trumpet</p> <p>This tree is not protected by ordinance. It will be removed because it is growing within the footprint of the proposed building.</p> <p>This tree is healthy.</p>

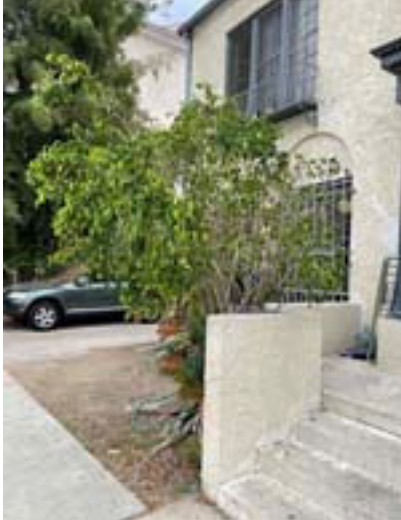
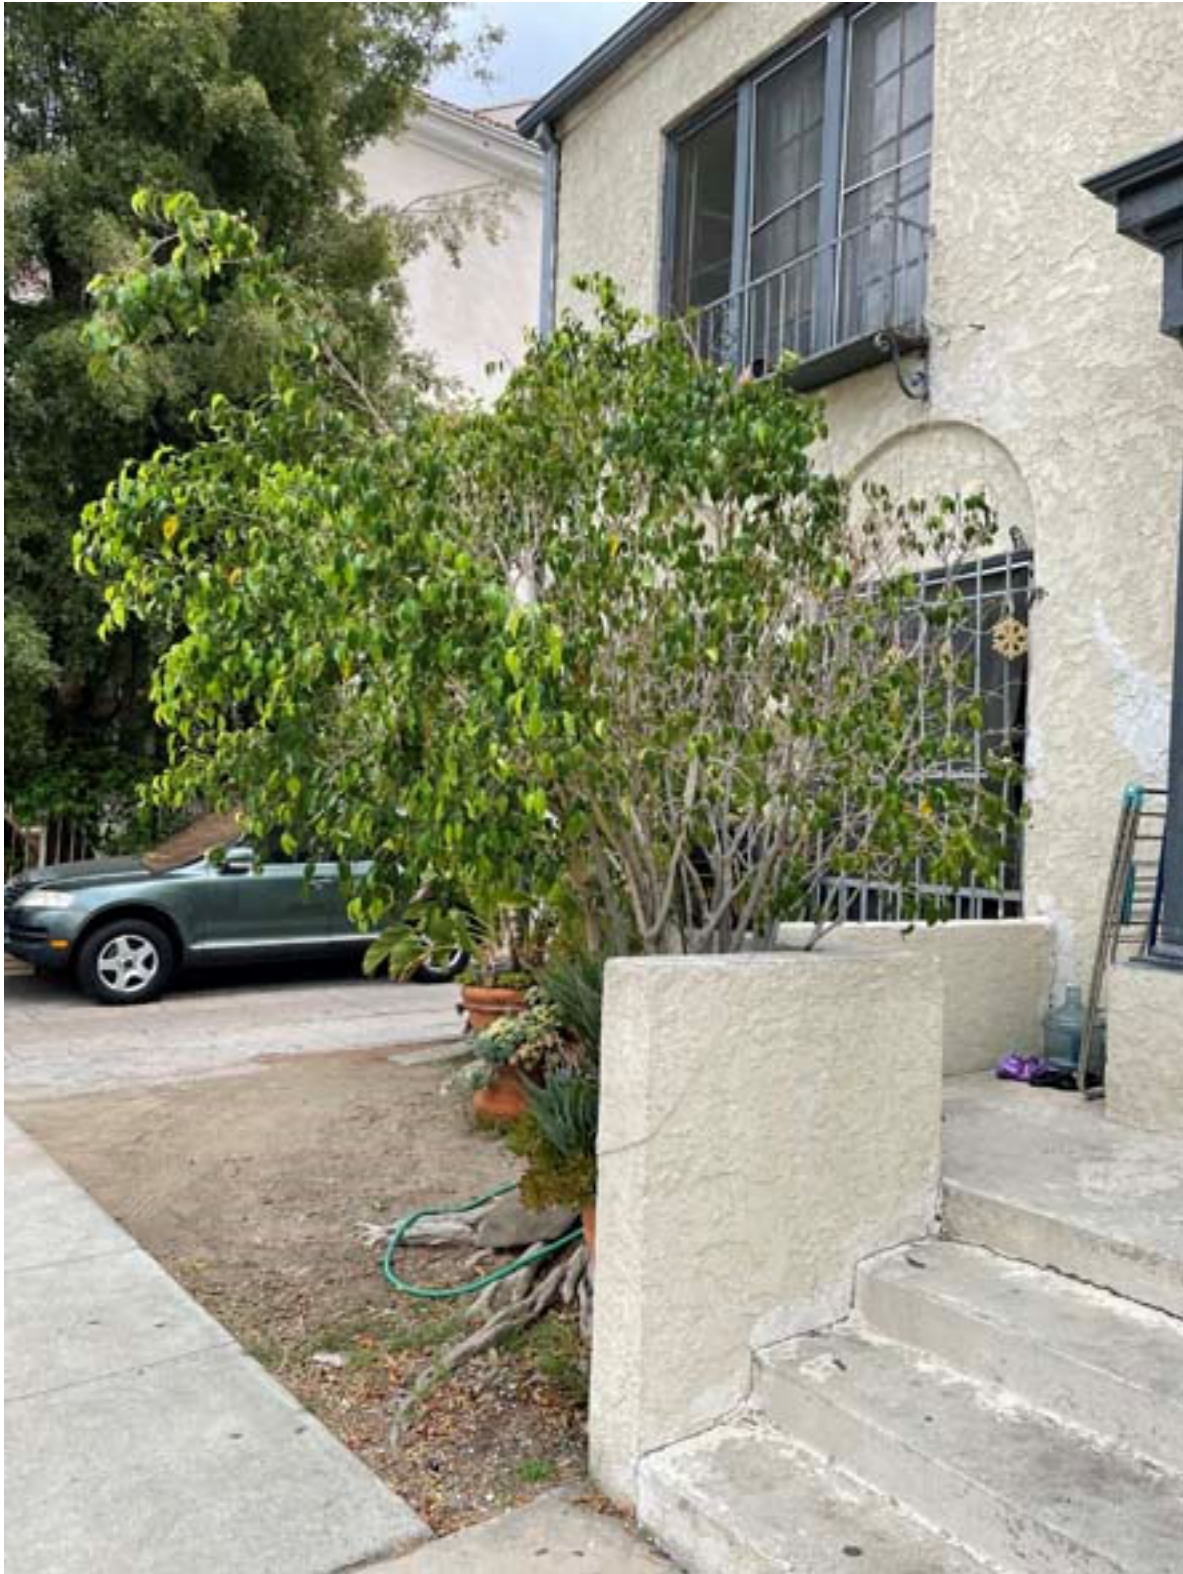
Figure 3: Tree 3

<p>Tree 3 <i>Ficus benjamina</i> – Weeping Fig</p> <p>This tree is not protected by ordinance. It will be removed because it is growing within the footprint of the proposed building.</p> <p>This tree is potted and root-bound, resulting in wilting foliage. It is in poor condition.</p>

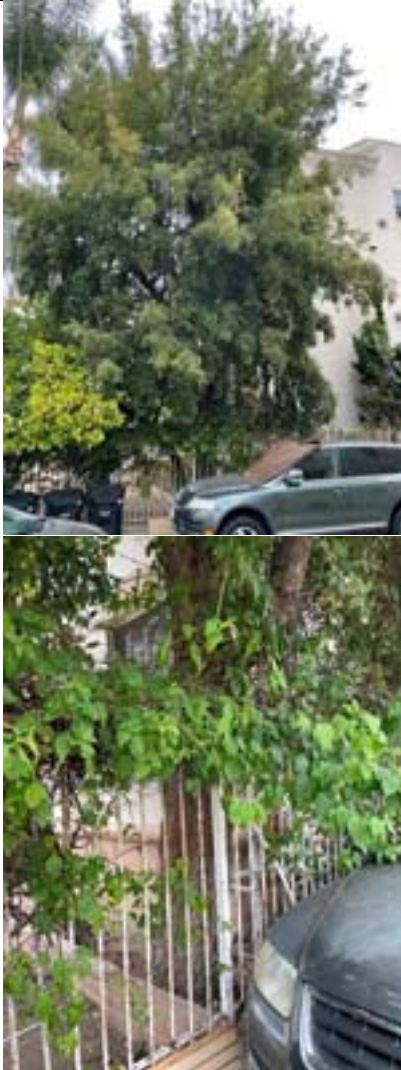
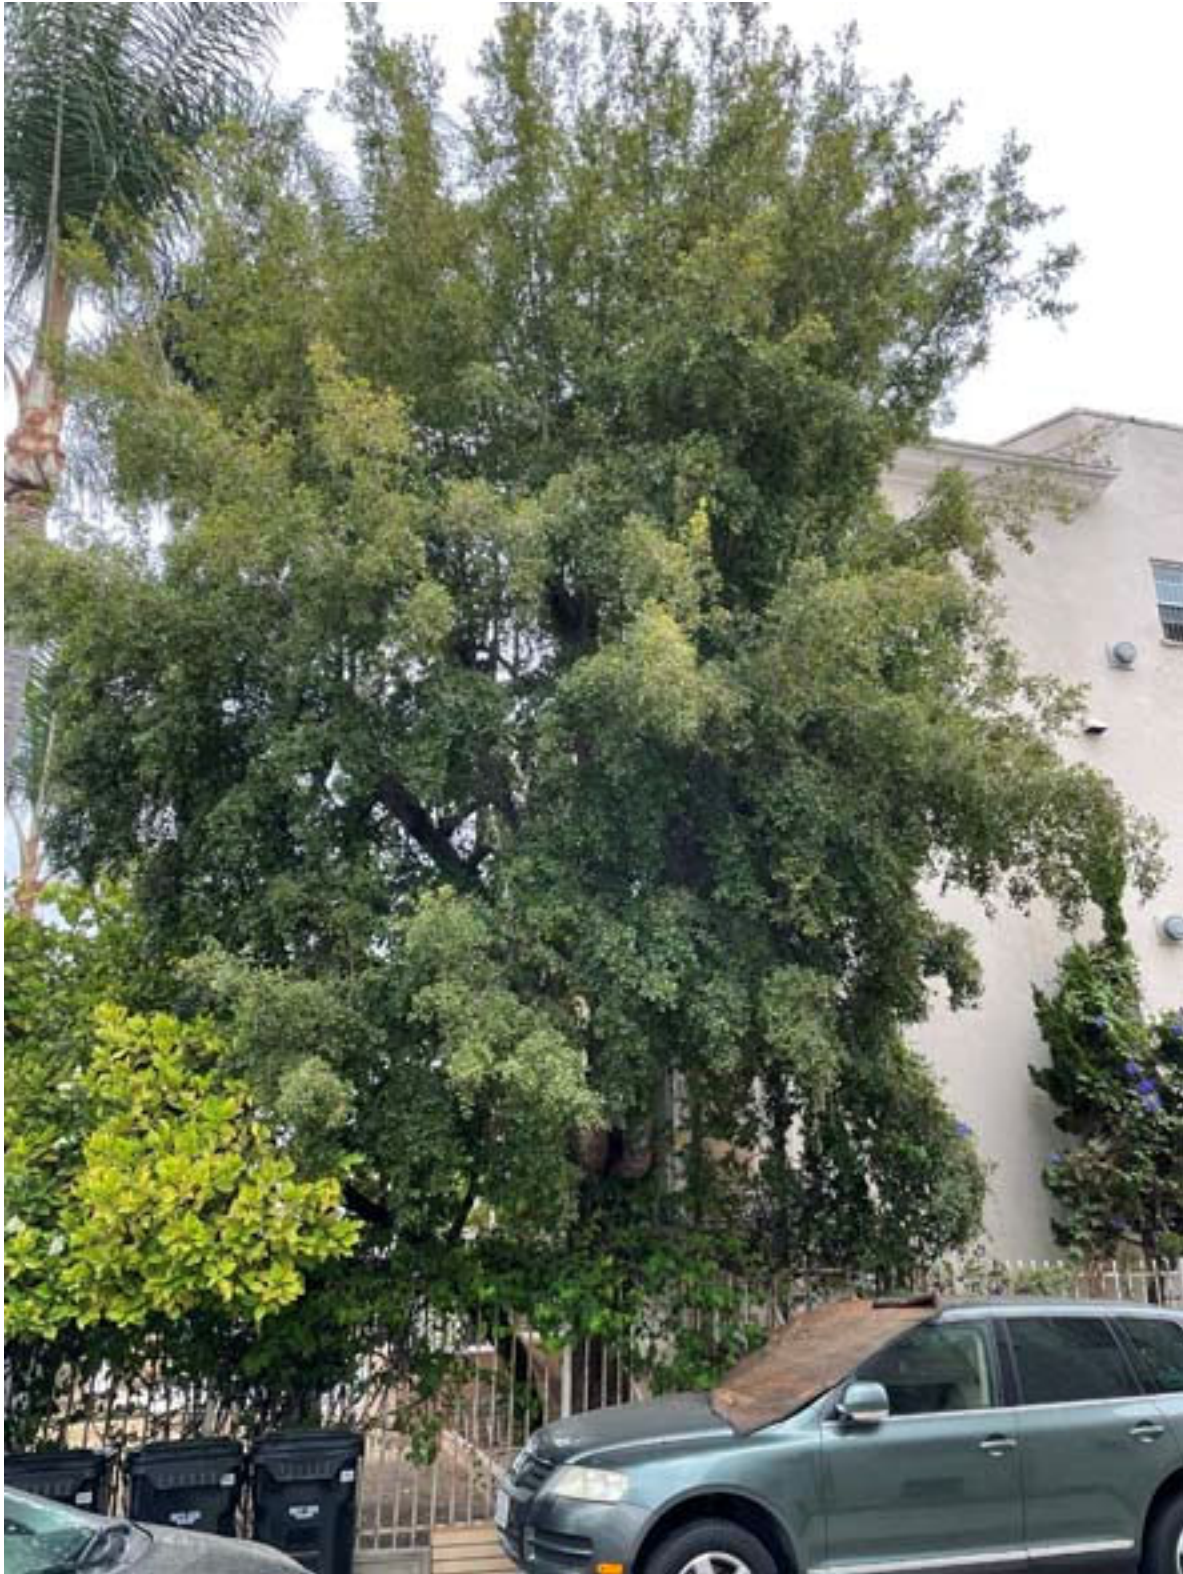
Figure 4: Tree OP4

<p>Tree OP4 <i>Syzygium australe</i> – Brush Cherry</p> <p>This tree is not protected by ordinance. It is growing on an adjacent property to the north. It will be retained in the landscape through the proposed project.</p> <p>This tree is healthy. It will be pruned for clearance over the work area. All pruning should be performed by a crew directly supervised by a Certified Arborist. Pruning cuts should not exceed 3 inches in diameter, and only the minimum amount of living foliage necessary to achieve work area clearance should be removed; the tree should not be pruned all the way to the property line. Provide reasonable notice to the neighboring property owner before performing the pruning.</p> <p>The proposed building will encroach within the critical root zone of this tree. All project activity within the drip line of this tree should be directly supervised by a Certified Arborist. Some of this tree's root system may be impacted, but it is intended to be retained in place throughout the project.</p> <p>The combined impacts of pruning and root disturbance will likely have a significant effect on this tree's condition. Notwithstanding, this tree is intended to be retained in place.</p>

- Prune Trees OP4 and OP13 for clearance over the work area. Pruning cuts should not exceed 3 inches in diameter. Lateral branches should be pruned back to their unions with their respective parent stems, and no stubs should be left.

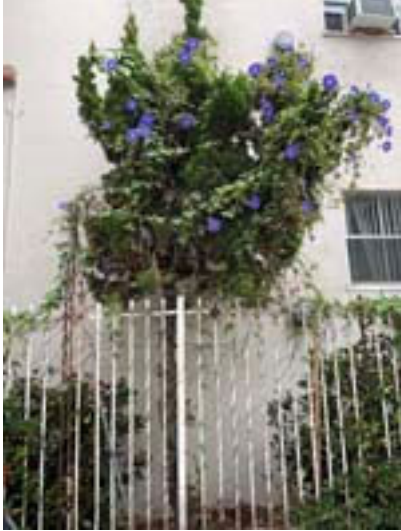
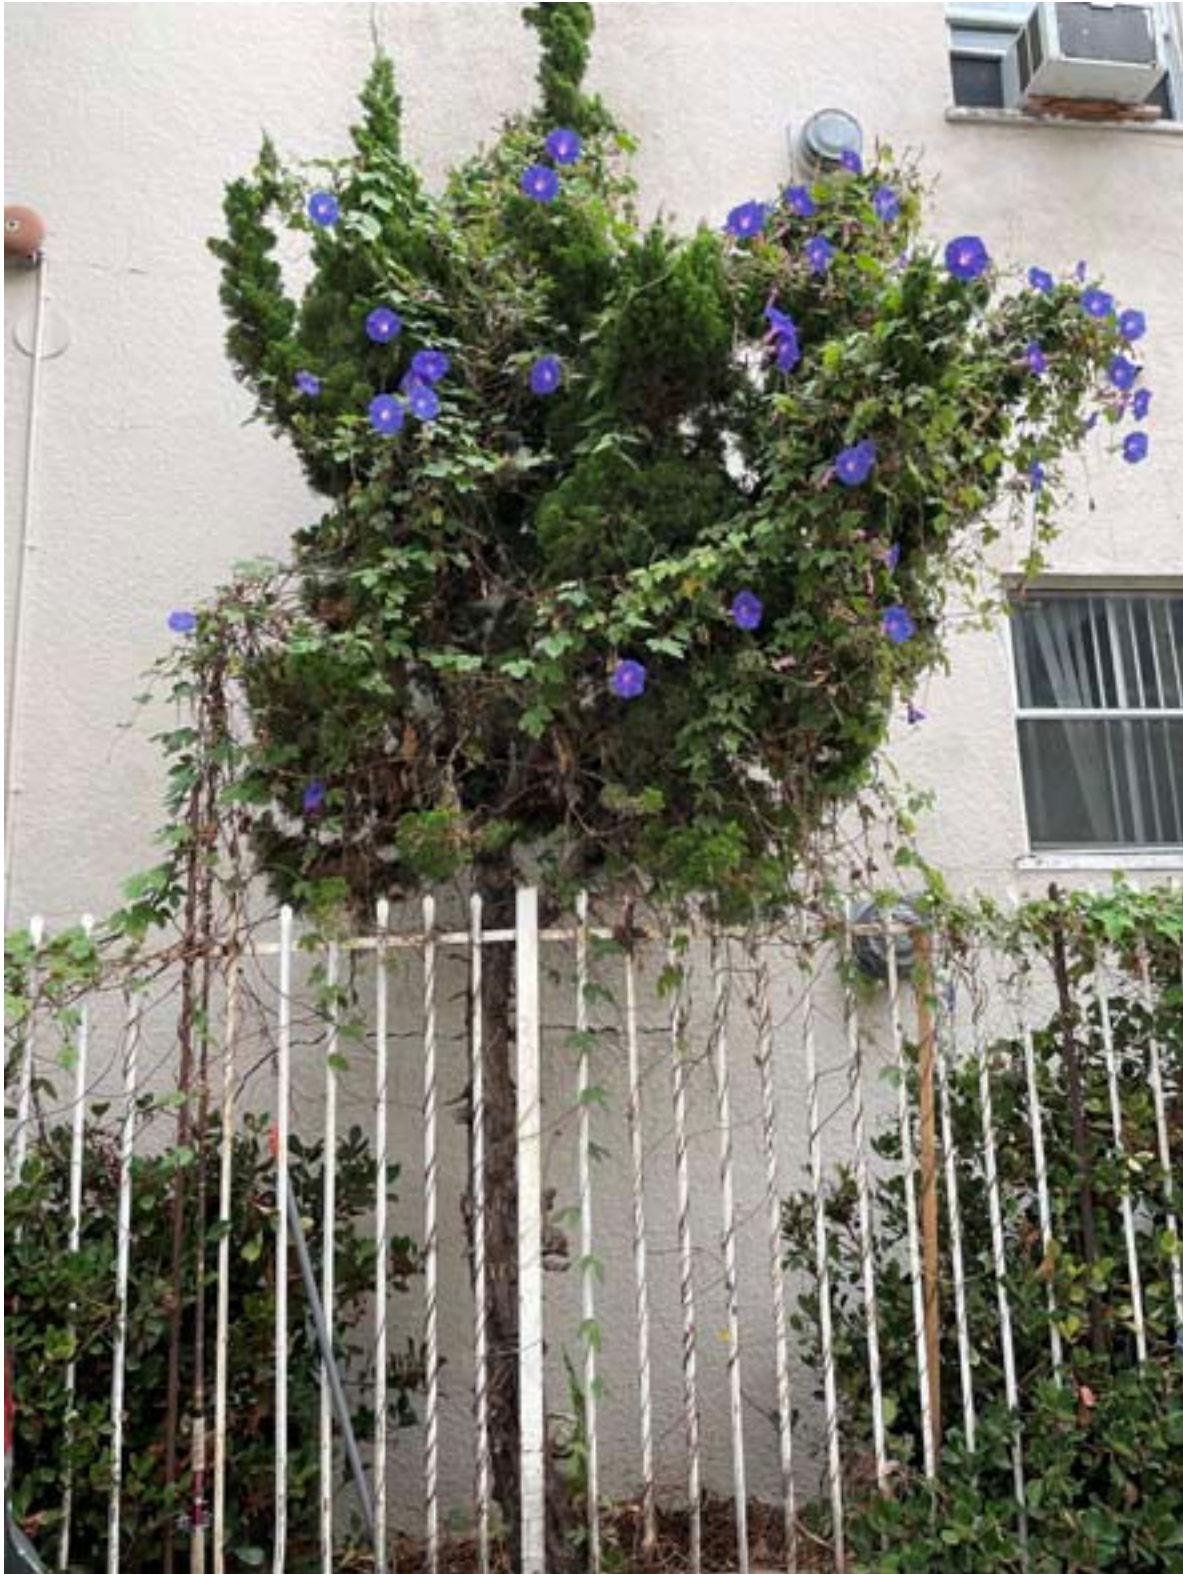
Figure 6: Tree OP5

<p>Tree OP5 <i>Juniperus chinensis</i> – Hollywood Juniper</p> <p>This tree is not protected by ordinance. It is growing on an adjacent property to the north. It will be retained in the landscape through the proposed project.</p> <p>This tree has been suppressed by a morning glory vine that has colonized its canopy. It is in average condition. I recommend pruning off the morning glory vine.</p> <p>The proposed access walkway along the northern property boundary will encroach within the critical root zone of this tree. All project activity within the drip line of this tree should be directly supervised by a Certified Arborist. Some of this tree's root system may be impacted, but it is intended to be retained in place throughout the project.</p>

- Remove the morning glory vine that has colonized Trees OP5-OP11. Avoid removing living branches from the trees themselves.
- After obtaining permits to do so, remove the trees approved for removal by the urban planner.

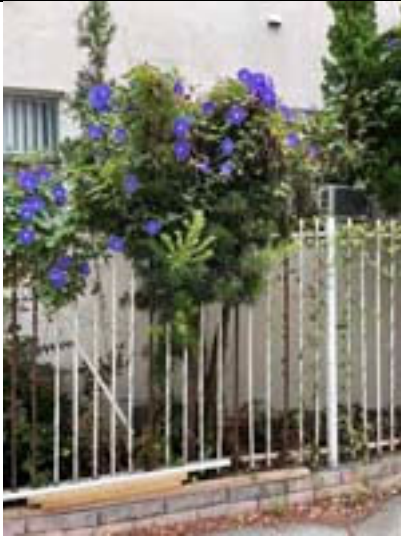
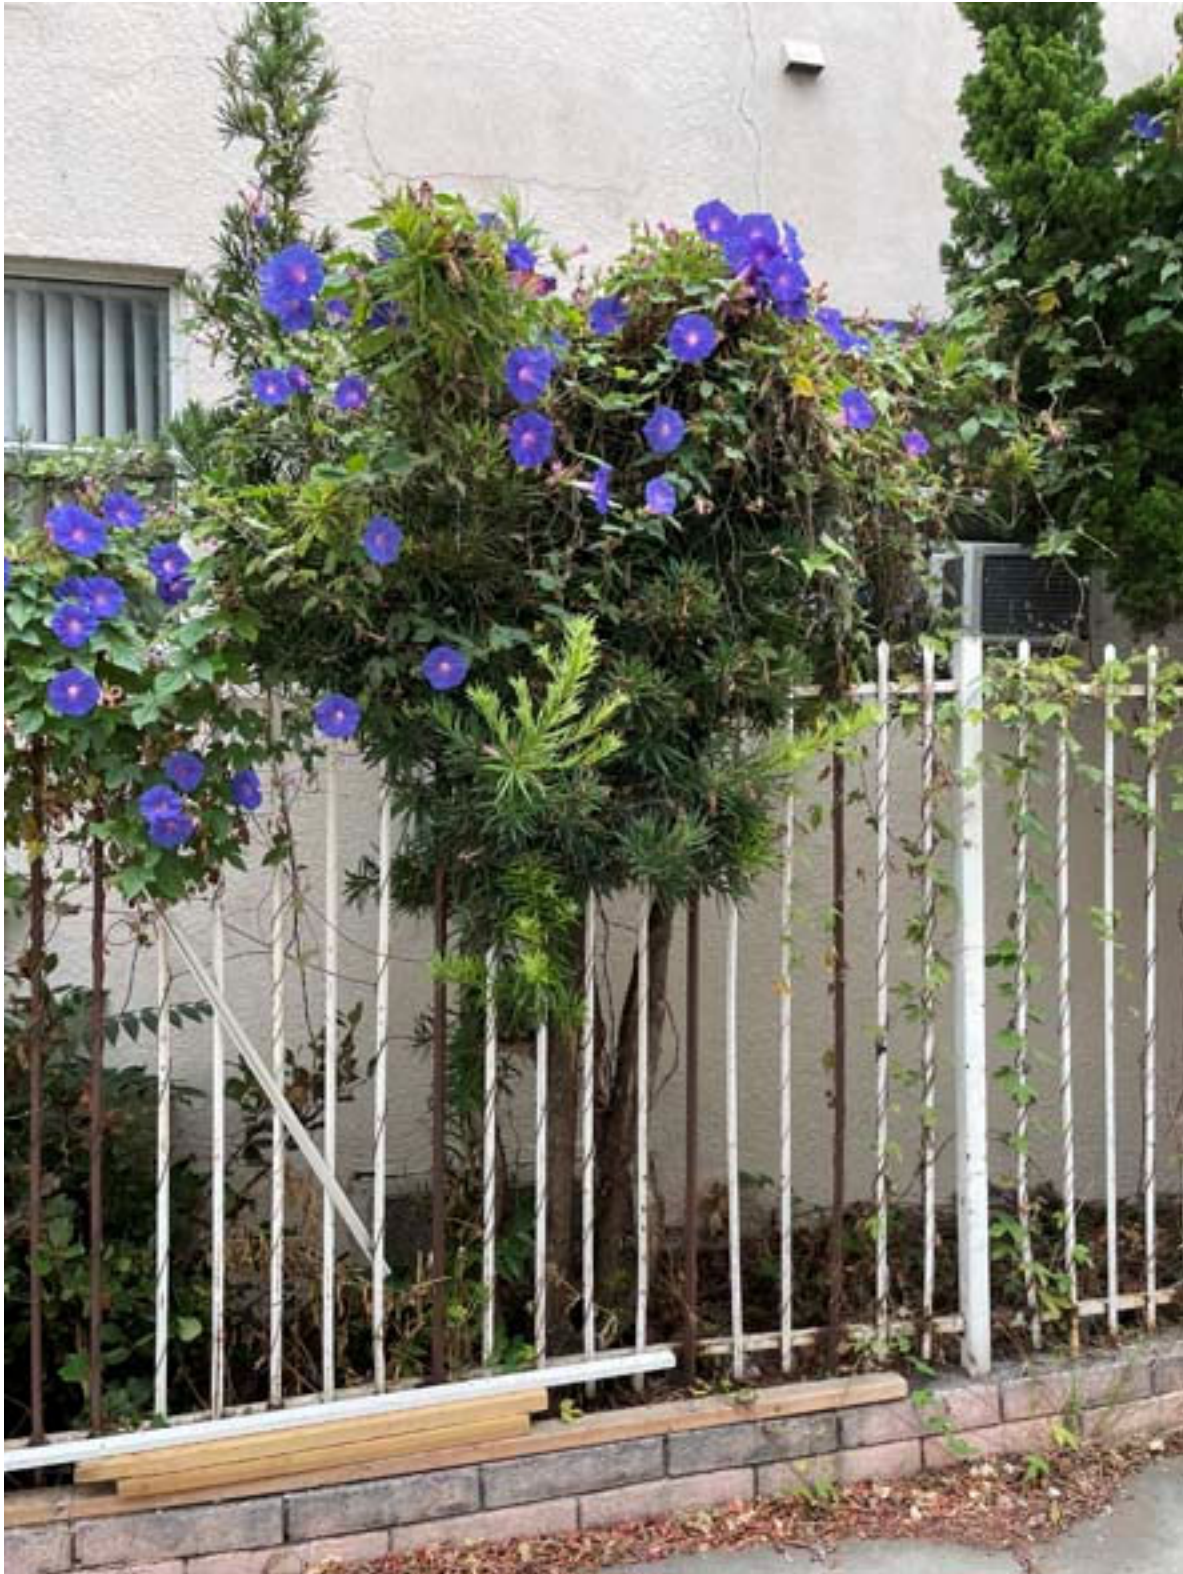
Figure 7: Tree OP6

<p>Tree OP6 <i>Podocarpus gracilior</i> – Fern Pine</p> <p>This tree is not protected by ordinance. It is growing on an adjacent property to the north. It will be retained in the landscape through the proposed project.</p> <p>This tree has been suppressed by a morning glory vine that has colonized its canopy. It is in poor condition. I recommend pruning off the morning glory vine.</p> <p>The proposed access walkway along the northern property boundary will encroach within the critical root zone of this tree. All project activity within the drip line of this tree should be directly supervised by a Certified Arborist. Some of this tree's root system may be impacted, but it is intended to be retained in place throughout the project.</p>

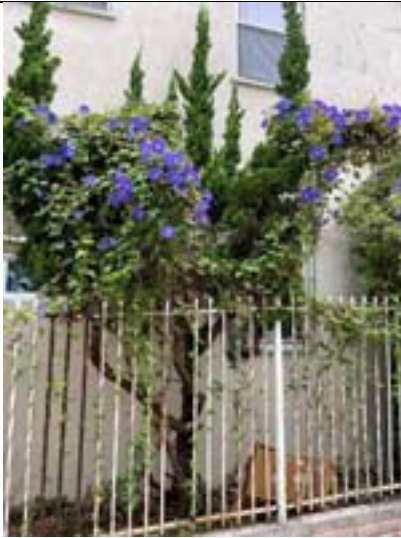
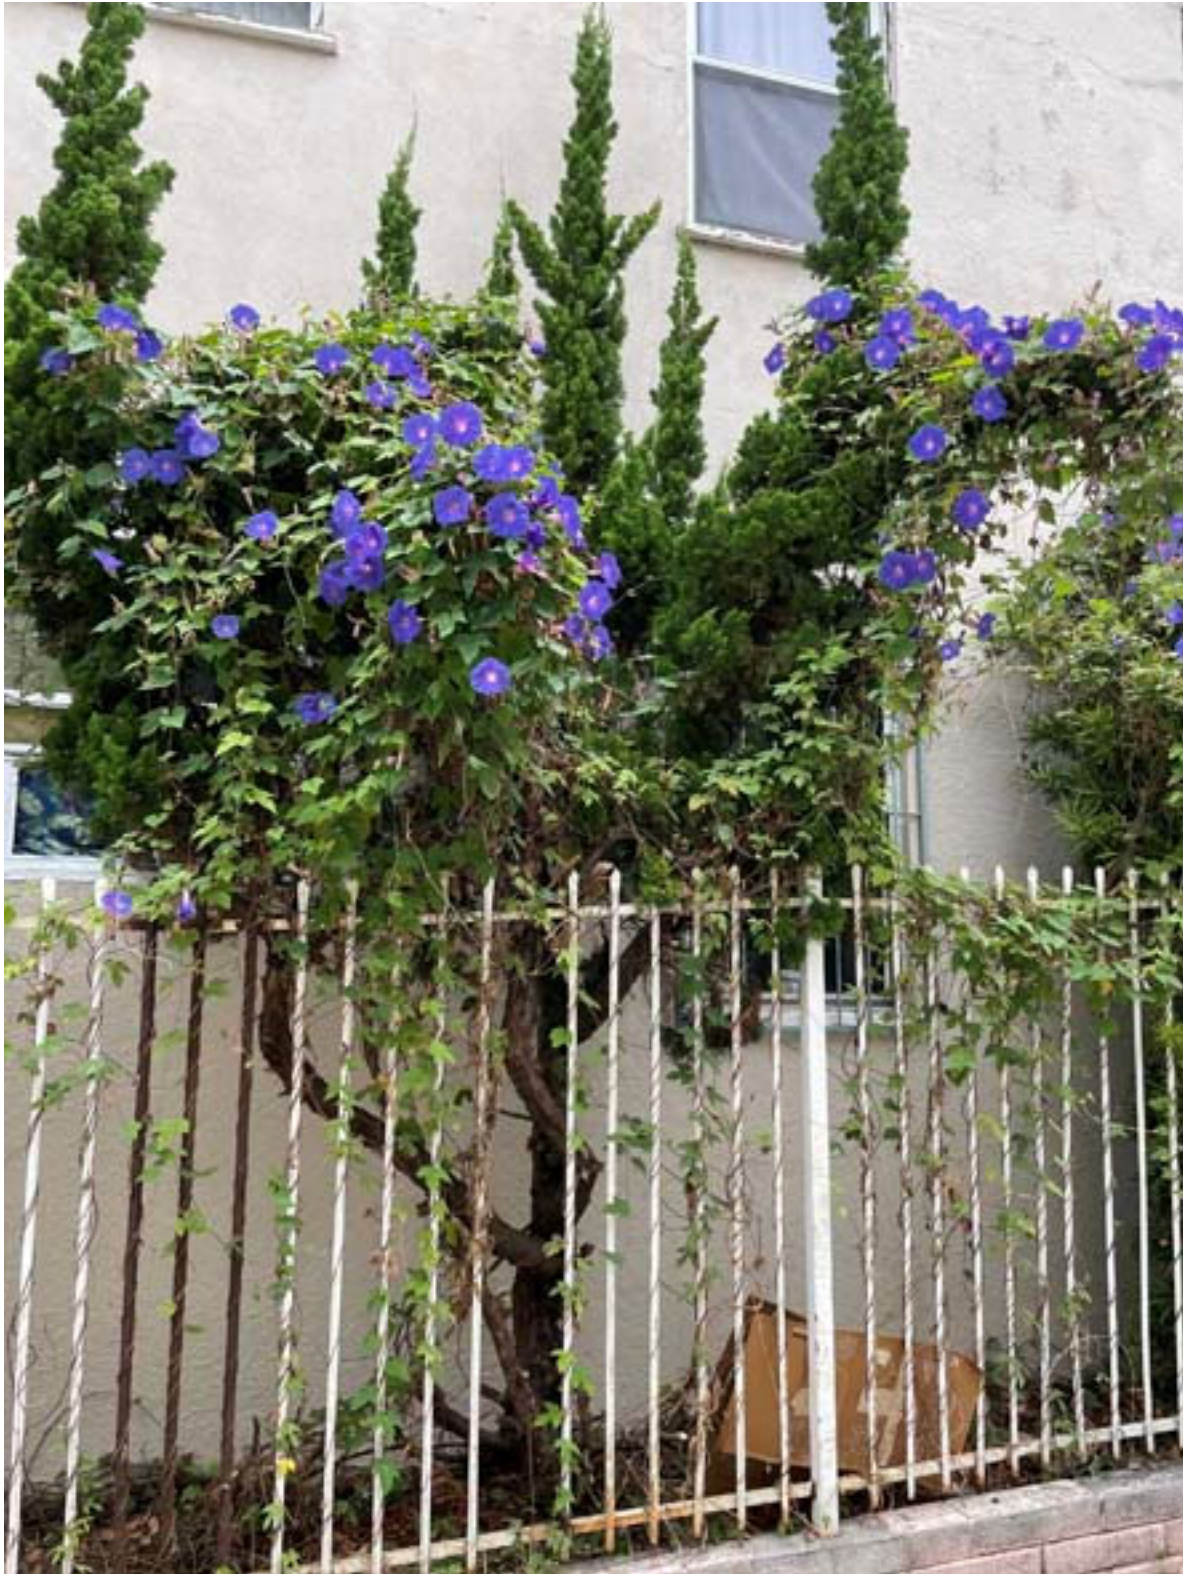
Figure 8: Tree OP7

<p>Tree OP7 <i>Juniperus chinensis</i> – Hollywood Juniper</p> <p>This tree is not protected by ordinance. It is growing on an adjacent property to the north. It will be retained in the landscape through the proposed project.</p> <p>This tree has been suppressed by a morning glory vine that has colonized its canopy. It is in average condition. I recommend pruning off the morning glory vine.</p> <p>The proposed access walkway along the northern property boundary will encroach within the critical root zone of this tree. All project activity within the drip line of this tree should be directly supervised by a Certified Arborist. Some of this tree's root system may be impacted, but it is intended to be retained in place throughout the project.</p>

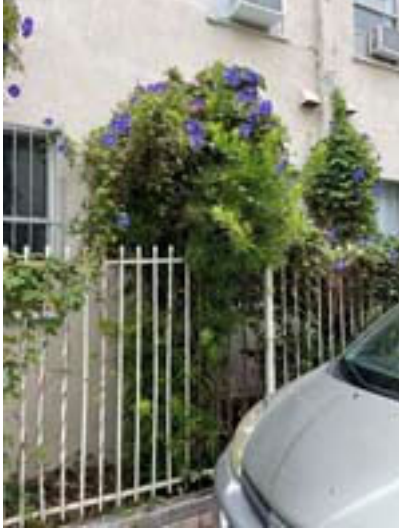
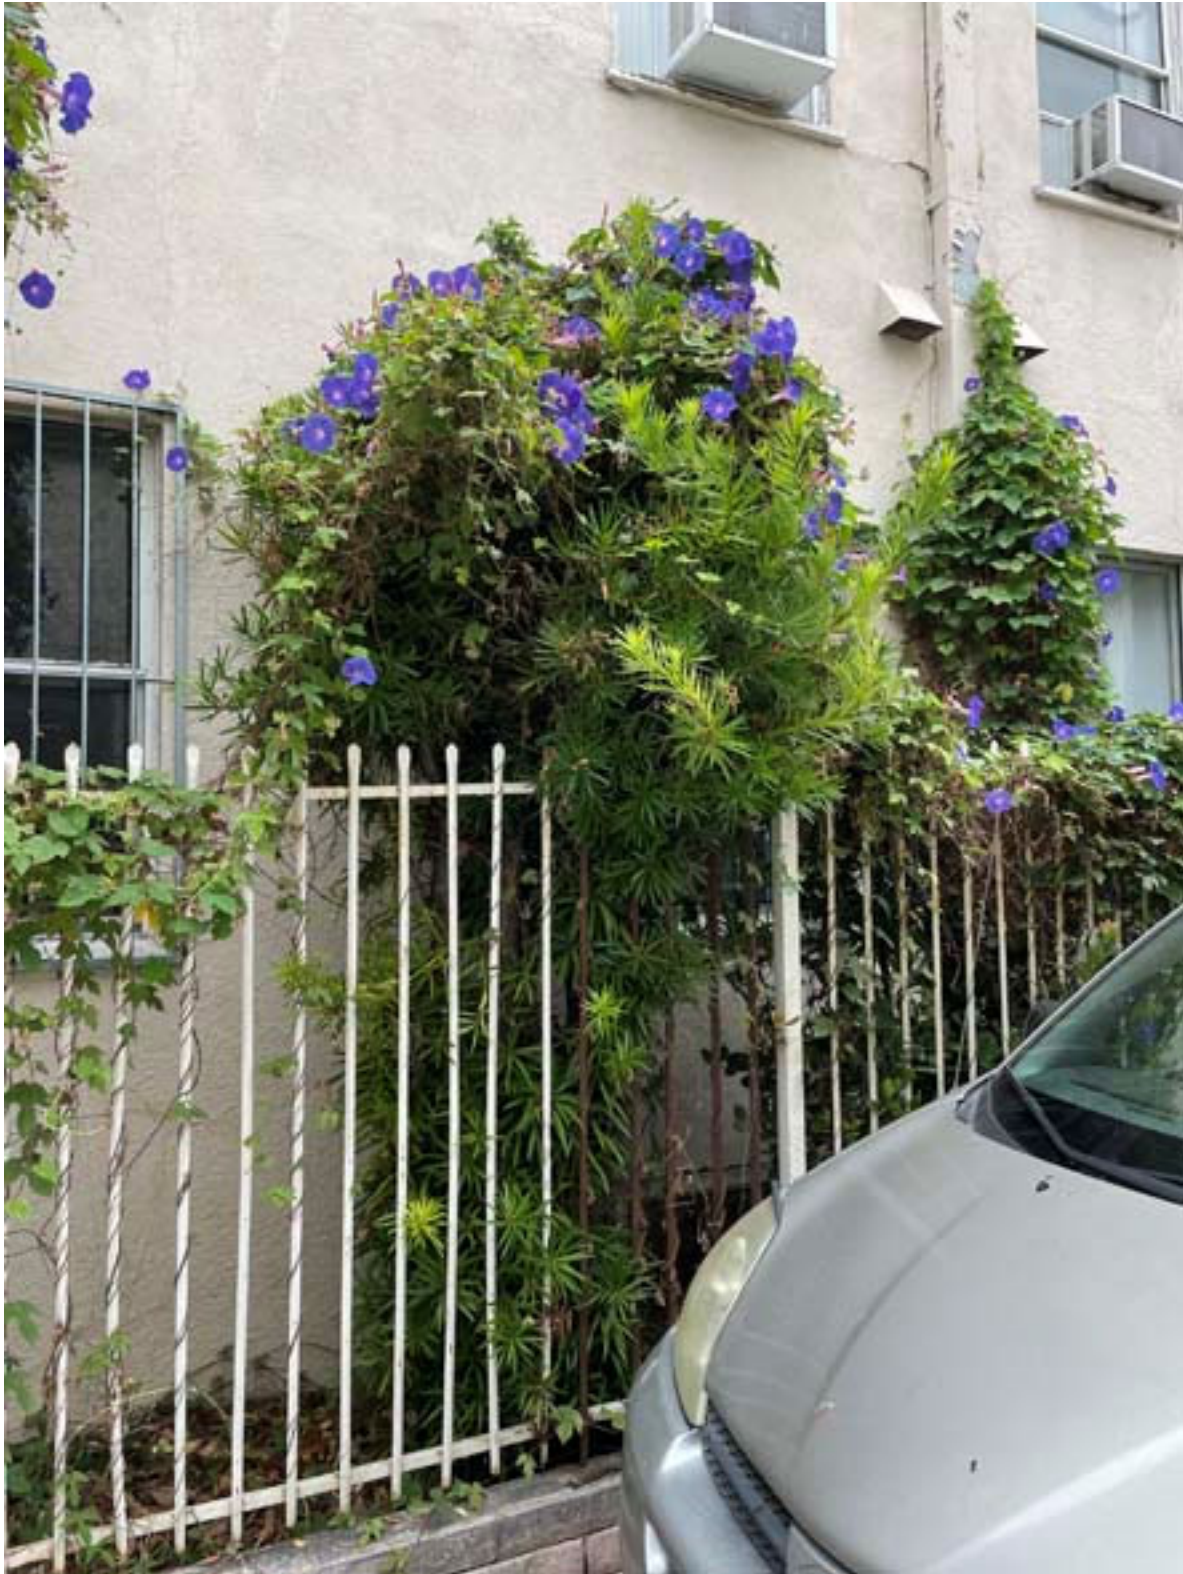
Figure 9: Tree OP8

<p>Tree OP8 <i>Podocarpus gracilior</i> – Fern Pine</p> <p>This tree is not protected by ordinance. It is growing on an adjacent property to the north. It will be retained in the landscape through the proposed project.</p> <p>This tree has been suppressed by a morning glory vine that has colonized its canopy. It is in poor condition. I recommend pruning off the morning glory vine.</p> <p>The proposed access walkway along the northern property boundary will encroach within the critical root zone of this tree. All project activity within the drip line of this tree should be directly supervised by a Certified Arborist. Some of this tree's root system may be impacted, but it is intended to be retained in place throughout the project.</p>

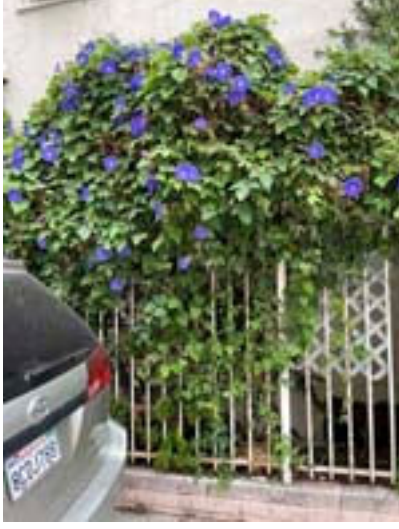
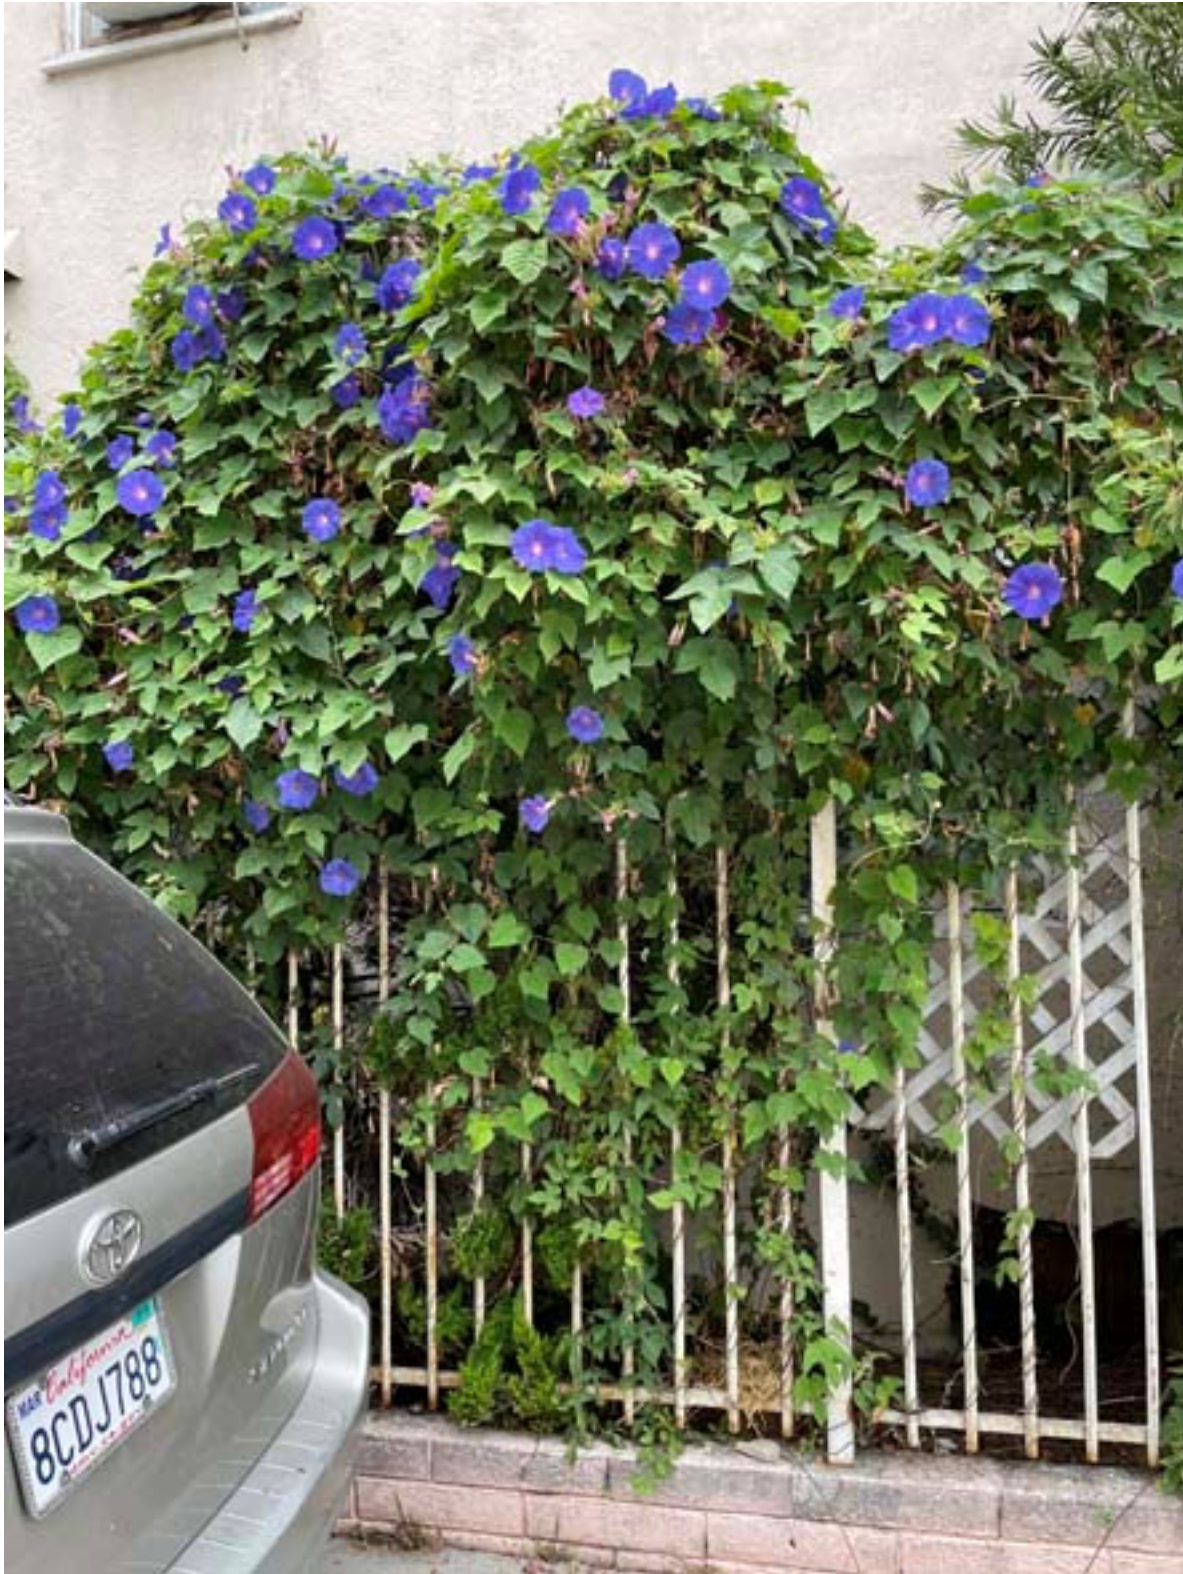
Figure 10: Tree OP9

<p>Tree OP9 <i>Juniperus chinensis</i> – Hollywood Juniper</p> <p>This tree is not protected by ordinance. It is growing on an adjacent property to the north. It will be retained in the landscape through the proposed project.</p> <p>This tree has been suppressed by a morning glory vine that has colonized its canopy. It is in poor condition. I recommend pruning off the morning glory vine.</p> <p>The proposed access walkway along the northern property boundary will encroach within the critical root zone of this tree. All project activity within the drip line of this tree should be directly supervised by a Certified Arborist. Some of this tree's root system may be impacted, but it is intended to be retained in place throughout the project.</p>

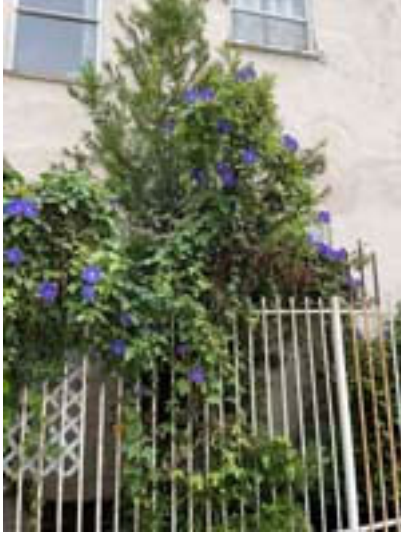
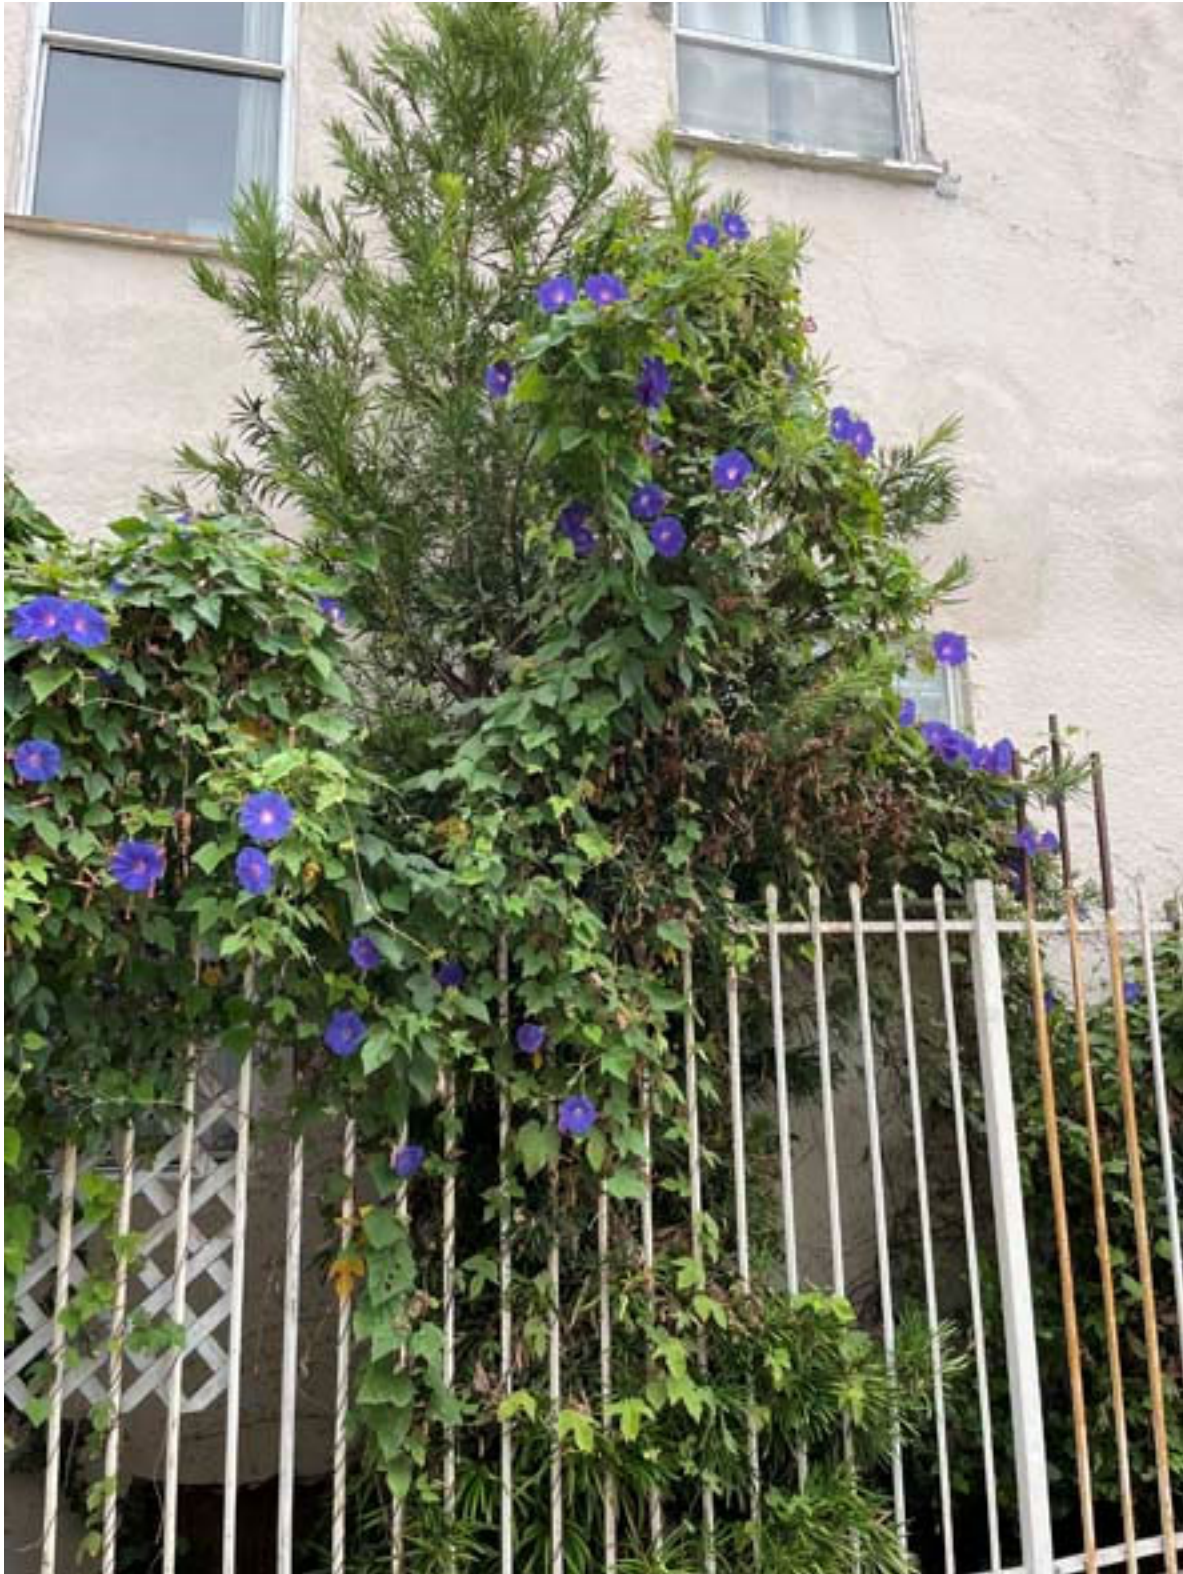
Figure 11: Tree OP10

<p>Tree OP10 <i>Podocarpus gracilior</i> – Fern Pine</p> <p>This tree is not protected by ordinance. It is growing on an adjacent property to the north. It will be retained in the landscape through the proposed project.</p> <p>This tree has been suppressed by a morning glory vine that has colonized its canopy. It is in average condition. I recommend pruning off the morning glory vine.</p> <p>The proposed access walkway along the northern property boundary will encroach within the critical root zone of this tree. All project activity within the drip line of this tree should be directly supervised by a Certified Arborist. Some of this tree's root system may be impacted, but it is intended to be retained in place throughout the project.</p>
