Example Construction Impact Arborist Report

Prepared for ****CLIENT**

Prepared by James Komen

Class One Arboriculture Inc.

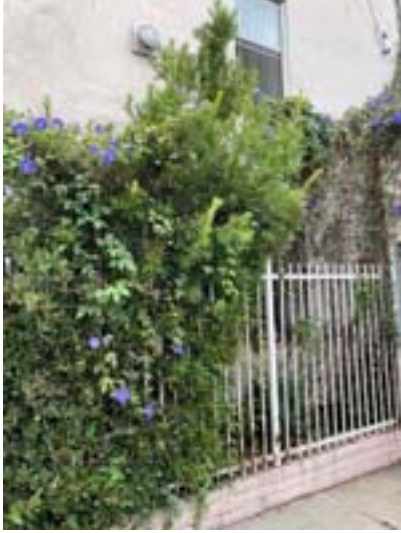
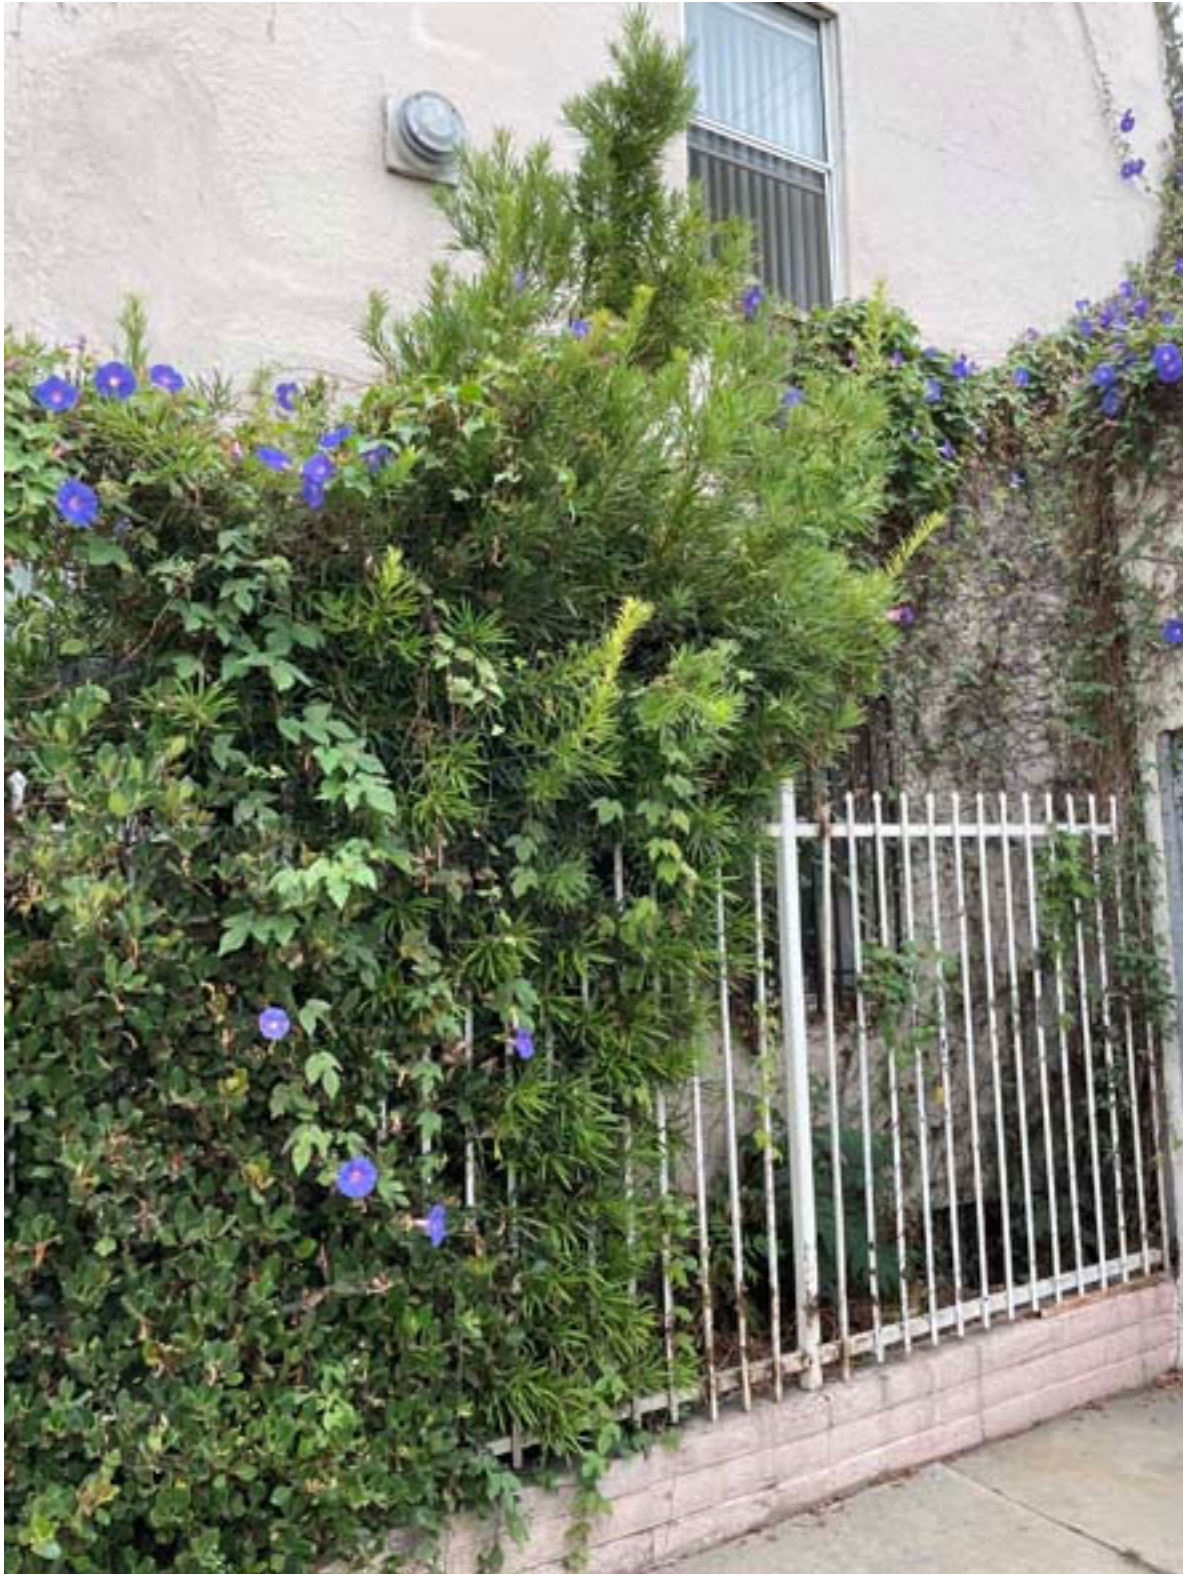
Figure 12: Tree OP11

<p>Tree OP11 <i>Podocarpus gracilior</i> – Fern Pine</p> <p>This tree is not protected by ordinance. It is growing on an adjacent property to the north. It will be retained in the landscape through the proposed project.</p> <p>This tree has been suppressed by a morning glory vine that has colonized its canopy. It is in average condition. I recommend pruning off the morning glory vine.</p> <p>The proposed access walkway along the northern property boundary will encroach within the critical root zone of this tree. All project activity within the drip line of this tree should be directly supervised by a Certified Arborist. Some of this tree's root system may be impacted, but it is intended to be retained in place throughout the project.</p>

- Remove the morning glory vine that has colonized Trees OP5-OP11. Avoid removing living branches from the trees themselves.
- After obtaining permits to do so, remove the trees approved for removal by the urban planner.

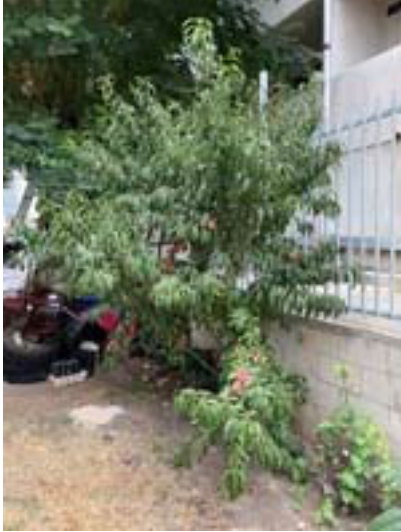
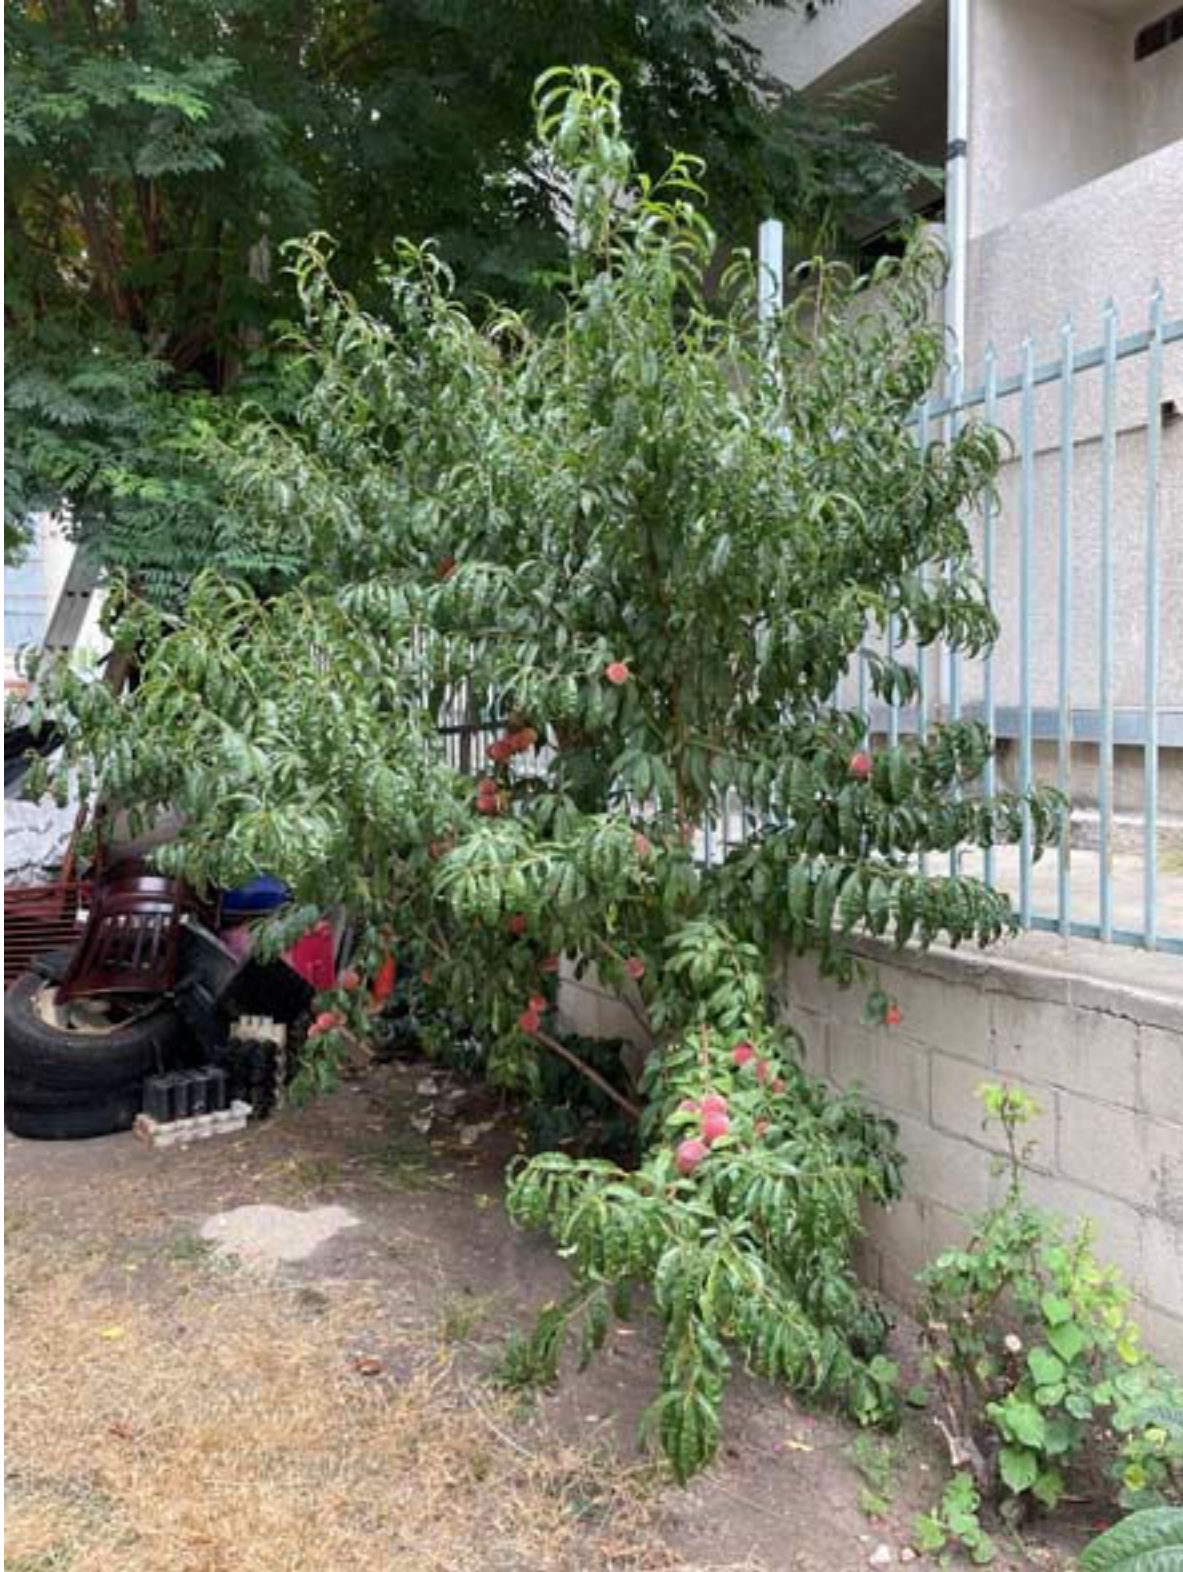
Figure 13: Tree 12

<p>Tree 12 <i>Prunus persica</i> – Peach</p> <p>This tree is not protected by ordinance. It will be removed because it is growing within the footprint of the proposed access walkway along the south side of the proposed building.</p> <p>This tree has symptoms of drought and heat stress. However, it is still in good condition.</p>

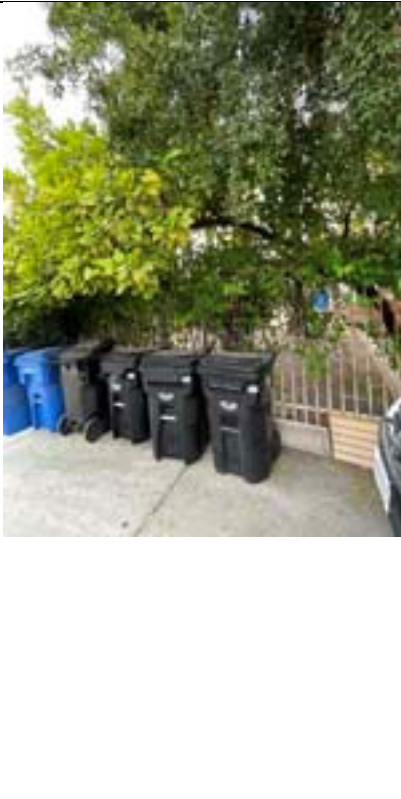
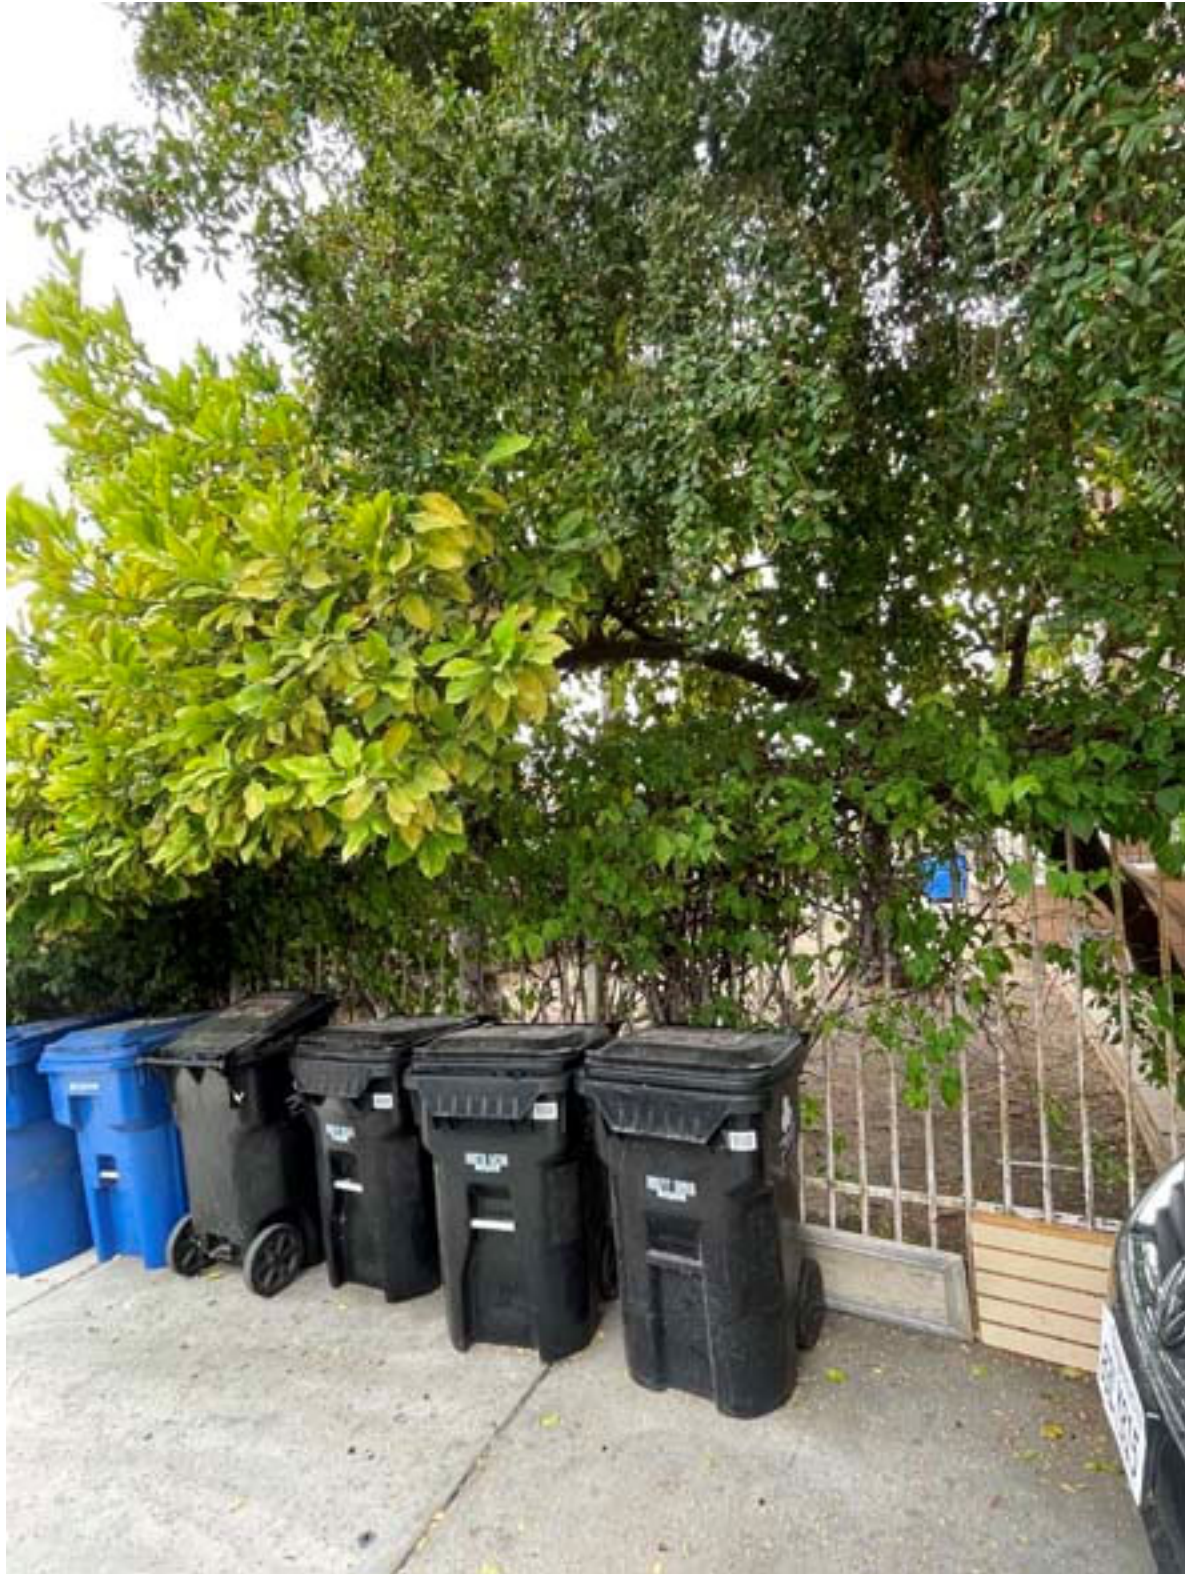
Figure 14: Tree OP13

<p>Tree OP13 <i>Citrus sp.</i> – Citrus</p> <p>This tree is not protected by ordinance. It is growing on an adjacent property to the north. It will be retained in the landscape through the proposed project.</p> <p>This tree has chlorotic foliage. It has a strong lean out from under Tree OP4 due to suppression from competition. Overall, this tree is in poor condition. This tree will be pruned for clearance over the work area. All pruning should be performed by a crew directly supervised by a Certified Arborist. Only the minimum amount of live foliage necessary to achieve clearance should be removed.</p> <p>The proposed access walkway along the northern property boundary will encroach within the critical root zone of this tree. All project activity within the drip line of this tree should be directly supervised by a Certified Arborist. Some of this tree's root system may be impacted, but it is intended to be retained in place throughout the project.</p>

- Prune Trees OP4 and OP13 for clearance over the work area. Pruning cuts should not exceed 3 inches in diameter. Lateral branches should be pruned back to their unions with their respective parent stems, and no stubs should be left.

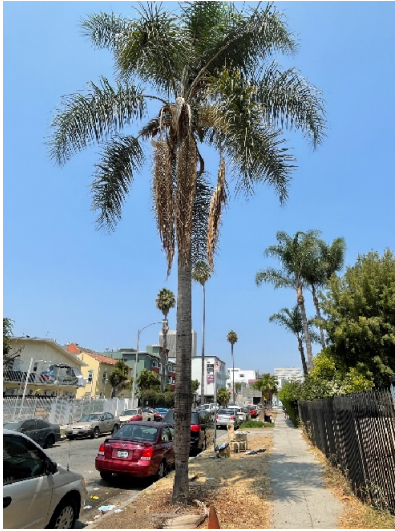
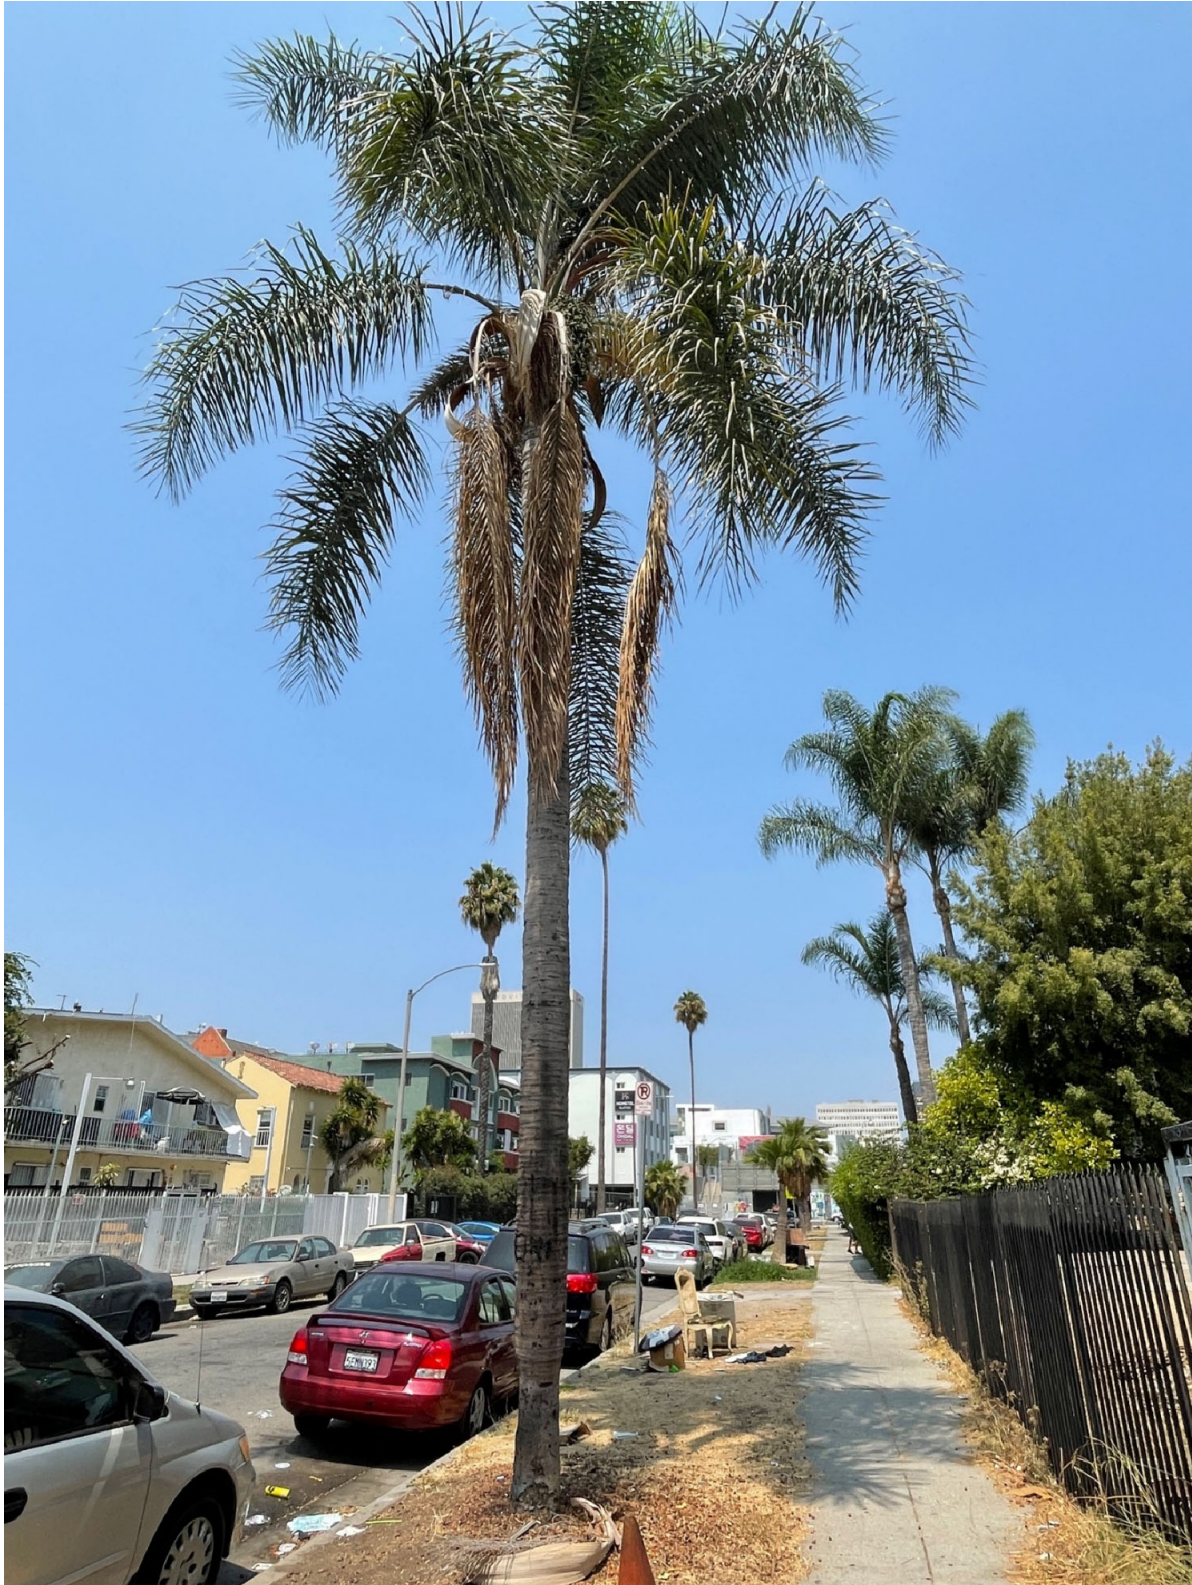
This tree has an inverted root crown; the base of the trunk is thinner than the middle of the trunk. This top-heavy form leaves the tree with a slightly increased likelihood of failure due to the amplification of loads at the base of the tree.

In the past, this tree was climbed with gaffs for pruning. The gaffs left spike wounds in the trunk that will never heal. These wounds have the potential to become entry points for decay over time.

The canopy appeared to be partially drought stressed. This tree is in average condition.

Figure 15: Tree 14 is growing within the public right of way. It will be removed because it is growing within the footprint of the proposed driveway apron.

This tree is growing within the footprint of the proposed driveway apron and must therefore be removed. Two replacement trees will be planted in the parkway strip adjacent to this tree.

The City of Los Angeles requires removed street trees be mitigated on a 2:1 basis. Two replacement trees must be planted for each street tree removed. One street tree is proposed for removal because it is growing within the footprint of the proposed driveway apron. Two replacement trees will be planted in the parkway adjacent to the driveway. Replacement trees will be 24" box size queen palms (*Syagrus romanzoffiana*). The species of the replacement trees may be adjusted with approval of the city's urban forester, the project arborist, and the project's landscape architect.

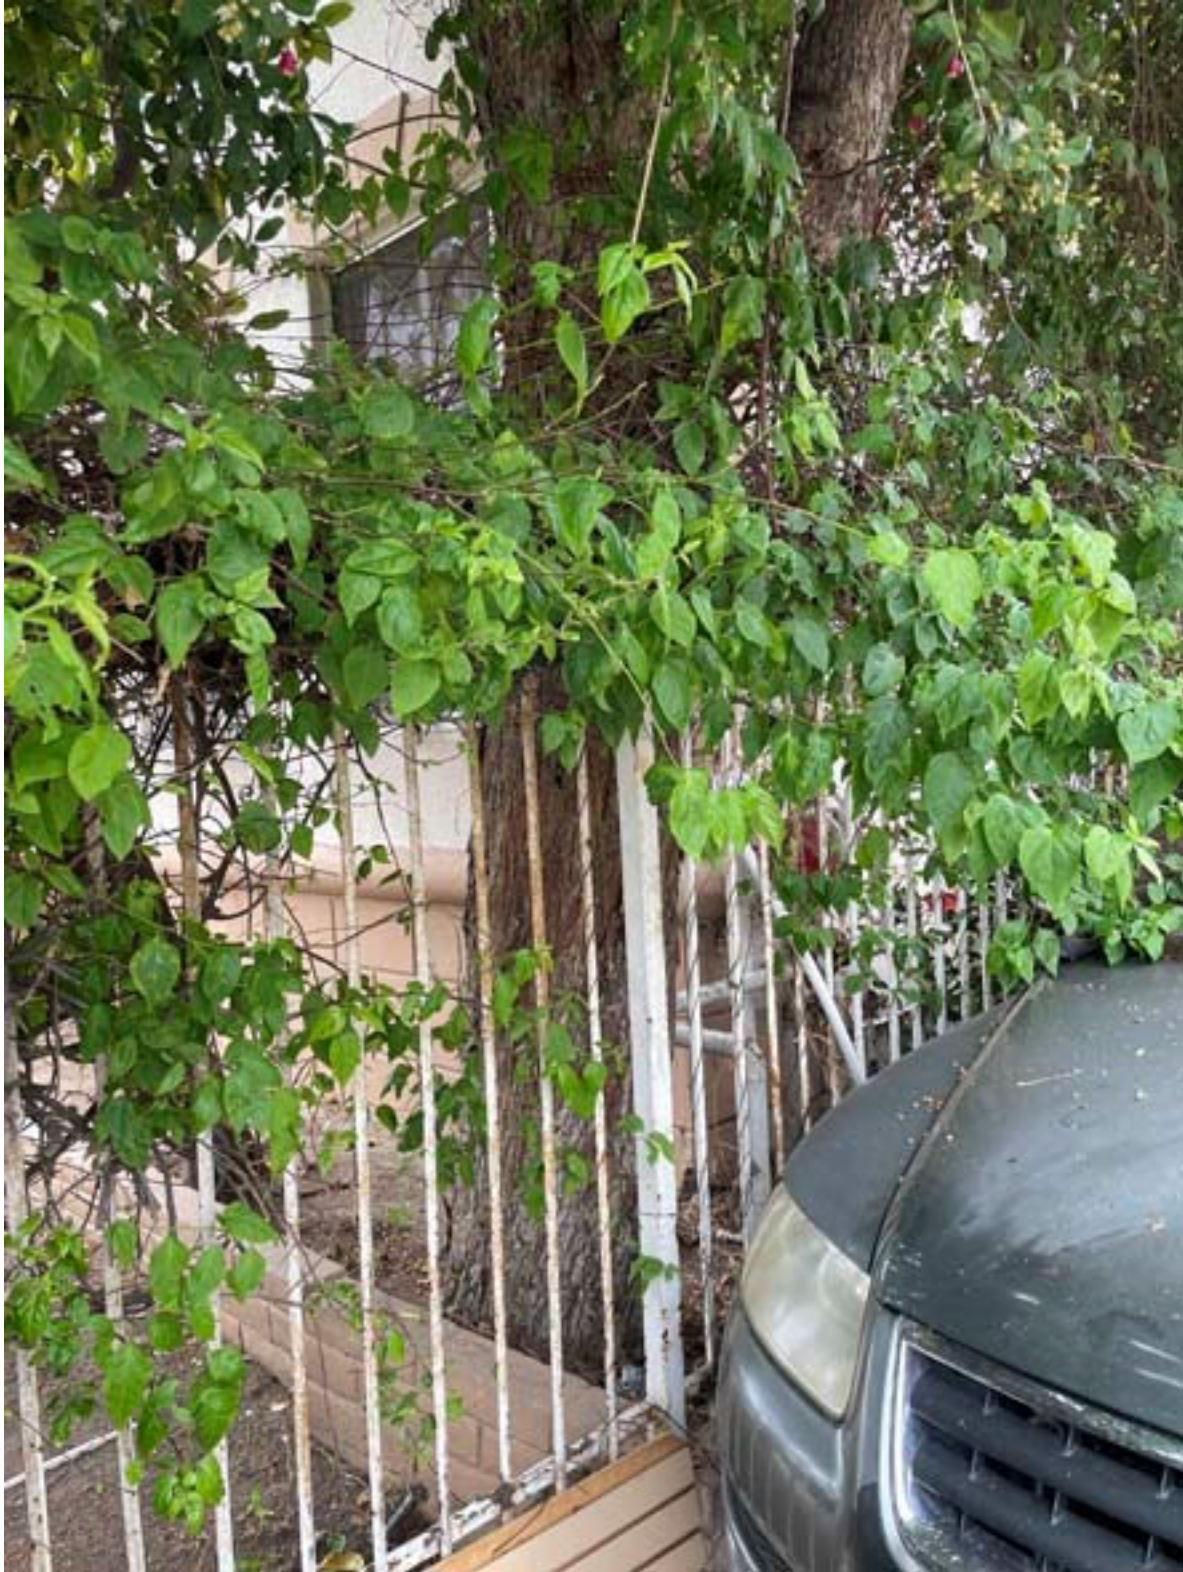
Figure 5: The trunk of Tree OP4 is close to the property line.

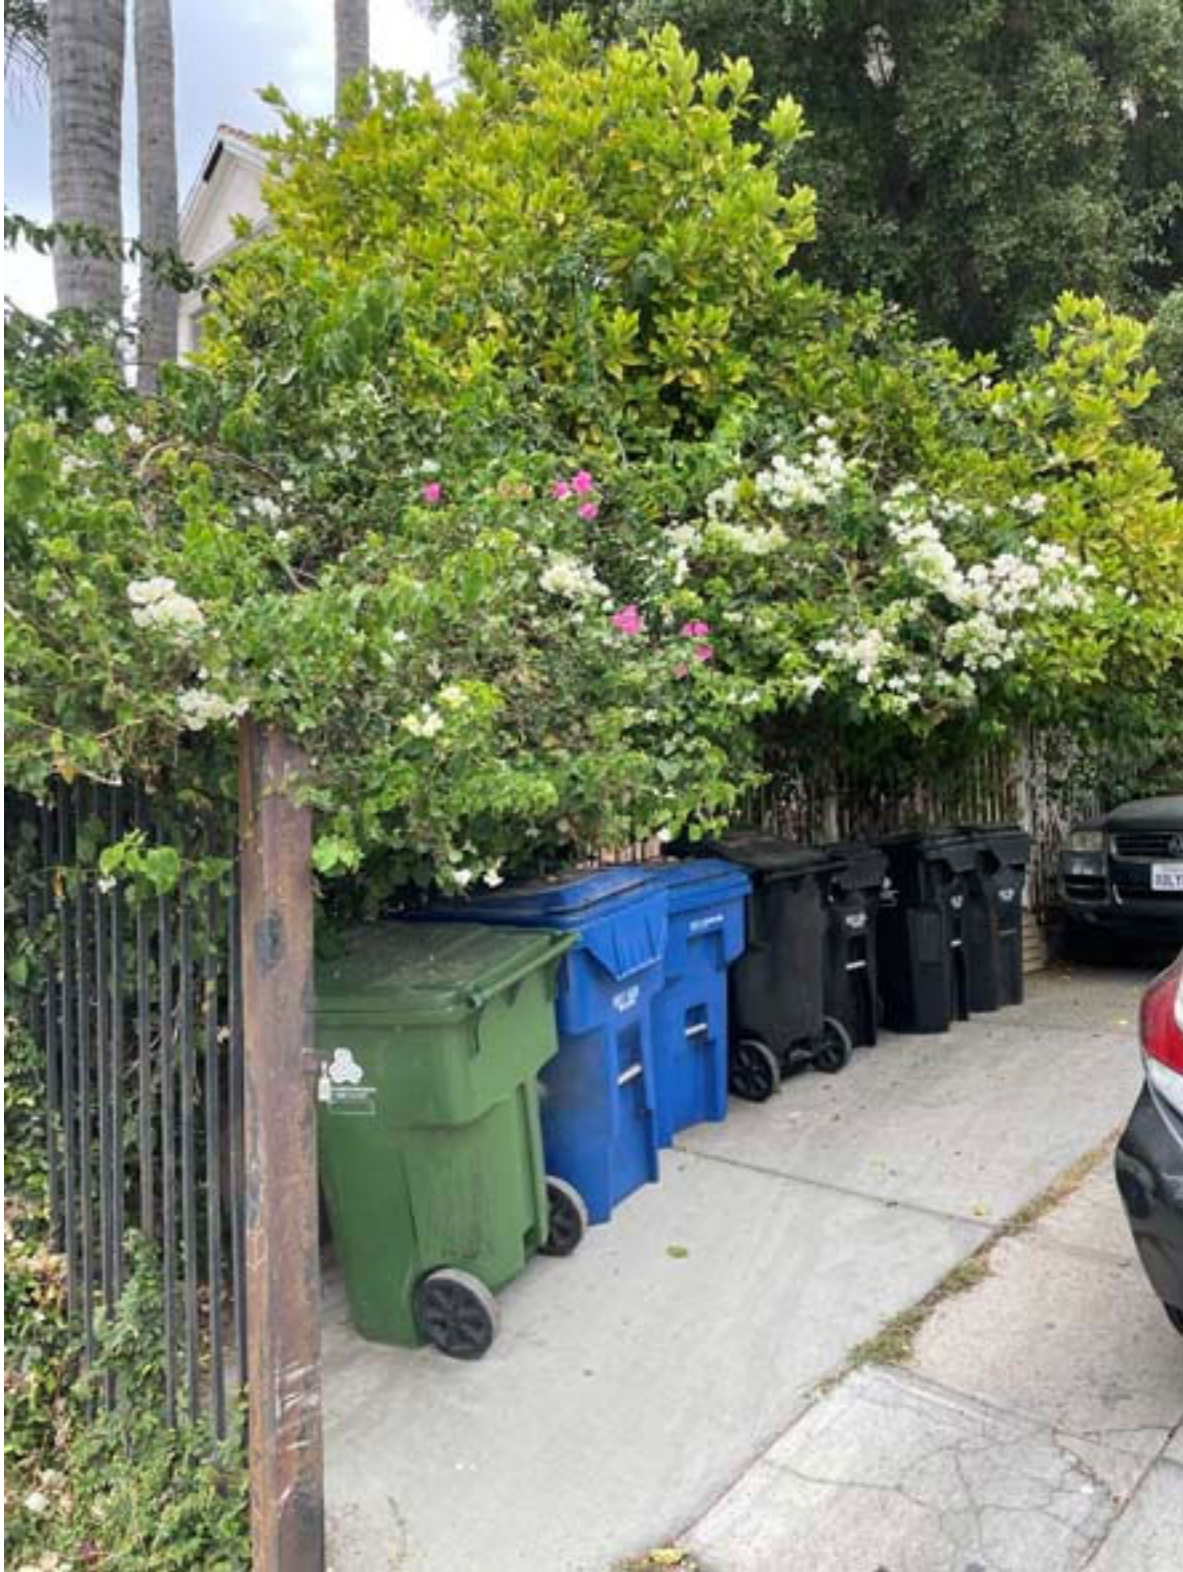
Figure 16: Bougainvillea is growing on the fence along the northern property boundary.
