City of Carlsbad Tyler St. and Chestnut Ave. Eucalyptus Risk Assessment Report

Prepared for City of Carlsbad c/o Morgan Rockdale 1166 Carlsbad Village Dr. Carlsbad, CA 92008

Class One Arboriculture Inc.

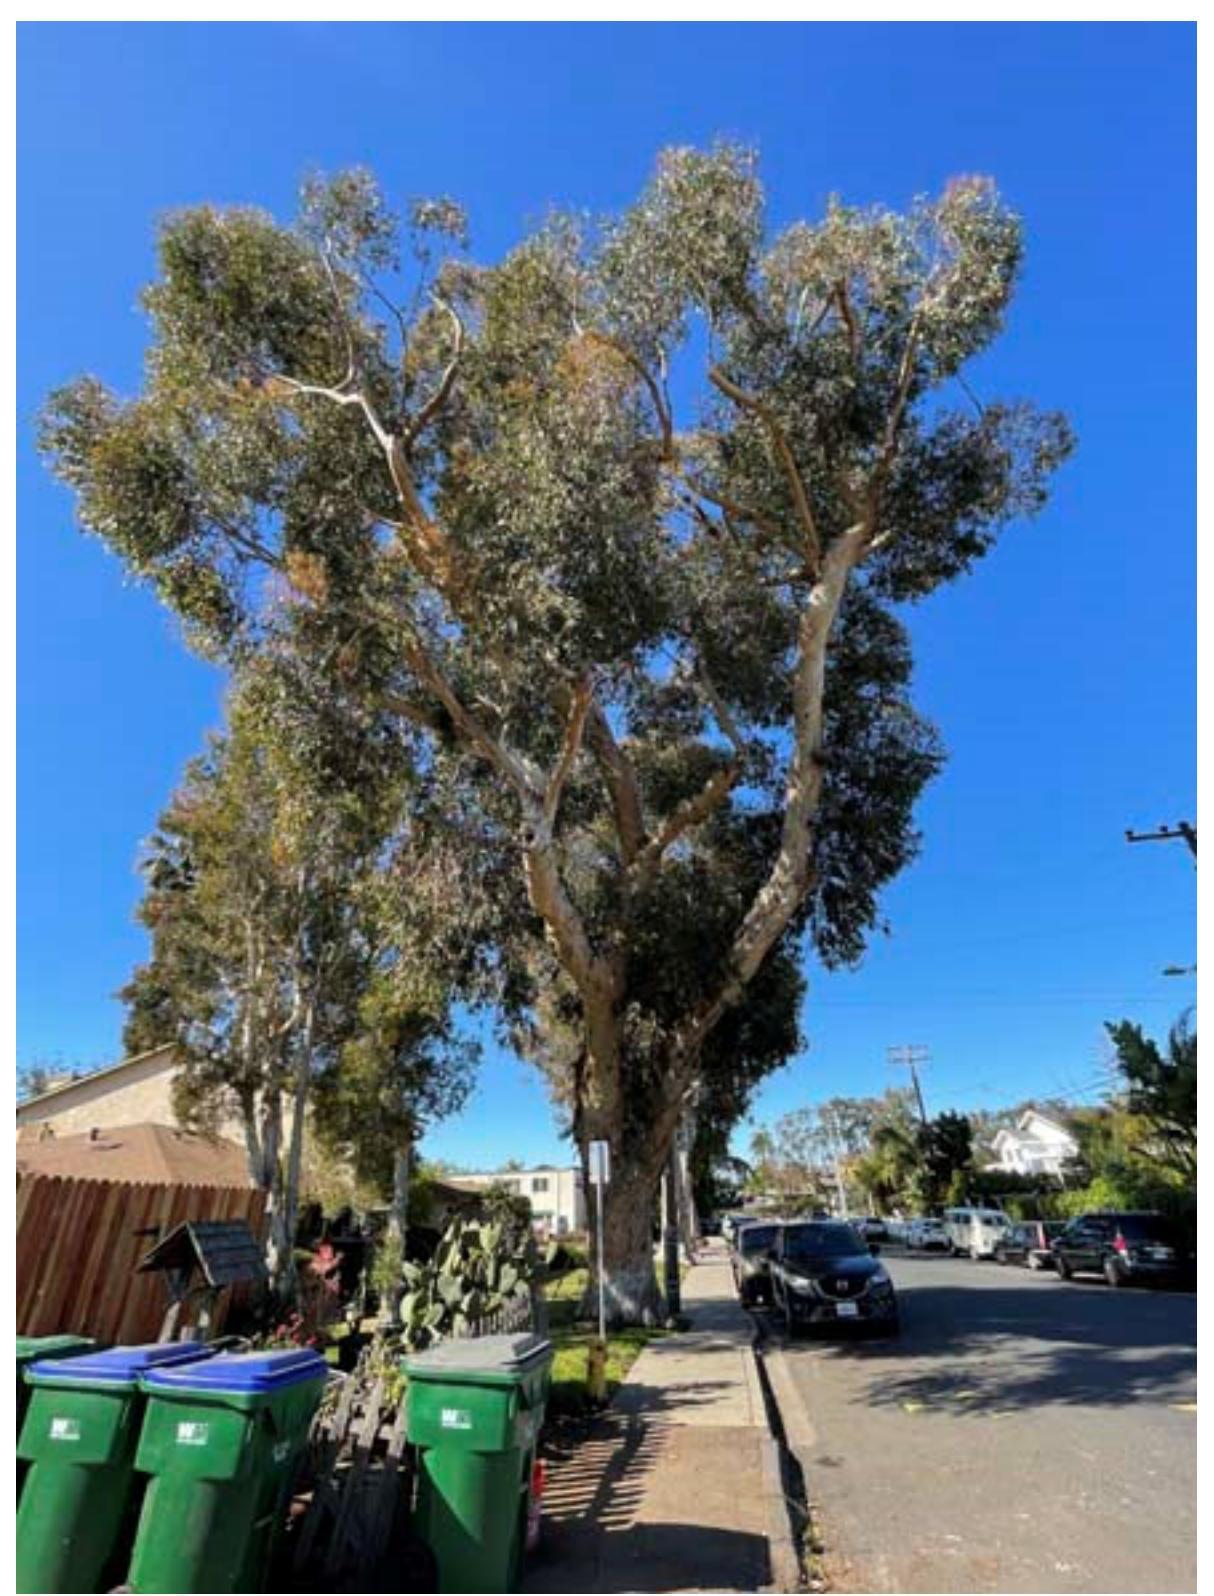
The most notable feature of the tree is its prevailing lean to the northeast, parallel to Chestnut Avenue. There is a normal root crown flare, and the adjacent sidewalk was re-configured to allow space for the tree's root crown over time. The tree is growing in an irrigated lawn, but I did not observe any evidence of decay at the base of the tree. I did not observe any soil heaving, cracking, or separation that would indicate the tree's angle of lean changed recently. In Google Street View imagery, I observed the tree had a similar angle of lean since June of 2008.

Despite the tree's prevailing lean, I observed no evidence of structural defects that would support an inference that the tree's likelihood of failure was elevated. I rated the likelihood of whole tree failure within the next one year time frame as *improbable*.

Figure 4: Looking southwest at the subject tree. It has a prevailing lean to the northeast.

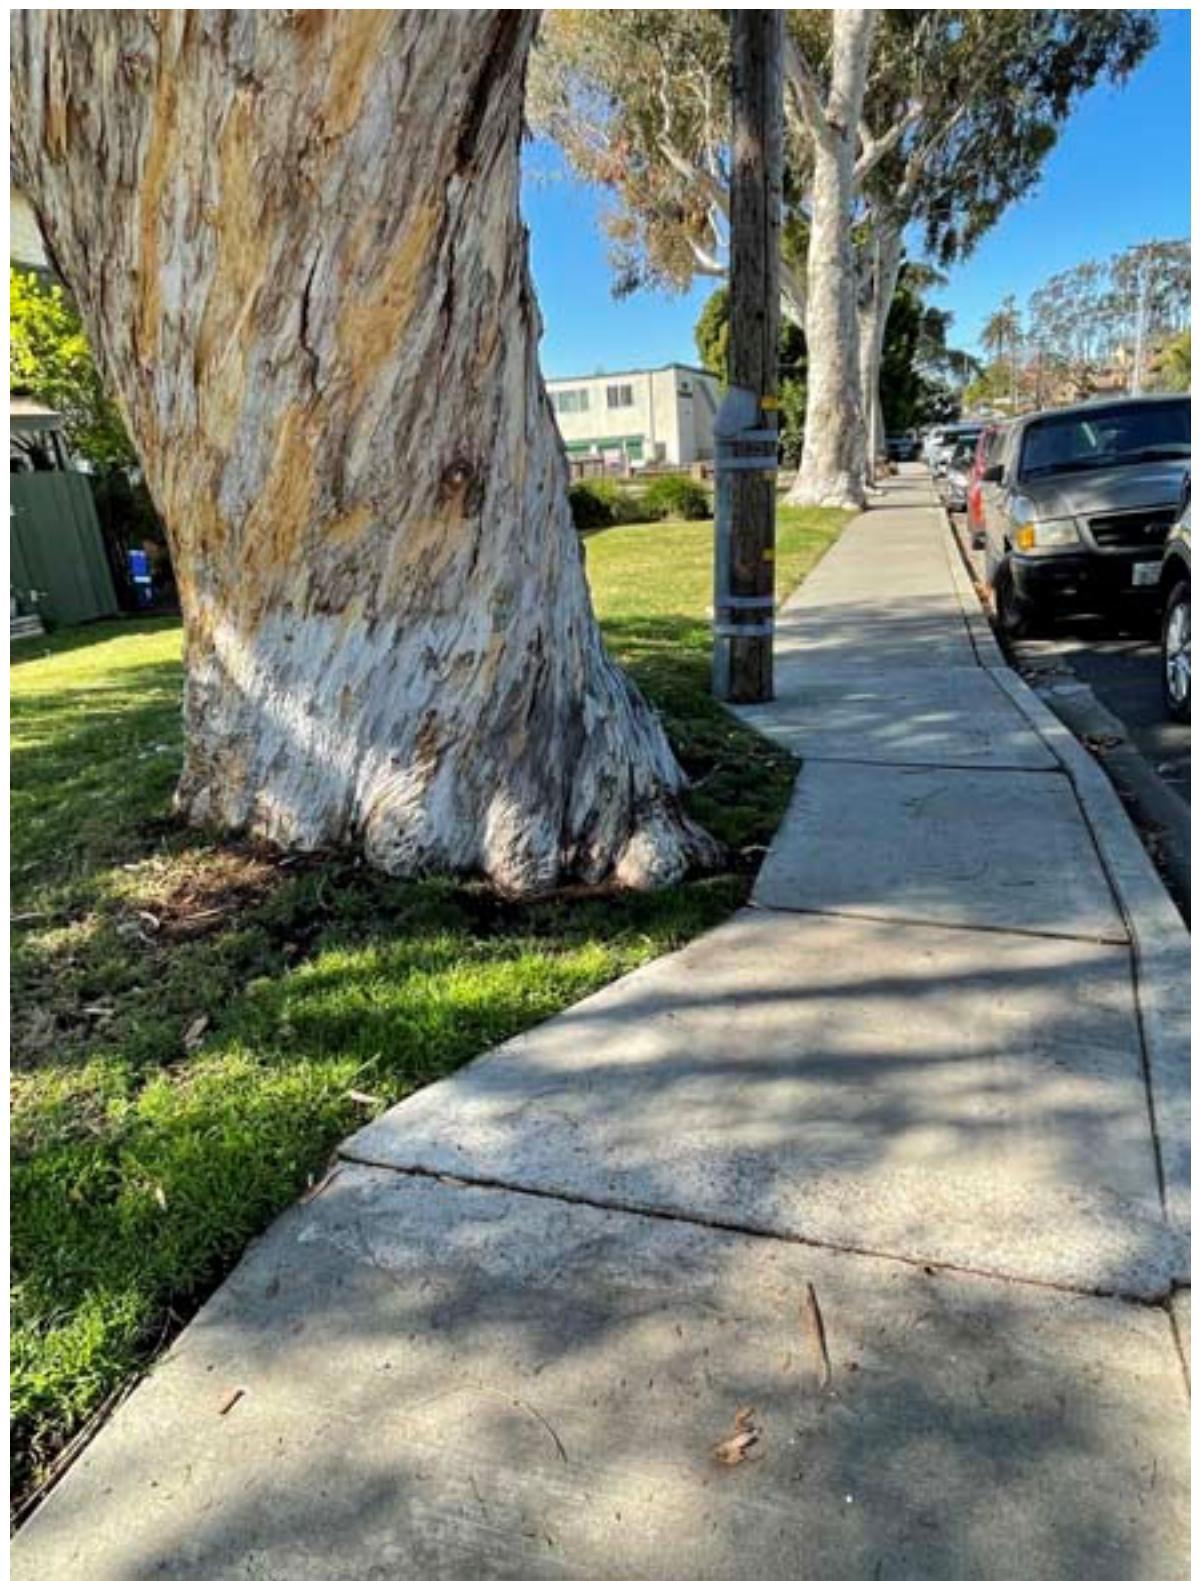
Three panels of the adjacent sidewalk appear to have been replaced between 2008 and 2009. Since then, the tree roots have lifted the replacement panels. More recently, the city has performed concrete grinding work at the joints to mitigate the resulting vertical displacement. The sidewalk lifting is evidence that the tree's roots are still actively growing beneath the sidewalk.

Figure 5: Three sidewalk panels were replaced near the tree between 2008 and 2009. The tree's roots continued to exert upward pressure on the panels, and the city later returned to grind the displaced joints.

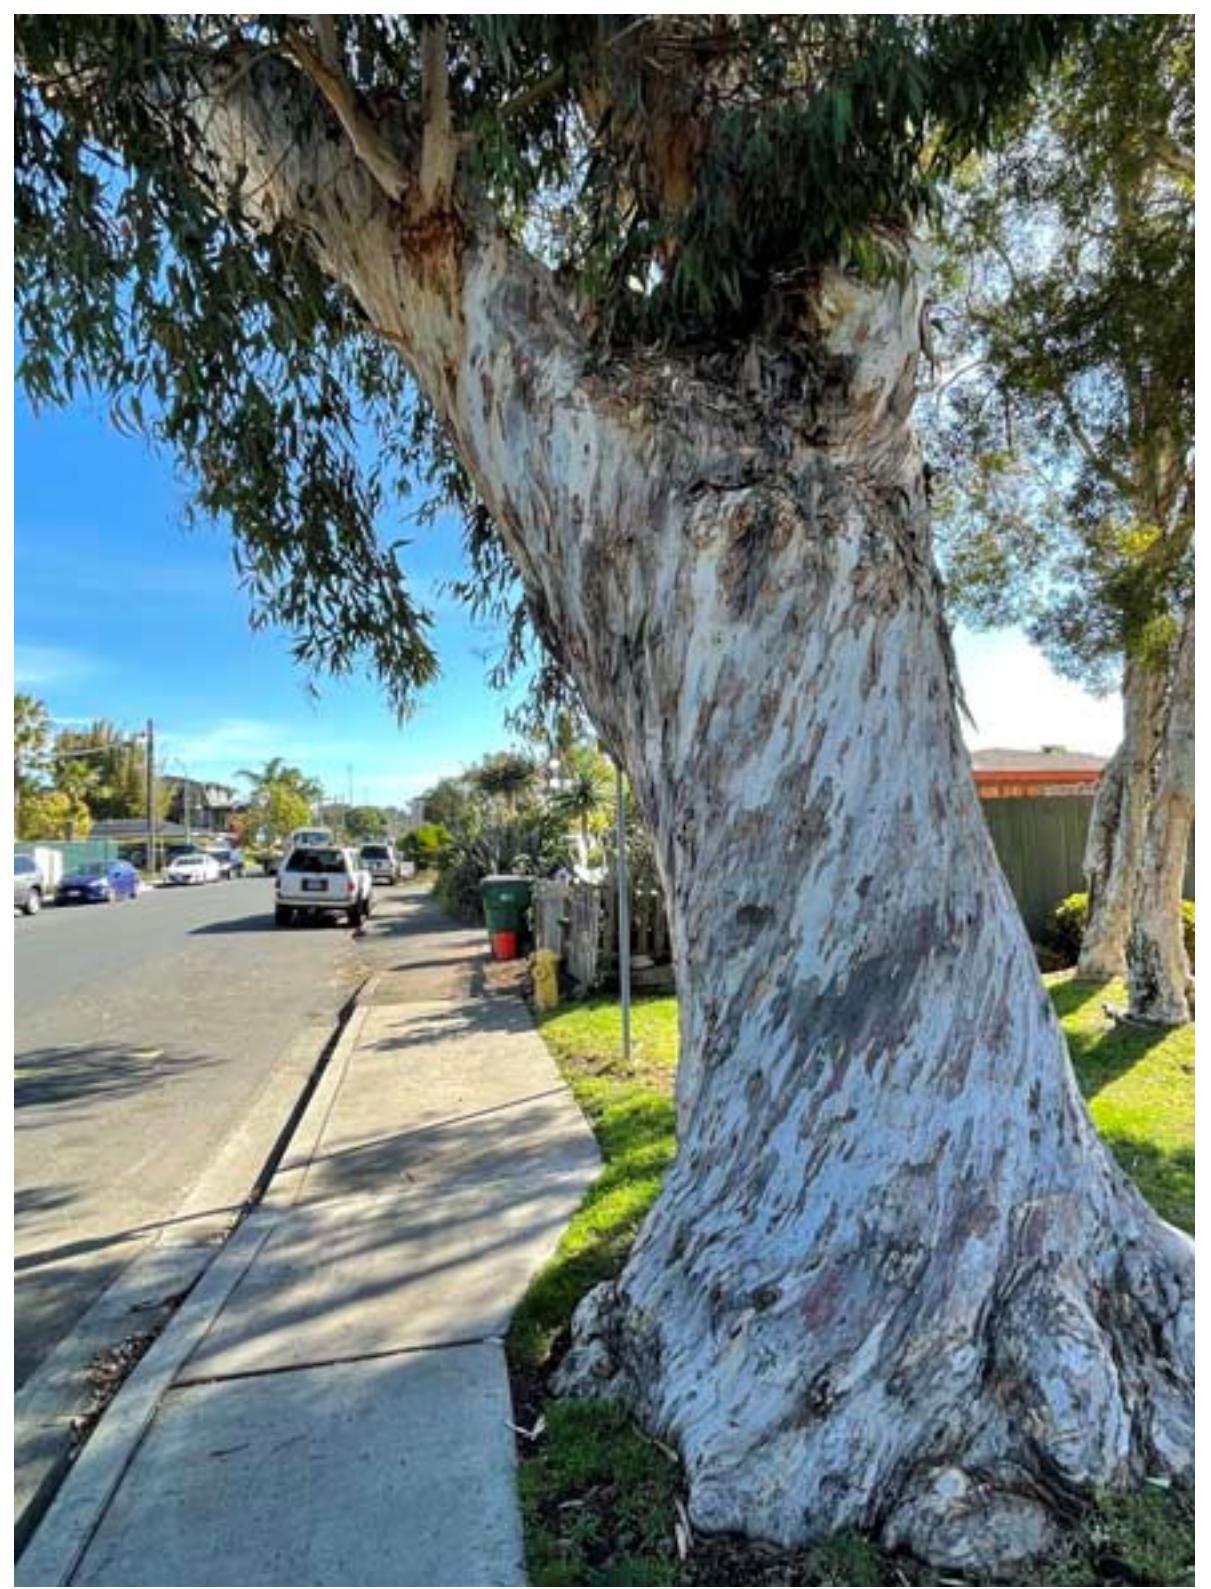
Figure 6: Looking northeast. The tree has a normal root crown flare. The width of the sidewalk was adjusted to accommodate the tree's trunk.

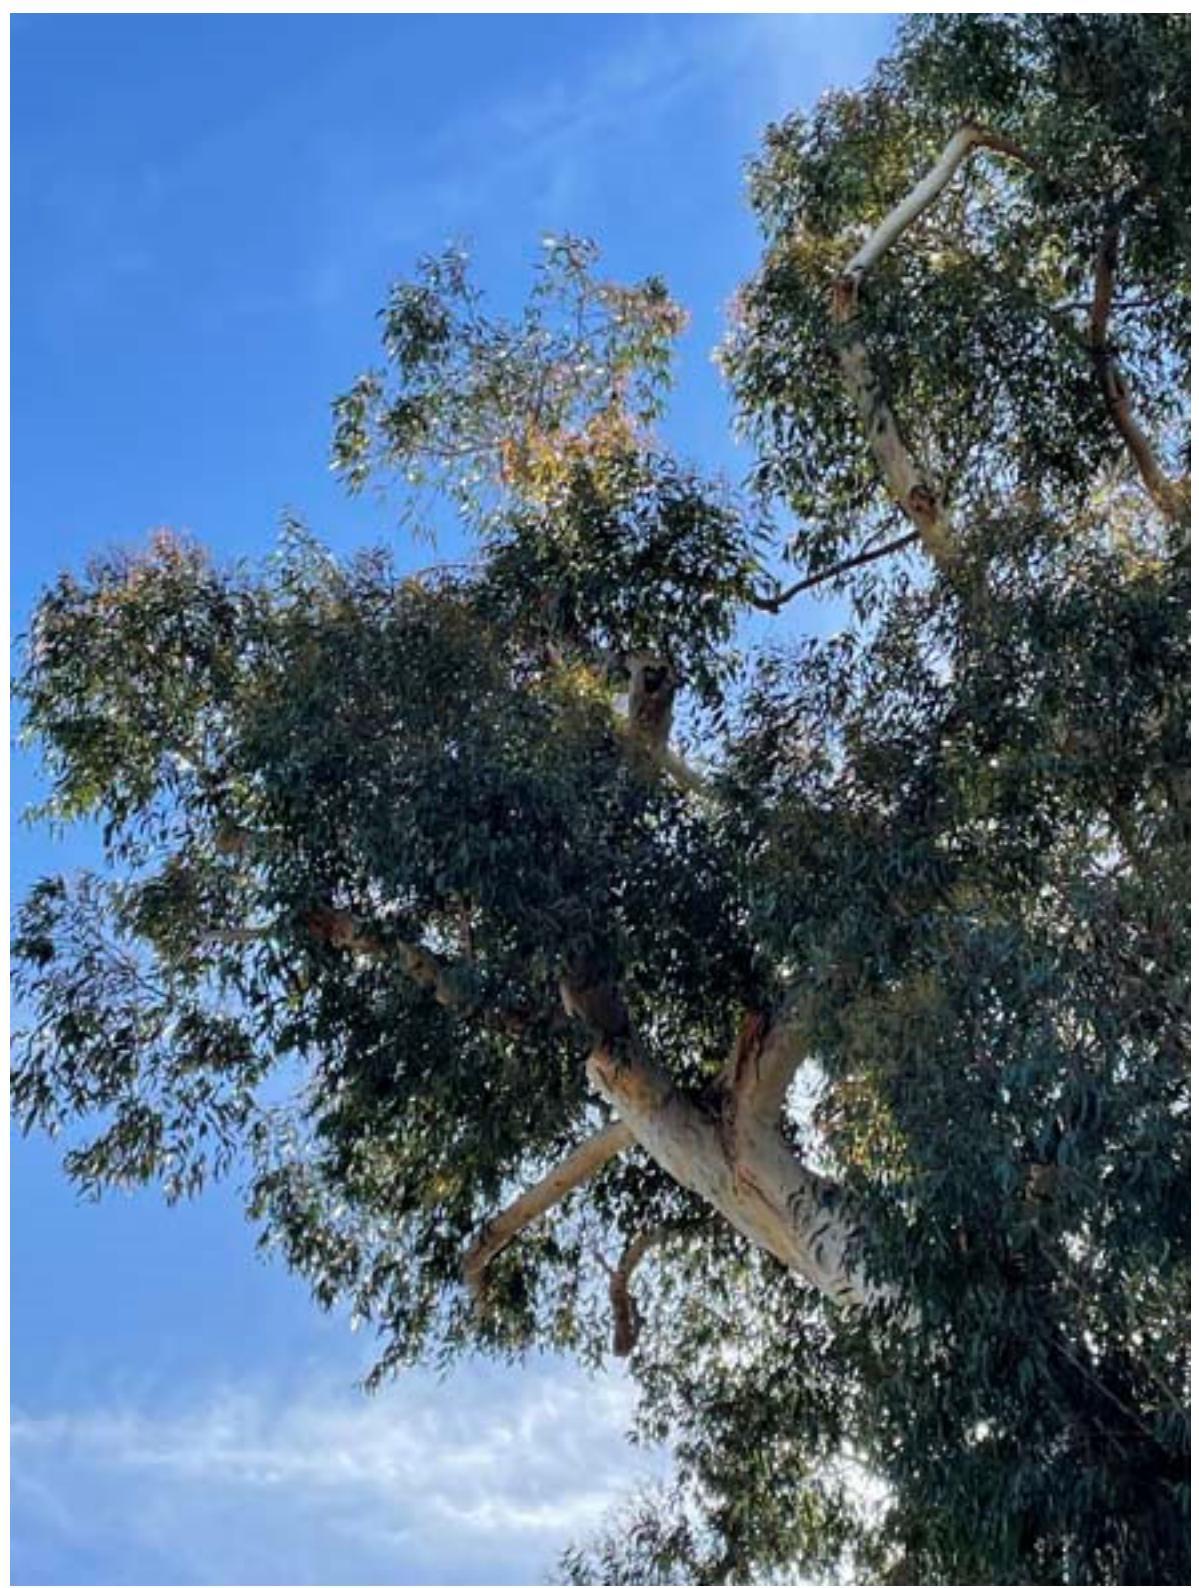
The subject tree is a *Eucalyptus* species. *Eucalyptus* species are known for their species failure profile of dropping branches, even in the absence of defects. Failure of defect-free branches tends to occur in high wind events or in the afternoon of hot summer days. The mere fact of this tree's species is sufficient to justify an elevated likelihood of failure rating for its branches, even where no specific structural defect is identified. However, just because a tree or one of its parts has an elevated likelihood of failure doesn't mean that a remedial action must be taken. In addition to the specific tree parts I assessed, I also assessed the likelihood of a branch 8 inches or larger failing due to the tree's species failure profile. The likelihood that a branch 8 inches or larger will fail from this tree within the next one year time frame is *possible*.

Figure 7: There was a history of small branch failures in the canopy. Branch tearout wounds were approximately 6-8 inches in diameter. I observed woundwood around these wounds.

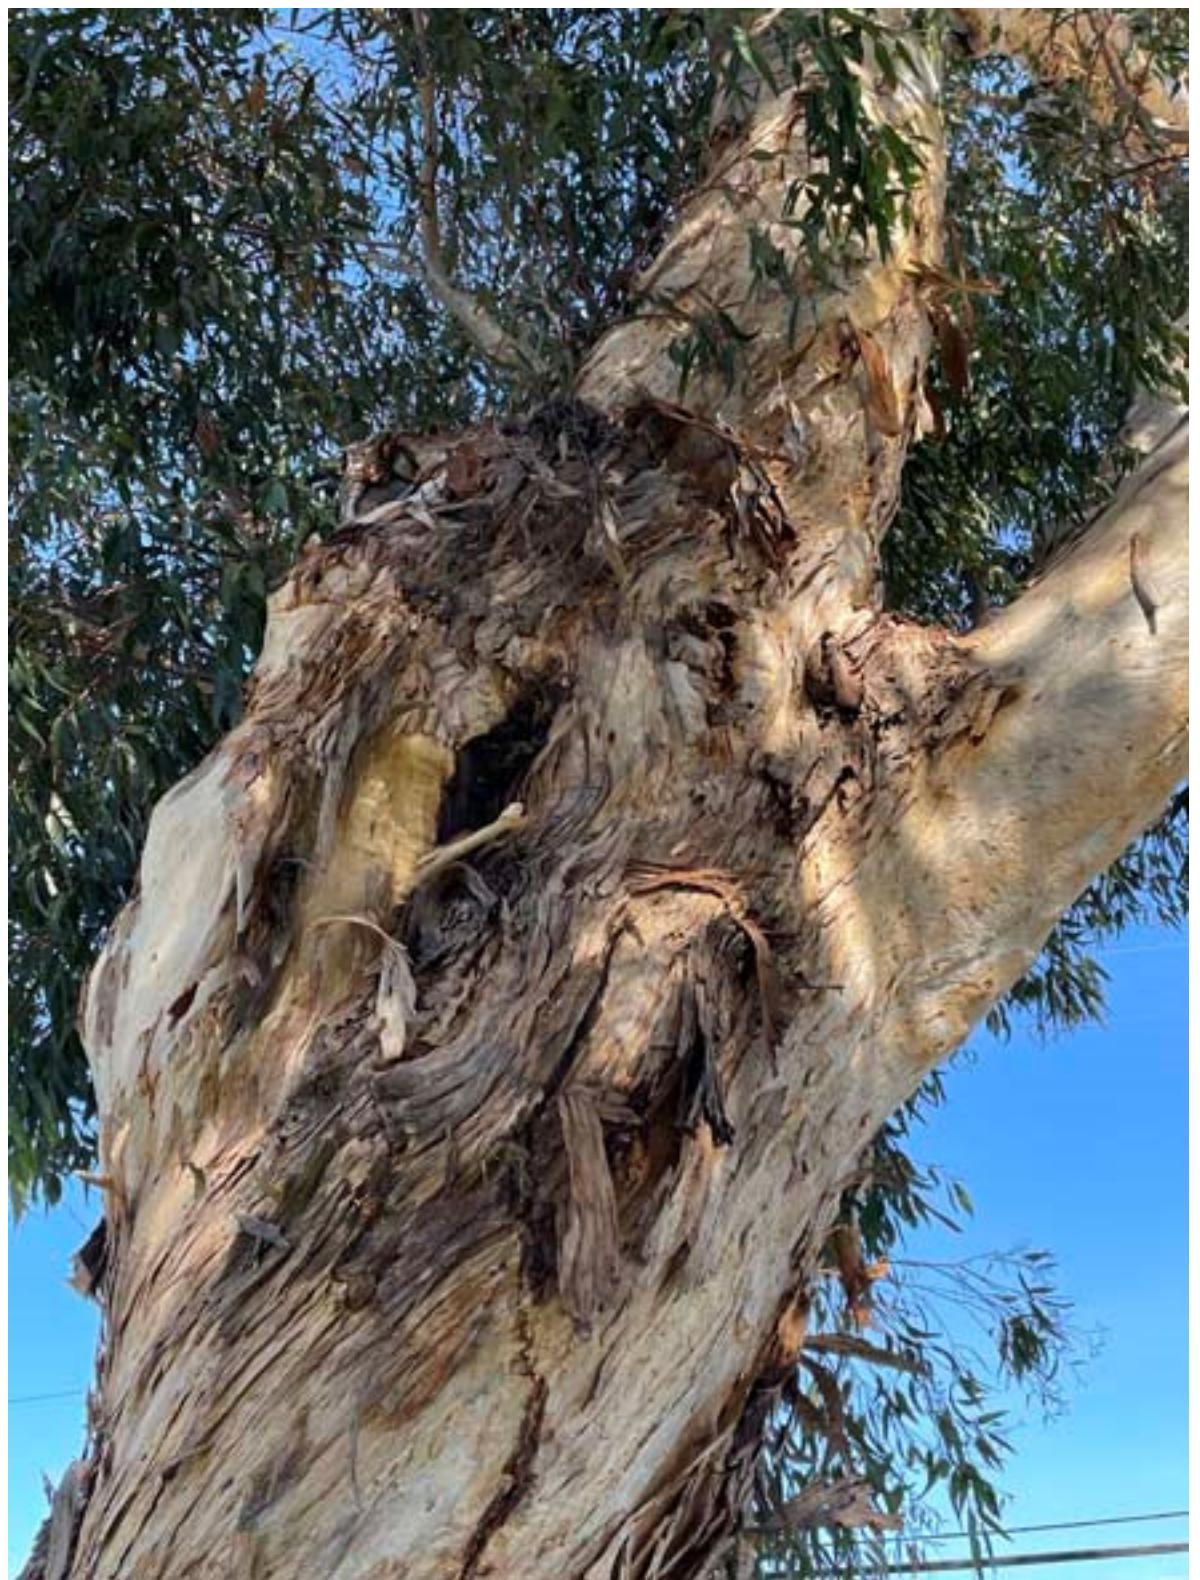
Approximately 9 feet up its main trunk is a large scaffold branch approximately 20 inches in diameter that leans out to the northeast, parallel to the tree's prevailing lean. On the eastern side of the tree, I observed an old wound at this scaffold branch union. It appeared there was some decay at this union, but the amount was obscured by sloughing bark. I did not probe the wound within the scope of my ground-based all-visual inspection.

Around the perimeter of the wound at the scaffold branch union was a layer of woundwood that appeared to be at least 10 years old. This woundwood indicates two things: (1) the wound has been present for many years, and (2) the tree's structural integrity has been reinforced by the deposition of new tissue over this time period. The presence of decay at the union of a large scaffold branch with cantilevered end weight led me to conclude that the likelihood of the scaffold branch failing within the next one year time frame was *possible*.

- 20-Inch Scaffold Branch Failure: The likelihood of the 20-inch scaffold branch failing due to its cavity is *possible*. Although there is a significant area of decay, the response growth woundwood partially offsets this strength loss.

Figure 8: I observed a cavity at the union of the 20" scaffold branch, approximately 9 feet above the ground on the east side of the tree. There was ample woundwood around this cavity opening. I did not probe the cavity within the scope of my ground-based all-visual inspection.

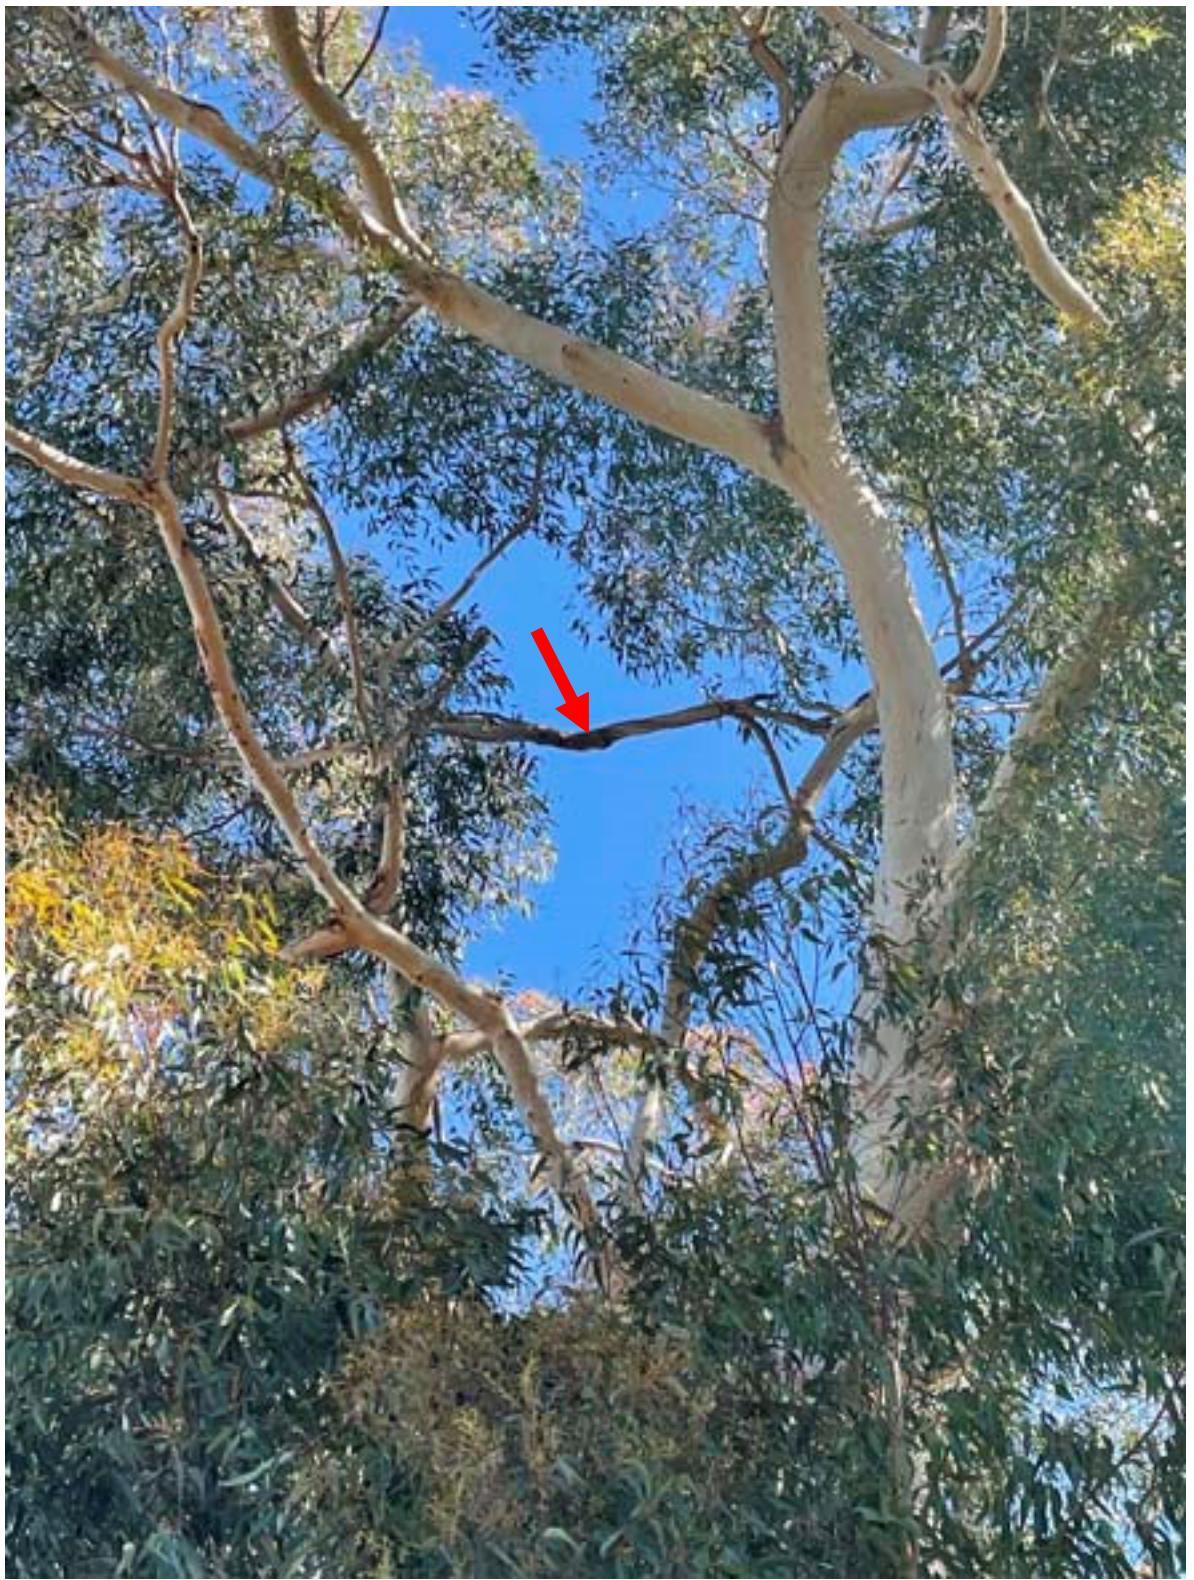
Approximately 60 feet above Chestnut Avenue is a dead broken branch approximately 6 inches in diameter. It has already partially failed, and it is leaning against an adjacent branch. This branch has an *imminent* likelihood of failure. I recommend pruning it off to reduce the risk to people and property.

- 6-Inch Dead Branch Failure: The likelihood of the 6-inch dead hanging branch failing is *imminent*. Failure has already partially occurred, and the branch is resting against a neighboring branch. I recommend pruning off this dead broken branch.

The risk posed by the 6" hanging dead branch causing property damage of parked vehicles is *high*. The risk posed by the 6" hanging dead branch to pedestrians and cars driving on Chestnut Avenue is *moderate*. All other risk permutations resulted in a low risk. If the 6" hanging dead branch were pruned off, then the overall residual risk rating of the tree would be *low*.

Figure 9: One 6" diameter dead branch (red arrow) had already partially failed and was hanging in the canopy at the time of my site visit. It has an *imminent* likelihood of failure. I recommend pruning off this branch.

- 1) *Remove the 6" Hanging Dead Branch*: The risk posed by the hanging dead branch to parked vehicles is *high*, and the risk posed to driving vehicles and pedestrians is *moderate*. By pruning off this branch, the overall residual risk of the tree would be reduced to *low*. I recommend pruning this dead branch at the earliest reasonable time, taking reasonable care to cause the minimum disturbance to the active bird nest in the tree.
