Class One Arboriculture CA Lic. #982988 2832 Manhattan Ave Glendale, CA 91214 Phone: (818) 495-5344

April 10, 2017

I am writing to summarize the results of my site visit to \*Redacted\*. After viewing 17 trees along the western side of the subject property, I can conclude that *Tree 15 poses a moderate risk* within a one year time frame, and *the other assessed trees have a low risk rating*.

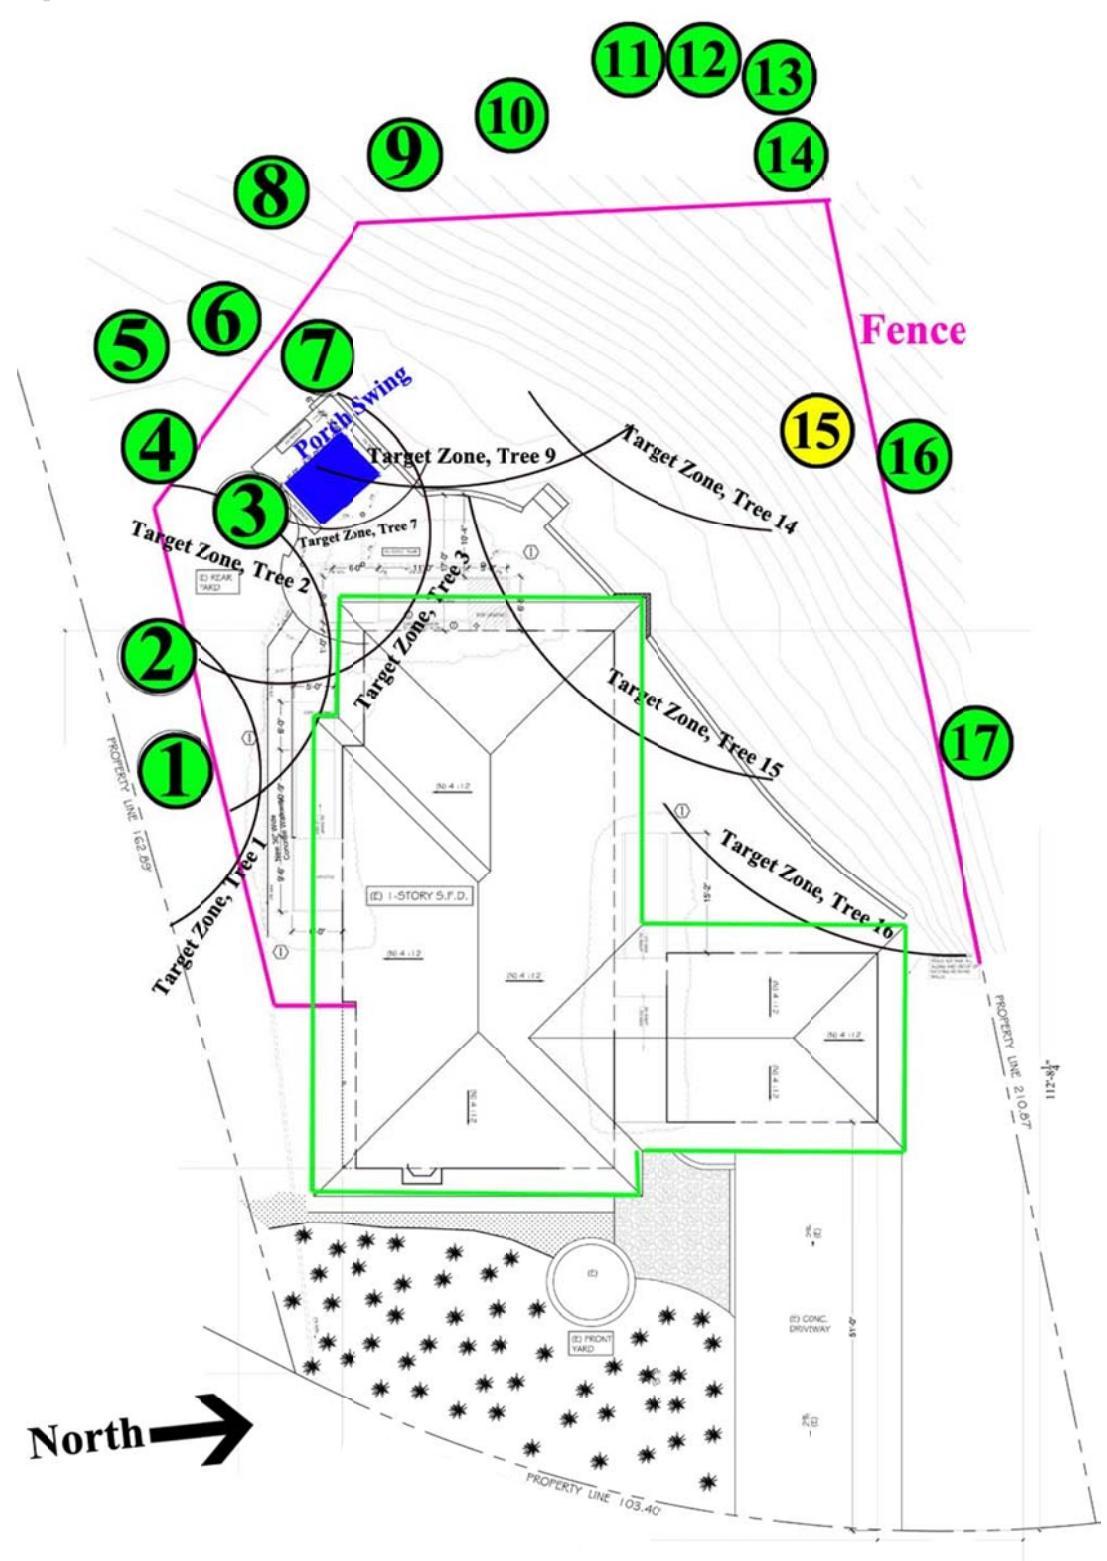
Site Map

**Figure 3**: Site map showing the subject trees and estimated target zones of one times tree height for several trees. The porch swing is shown in blue, and the fence is shown is purple. Trees are color-coded based on their overall risk rating. Trees with a low risk rating are marked green; trees with a moderate risk rating are marked yellow.
