# Tree Appraisal Report

**Prepared by James Komen**  
BCMA WE-9909B  
RCA #555

**Class One Arboriculture**  
3763 Ramsdell Ave  
Glendale, CA 91214  
818-495-5344  
classonearboriculture@gmail.com

August 27, 2018

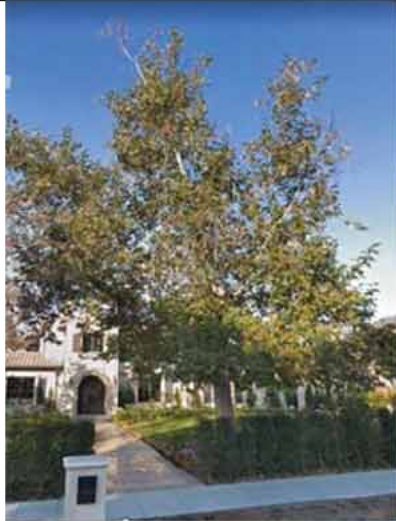
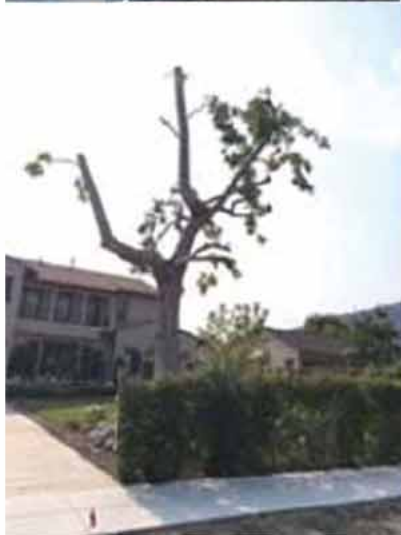
### Tree 1

The structure was *Good*. There was a well-developed structure with a minor co-dominant stem defect at a height of approximately 15 feet. Around the co-dominant stem union was ample response growth, so this union was not a significant structural concern. The co-dominant union was unlikely to fail in normal expected weather conditions.

The health of the tree is now *Fair*. It has significantly reduced vigor as a result of the removal of 90% of the living foliage. I observed evidence of re-sprouting beginning already, indicating the tree has energy reserves from which to draw, and it still has some vigor.

The structure of the tree is now *Poor*. Multiple significant topping cuts were made on the scaffold branches and trunk. These heading cuts will likely turn into decay sites, significantly limiting the structure of the tree in the long term. Re-growth sprouts will be weakly attached to the scaffold, increasing likelihood of branch failure.

The form of the tree is now *Poor*. It now has an abnormal form due to severe pruning. The pruning detracts to a significant degree from the tree's intended use of an aesthetic specimen tree and screening from street. I did not choose a rating of *Very Poor* because the tree still does provide some function in the landscape, albeit significantly limited.

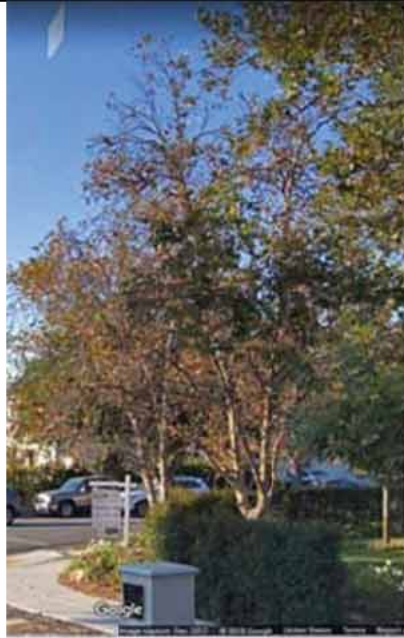
## Tree 2

The structure was *Fair*. There is a co-dominant stem defect at a height of about four feet. There is a ample response growth joining the two stems, so it was unlikely to fail in normal weather conditions before the pruning.

The structure of the tree is now *Fair*. There are now multiple moderate topping cuts on the scaffold branches. The tree has the potential to recover with several years of restoration pruning management.

The form of the tree is now *Fair*. Its aesthetic function as a specimen tree has been compromised as a result of the topping.

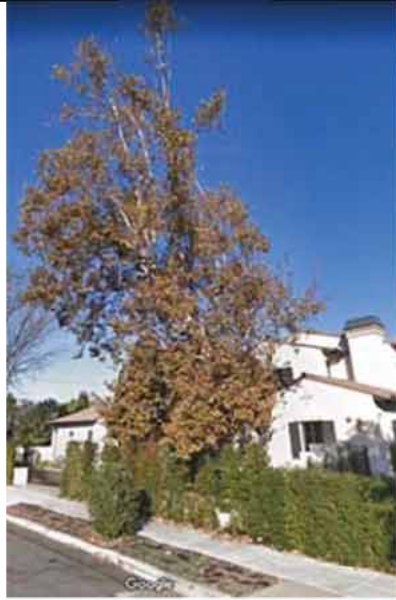
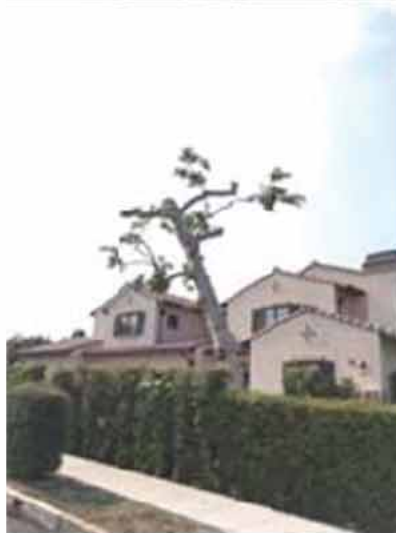
#### Tree 4

The health of the tree was *Fair*. It had a pre-existing history of the common *Anthraxnose* foliar fungus and minor dieback at tips. I observed minor bark beetle activity in the trunk, but it did not appear to be affecting the conductivity of water along the stem. From the Google Maps Street View image from December 2017, the tree had a dense canopy and normal vigor for species.

The structure was *Good*. It had a minor prevailing lean to southwest, away from a former neighboring tree that was removed between 2012 and 2017 for construction of the house. Although Tree 4 was leaning, the degree of lean was well within the tolerable range for this species. Just because a tree is leaning does not mean that it is likely to fail.

The health of the tree is now *Fair*. It has a significantly reduced vigor as a result of the removal of 90% of its living foliage. I observed evidence of re-sprouting beginning already, indicating the tree has energy reserves from which to draw and still has some vigor.

The structure of the tree is now *Poor*. Multiple significant topping cuts were made on scaffold branches and trunk. These heading cuts will likely turn into decay sites, significantly limiting the structure of the tree in the long term. Re-growth sprouts will be weakly attached to the scaffold, increasing likelihood of branch failure.

The form of the tree is now *Poor*. It now has an abnormal form due to severe pruning. The pruning detracts to a significant degree from the tree's intended use of an aesthetic specimen tree and screening from street. I did not choose a rating of *Very Poor* because the tree still does provide some function in the landscape, albeit significantly limited.

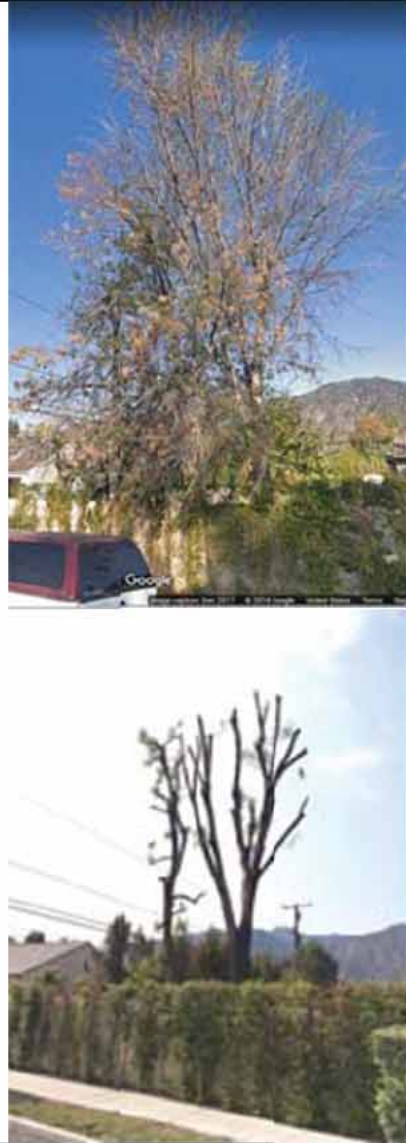
## Tree 5

The structure was *Good*. It had a normal vase-shaped structure for the species. Co-dominant stem unions are known defects that tend to develop in this species.

The structure of the tree is now *Poor*. The severe topping cannot be corrected, even with restoration pruning over a period of years. Re-sprouting will be weakly attached to the parent stems and will have an increased likelihood of failure.

The form of the tree is now *Very Poor*. The tree no longer provides its intended function of shading the rear yard from southern sun. The severe topping has left the tree visually unappealing.

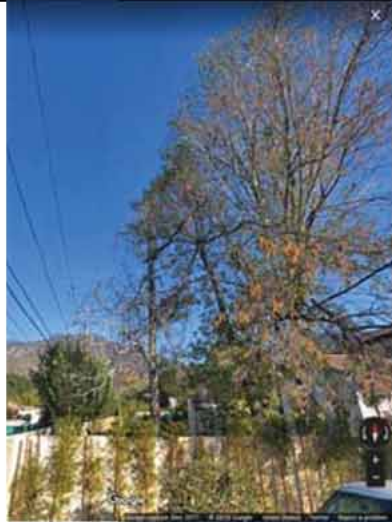
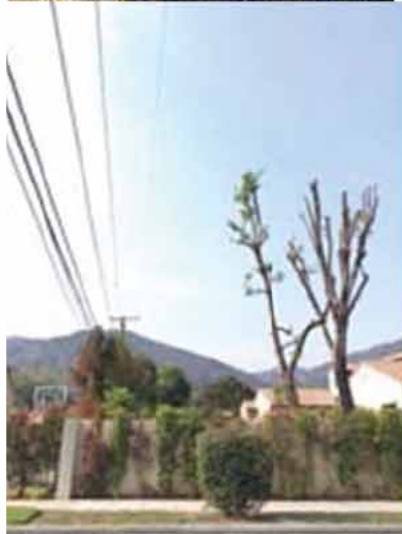
## Tree 6

The structure was *Fair*. Its phototropic response growth towards the west out from under Tree 5 caused the tree to have a prevailing lean. I also observed several weakly attached and hanging branches in the December 2017 Google Maps Street View image.

The structure of the tree is now *Poor*. The severe topping cannot be corrected, even with restoration pruning over a period of years. Re-sprouting will be weakly attached to the parent stems and will have an increased likelihood of failure.
