Example Mt. Washington Arborist Report

Prepared by James Komen

Class One Arboriculture

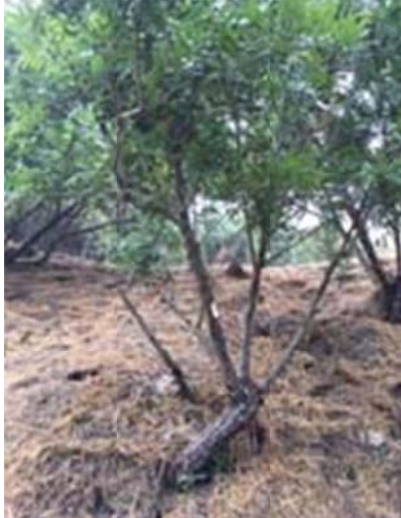
<p>Tree 5 <i>Juglans californica</i> – California Black Walnut</p> <p>This tree is too small to be protected by ordinance. It will not be removed as part of the construction process.</p>

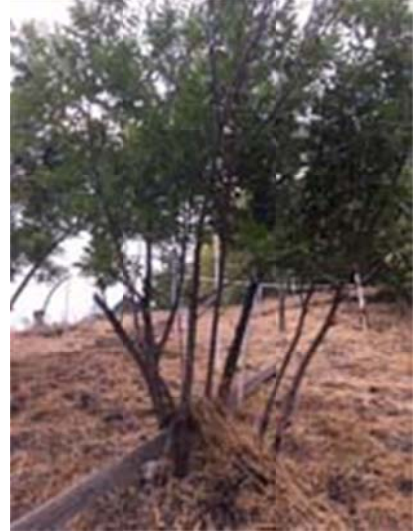
<p>Tree 6 <i>Juglans californica</i> – California Black Walnut</p> <p>This tree is protected by ordinance. It must be removed because its trunk is growing within the footprint of the proposed driveway. Protecting this tree would preclude the reasonable development of the property.</p>

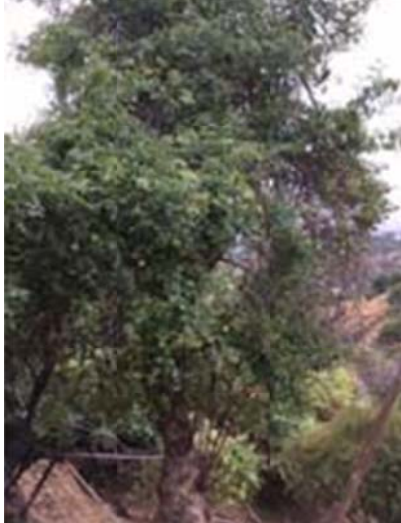
<p>Tree 9 <i>Juglans californica</i> – California Black Walnut</p> <p>This tree is protected by ordinance. This tree must be removed because it is within the footprint of the proposed garage deck.</p>

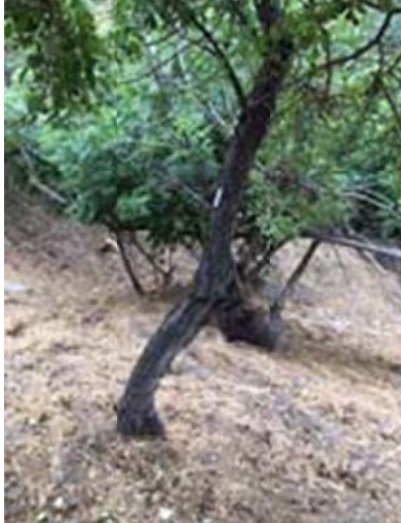
<p>Tree 10 <i>Sambucus mexicana</i> – Mexican Elderberry</p> <p>This is a significant tree, protected for its 12” trunk diameter by the Mt. Washington specific plan. This tree must be removed because it is within the footprint of the proposed construction.</p>

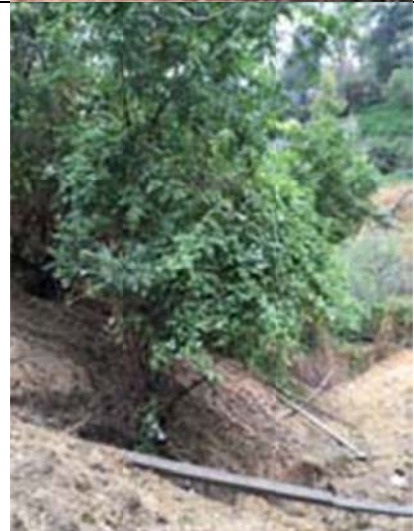
<p>Tree 14 <i>Sambucus mexicana</i> – Mexican Elderberry</p> <p>This tree is not protected by ordinance. It must be removed because it is within the footprint of the proposed construction.</p>

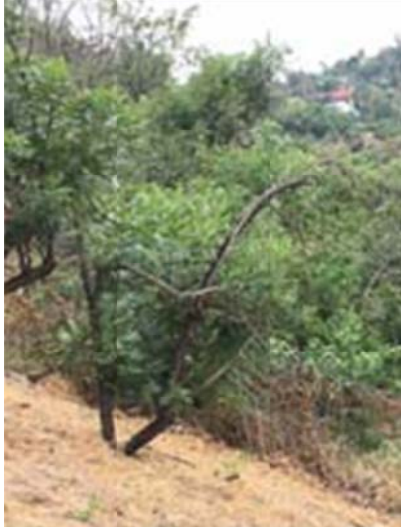
<p>Tree 24 <i>Juglans californica</i> – California Black Walnut</p> <p>This tree is protected by ordinance. It is showing signs of drought stress. If the tree protection fencing shown in this report is not crossed, it is unlikely this tree will be affected by construction activity.</p>

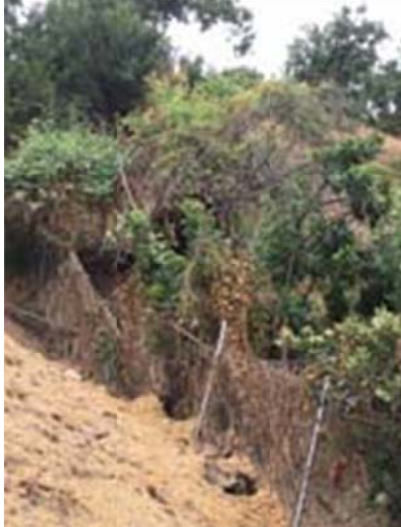
<p>Tree 25 <i>Juglans californica</i> – California Black Walnut</p> <p>This tree is protected by ordinance. It is showing signs of drought stress. If the tree protection fencing shown in this report is not crossed, it is unlikely this tree will be affected by construction activity.</p>

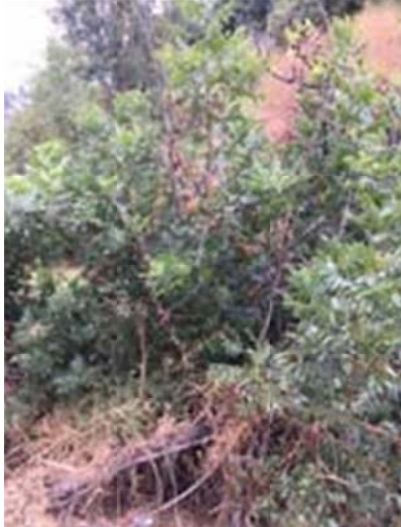
<p>Tree OP26 <i>Juglans californica</i> – California Black Walnut</p> <p>This tree is protected by ordinance. It is nearly dead. If the tree protection fencing shown in this report is not crossed, it is unlikely this tree will be affected by construction activity.</p>

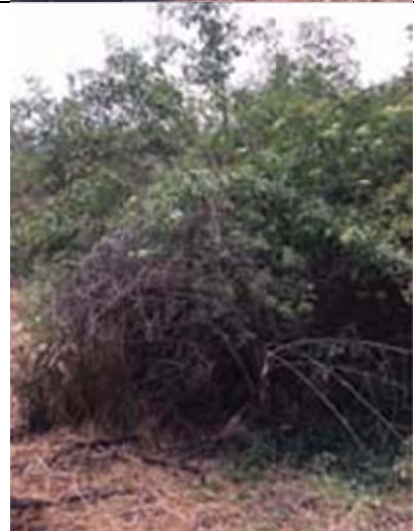
<p>Tree 35 <i>Sambucus mexicana</i> – Mexican Elderberry</p> <p>This tree is not protected by ordinance. It will be retained in the landscape.</p>

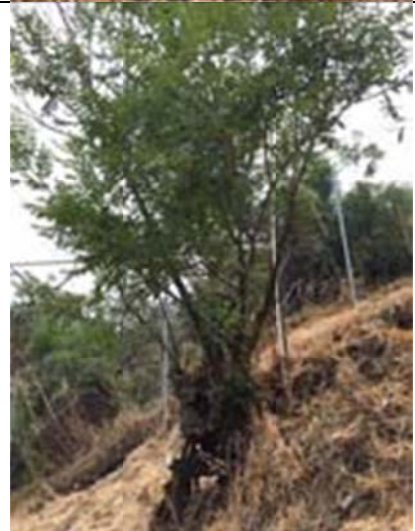
<p>Tree 38 <i>Juglans californica</i> – California Black Walnut</p> <p>This tree is protected by ordinance. It is nearly dead. If the tree protection fencing shown in this report is not crossed, it is unlikely this tree will be affected by construction activity.</p>

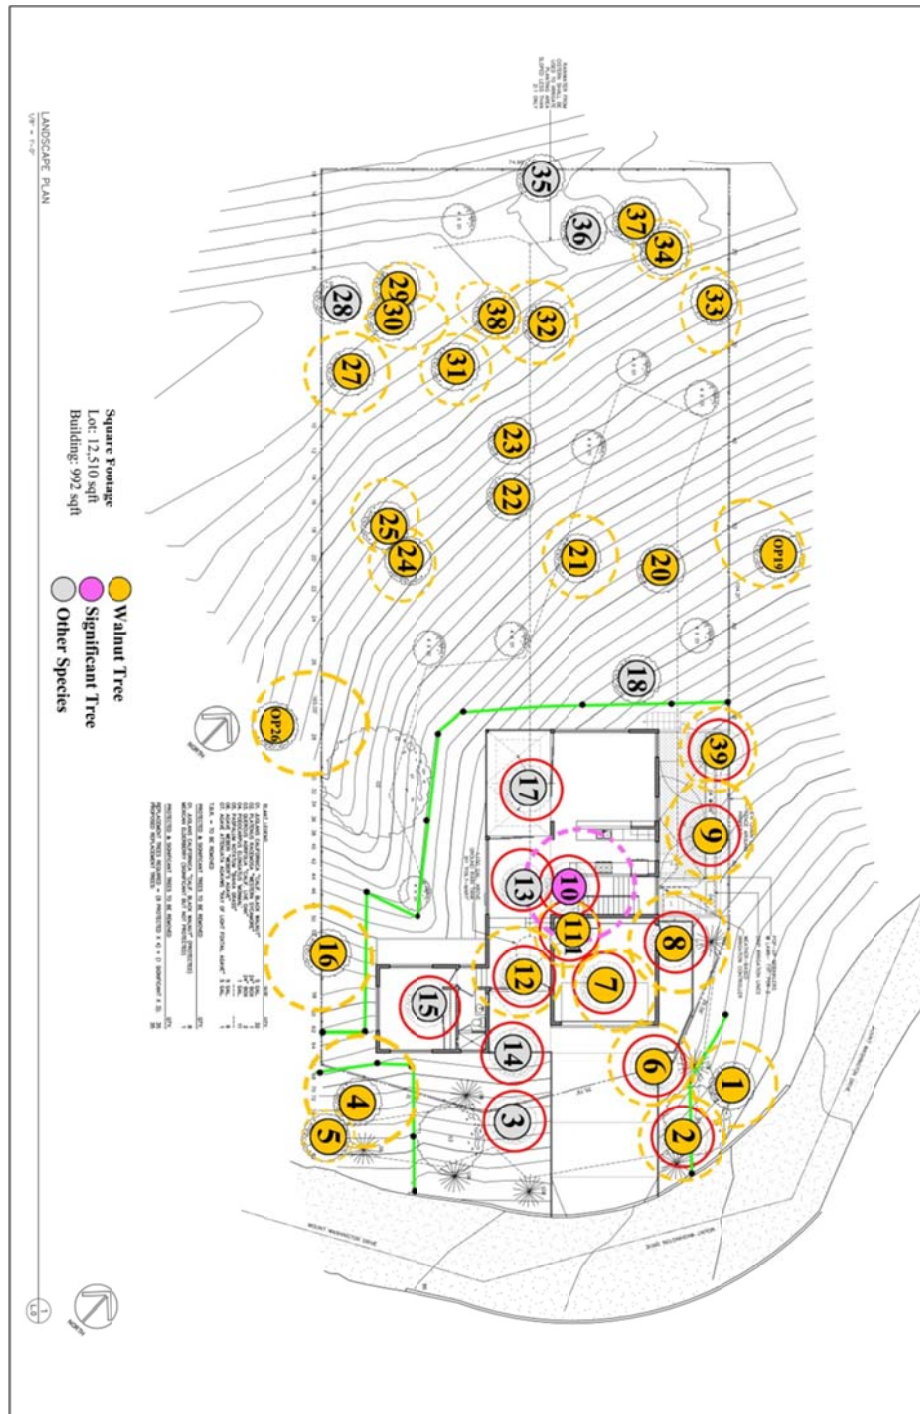
Figure 1: Site map of the subject trees. Walnut trees are shown in orange. Significant trees are shown in purple. Trees that are not protected species are shown in grey. The trees proposed for removal are circled in red. The proposed tree protection fencing is shown in green.

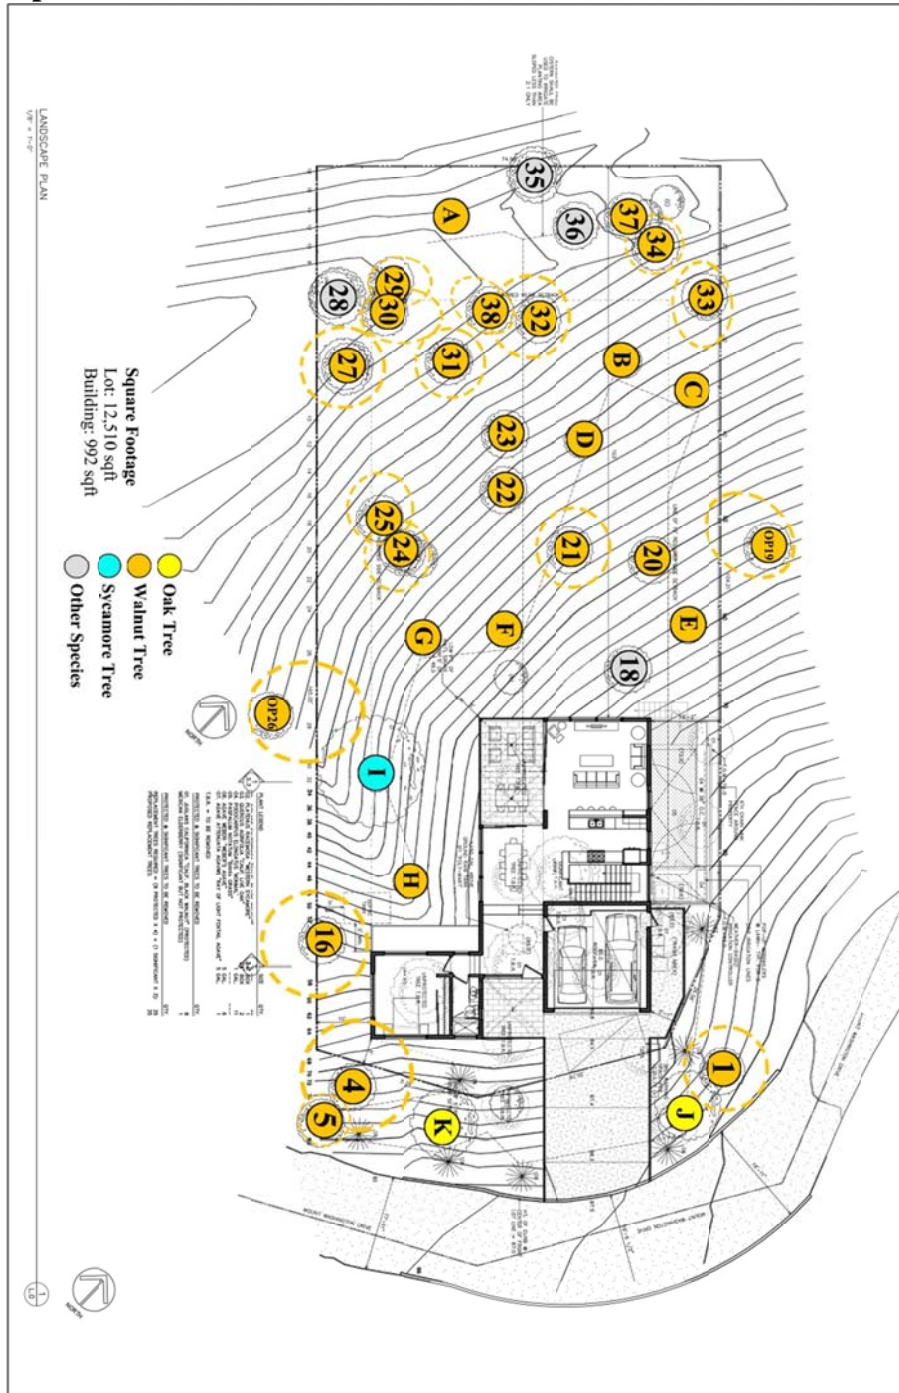
Figure 2: Mitigation tree map showing suggested locations for replacement trees. 8 clusters of 4 replacement walnut trees each are labeled A-H. Two oaks and a sycamore labeled I-K will replace the one significant tree removed.
