Appraisal Report

Prepared by James Komen BCMA WE-9909B RCA #555

Class One Arboriculture

Summary of Appraisal

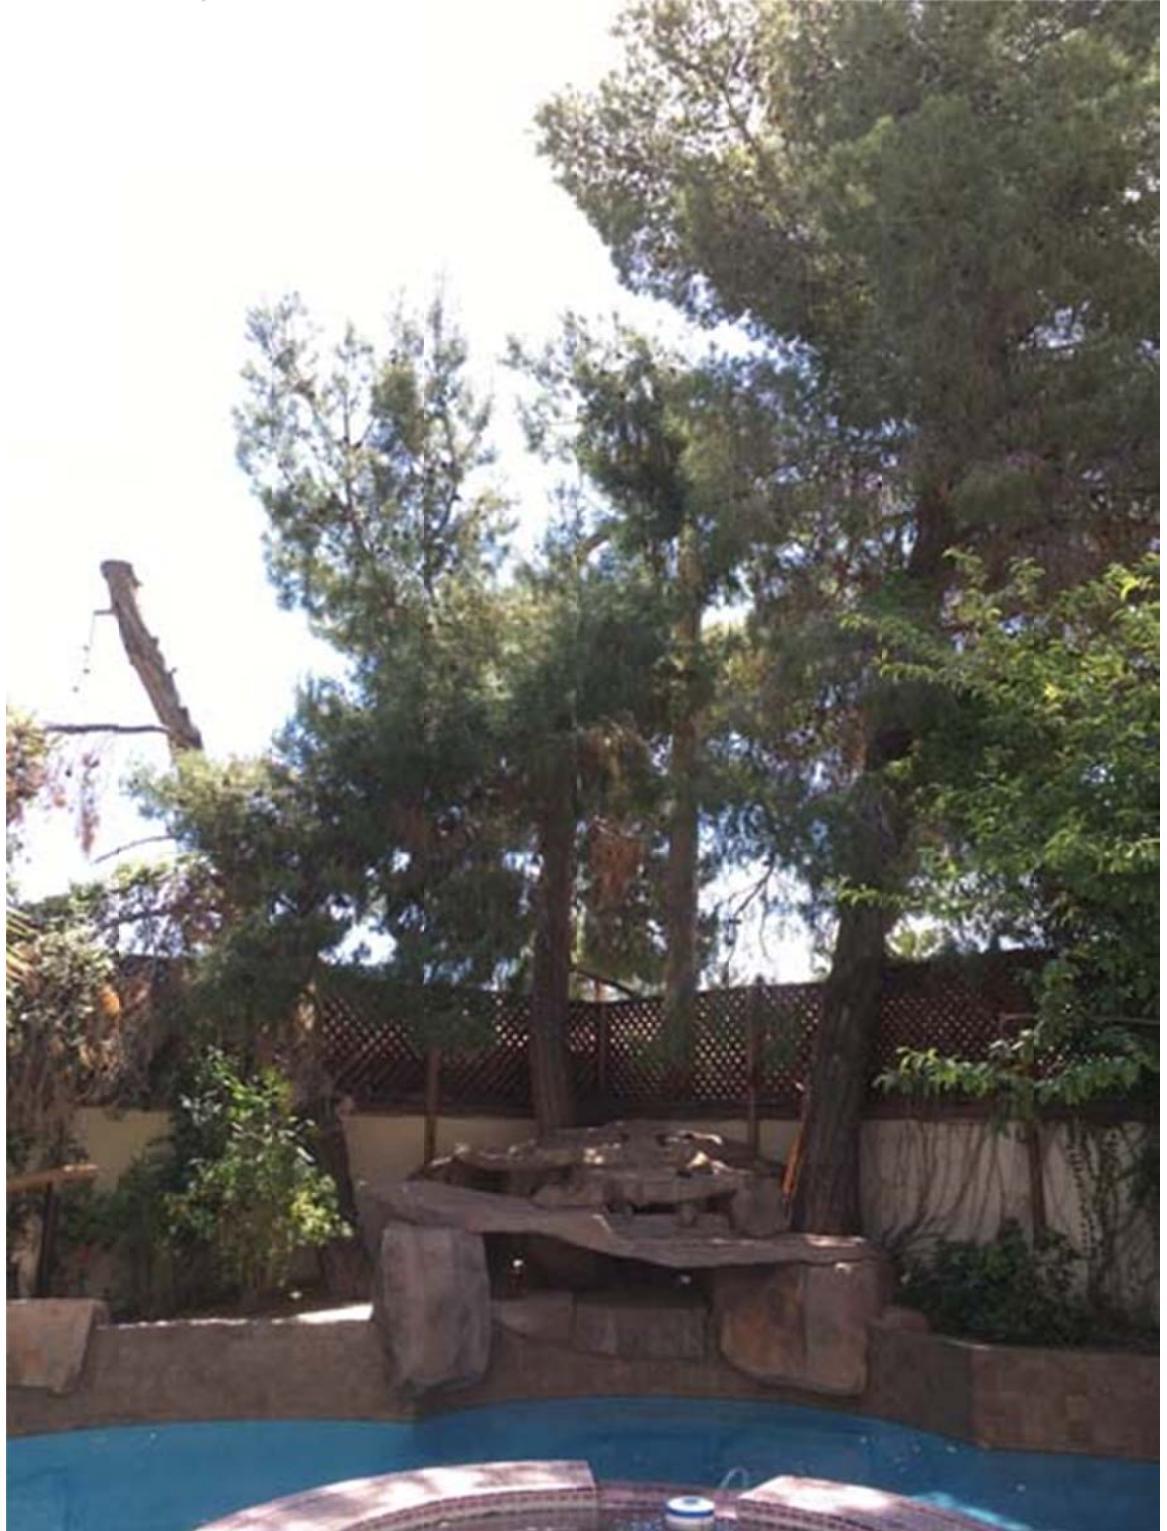
Figure 1: Looking southeast at the stand of three Aleppo pines behind the pool (below frame). The subject tree is the tree on the left.

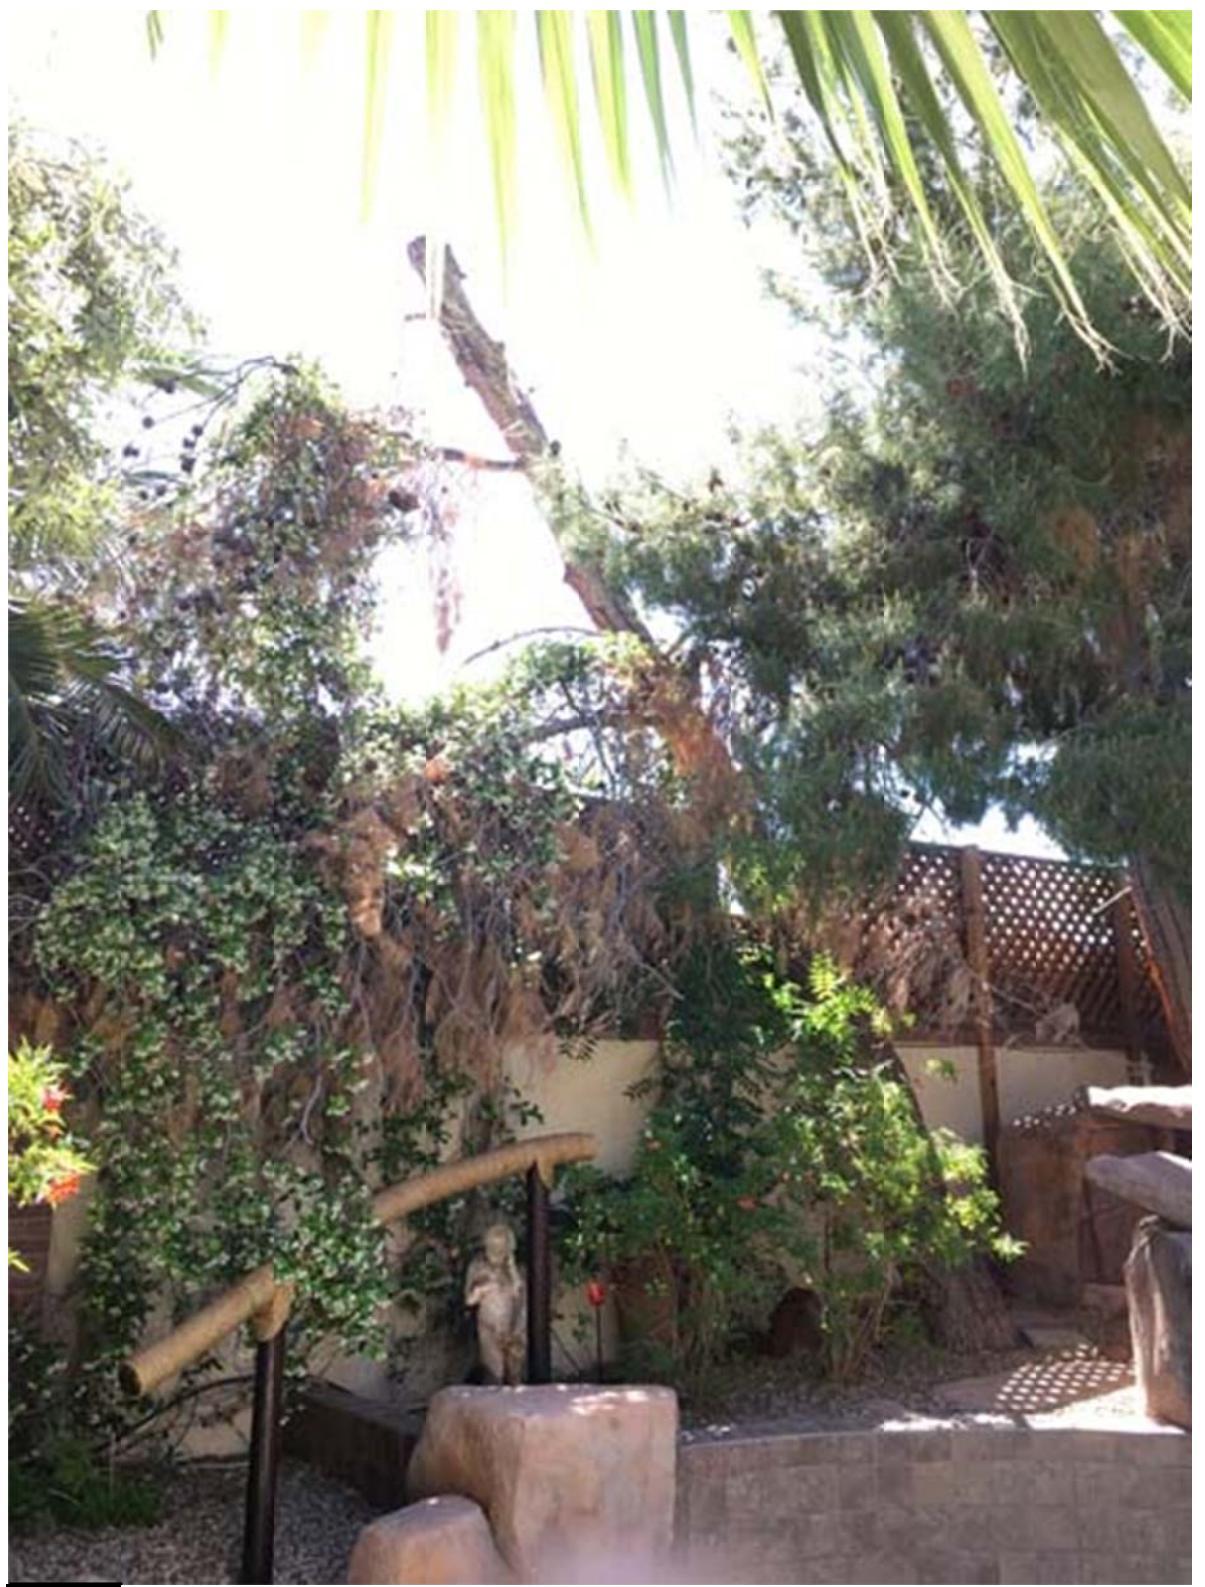
The subject tree was growing in an irregular planter space measuring approximately 8 feet from the wall to the pool, 16 feet from the edge of the planter to a point near the eastern wall, and 23 feet from the edge of the planter to the southern wall. Although this amount of soil volume is not ideal for this tree, the two remaining trees in the planter do not show evidence of stress related to low root volume.

: Looking southeast at the subject tree growing in an irregular planting space behind a ure (lower right of frame) and a wall along the property line.

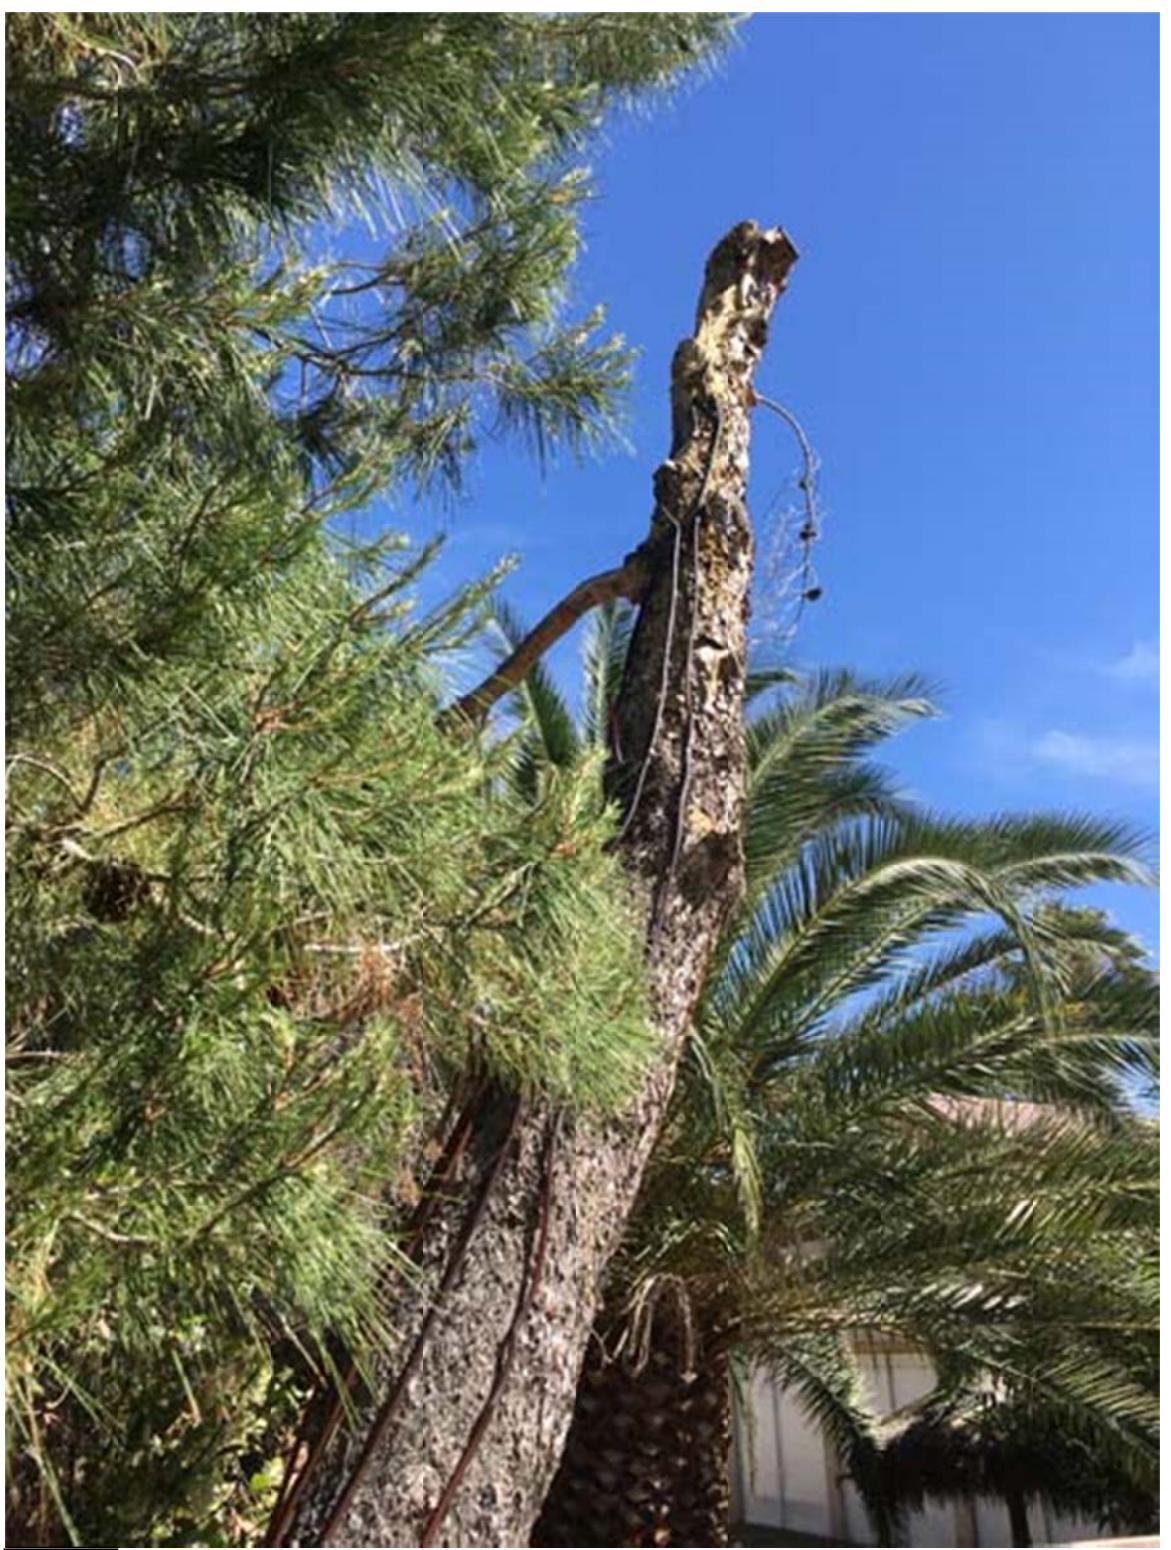
The subject tree was not completely dead at the time of my observation. There was one branch on the northern side of the canopy that had some green needles. From my personal experience with this species of tree, it is unlikely that it will survive much longer in the landscape, and it is highly unlikely that it would ever grow to recover its former size and landscape contribution. Therefore, I recommend the removal of the remaining trunk. Since I have recommended removal of the tree, I did not rate it for post-loss condition.

Looking north at the subject tree. Nearly all of its foliage was recently removed. It is likely this species of tree would be able to survive in the long term as a result of the

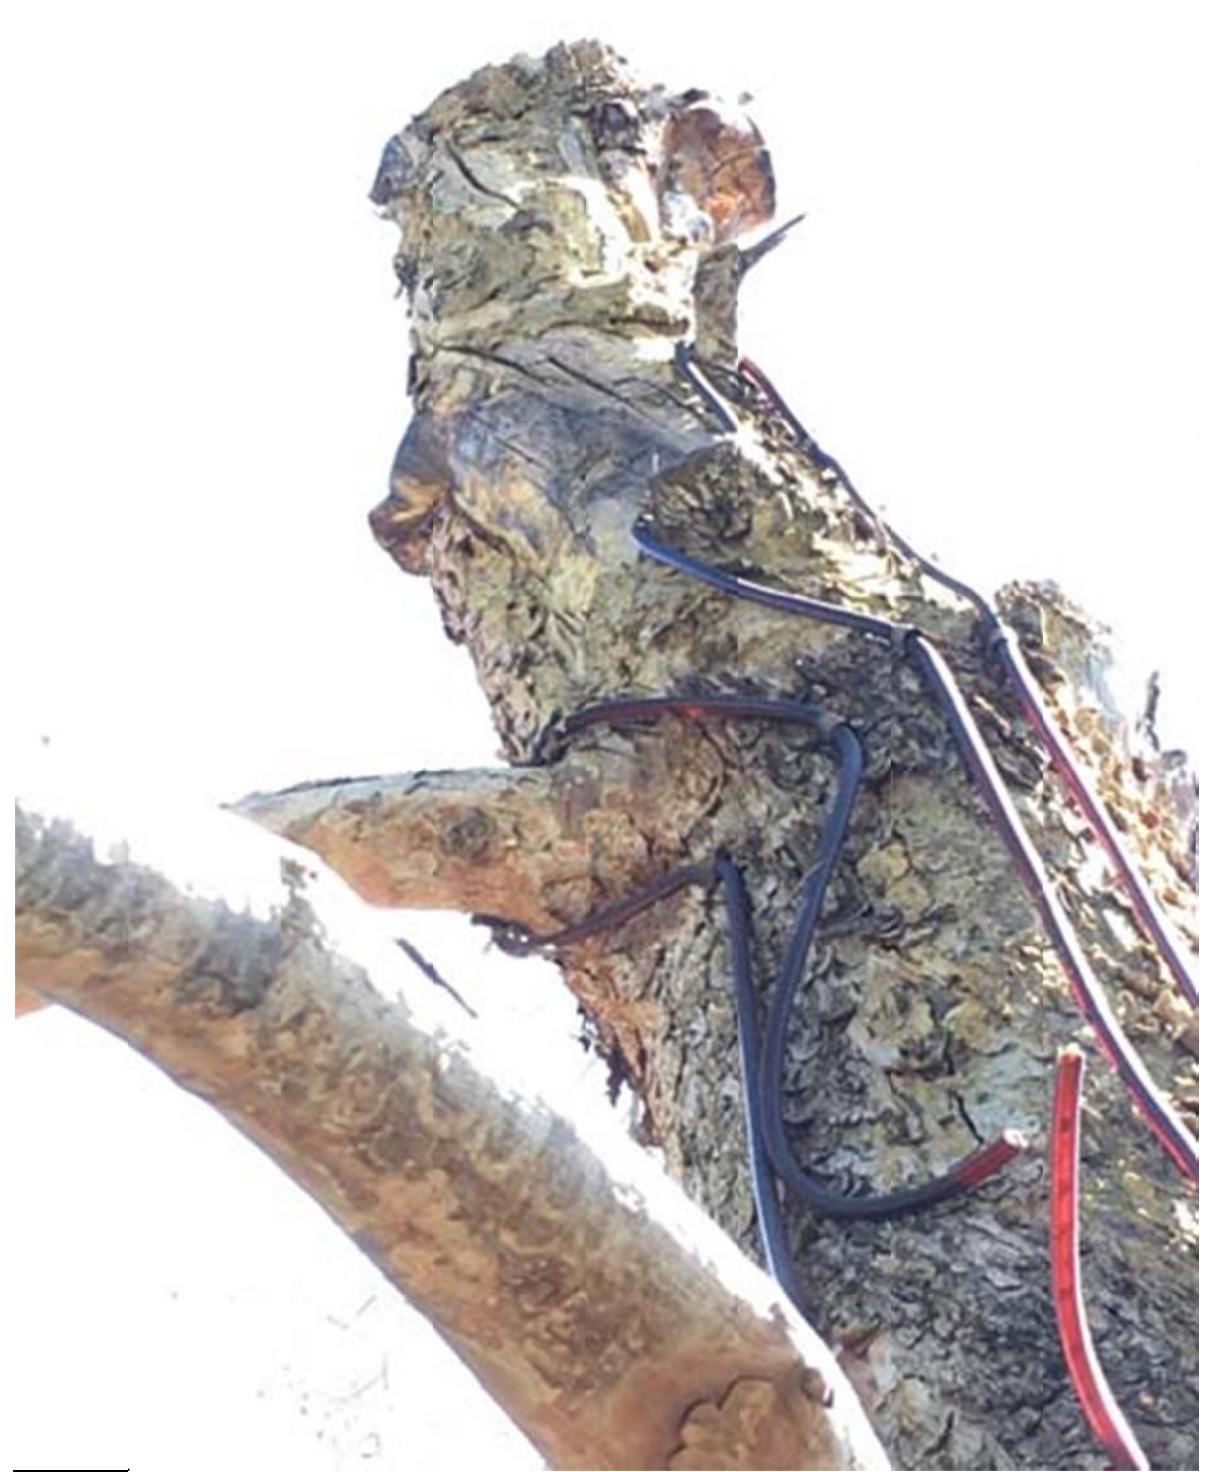
I observed some sunburn injury on the bark on the western side of the trunk near the topping cut along the main stem. This sunburn injury appeared to pre-date the topping cut, so I considered it for the pre-loss condition rating. Sunburn occurs as a result of excessive solar exposure raising the temperature of the living cells underneath the bark. The extent of the sunburn did not appear to significantly affect the health of the rest of the tree. The wound did not have substantial decay associated with it either. Therefore, I rated the defect as minor.

Close up of the top of the subject tree. I observed some old sunburn injuries that have pre-dated the pruning event discussed in this appraisal report.

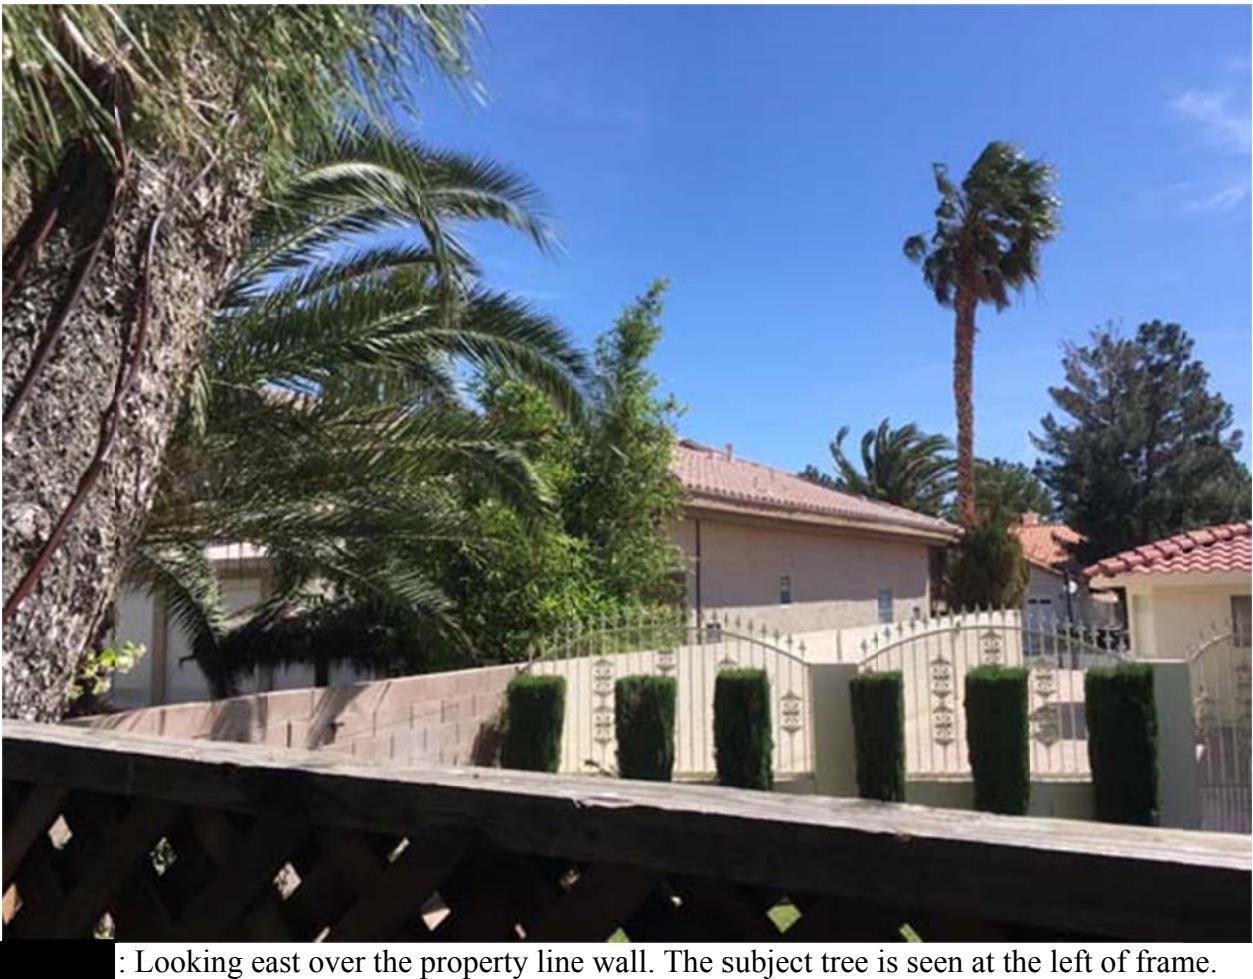
: Looking east over the property line wall. The subject tree is seen at the left of frame. hbor's driveway would be the most feasible access point for a crane to unload the ent tree. The property line wall (bottom of frame) would need to be demolished to allow lation of the proposed direct replacement tree.

- 2. A portion of the adjacent wall must be demolished to fit the replacement tree in the same location as the former tree. A sufficient portion of the wall must be demolished to allow the installation of two piers on either side of the replacement tree's root ball to allow the new wall to bridge over the root ball without placing any new weight upon it. This appraisal does not include the cost of wall demolition.

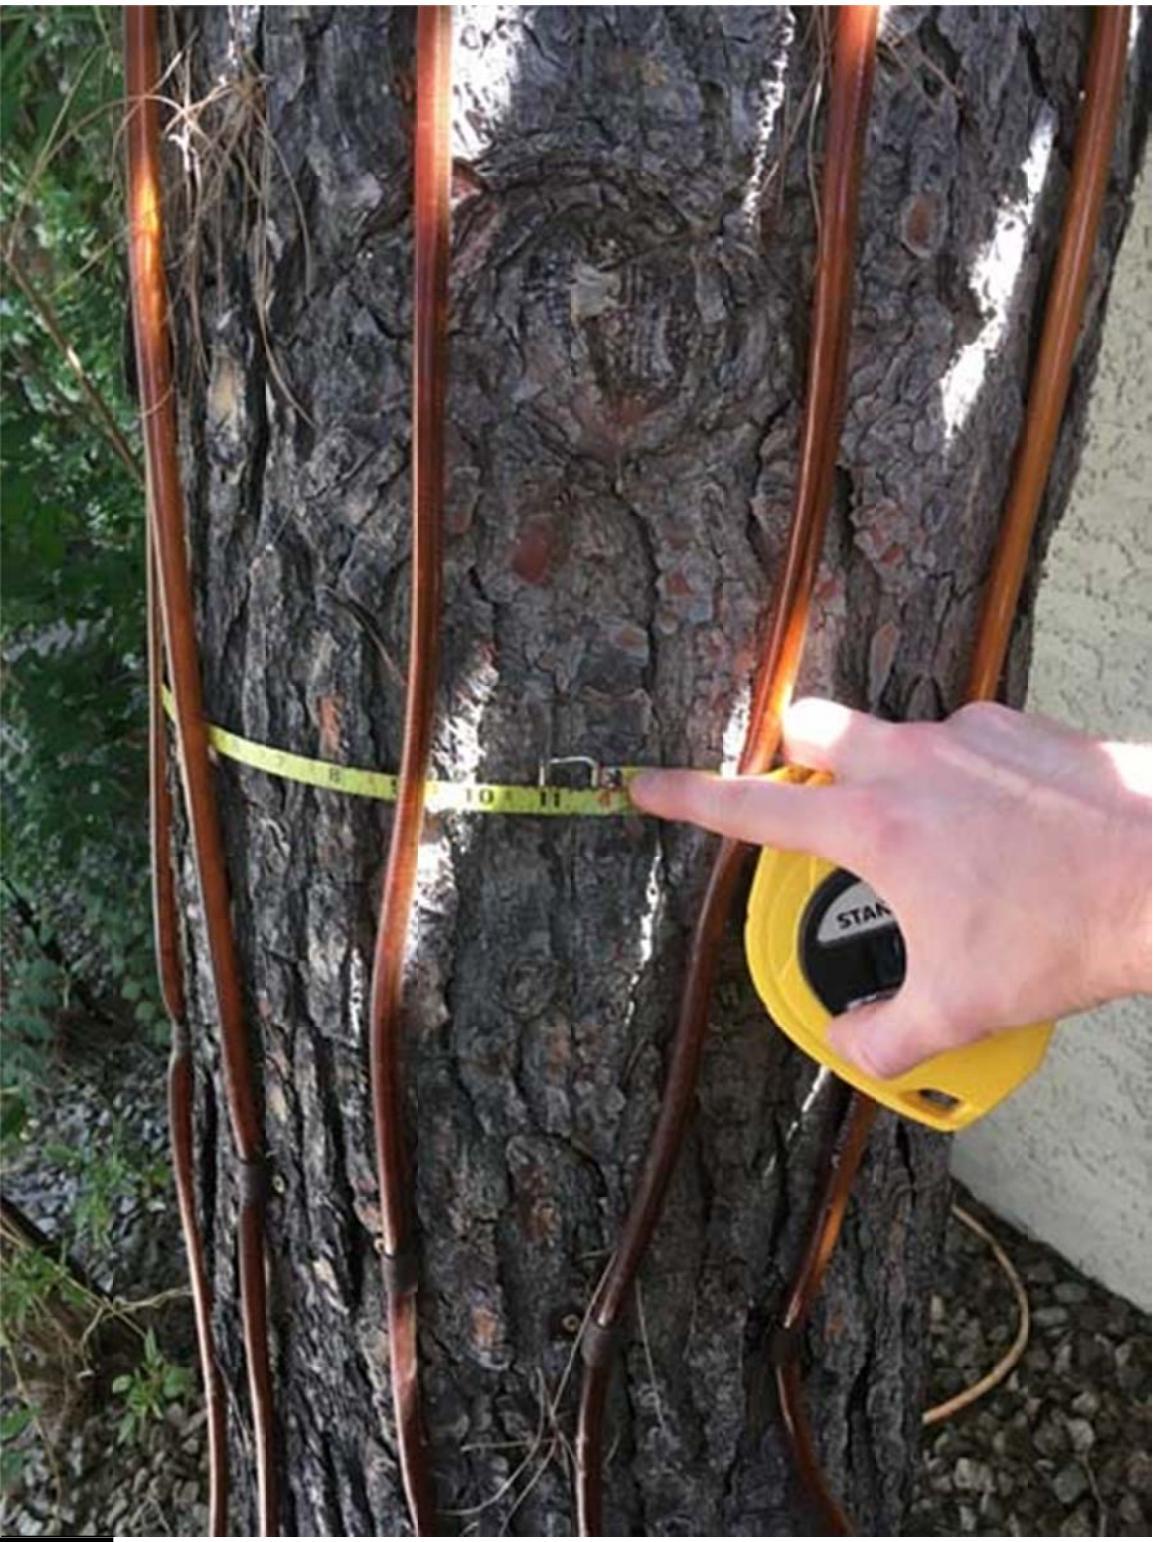
First, the diameter of the subject trunk is measured. The height of the measurement is made at 4.5 feet above natural grade. I made my measurements with a regular measuring tape and then used my circumference measurements to calculate the diameter and then the cross sectional area of each tree. The circumference of the tree was 3 feet, 11 inches, and the calculated DBH was 15 inches. The cross sectional area (A) is calculated by the formula $A = \pi/4 d^2$ for trees with circular trunks. The trunk formula method assumes that the trunk of a tree can be approximated by a perfect circle.

: Trunk measurement was taken by threading the tape measure underneath lights that ched to the trunk. The circumference was measured to be 3'11". The DBH was d to be 15".

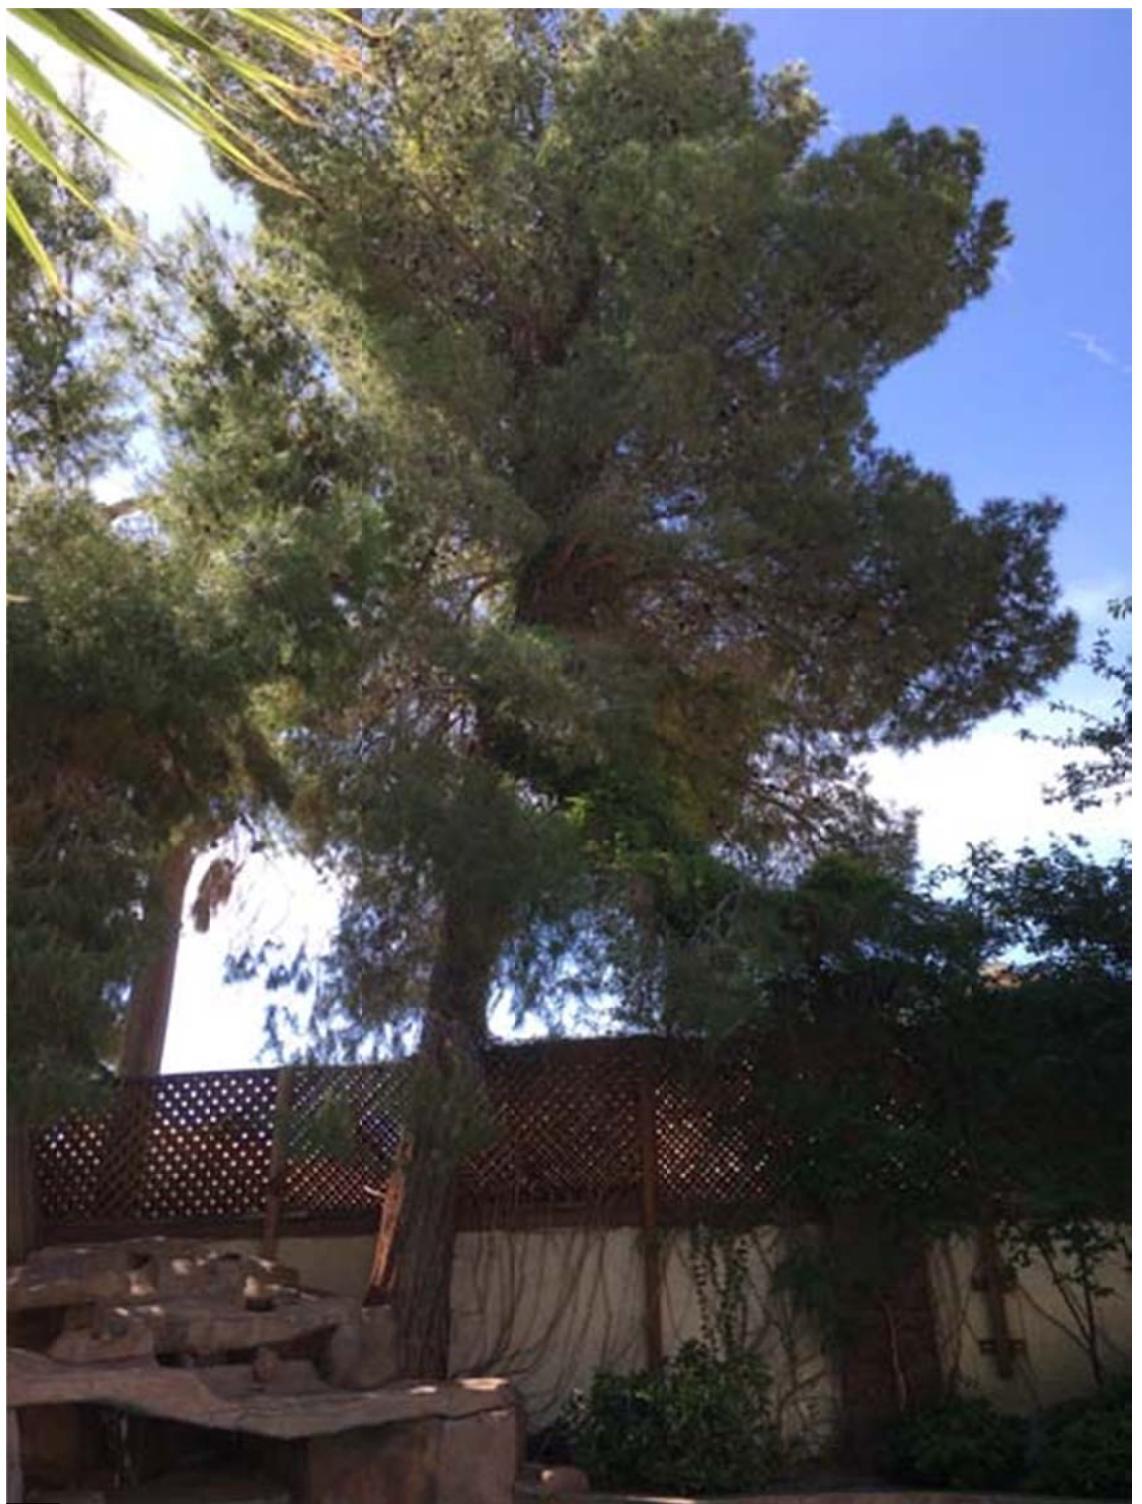
- Branch Health: 3 Minor Defects. Since most of the branches of this tree had been removed, I was not able to rate the tree by direct observation. Rather, I observed the neighboring Aleppo Pines that were the same age and size and assumed that the subject tree had similar branch health. The neighboring Aleppo Pines each had evidence of "Aleppo Pine Blight," a common, albeit minor dieback of twigs in the outer portions of the canopy. Aleppo Pine Blight is associated with dry soils and cold, drying winds. On these trees, it did not appear to be a problem to the branch health, so I rated the defect as minor.

: Looking south at Tree 3. This tree did not appear to be damaged by the pruning event . This tree was approximately the same size and was likely planted at the same time as ct tree. The condition of this tree I observed at my site visit likely represents the pre-loss of the subject tree.

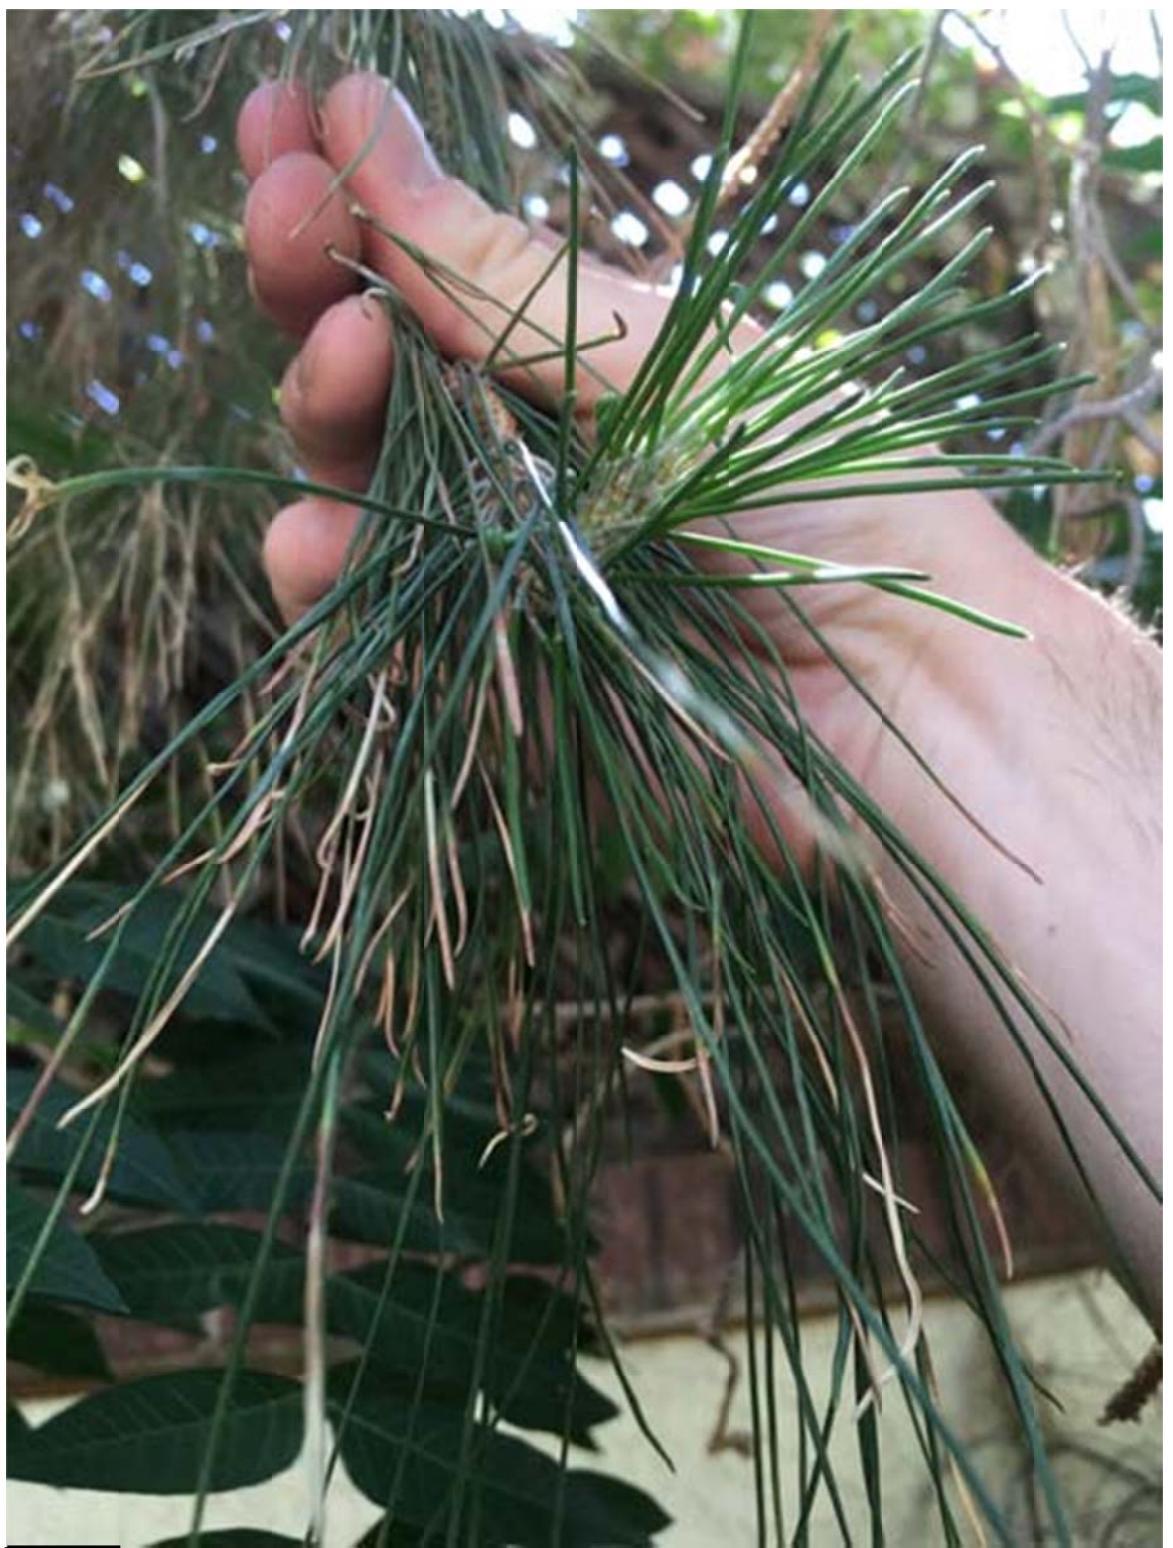
Close up of some of the remaining foliage on the subject tree. The subject tree was still e time of my observation, but it will not likely survive in the long term.

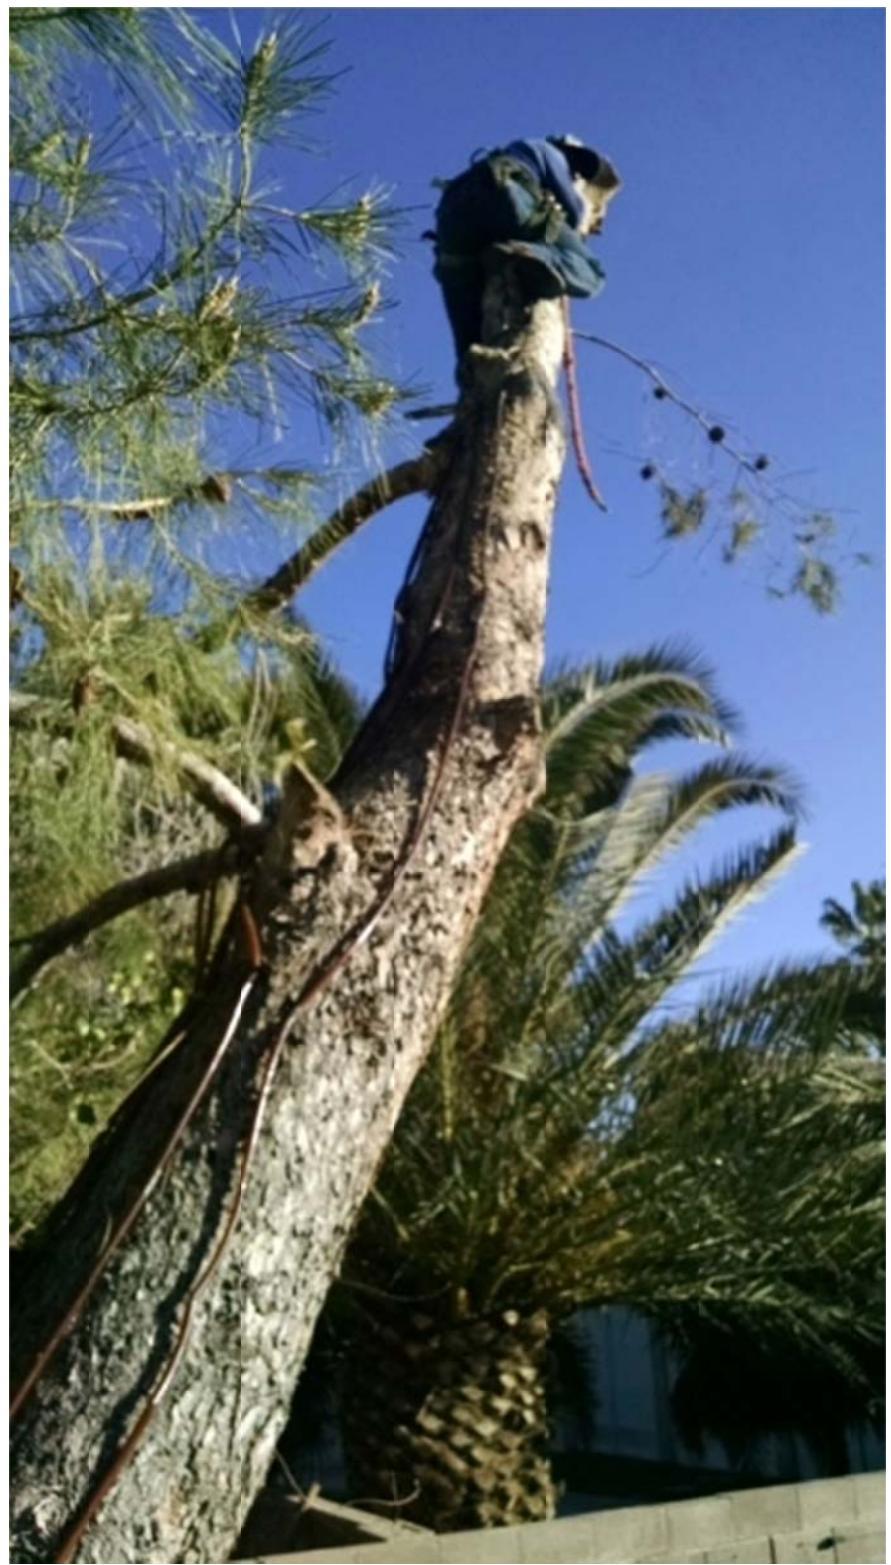
: Looking up at a worker making cuts on the subject tree. This photo was provided to

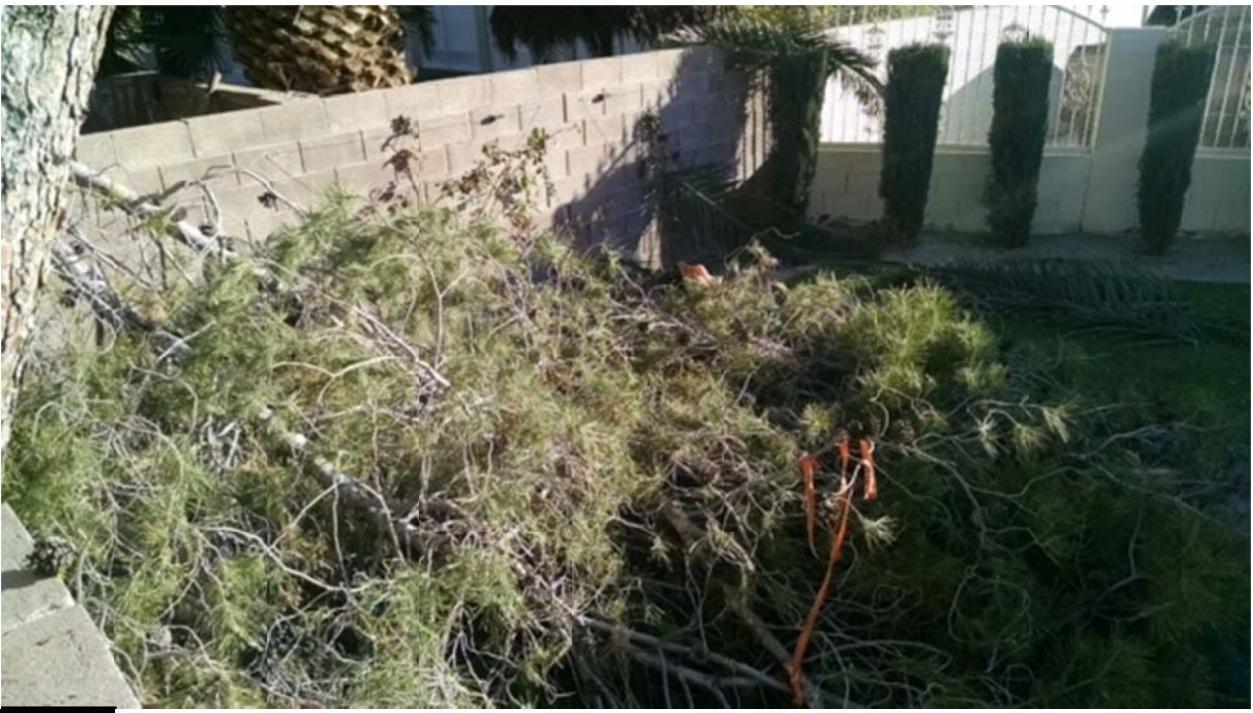
1: Looking northeast at the pile of brush removed from the subject tree. This photo was to me by **bruck** I was told that it was taken at the same time as Figure 10. The green dicates the branches were recently severed from the tree. This quantity of foliage o constitute most if not all of the former canopy of the subject tree.

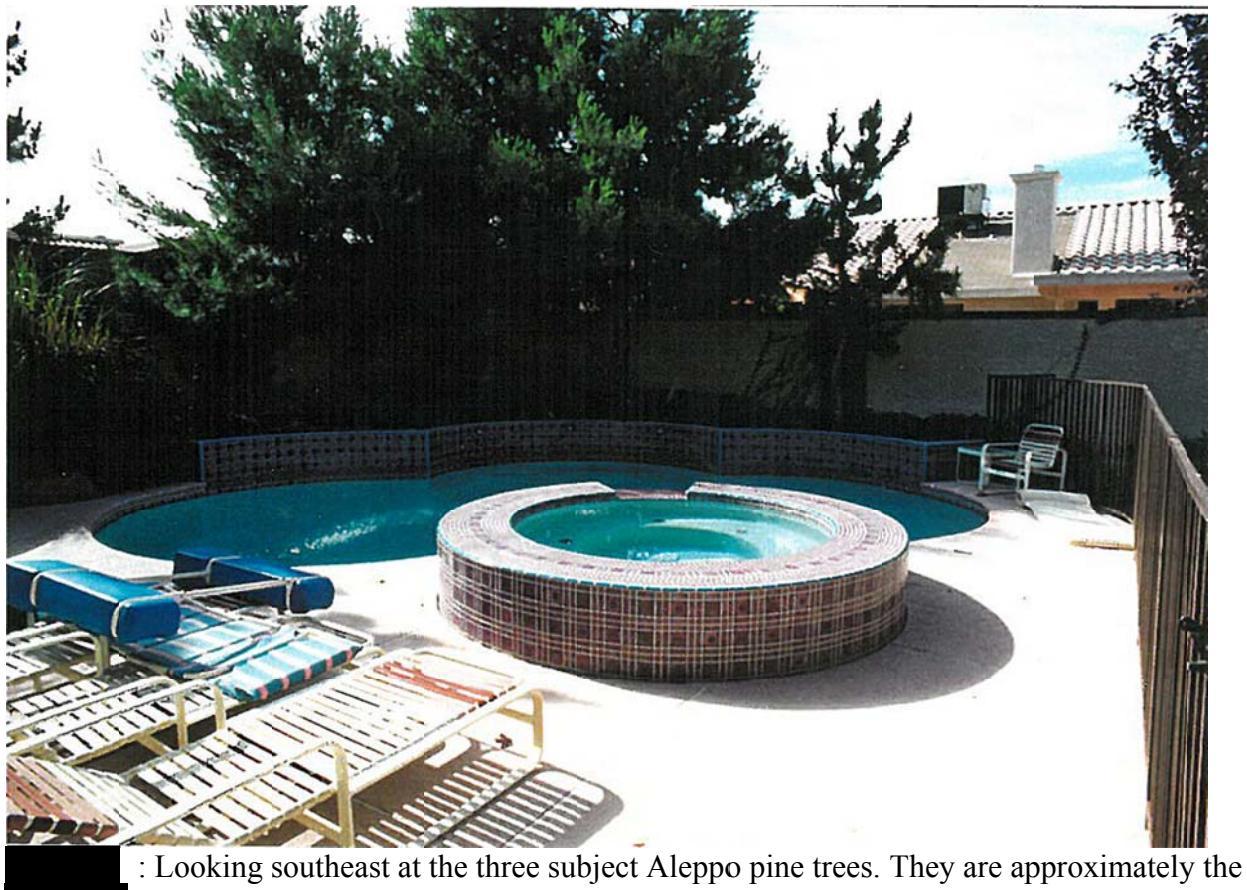
: Looking southeast at the three subject Aleppo pine trees. They are approximately the as each other. They significantly contribute to the aesthetic appearance of the This photo was taken in 1997 and was provided to me by

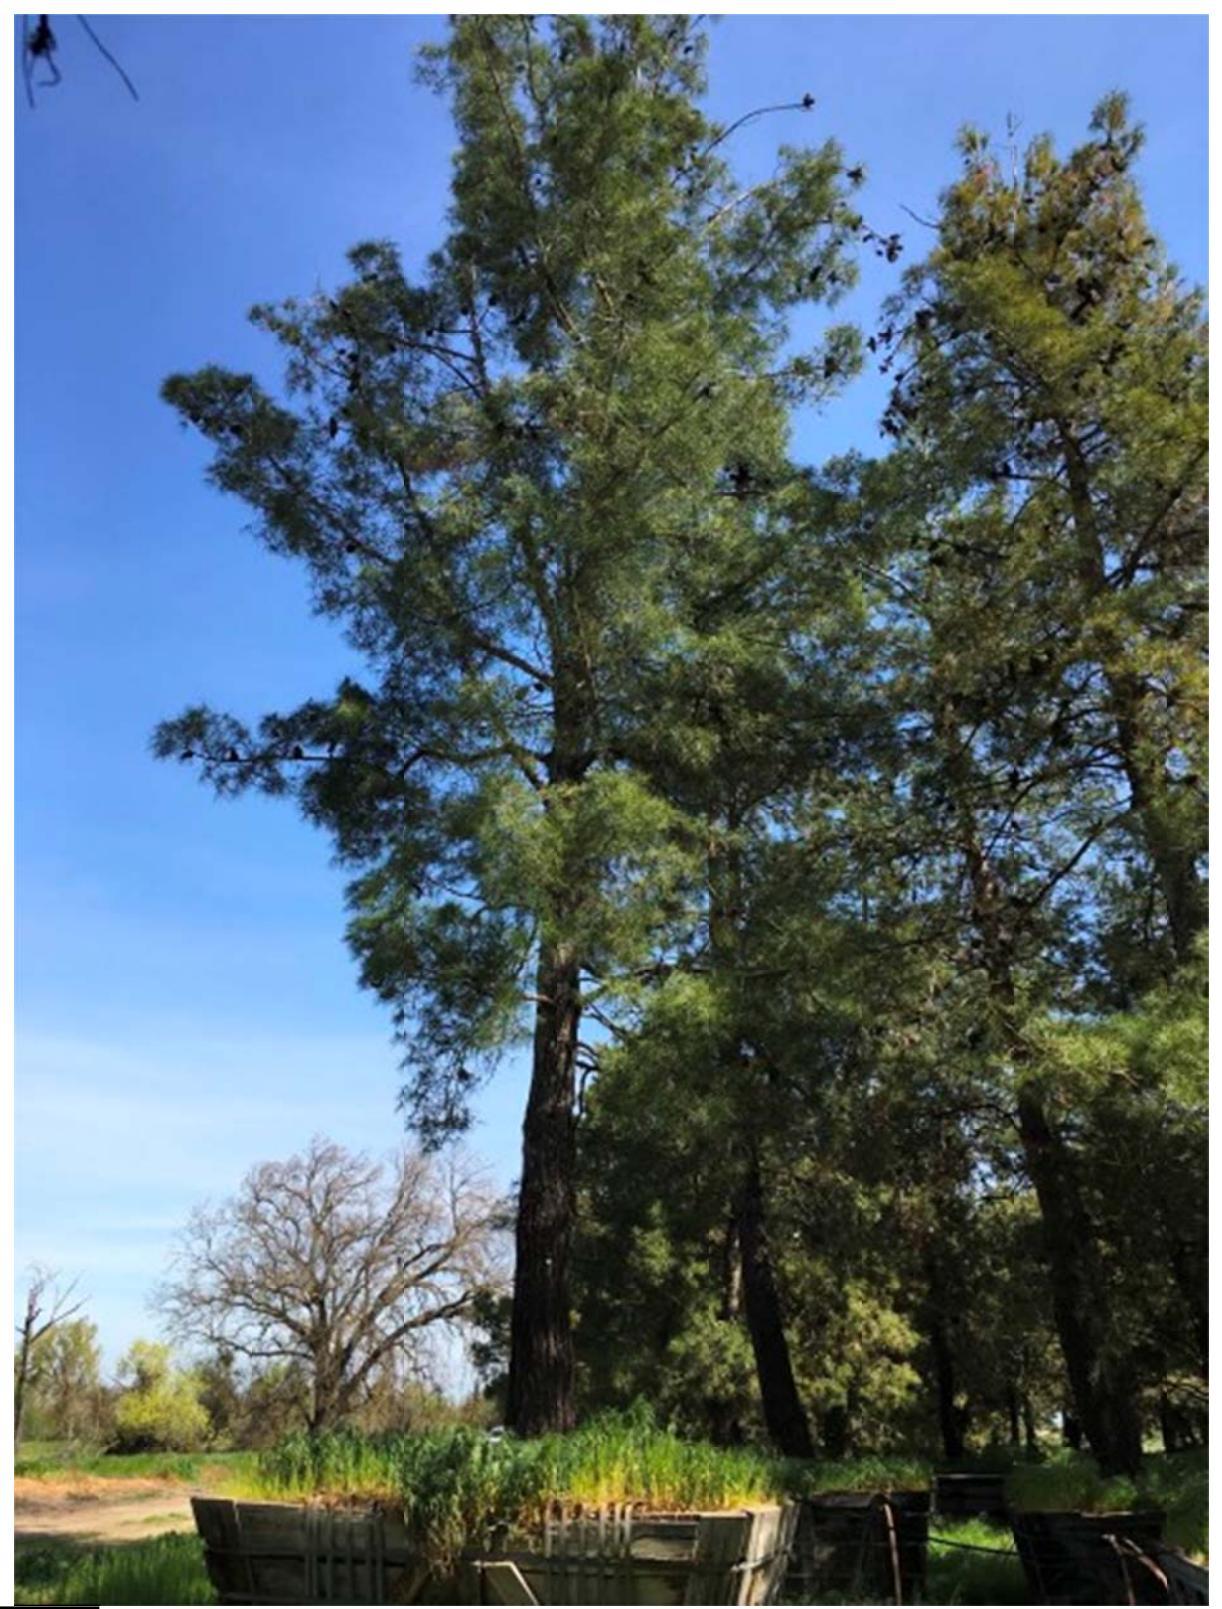
3: Image of the replacement Aleppo Pine tree for sale by Shady Tree Farm. This photo ided to me by a sales representative.

- *Tree Acquisition*: The cost of acquiring a tree from the nursery is the sale price of the property. It reflects a combination of the supplier's cost of production and the general marketplace demand for a tree of that size. First, the largest actually available tree must be located. The referred me to a supplier in California that sold a 40-foot *Pinus halepensis*. I then obtained tree acquisition quotes from three other nurseries. One nursery had two adequate replacement trees: one was taller but had a smaller DBH, and the other one was shorter and had a larger DBH. Both trees were included in my calculation. One nursery's largest tree was much smaller than the others, so it was not included in the calculation because it was not an adequate replacement. I took the median cost of the remaining four possible replacement trees.
